*Morphology and Dynamics of the Sandy River at the Boat Ramp
in Oxbow Regional Park, Oregon*

Metro Regional Parks and Greenspaces

Final Report
December 2000

The Sandy River at Oxbow Park, Oregon
Morphology and dynamics in the vicinity of the boat ramp

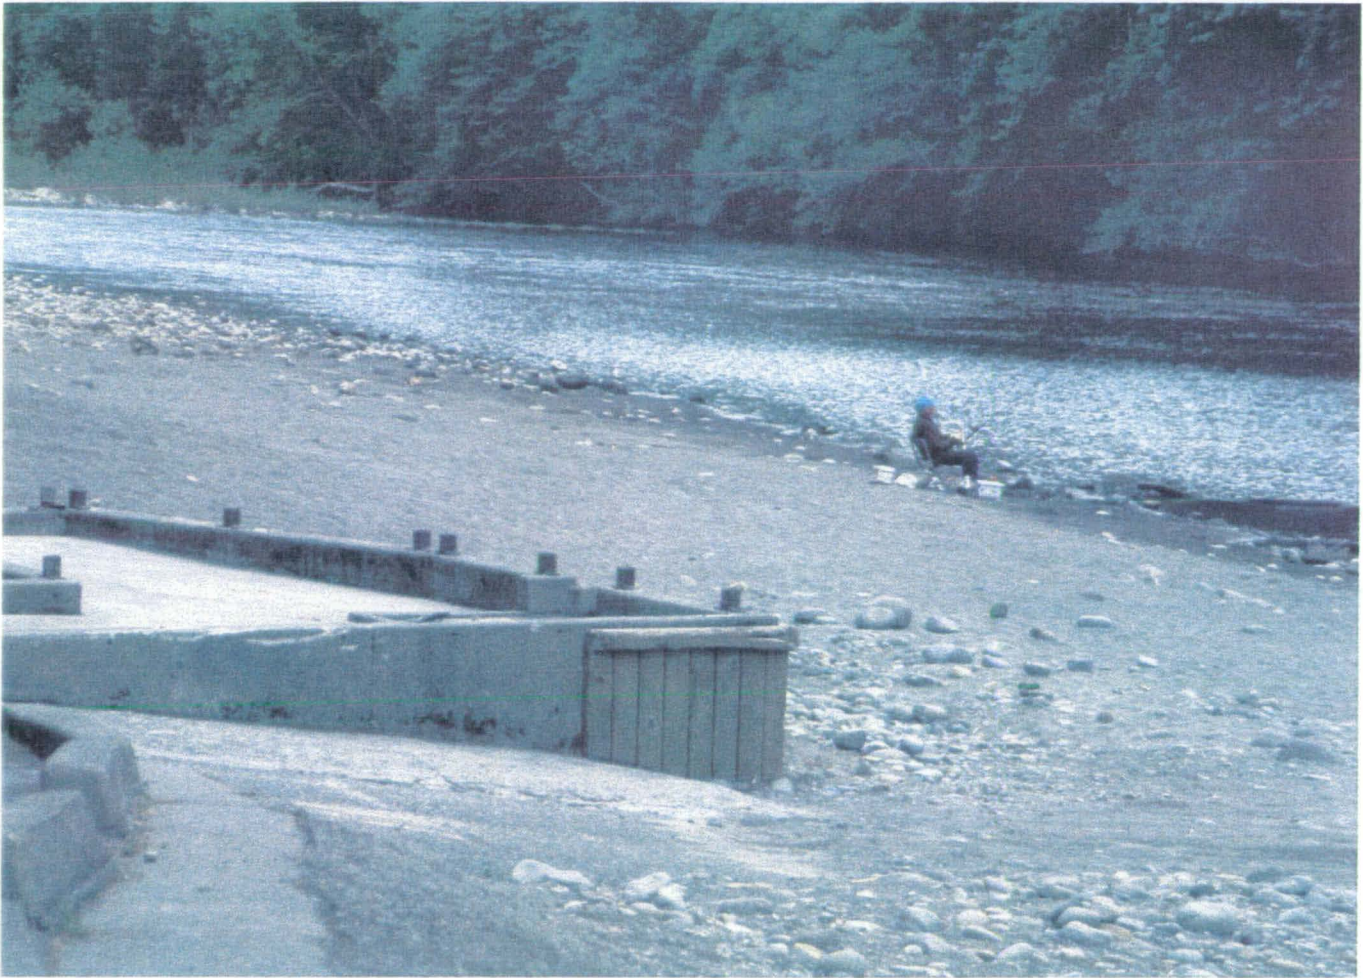
The handicap fishing platform near the boat ramp at Oxbow Regional Park was built in the mid- to late 1980s. Sand that formerly veneered the cobble point bar here has been eroded and has not been replenished by normal beach-building processes. It appears that asphalt and gunnite surfaces at the platform, the boat ramp and in the back beach area are partly responsible for sand starvation here. The large runoff events of 1996 and 1999 probably hastened the erosion of beach sand by focusing flow velocities in the back beach area.

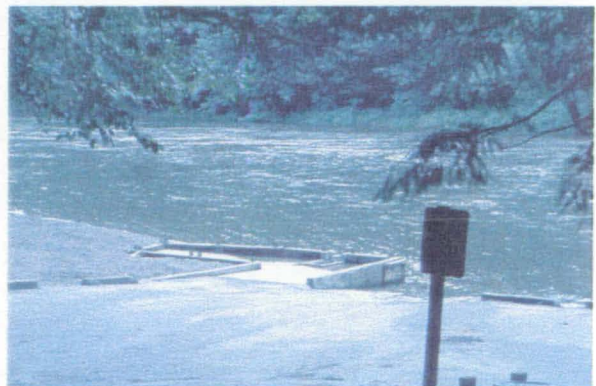
Right: Summer water levels relative to the platform have dropped in recent years, according to park managers. Presently, summer levels reach to the dock only during the late spring freshet or after large runoff events, such as on June 12 after several days of intense rainfall. There is evidence that the channel bottom in this reach is incising.

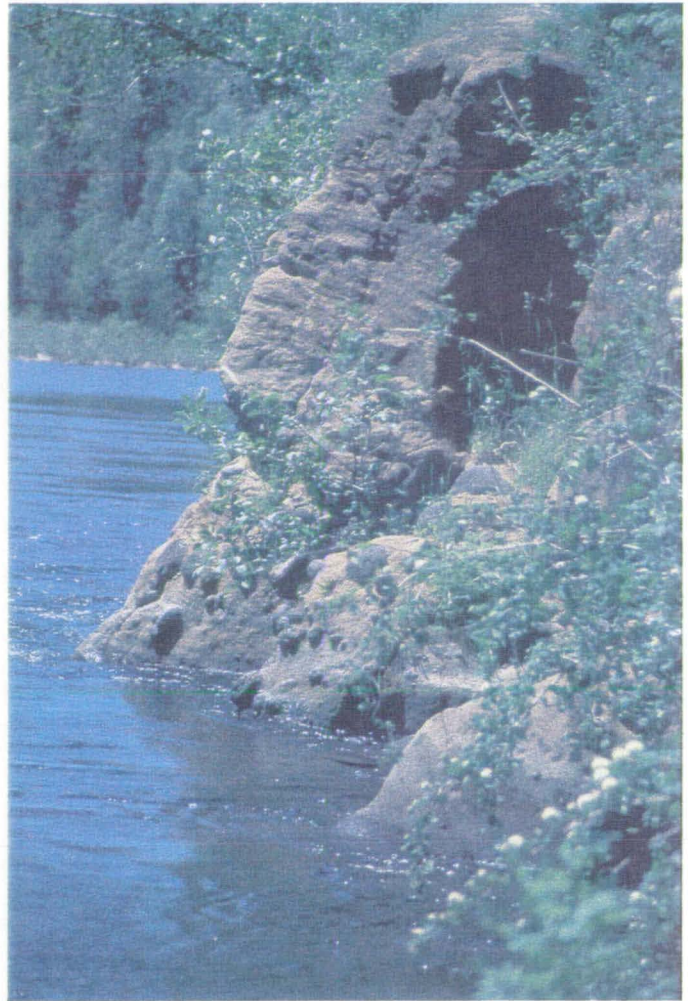
Left: Sandy River mudstone forms a resistant, vertical bank opposite the point bar on which the boat ramp and fishing platform are located. The thalweg is close to the bank in this location, creating a deep pool. Opposite, the point bar is shallow-shelving, as would be expected.

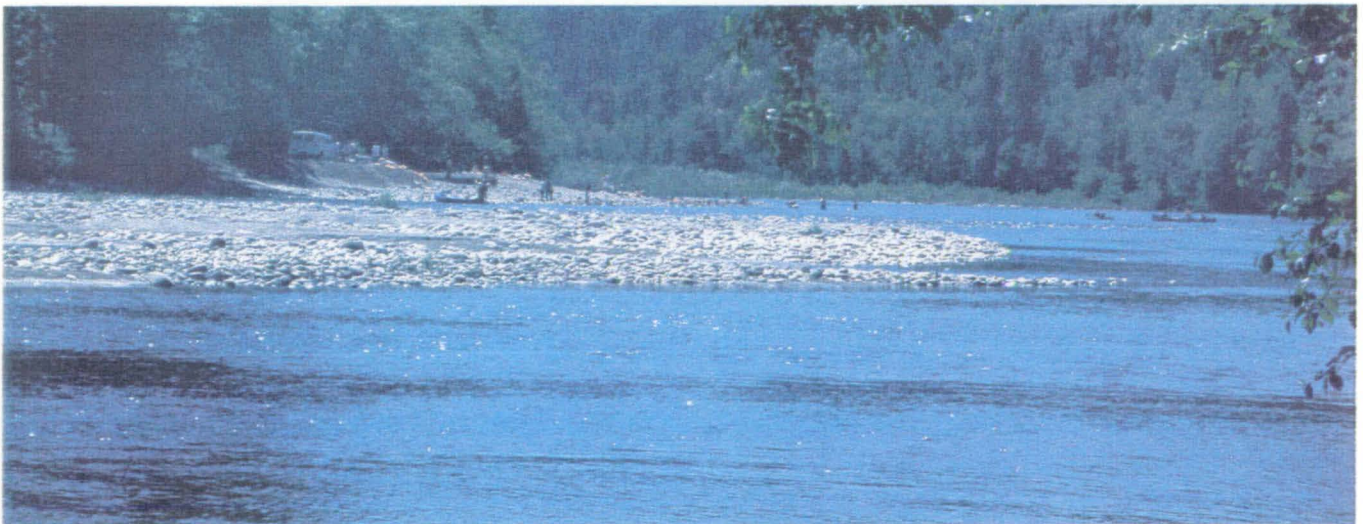
Below: A mid-channel bar tails out just above the point bar where the boat ramp and fishing platform are located. The channel between this bar and the riverbank immediately upstream of the boat ramp is broad and shallow, and, in summer, lacks a defined thalweg.

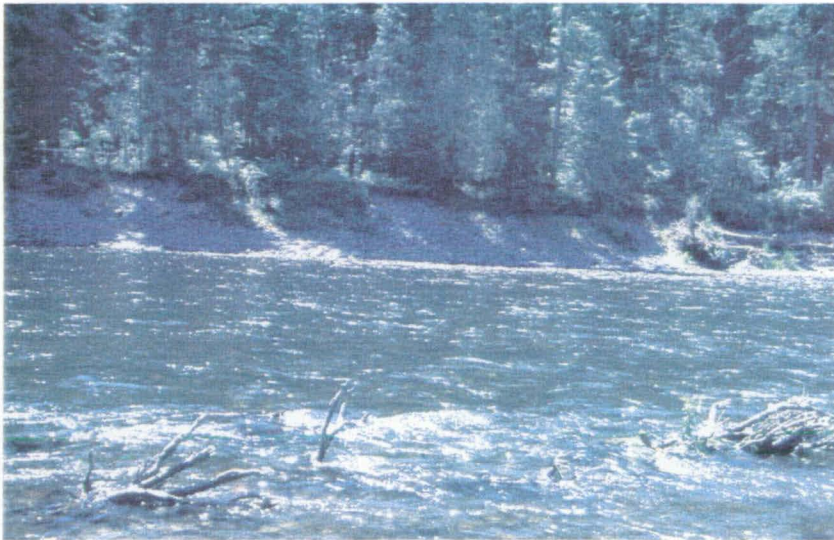
Left: In 63 years of aerial photos, the riverbank immediately upstream of the boat ramp on this straight reach appears to be chronically eroding, resulting in incremental removal of a remnant terrace in this area.

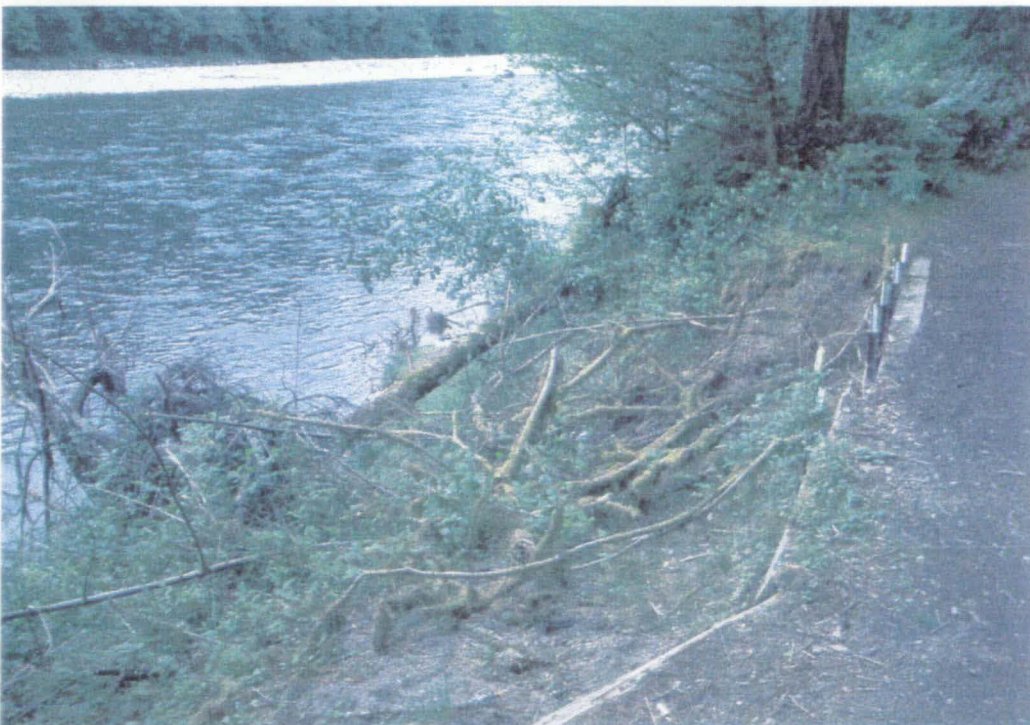
The willows submerged in the foreground are growing on a long mid-channel bar that tails out just above the point bar and boat ramp. The bar is covered on this date by high water following a storm of several days' duration. The channel here is broad and shallow, lacking a defined thalweg.

Left: The riverbank upstream of the boat ramp is chronically eroding due to shear stresses on the non-cohesive bank materials during high flow events. Incremental erosion is slowly reducing the extent of a remnant lahar outwash terrace in this area. Segments of trail along the river in this location have been undermined, washed out or abandoned. The mid-channel bar can be seen in the upper left.

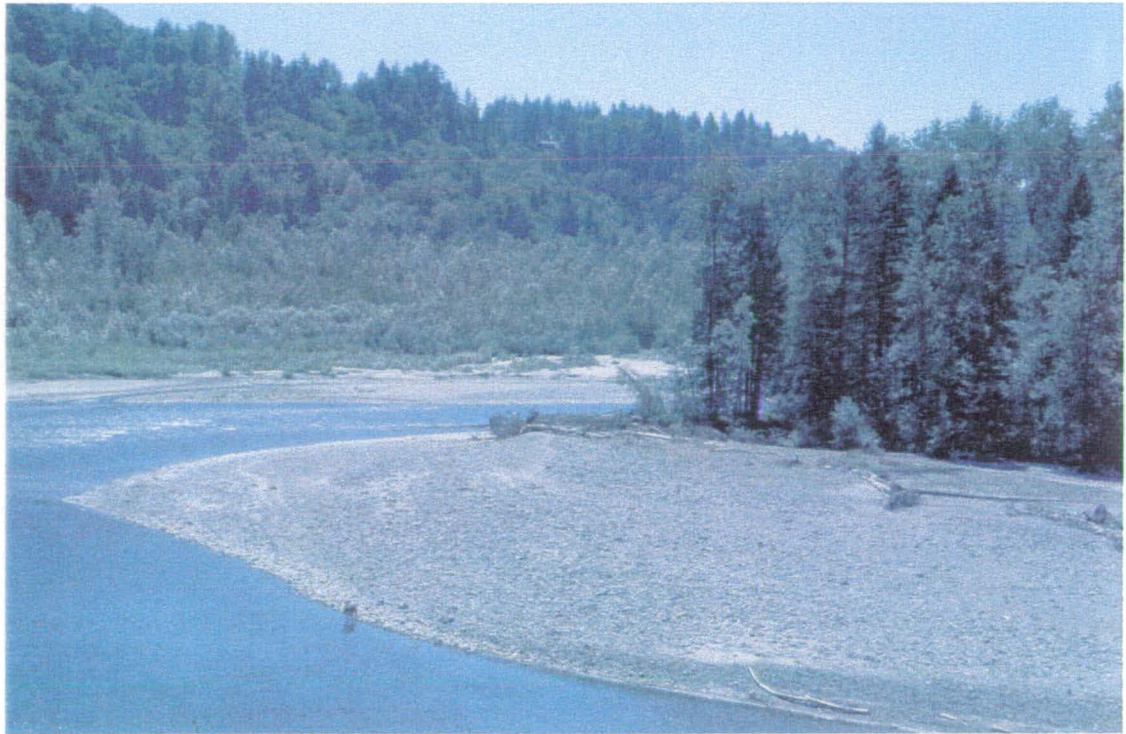
Right: This extensive bar opposite the mouth of Gordon and Trout creeks was laid in the 1996 flood event. A 1966 aerial photo shows a former extensive bar in this general location after the 1966 flood. The lower river is a dynamic zone of sediment transport and deposition.

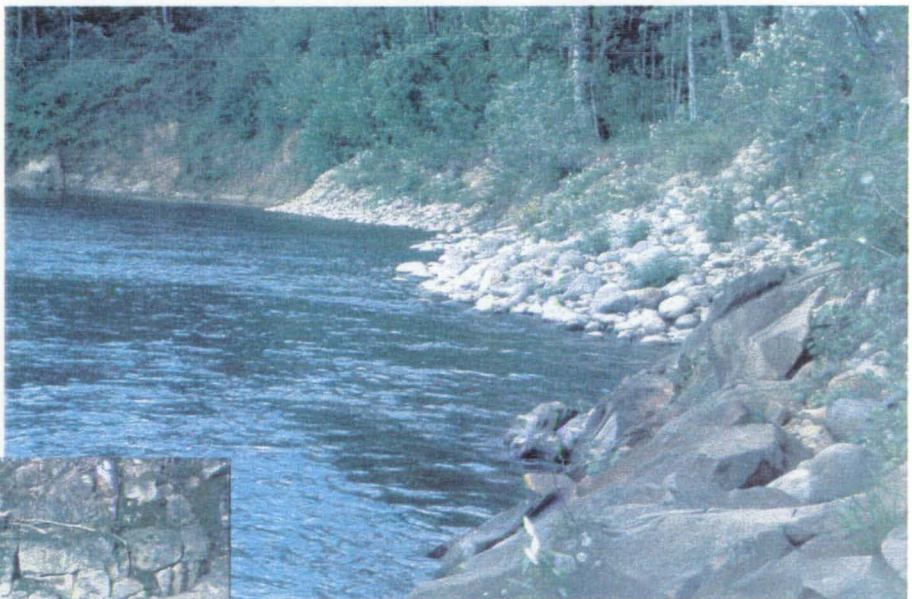
Right and below: Resistant materials outcrop on the bank opposite the new bar, forcing the river to make an abrupt bend to the west. The bar above was deposited in a zone of decreased flow energy just downstream of this constrained reach.

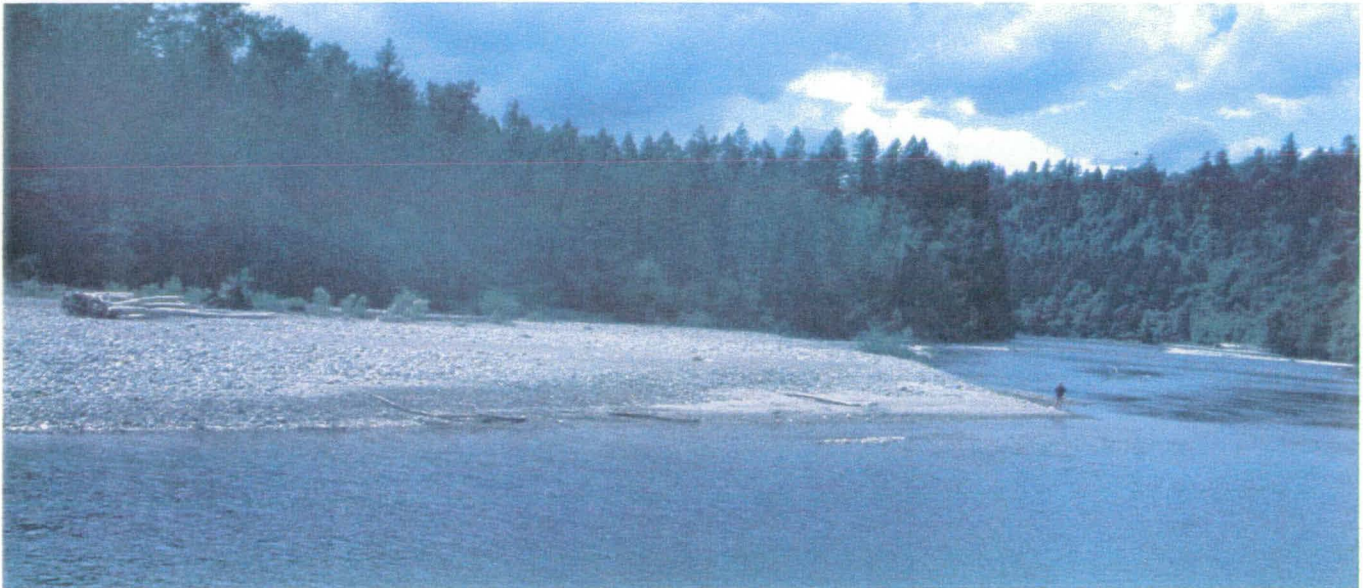
Boring lava, Troutdale formation and Sandy River mudstone confine the channel on the outside bend starting below the mouth of Gordon and Trout creeks.

Above: A different view of the same bar, located just downstream of "The Point," shows it bulging high above the river (note the person standing at the water's edge at the right, for scale). This bar squeezes the channel against the opposite bank and increases velocity in the long straight reach just above the boat ramp.

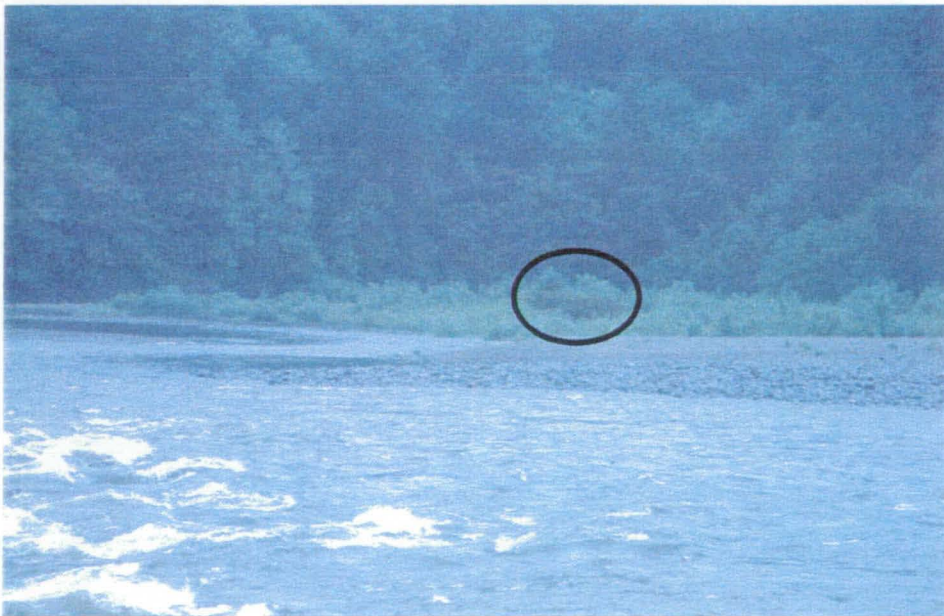
In the flood of 1996, erosion of the lahar terrace near Group Camp 2, and deposition on the downstream portion of the bar at the mouth of Gordon and Trout creeks, resulted in the channel shifting west. Prior to the 1996 flood, the rock circled in the photo to the left had been on a point bar at the tip of Alder Ridge. The rock today is on a bar across the channel (east) from its prior location, as this photo shows. The rock itself has not moved, but dynamic erosion and deposition have shifted the location of the channel where it rounds the point of Alder Ridge.

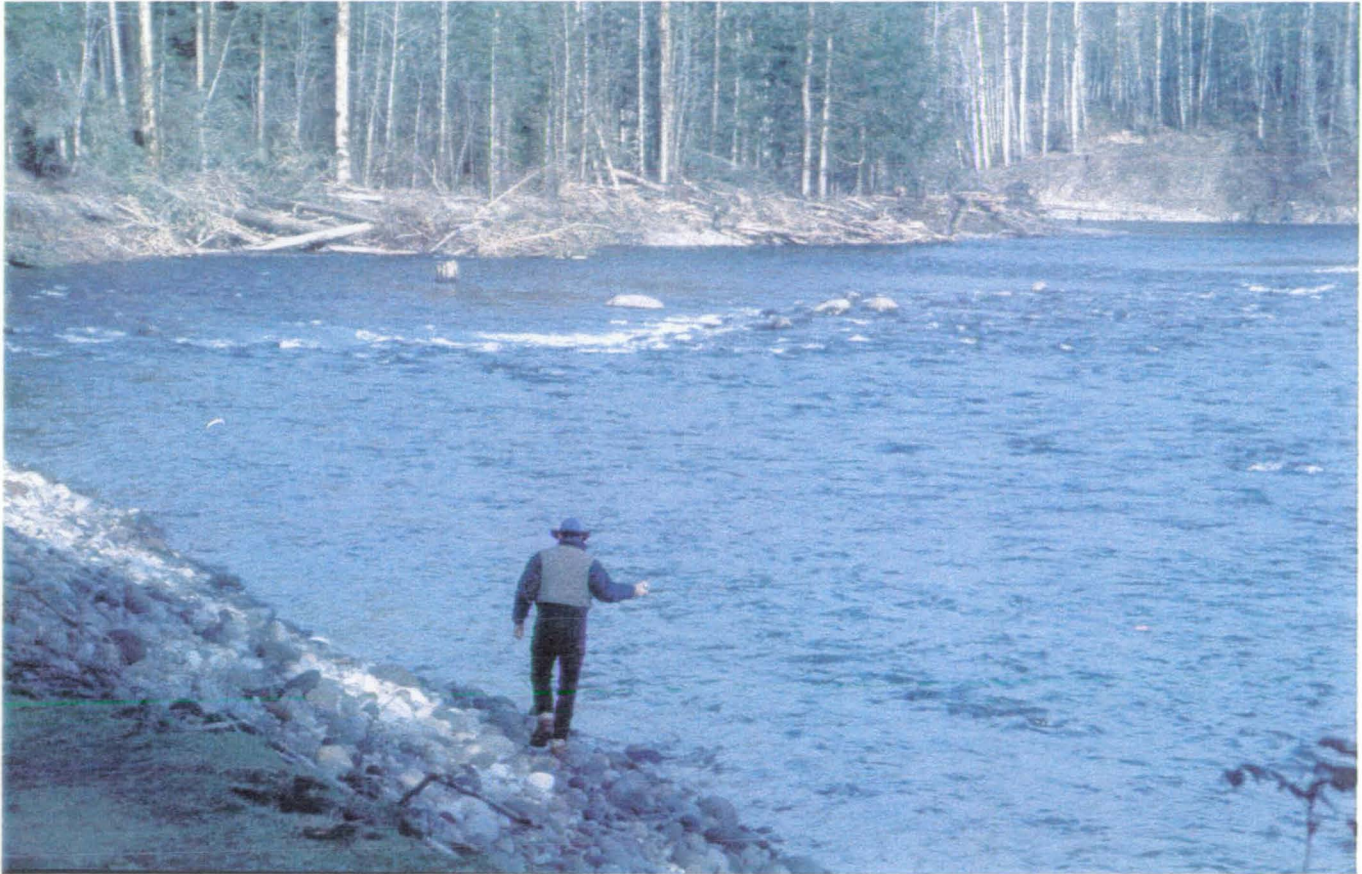
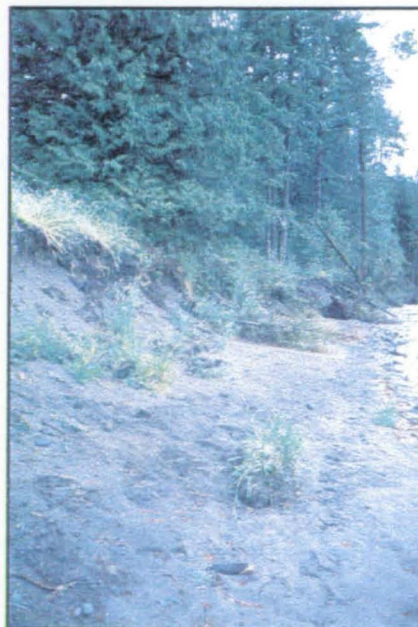
Erosion of the streambank near Group Camp 2 proceeds as follows: Ordinary bankfull events exert shear stresses on the highly erodible lahar sands comprising the riverbank. Materials at the toe of the bank are swept away and the top of the bank is undercut. The bank is not stable at such a

steep angle, and begins to ravel. Unsupported vegetation falls from the top. Shear stresses are intensified during events of magnitude, resulting in greater bank erosion during these events. Thus, there is a repeated cycle of chronic erosion during both ordinary bankfull events and events of greater magnitude.

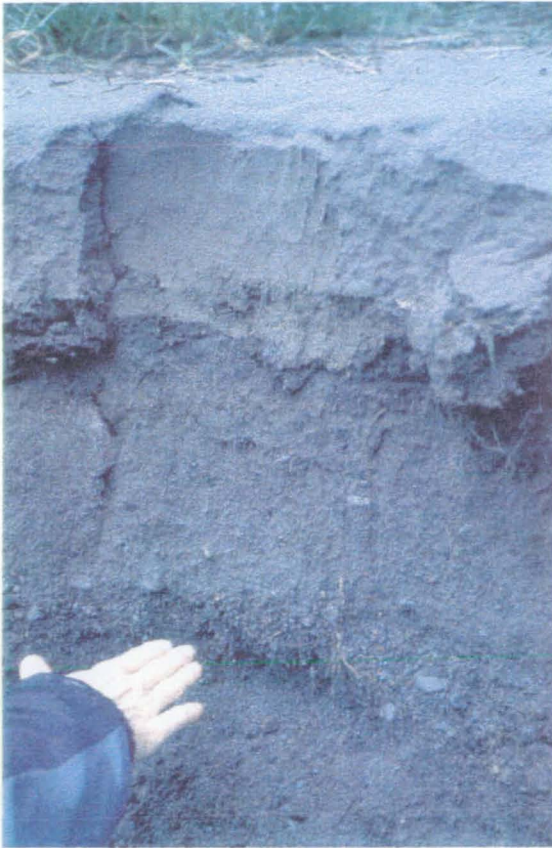
Left: The root zone of annual grasses in coarse, gray lahar sands can be seen in the riverbank near Group Camp 2. Finer, lighter alluvial sands that were deposited in the '96 and '99 events overlie the lahar sands in this location. **Below:** Overbank flow during these events left fresh deposits in the woods and created new high flow channels across the terrace.

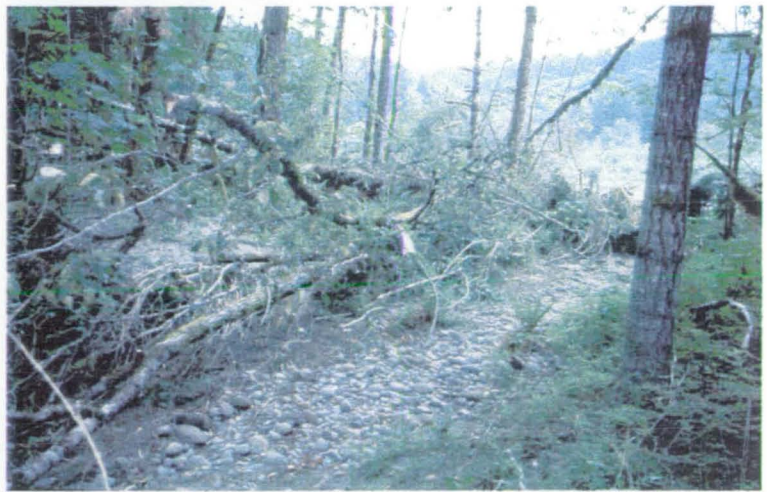
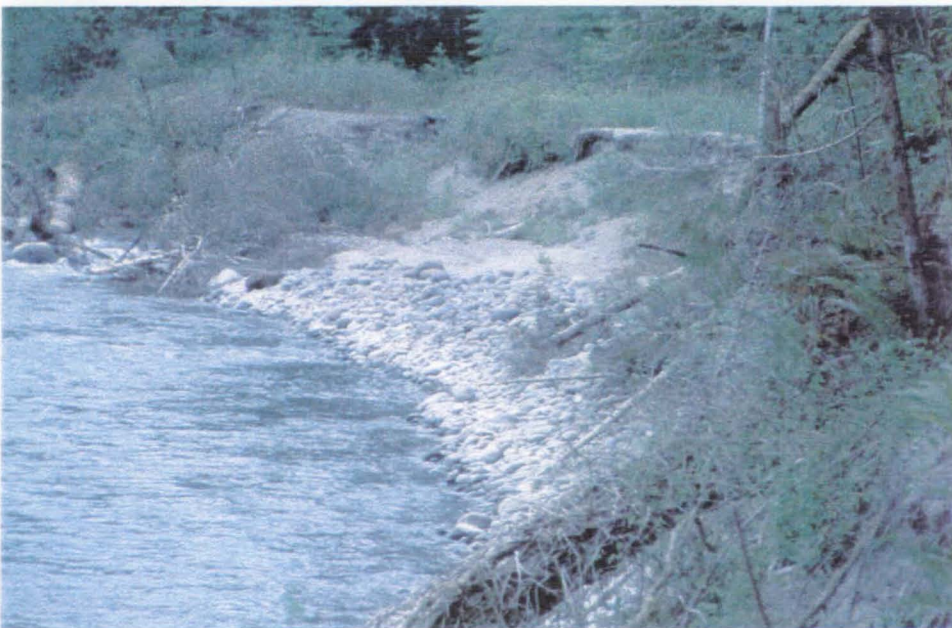
Thus, both lateral erosion and deposition are occurring at the point of Alder Ridge, where, over time, the river is removing the lahar terrace here. **Left:** Gravel lag deposits temporarily armor the toe of the eroding bank. However, these materials will also be moved by shear stresses in subsequent high flow events and the bank will continue to retreat.

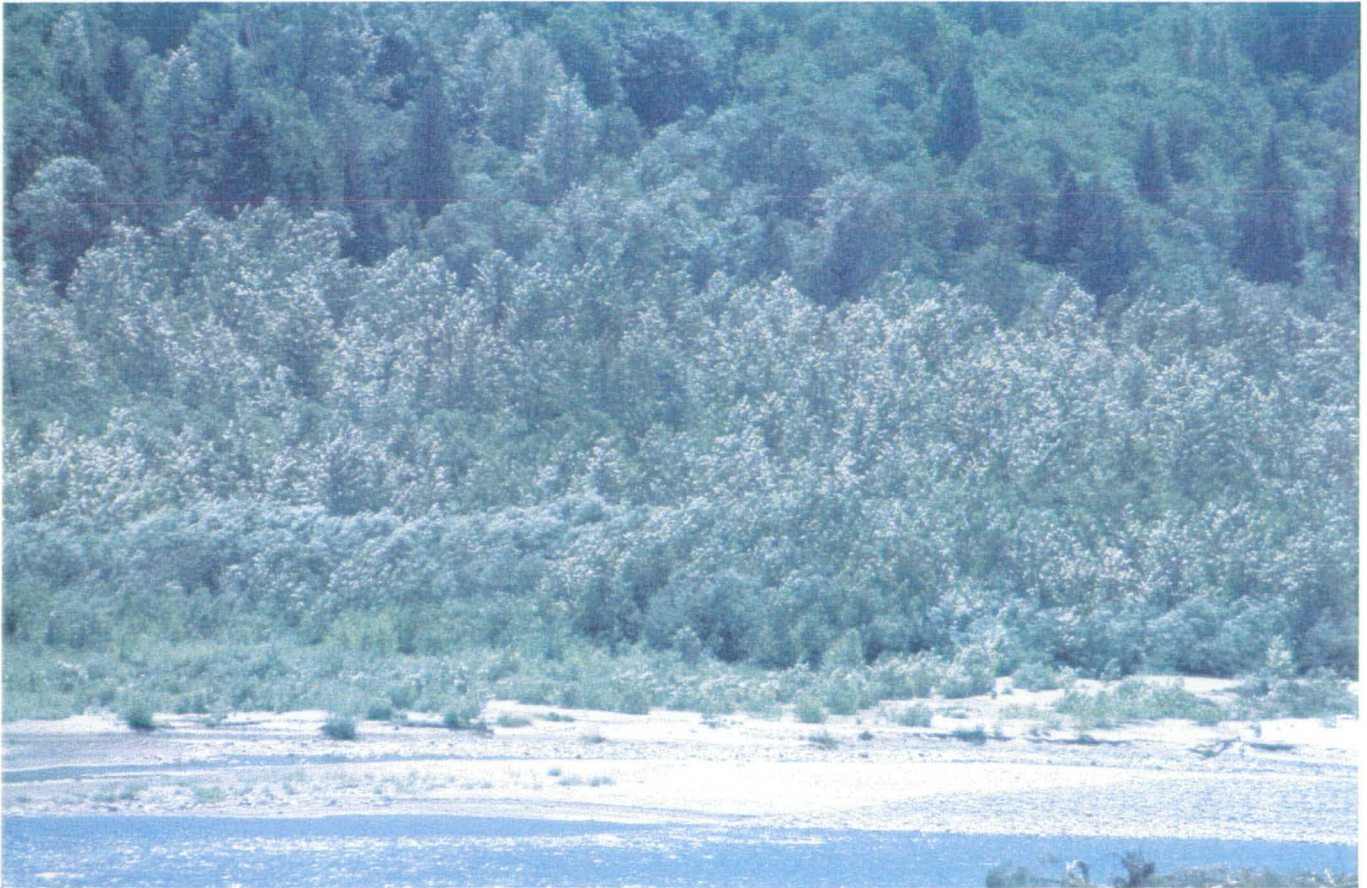
The bar at the mouths of Gordon and Trout creeks enlarged in the downstream direction as a result of sediment deposition during the '96 and '99 events. It is interesting to note that the older vegetation of the bar (shown above) was not disturbed by these high water events, as was the case on "The Floodplain" bar in the vicinity of Camp Collins, downstream. This further suggests that channel incision is taking place in this reach of river.

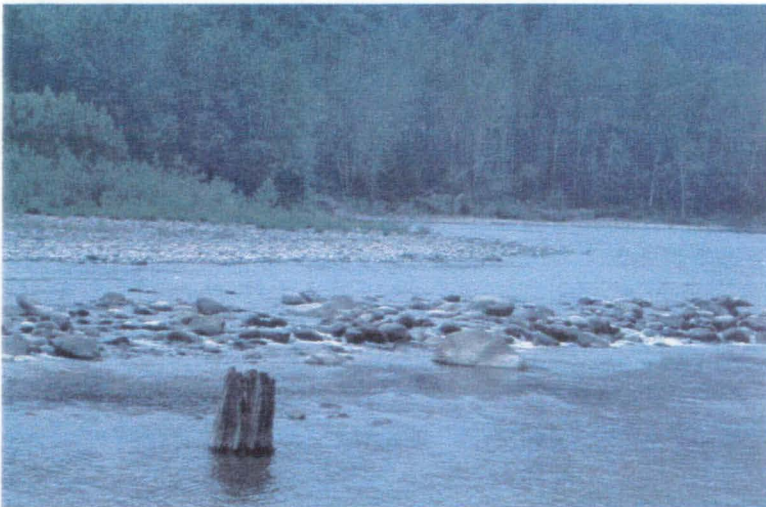
Left: The 1999 Thanksgiving Day flood exhumed a tree in growth position in the channel in the vicinity of Group Camp 2.

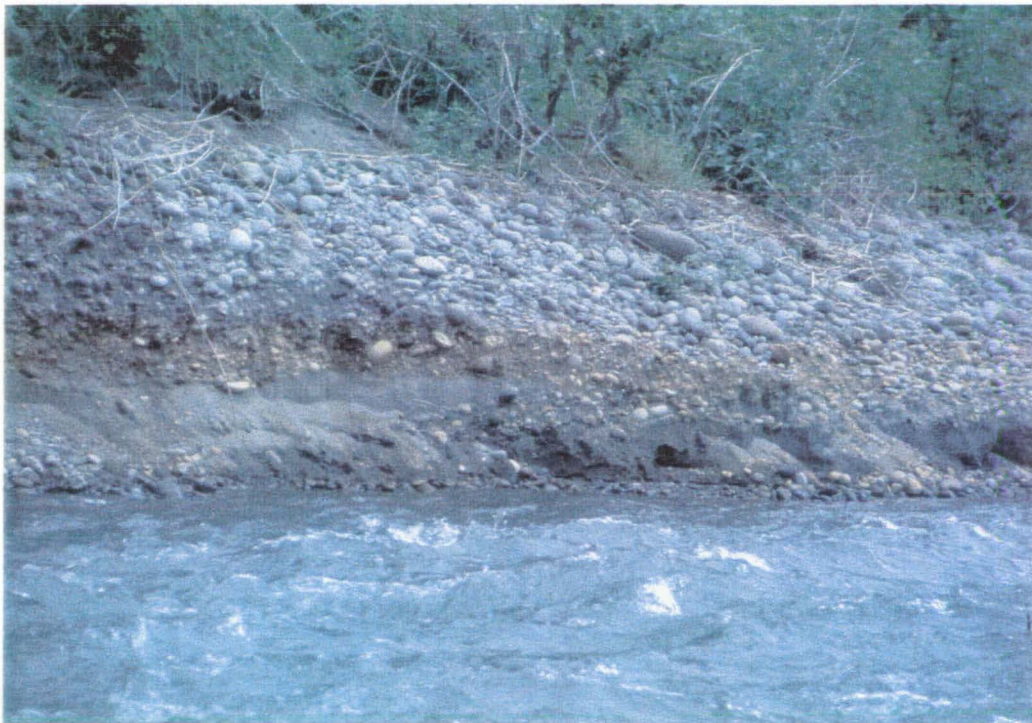
left: The downstream end of the mid-channel bar that tails out near Group Picnic Area A has high, vertical banks, in which an oxidized layer and imbricated cobbles are exposed, suggesting incision in this part of the channel.

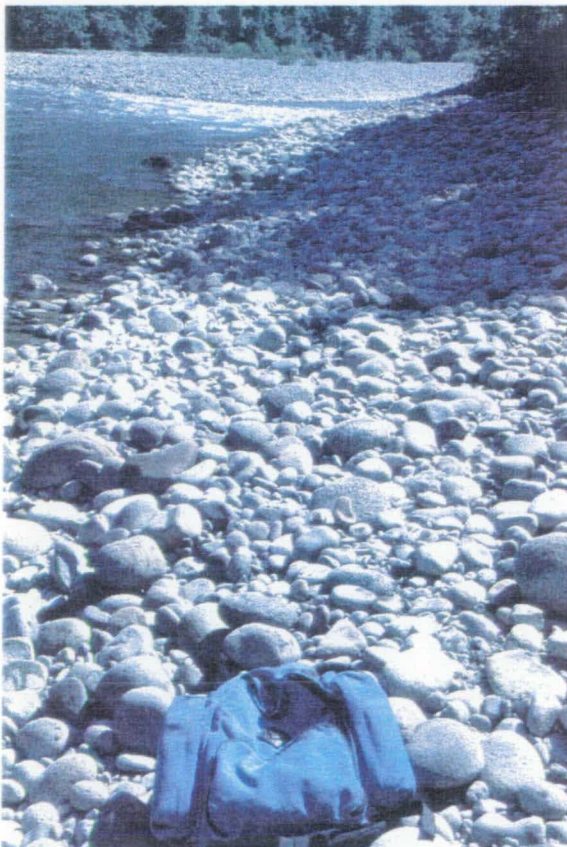
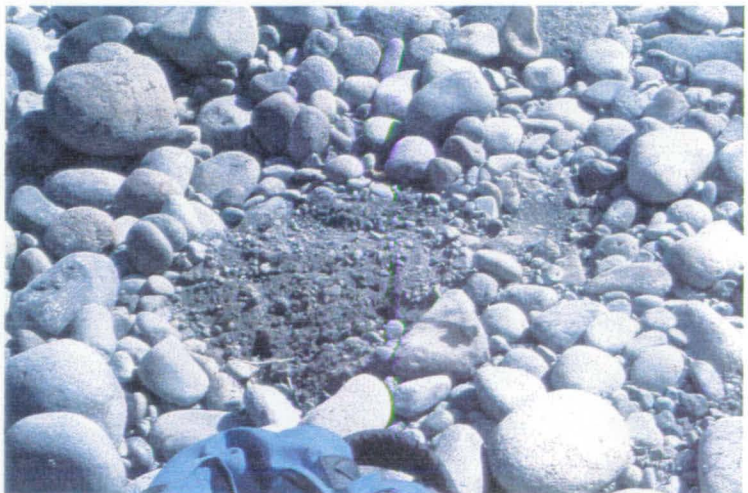
Left: Downstream view of the same mid-channel bar. The vertical bank shown above is just out of sight in the upper right corner of the photograph to the left. The cobbles in the foreground armor the channel and are under water under bankfull discharges.

Below: When one layer of cobbles is removed, fine gravels and sand are revealed beneath the armoring layer.

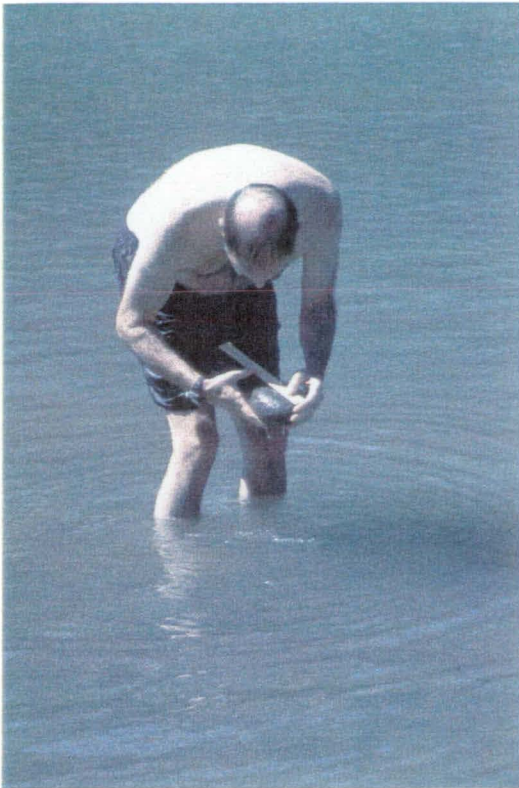
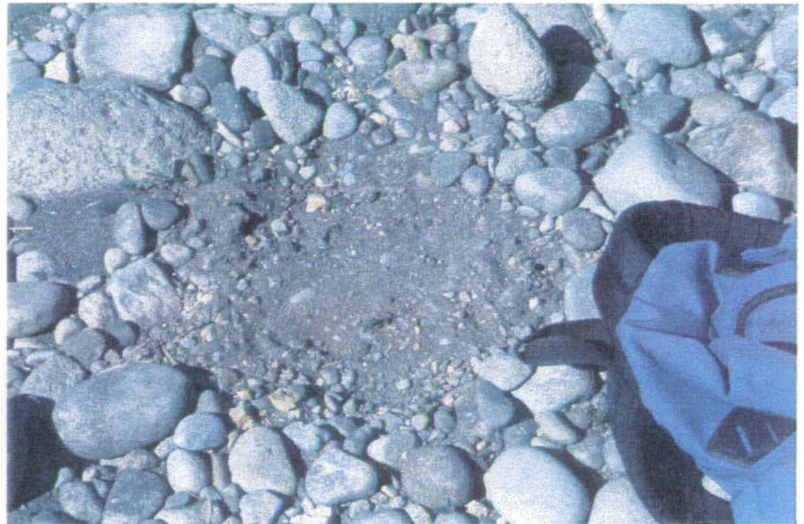
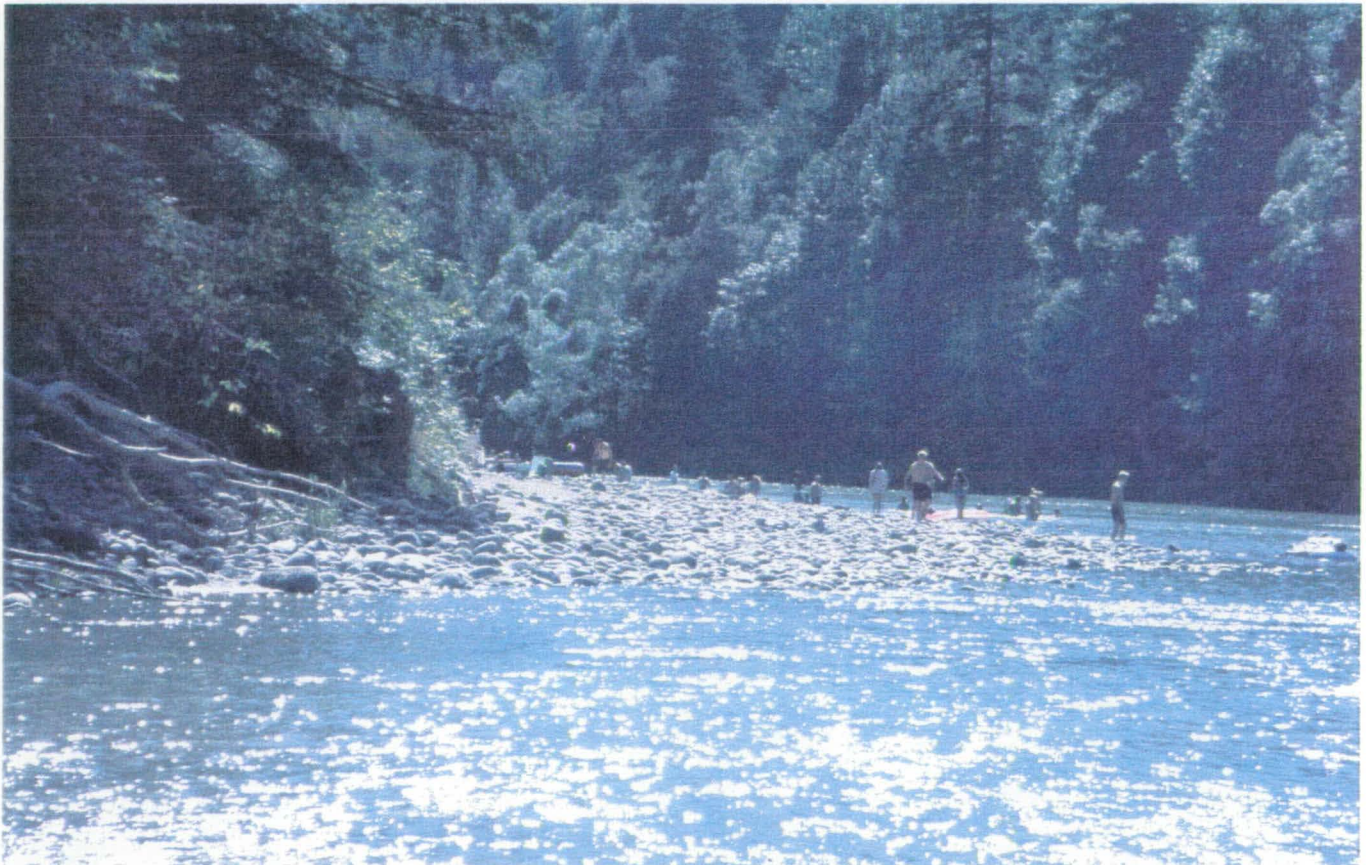
Left: Measuring sediment grain size along a cross-channel transect.
Above: Fine sediments beneath the armoring layer on the bar at the launching area.
Below: "Skeletal" point bar at the launch area, with eroding bank directly upstream.

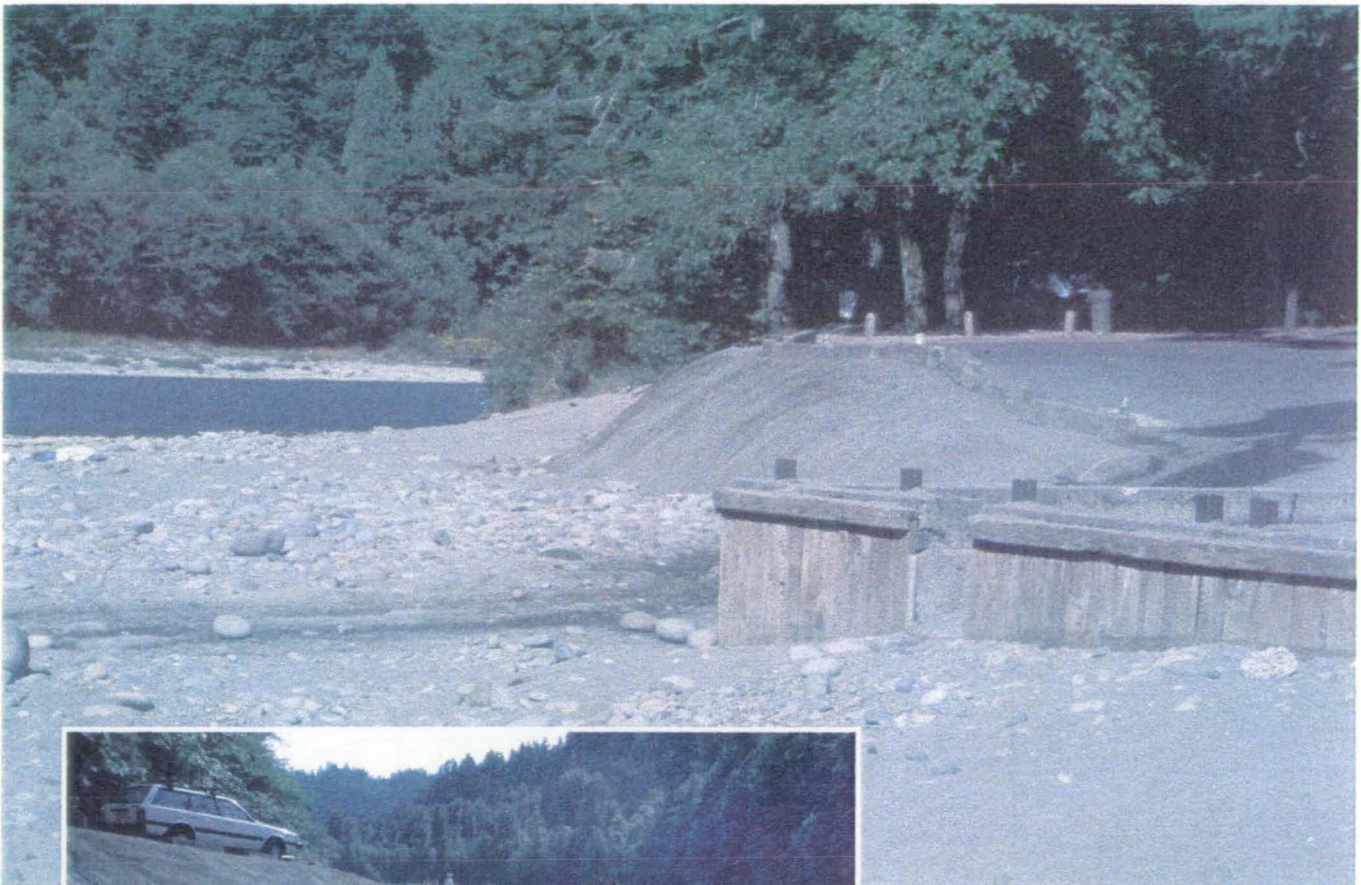
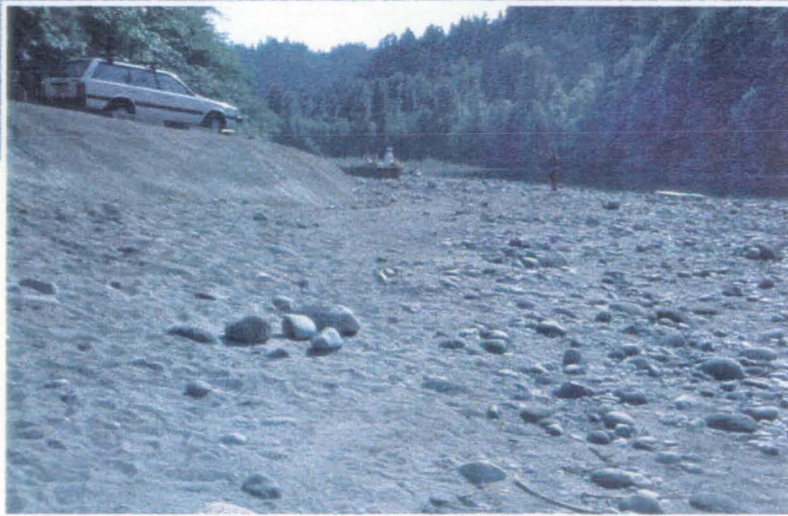
Above: A vehicle maneuvering area, a picnic area and a handicap fishing dock extend into the floodway on this point bar at the boat launch area.

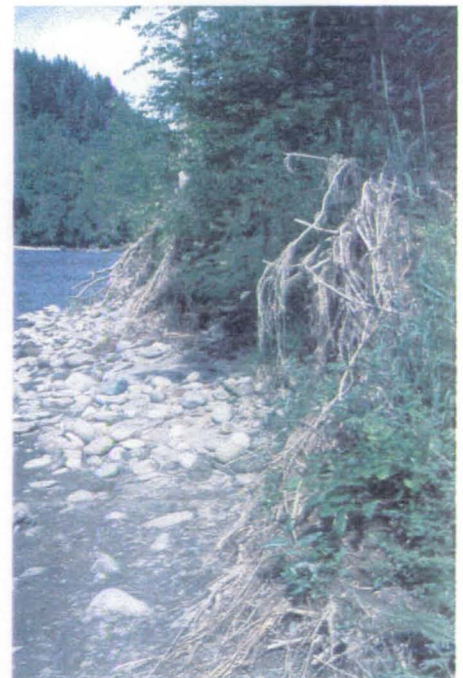
Right: The bank upstream of the launch area shows chronic erosion due to the confined nature of the channel in this reach. Despite the availability of sand in the the transport system, it appears that velocities are now too high in the launch area for the deposition of sand. The structures in the floodway contribute to this problem.
