United States Department of the Interior

FISH AND WILDLIFE SERVICE

Re: Smith-Bybee Lake Water Control Structure and Dike Rehabilitation

SMITH-BYBEE WATER CONTROL STRUCTURE

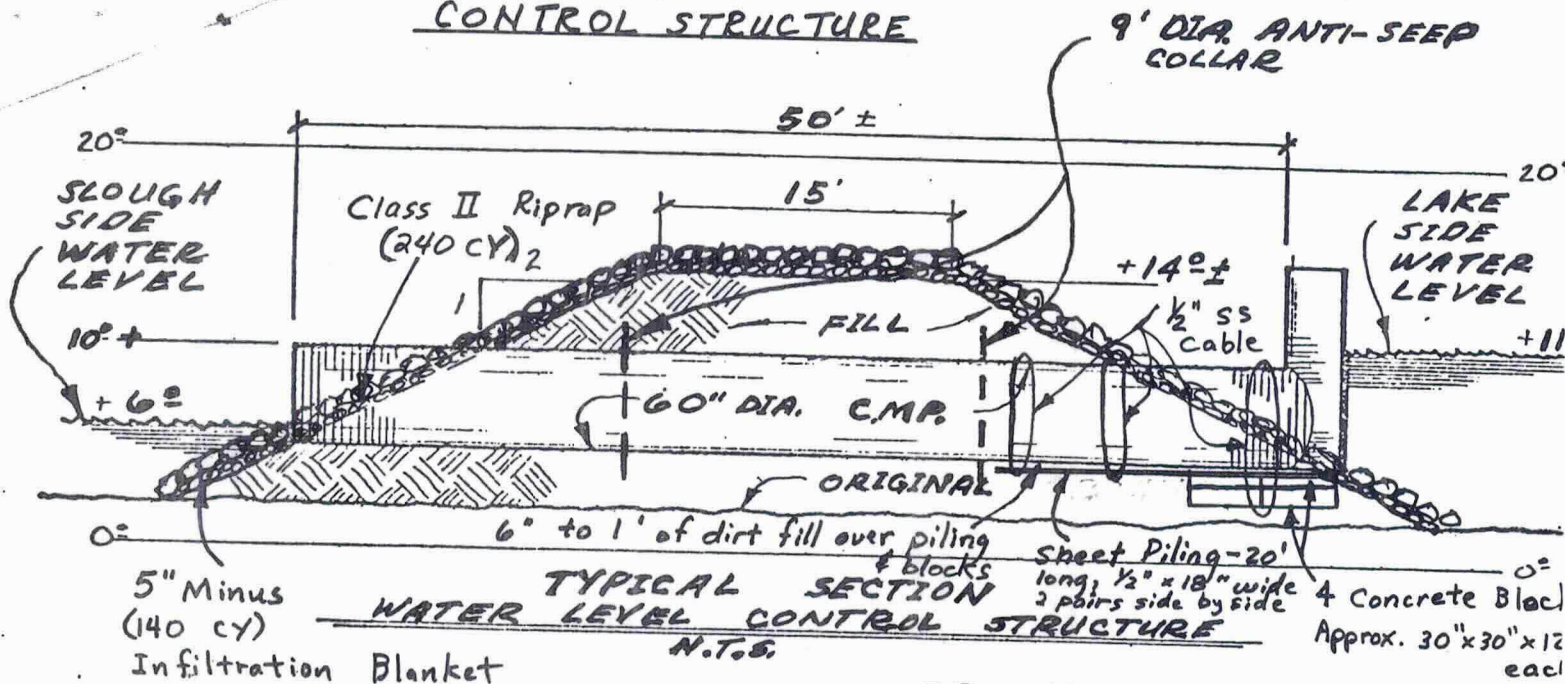
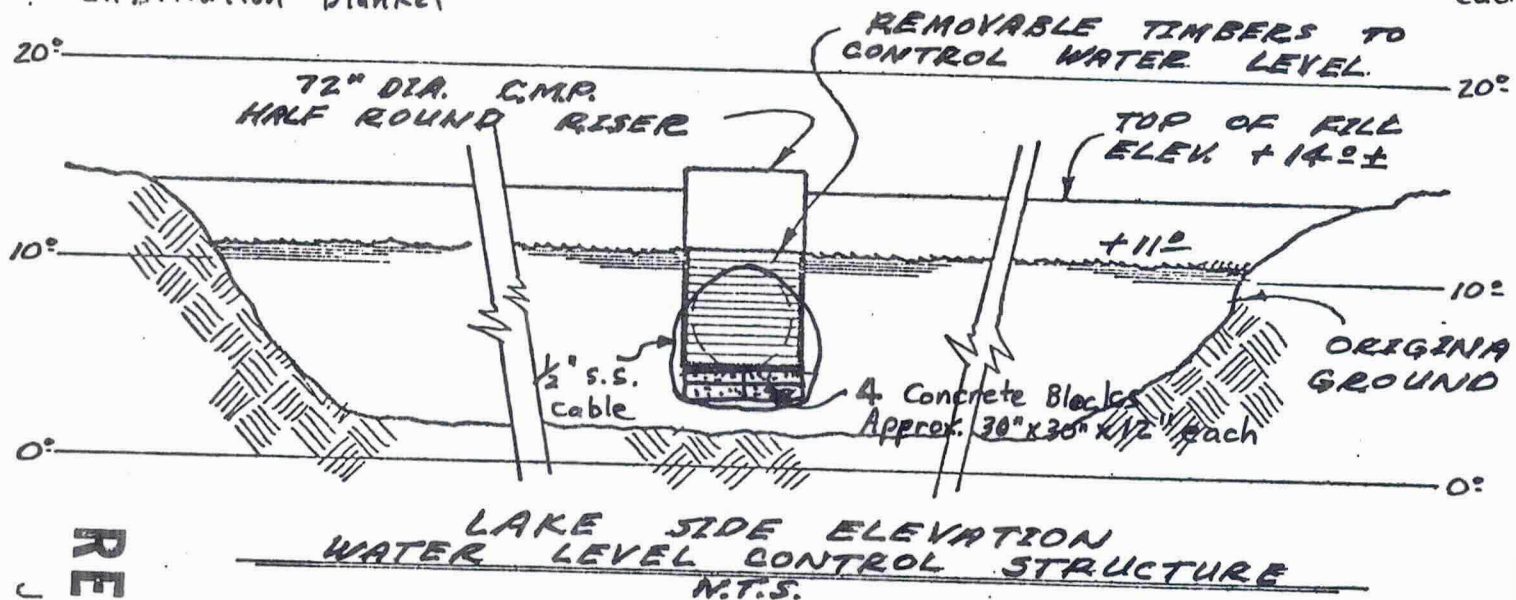
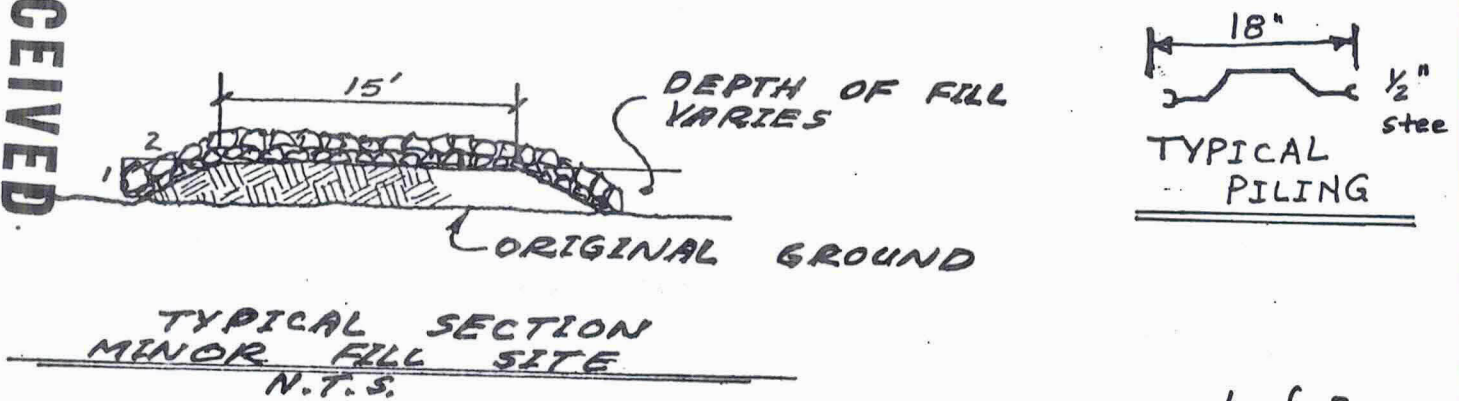
The rehabilitation work consisted of replacing previously eroded dike material, realigning and relocating the displaced 60-inch diameter CMP, adding anti-flotation devices to the CMP, constructing a natural spillway, and adding riprap material to the surface of the dike.

Class II Riprap; Thickness 18", Tolerance 6", in COLUMBIA SLOUGH
Stone Protection - at PORTLAND
Gradation Weight In Pounds
25 to 250, 75 % 50 to 250, 30 % > 150
stones under 25 lbs must not exceed 10% by wt.
County of MULTNOMAH, State OR
U.S. Fish & Wildlife
