CONDITION RATING SHEET  
EARTH EMBANKMENTS

DAM NAME SMITH-BYBEE <sup>Lakes</sup> DATE 10-25-88 PERMIT# \_\_\_\_\_ FILE# S-79  
INSPECTOR'S NAME CR King COUNTY Multnomah DISTRICT 16  
PHOTOS?? (Y or N) N RESERVOIR ELEV. (S/W CREST) \_\_\_\_\_  
=====

OWNER City of Portland

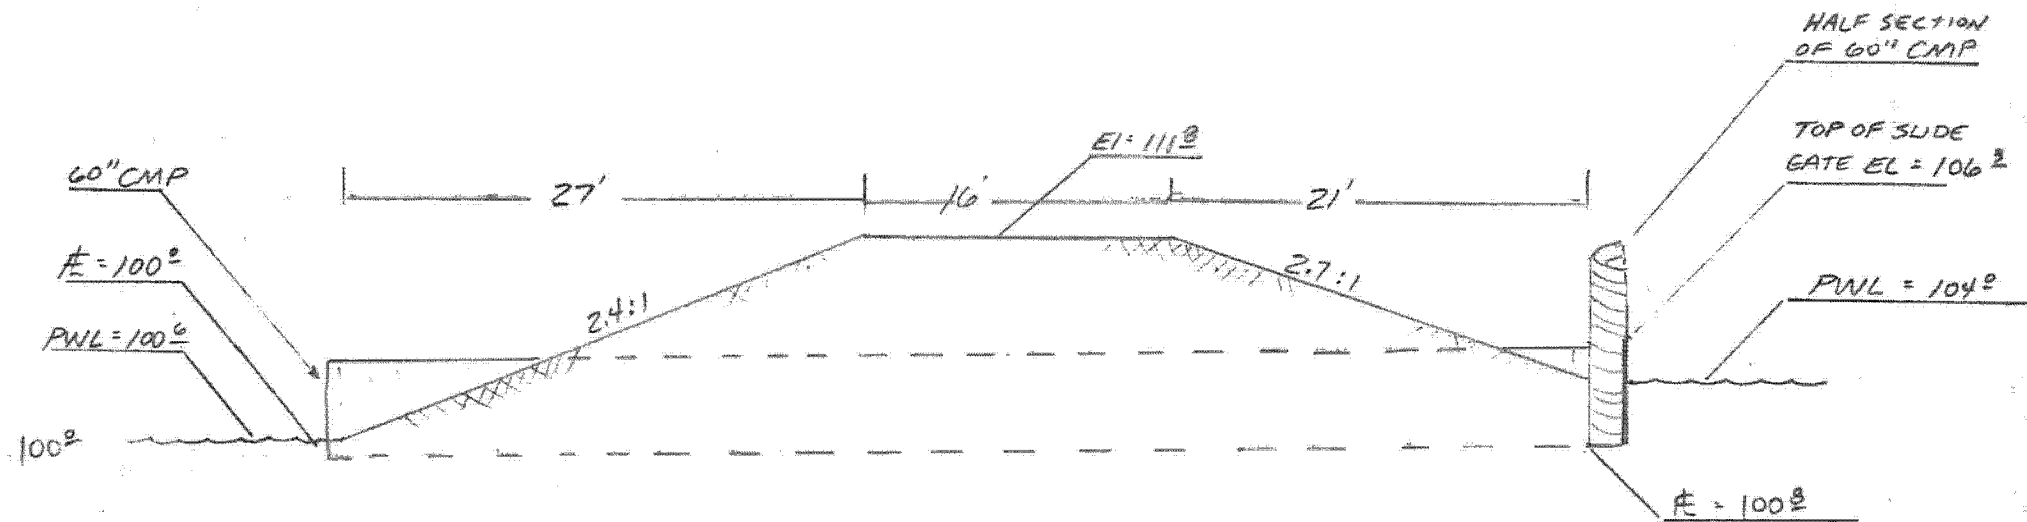
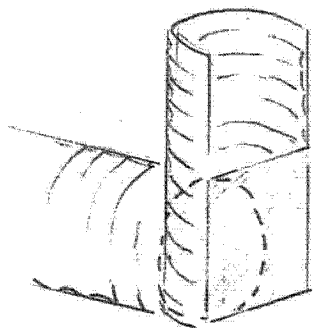
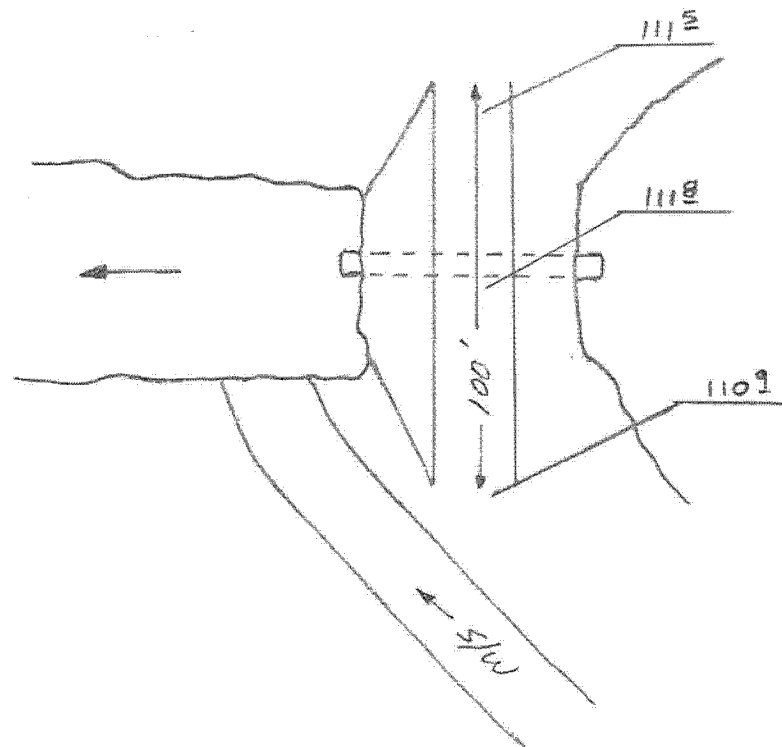
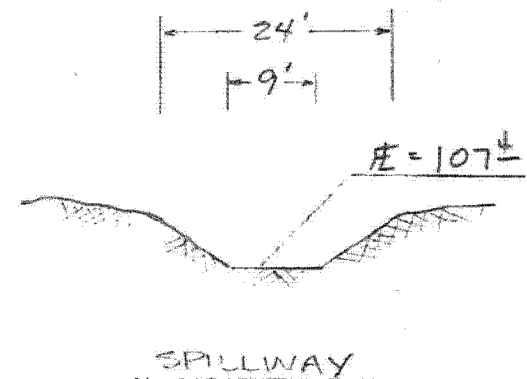
SMITH-BYBLE 10-25-88  
BY CR KING

PRIMARY OUTLET  
60" CMP w/ HALF  
SECTION 60" CMP  
UPRIGHT w/ STEEL  
SLIDE GATE

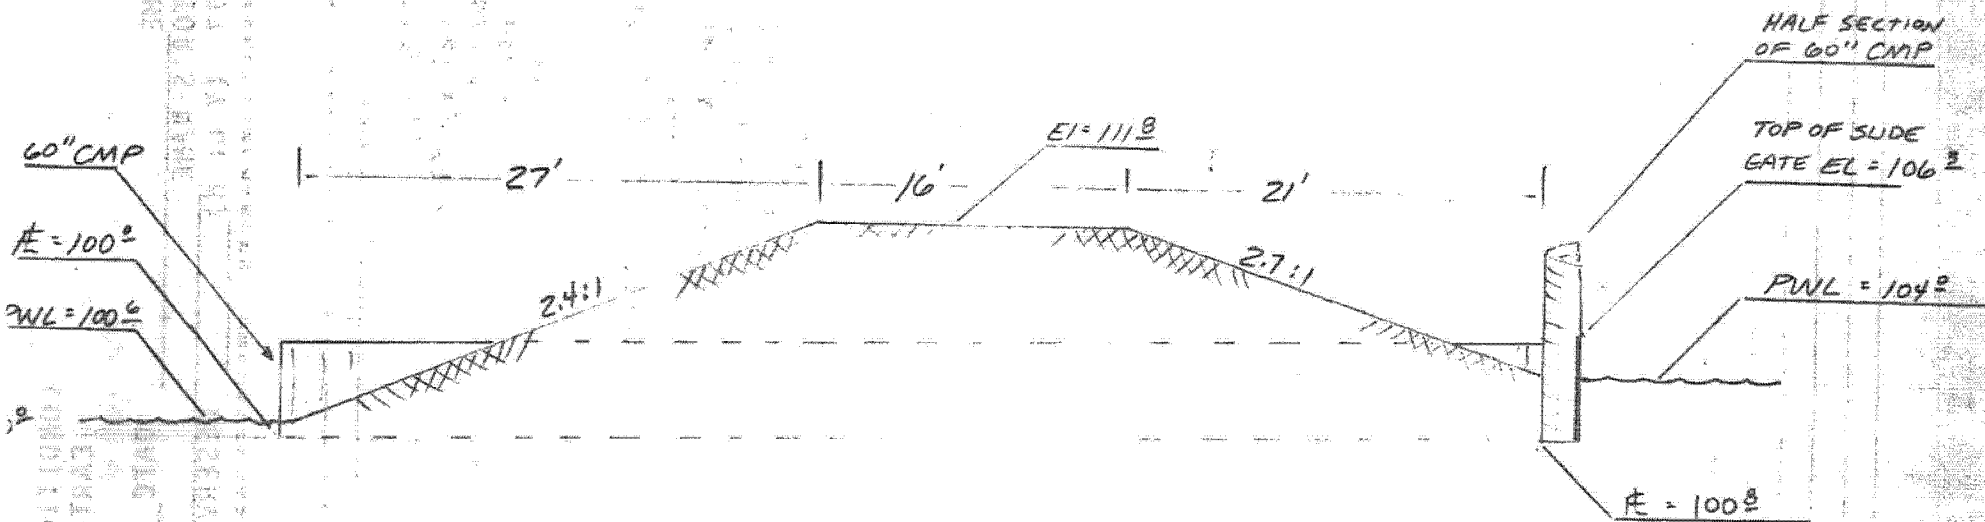
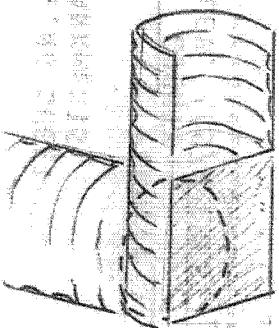
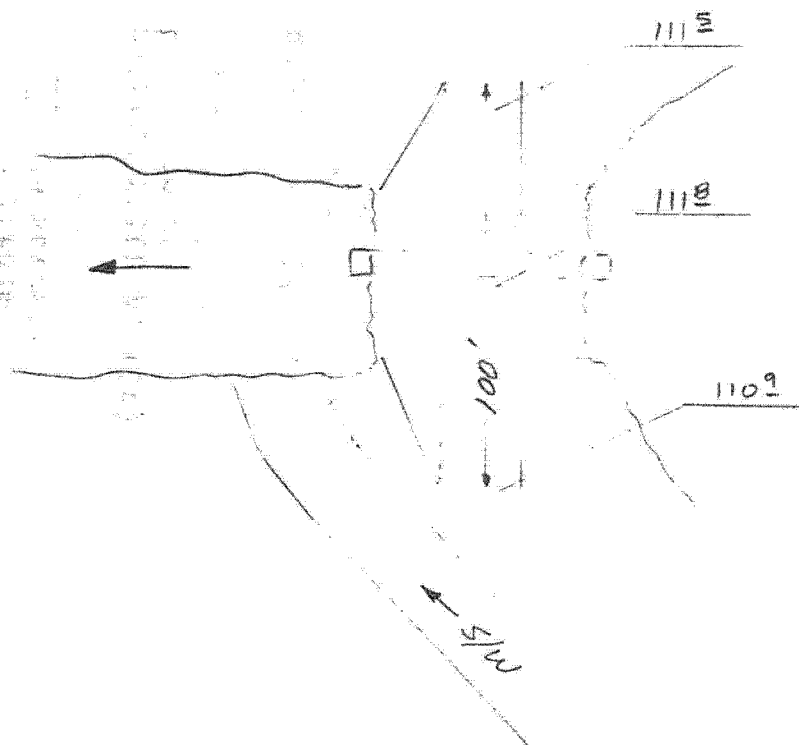
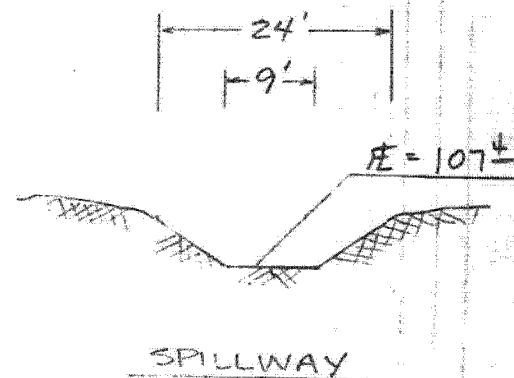
SMITH-BYBEE 10-25-88

PRIMARY OUTLET  
60" CMP w/ HALF  
SECTION 60" CMP  
UPRIGHT w/ STEEL  
SLIDE GATE

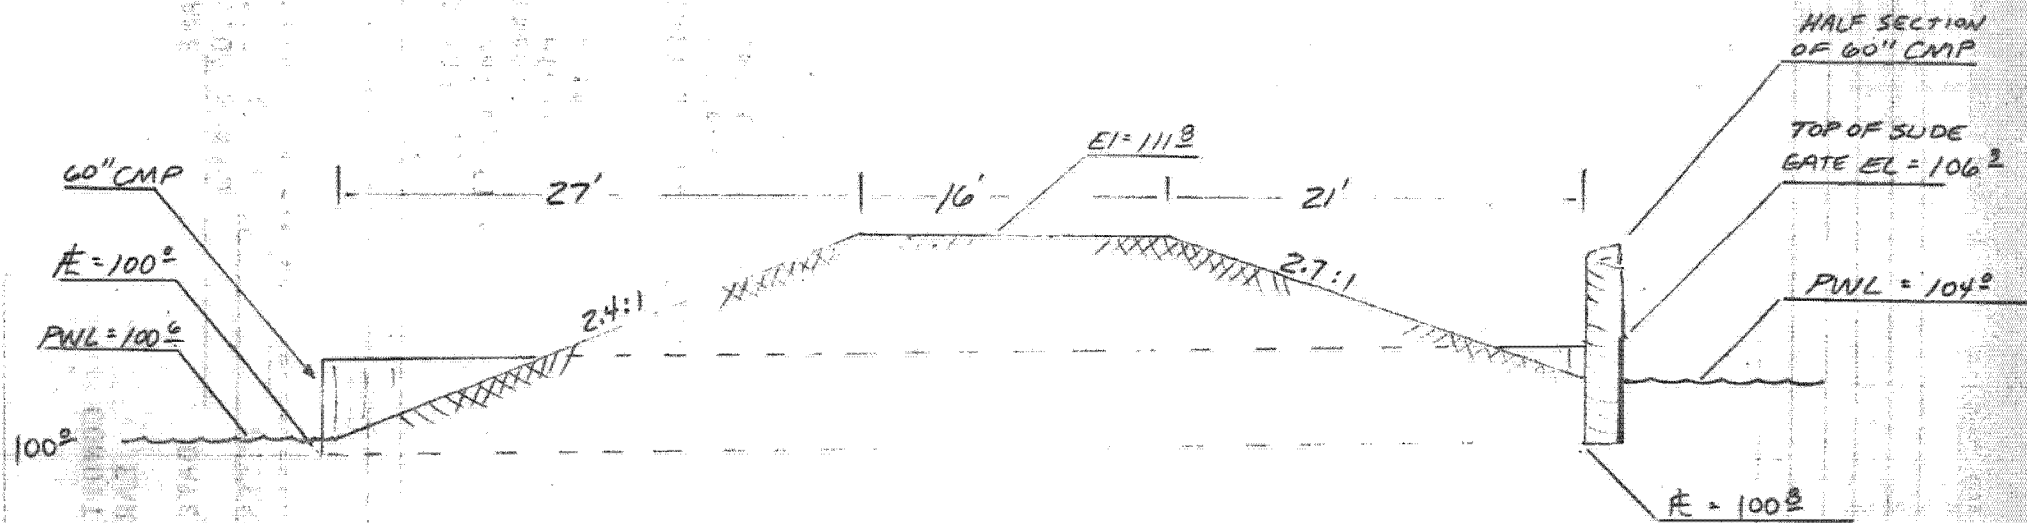
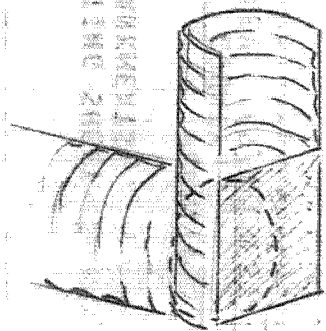
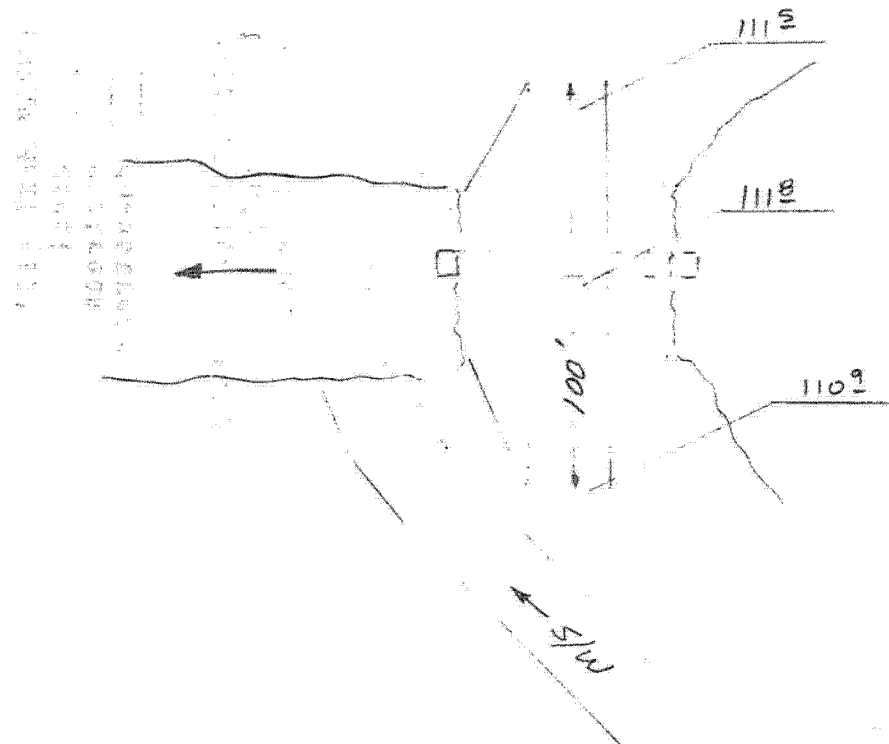
# SMITH-BYBLE 10-25-88

PRIMARY OUTLET  
60" CMP w/ HALF  
SECTION 60" CMP  
UPRIGHT w/ STEEL  
SLIDE GATE

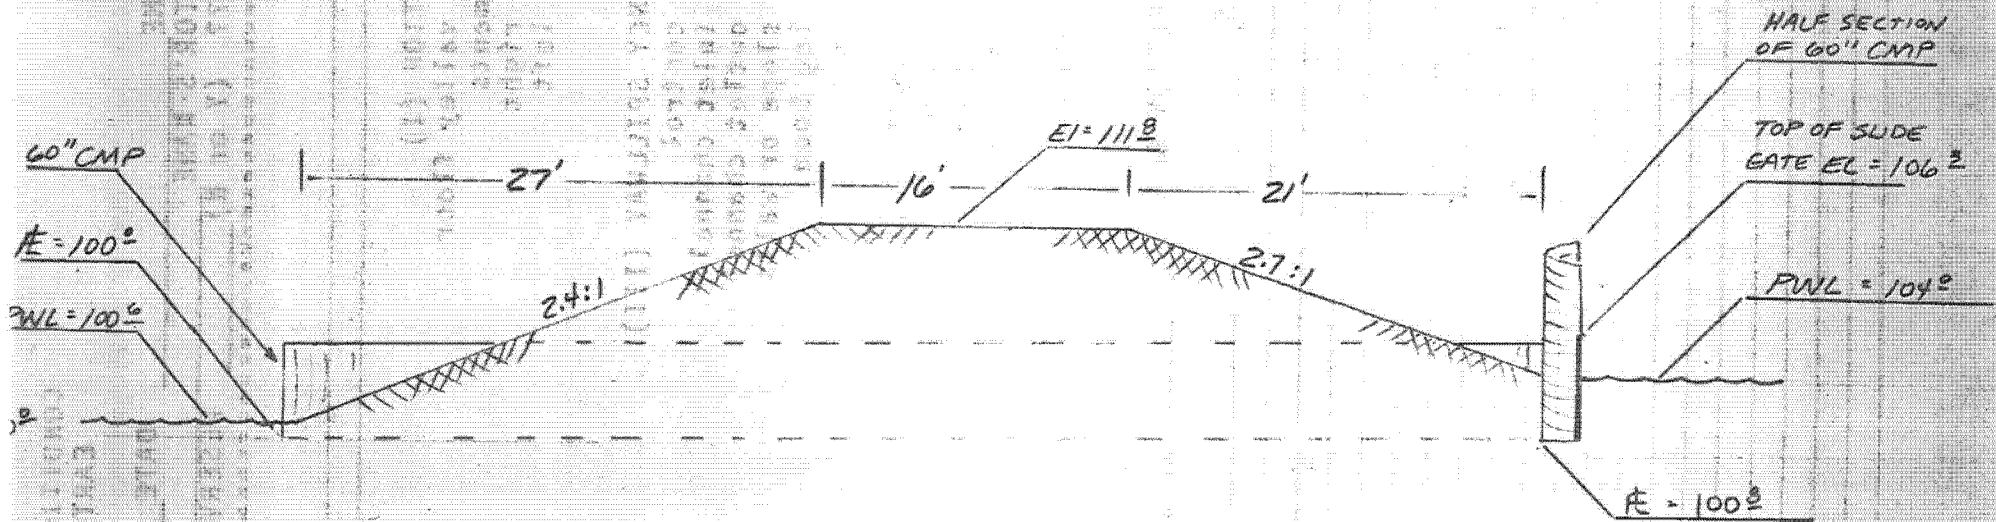
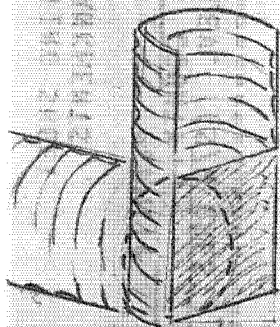
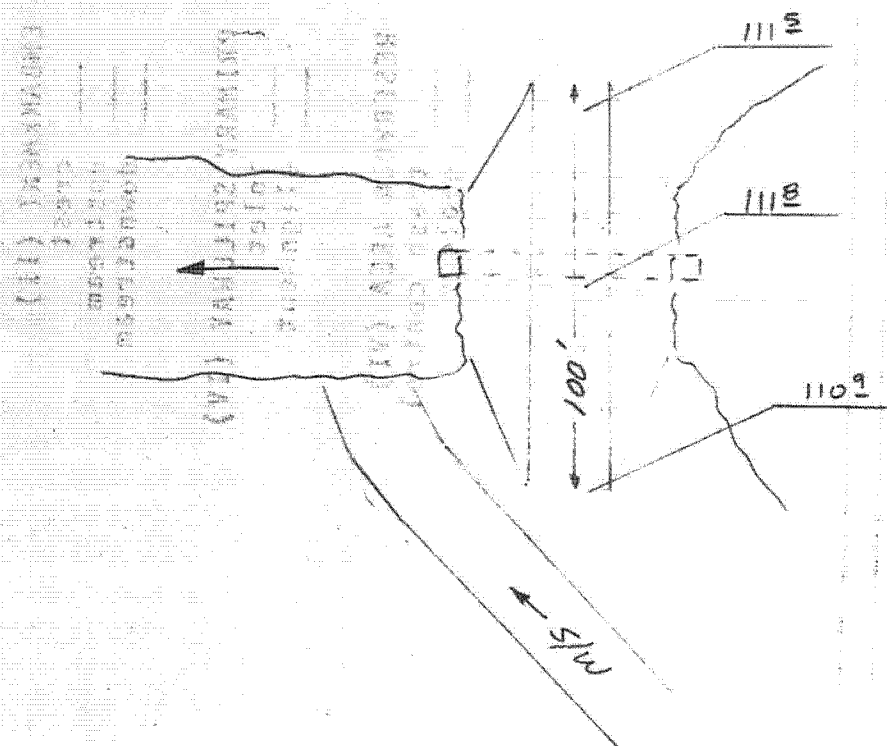
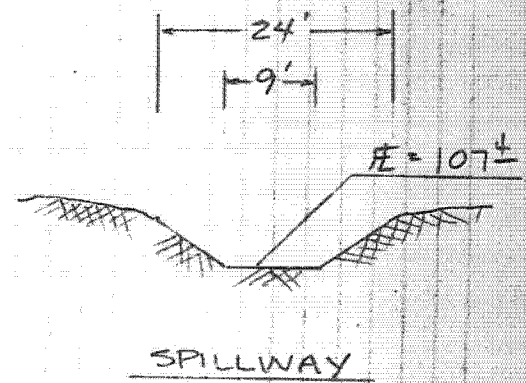
SMITH-BYBEE 10-25-88

PRIMARY OUTLET  
60" CMP w/ HALF  
SECTION 60" CMP  
APRIGHT w/ STEEL  
SLIDE GATE
