## LOSS CONTROL SERVICES

January 22, 2015

### Introduction

A hazard recognition evaluation survey was conducted at Metro's Multnomah Channel North and South Water Control Structures. The purpose of the evaluation was to determine if the process of adjusting the weir height in the North and South water control structures that separate the channel from adjacent wetlands presents employee workplace and "Permit Required" confined space hazards.

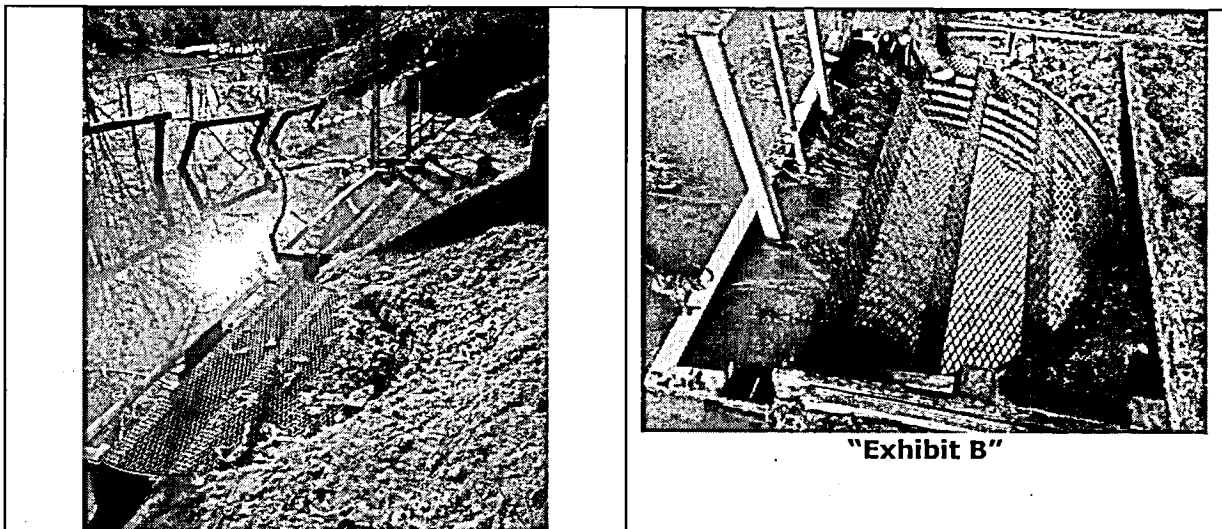
1. To install or remove the stop-logs employees must bend over and kneel down on the riser's steel grate covers in an ergonomically stressful position that increases their chance of experiencing a back injury and puts their reaching arms in ergonomically stressful "Red Zone" postures. The task also increases their chance of falling into the water, getting entangled in debris, developing hypothermia in the cold water and possibly drowning before they can be assisted by a co-workers. See exhibit B.

2. The wetlands sides of both the North and South channel's gates are unprotected by standard guardrails increasing the potential that an employee may fall into the water during routine servicing of the gates. See exhibits A & E.

5. One thousand pound capacity rotating davit lift arms, equipped with a hand operated winches, were at one time available to remove debris and stop-logs from the risers but have since been damaged by vandals and removed from service requiring employees to manually do the work. The base holes are still available for use on the wetlands side of the structures but were not constructed for use on the channel sides. See exhibit E for base holes.

1. Install standard guardrails on the wetlands sides of both water control structures as a strategy to prevent fall-in water and drowning hazards.
2. At the South structure install a stairway from the road to the riser access area as a strategy to prevent slip and fall related injuries when ascending and descending the slope.

3. Require employees to wear personal flotation devices when servicing the risers as a strategy to help prevent drowning accidents.
4. Reinstall and/or reacquire a 1,000 lb rated rotating davit lift arm with a hand operated winch for use at both water control structures to install or remove heavy stop-logs from the riser channels and as a strategy to prevent manual material handling and laceration injuries.

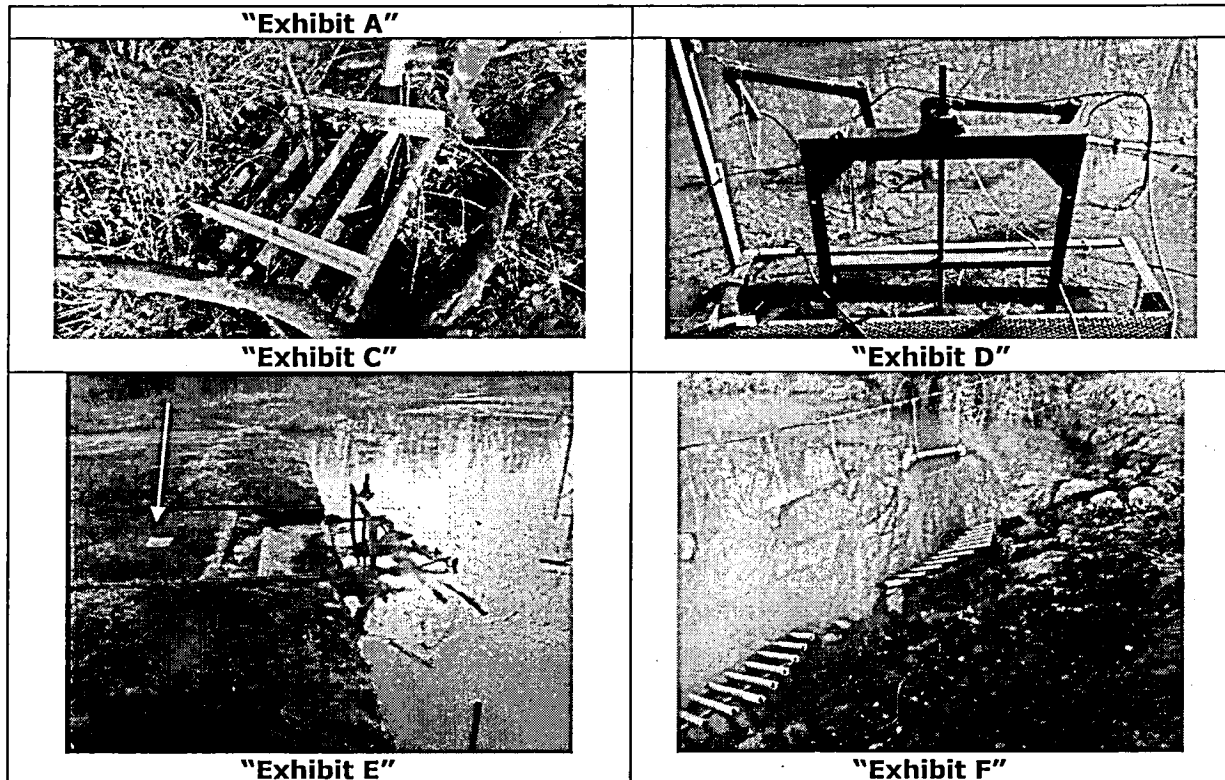
4. The debris grates on the discharge or channel side of the water control structures are stuck, bolted or welded in place. The structure's plans call for hinged gates but the hinges have long since rusted tight preventing the gates from functioning as designed. Access holes have been cut into the grates (South gate observed) in order to allow employee entry into to pipes for access to the tide gates and stop-logs. It also allows debris to enter the inverted pipes during high tides further increasing the number of debris clean-outs required to be done by staff. See exhibits C & F.

6. The manual opening and closing of the slide gates to drawdown the wetlands takes an employee approximately one hour of turning a ring handle in an ergonomically stressful "High Red Zone" posture that increases ergonomic stressors to their shoulders. In most cases the worm gears are rusted increasing the force necessary to raise or lower the slide gates. See exhibit D.

6. Reinstall the cut-out sections of the debris grates on the channel side of the South water control structure and repair or replace the frozen hinges (on North structure as needed) as a strategy to prevent tidal debris from entering the inverted pipes and reducing the number of required entries. Consider additional study of the task to determine if the area is a "Permit Required" confined space and develop OSHA required entry procedures as needed.

7. Replace the rusted stems (worm gears) on the tide gates or install a gear/power drive unit as a strategy to decrease the force necessary, and resulting ergonomic stressors to the employees, when opening or closing the units.

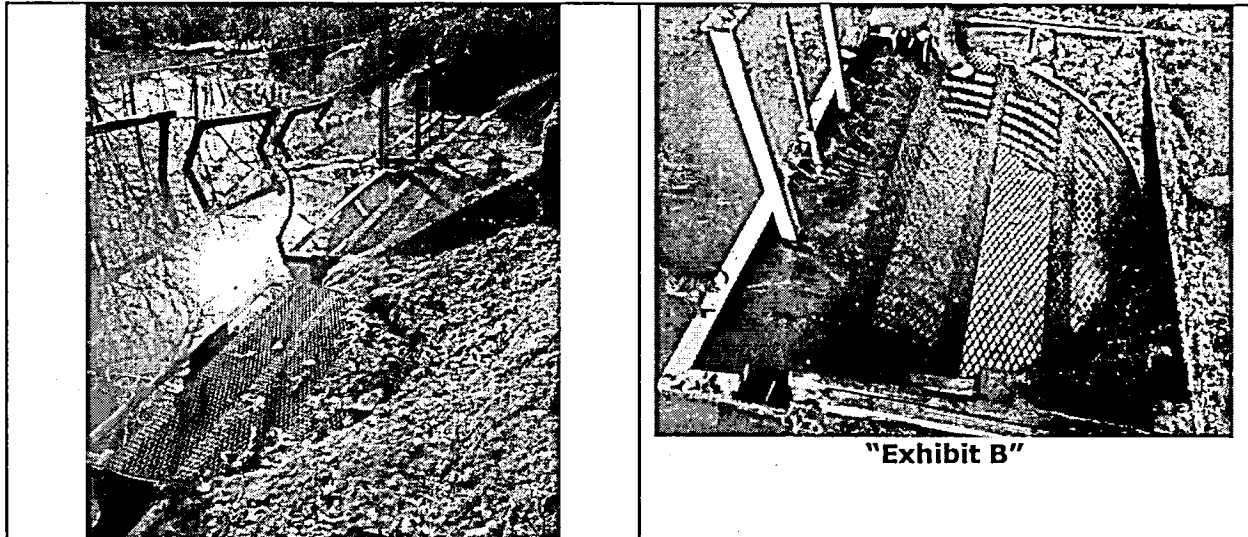
1. To install or remove the stop-logs employees must bend over and kneel down on the riser's steel grate covers in an ergonomically stressful position that increases their chance of experiencing a back injury and puts their reaching arms in ergonomically stressful "Red Zone" postures. The task also increases their chance of falling into the water, getting entangled in debris, developing hypothermia in the cold water and possibly drowning before they can be assisted by a co-workers. See exhibit B.

2. The wetlands sides of both the North and South channel's gates are unprotected by standard guardrails increasing the potential that an employee may fall into the water during routine servicing of the gates. See exhibits A & E.

5. One thousand pound capacity rotating davit lift arms, equipped with a hand operated winches, were at one time available to remove debris and stop-logs from the risers but have since been damaged by vandals and removed from service requiring employees to manually do the work. The base holes are still available for use on the wetlands side of the structures but were not constructed for use on the channel sides. See exhibit E for base holes.

1. Install standard guardrails on the wetlands sides of both water control structures as a strategy to prevent fall-in water and drowning hazards.
2. At the South structure install a stairway from the road to the riser access area as a strategy to prevent slip and fall related injuries when ascending and descending the slope.

3. Require employees to wear personal flotation devices when servicing the risers as a strategy to help prevent drowning accidents.
4. Reinstall and/or reacquire a 1,000 lb rated rotating davit lift arm with a hand operated winch for use at both water control structures to install or remove heavy stop-logs from the riser channels and as a strategy to prevent manual material handling and laceration injuries.

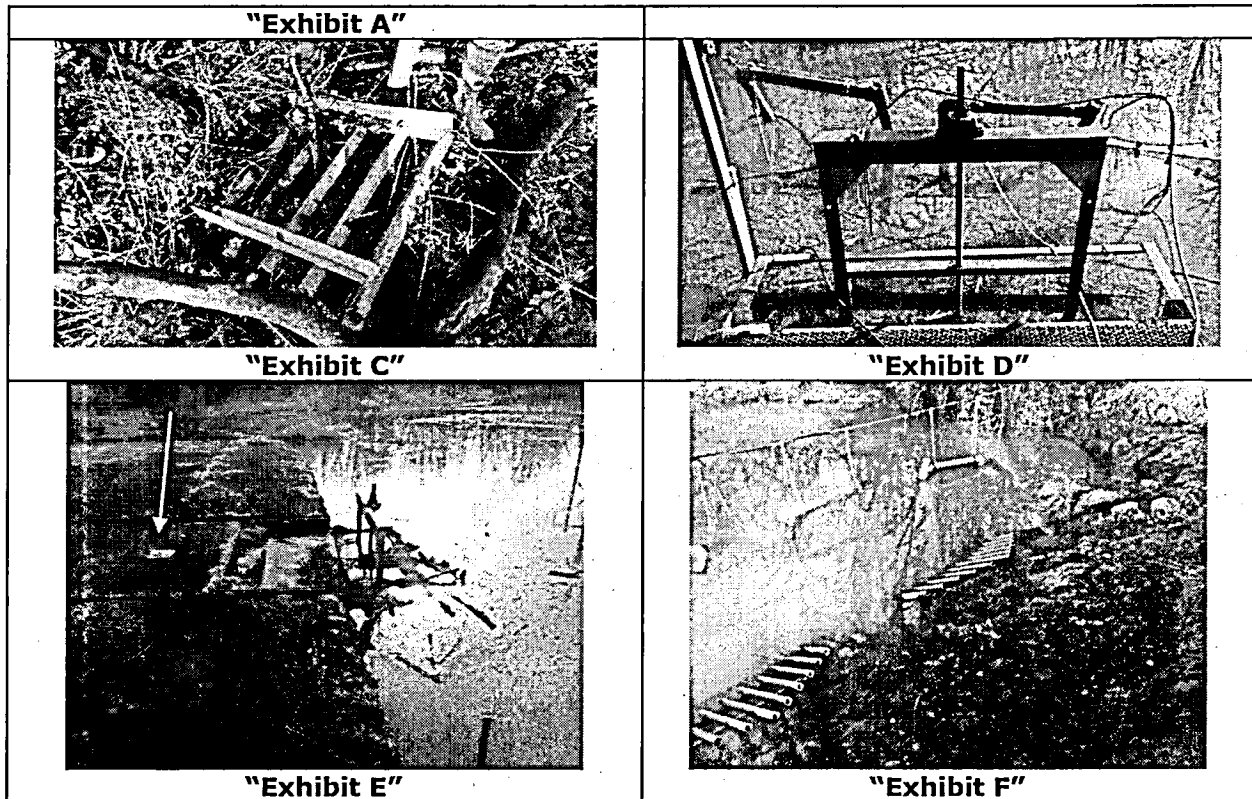
4. The debris grates on the discharge or channel side of the water control structures are stuck, bolted or welded in place. The structure's plans call for hinged gates but the hinges have long since rusted tight preventing the gates from functioning as designed. Access holes have been cut into the grates (South gate observed) in order to allow employee entry into to pipes for access to the tide gates and stop-logs. It also allows debris to enter the inverted pipes during high tides further increasing the number of debris clean-outs required to be done by staff. See exhibits C & F.

6. The manual opening and closing of the slide gates to drawdown the wetlands takes an employee approximately one hour of turning a ring handle in an ergonomically stressful "High Red Zone" posture that increases ergonomic stressors to their shoulders. In most cases the worm gears are rusted increasing the force necessary to raise or lower the slide gates. See exhibit D.

6. Reinstall the cut-out sections of the debris grates on the channel side of the South water control structure and repair or replace the frozen hinges (on North structure as needed) as a strategy to prevent tidal debris from entering the inverted pipes and reducing the number of required entries. Consider additional study of the task to determine if the area is a "Permit Required" confined space and develop OSHA required entry procedures as needed.

7. Replace the rusted stems (worm gears) on the tide gates or install a gear/power drive unit as a strategy to decrease the force necessary, and resulting ergonomic stressors to the employees, when opening or closing the units.
