Metro
Smith and Bybee Wetlands
Multnomah Channel Marsh
Water Control Facilities
Structural Inspection Report
 March 16, 2015

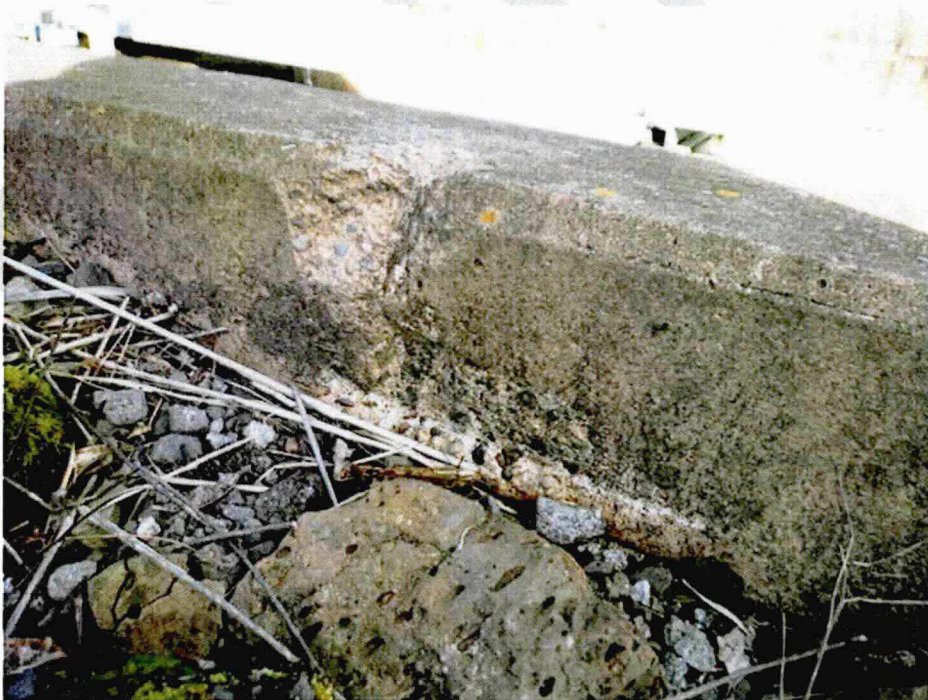
Concrete walls comprise most of the structure and appear to be in good condition. On the southern face of the northeast wall, concrete spalling occurs approximately 52 inches from the east end. The spall is approximately three inches deep and three inches wide at the top of the curb, and approximately three inches deep and seven inches wide on the wall face (see photo A6).

Photo A6: Spall in Northeast Wall

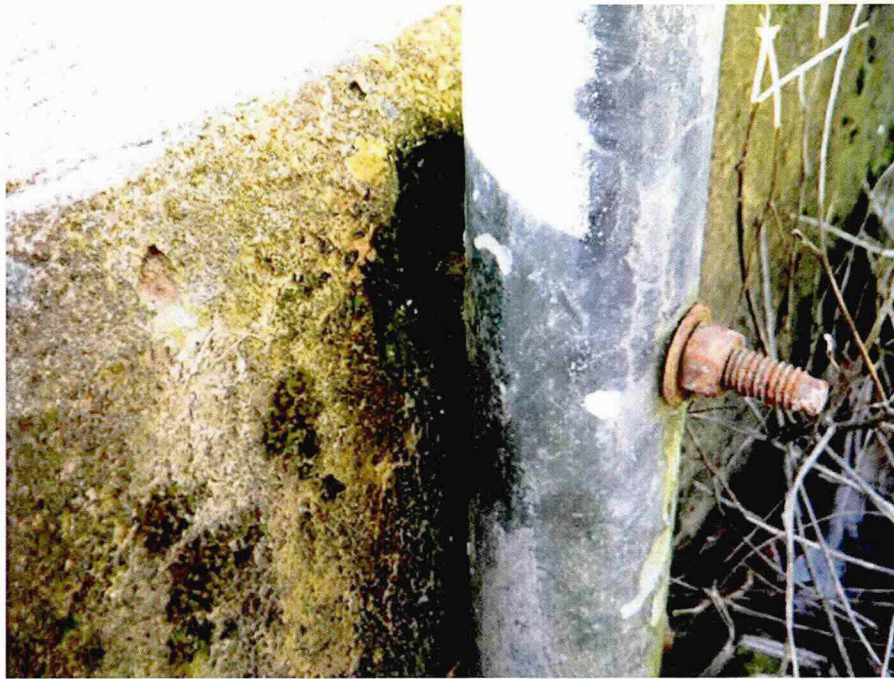
On the southwest wall, at the third railing post from the north end, the concrete is spalled at the top anchor of the rail post connection (see photo A7).

Photo A7: Spall in Southwest Wall at Rail Post Anchor

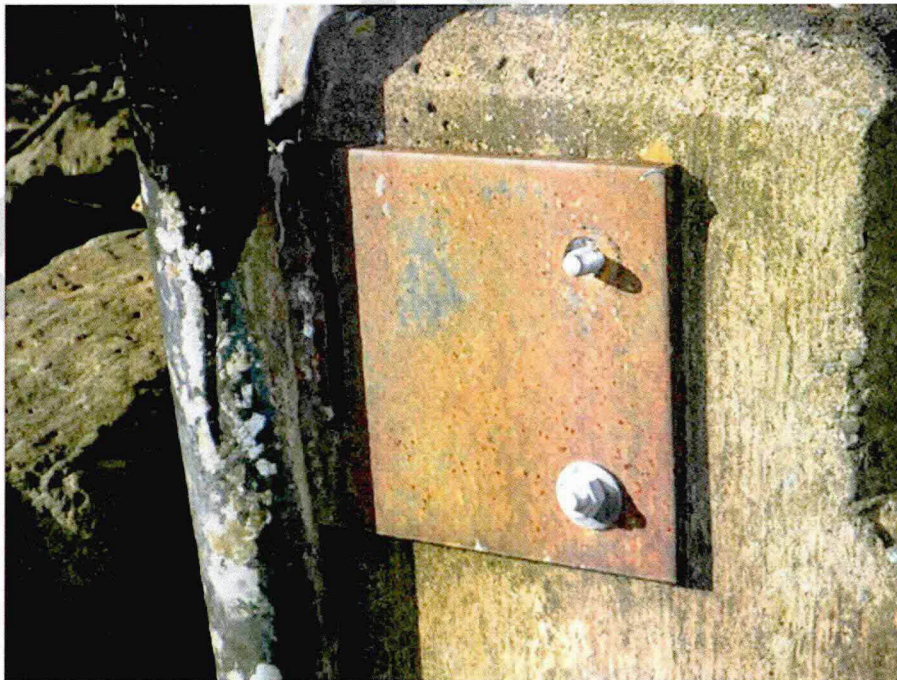
- On the southern end of the northeast wall at the rail post connection plate, a nut and washer appear to be missing from the top anchor and the connection plate shows signs of light corrosion (see photo A8).

Photo A8: Southern End of Northeast Wall - Rail Post Connection

- Replace missing washer and nut at rail post connection located at the southern end of the northeast wall.
- Expose buried rail posts.
- Repair separated or split top rails.
- Clean and recoat railing.
- Tighten loose anchor nuts.
- Clean and touch-up coating on miscellaneous metal framing.
- Tighten or reset anchors, as needed, at chain rail posts.

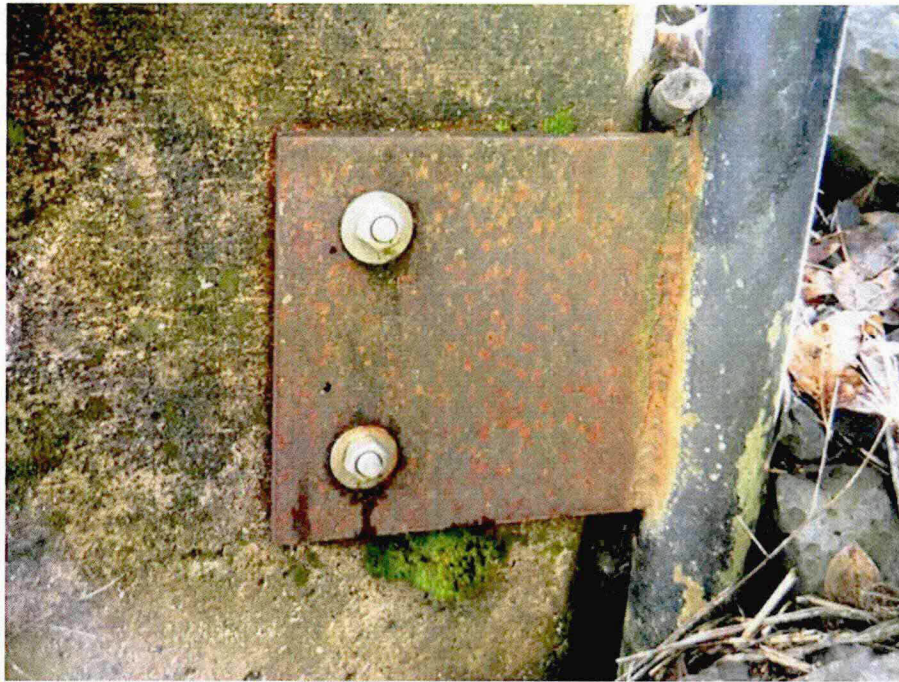
- On the northern end of the northeast wall, the rail post connection plate shows signs of light corrosion (see photo A9).
- Along the northeast wall and a few locations along the southwest wall the rail posts and their connections appear to be buried below grade. This condition may accelerate corrosion at the buried post sections (see photo A10).

Photo A9: Northern End of Northeast Wall – Rail Post Connection

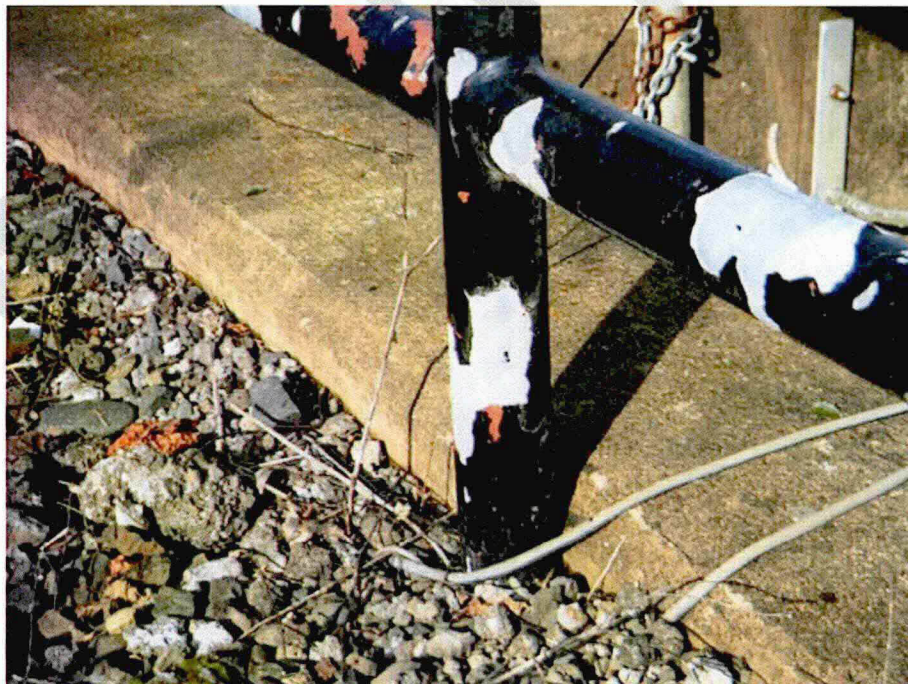
Photo A10: Northeast Wall – Typical Buried Rail Post

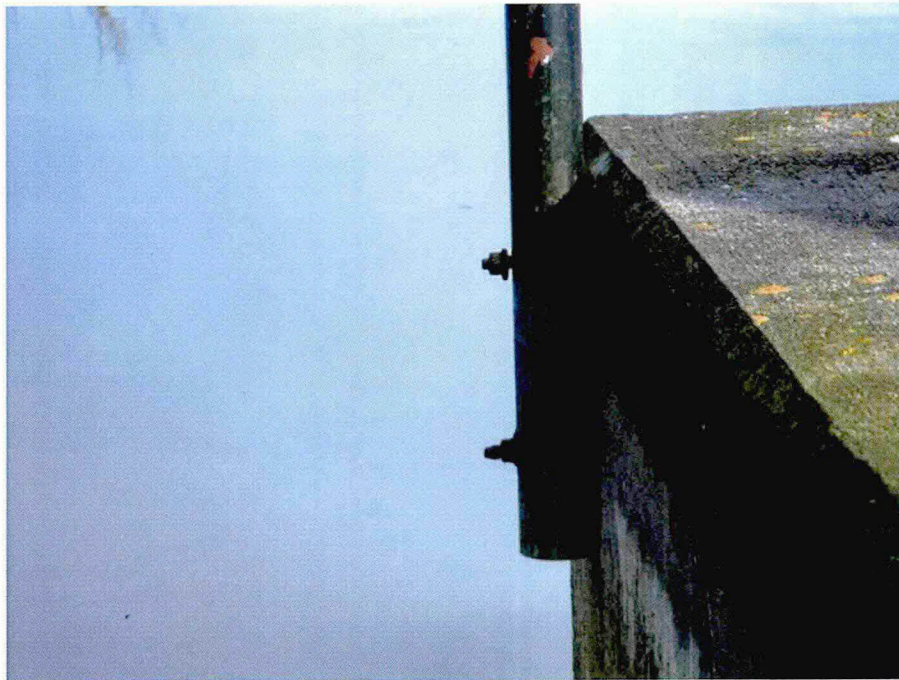
- At the end rail post connection to the concrete at the northern end of the northeast wall the top anchor nut appears loose (see photo A11).
- At some of the rail post connection anchors, the anchors show signs of corrosion (see photo A12).

Photo A11: Northeast Wall Northern End– End Rail Post Connection

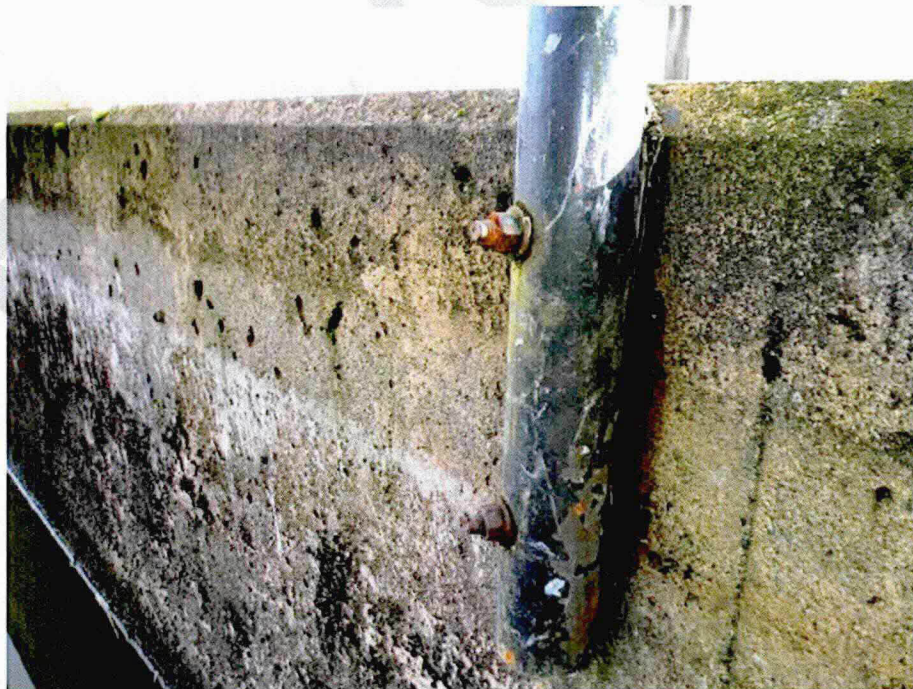
Photo A12: Typical Rail Post Connection – Corrosion at Anchors

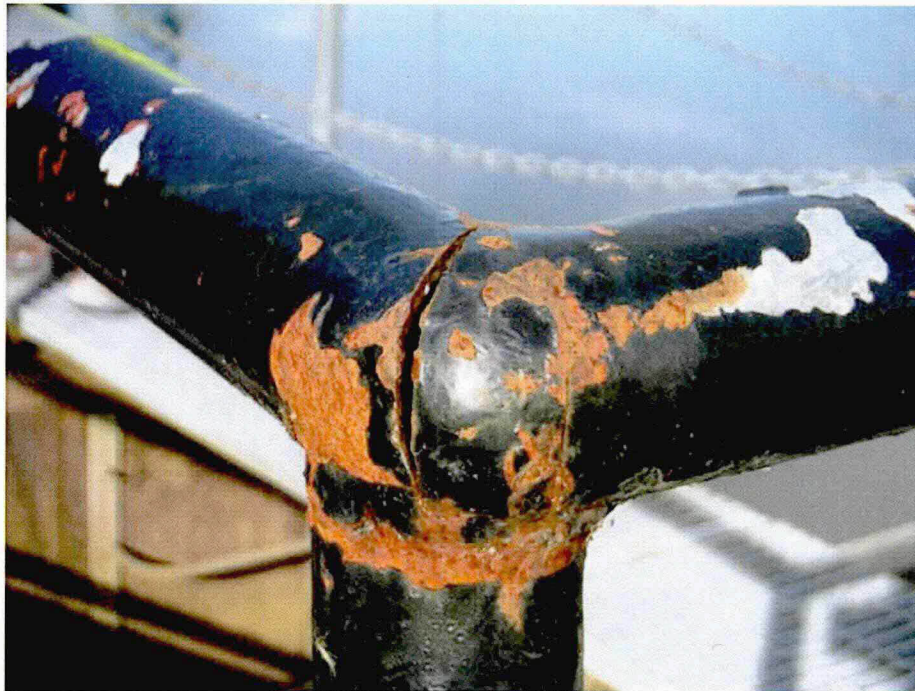
- At the southern end of the northeast wall, the top rail is split at the corner with signs of corrosion (see photo A13).
- On the northeast wall, approximately 10 inches from the southern corner, the top rail appears to be dented (see photo A14).

Photo A13: Southern End Northeast Wall – Split Top Rail

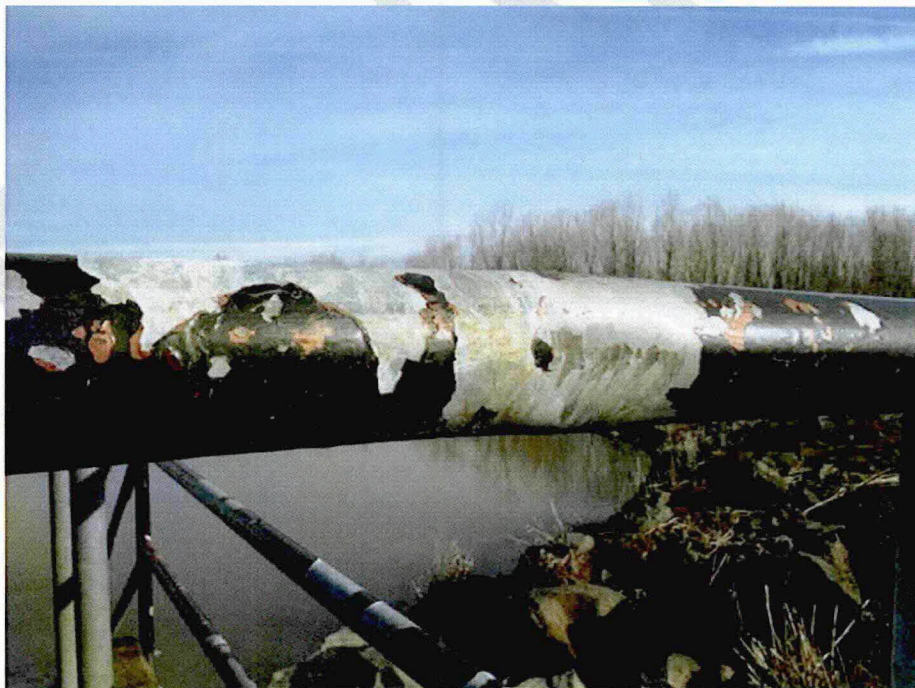
Photo A14: Northeast Wall – Dented Top Rail

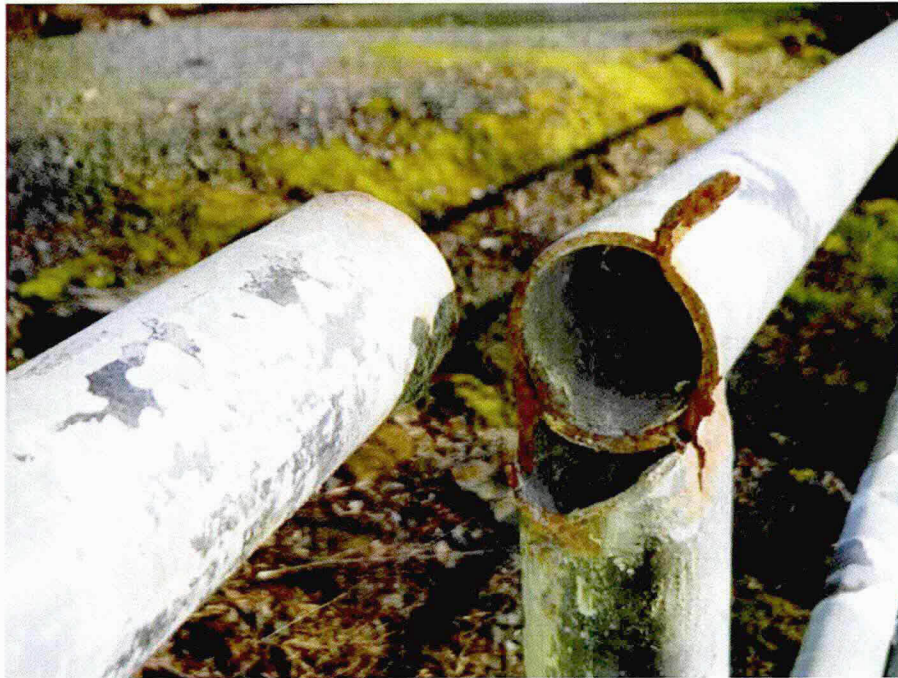
- On the southwest wall at the center rail post, the top rail has sheared apart (see photo A15).
- Loss of paint coating has occurred on many areas of the rail and is peeling in other areas (see photo A16).

Photo A15: Southwest Wall – Separated Top Rail

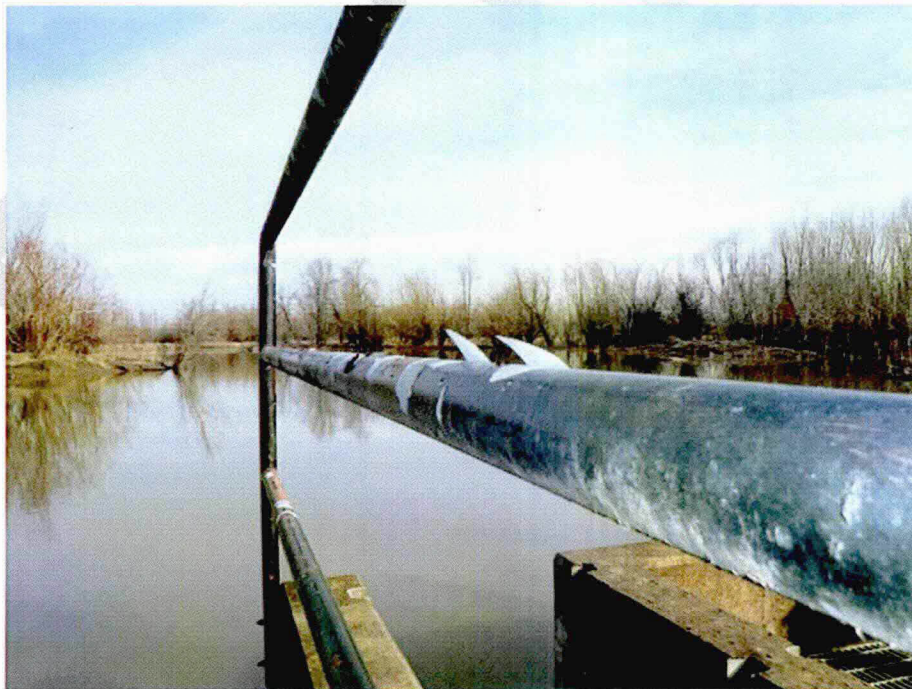
Photo A16: Typical Railing – Coating Loss and Peeling

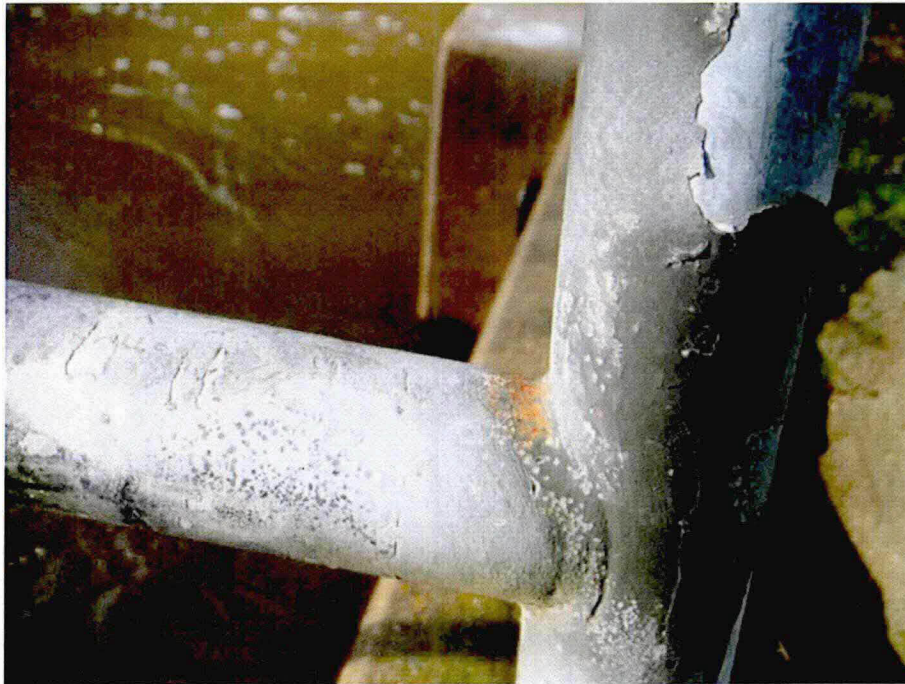
- At many locations on the rails, small areas of corrosion are noticeable through the rail coatings (see photos A17).

Photo A17: Typical Railing Corrosion

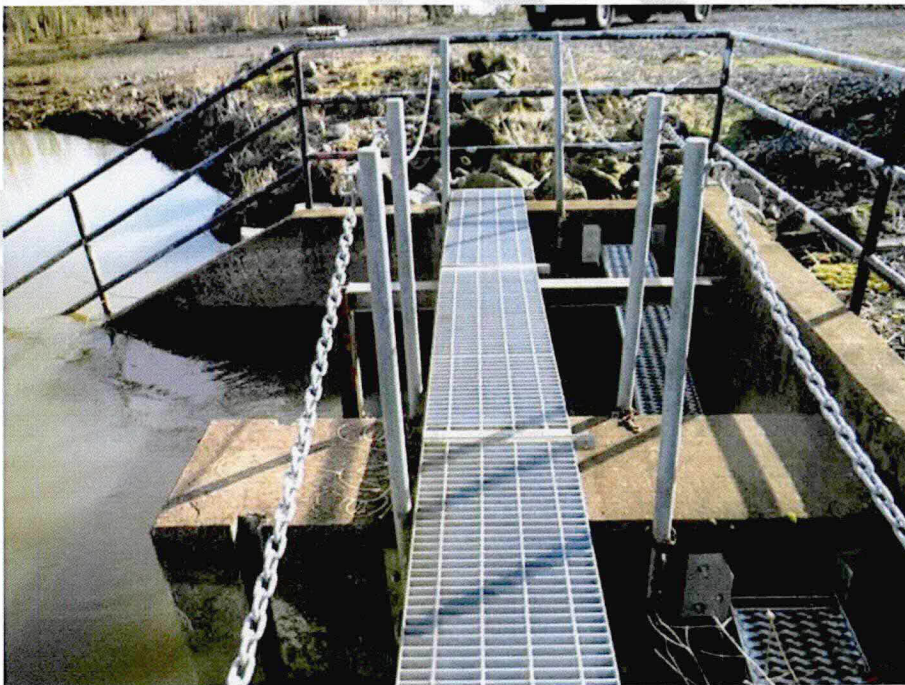
A metal grating catwalk with metal posts and chain rail is located over the inlets and appears to be in good condition. Approximately half of the chain rail posts are wobbly. It is unclear if this condition is due to inappropriately tightened anchors, oversized holes in the posts, or initial failure of the anchors (see photo A18).

Photo A18: Walkway Over Inlets and Chain Railing

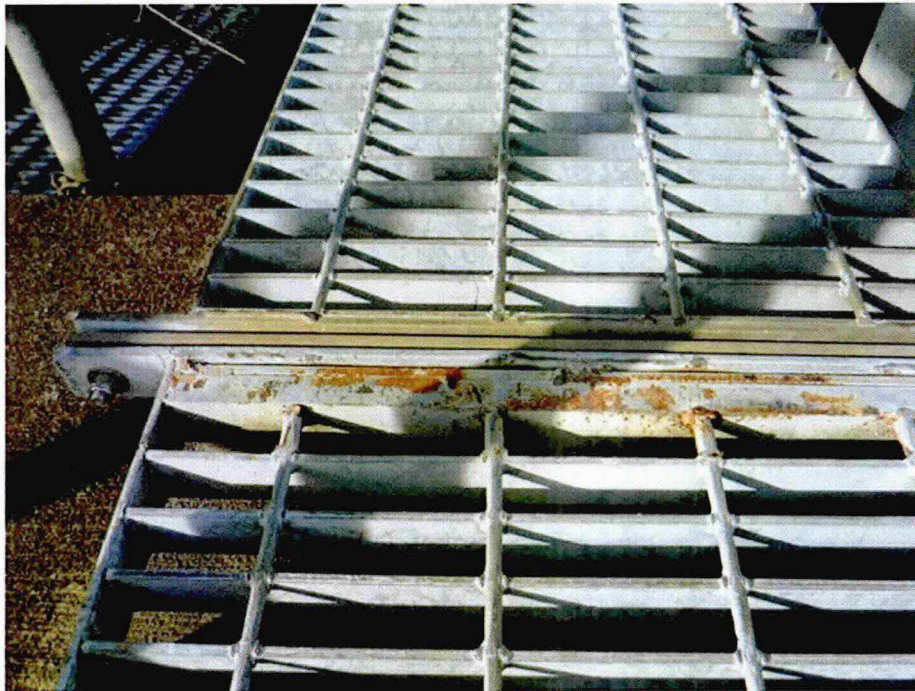
On the walkway grating, minor areas of corrosion occur (see photo A19) and some sections of grating do not appear to be anchored to supports.

Photo A19: Walkway Over Inlets – Typical Corrosion

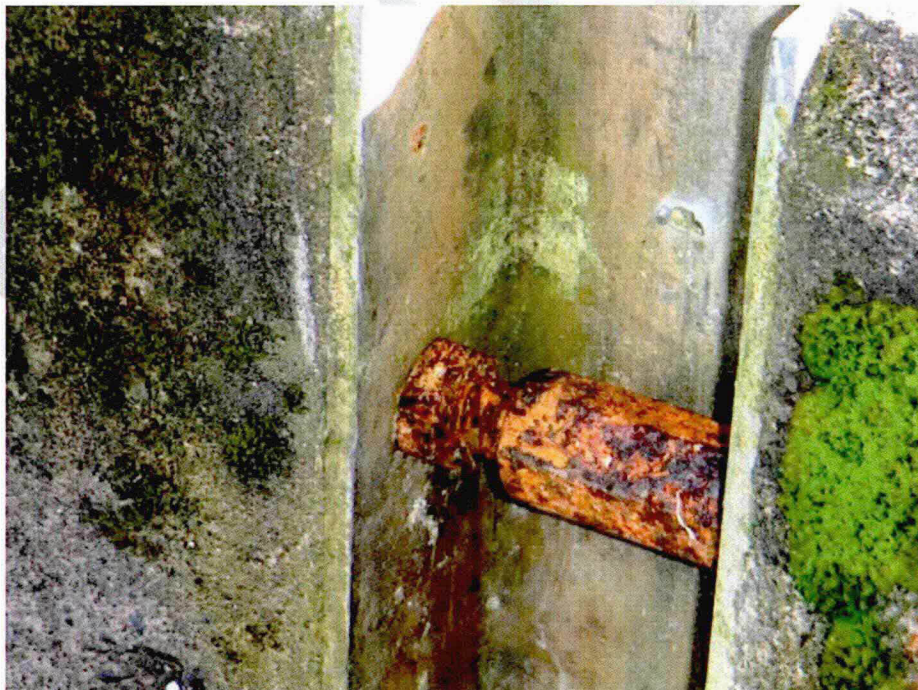
The miscellaneous metal framing for the water retention structure appears to be in good condition. Pins located near the top of the inlet keeper slots show signs of corrosion (see photo A20). Light corrosion appears at many locations on the miscellaneous metal inlet framing (see photos A21 through A23).

Photo A20: Pin Corrosion at Inlet Keeper Slots

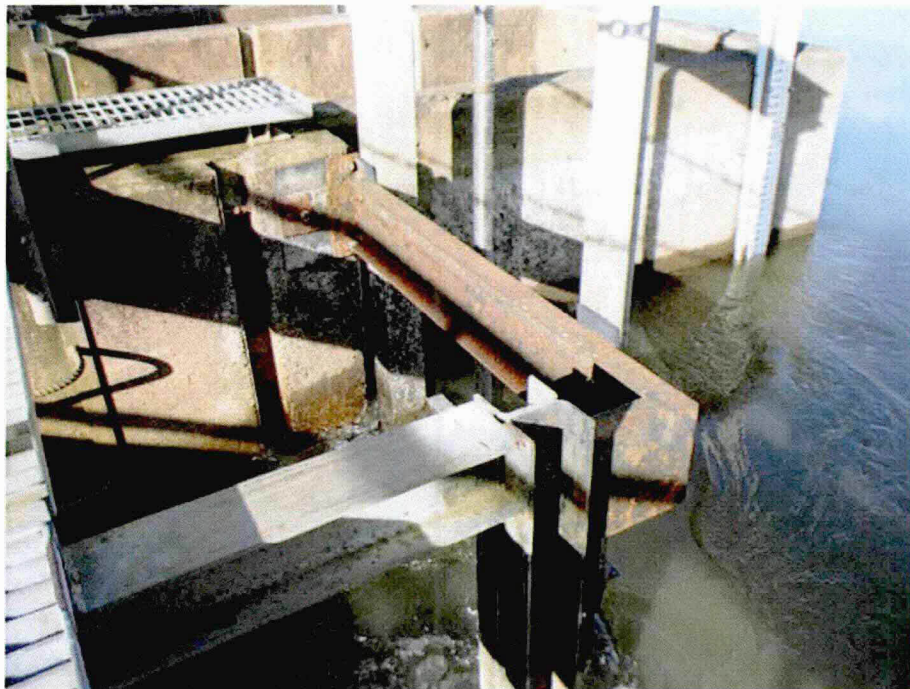
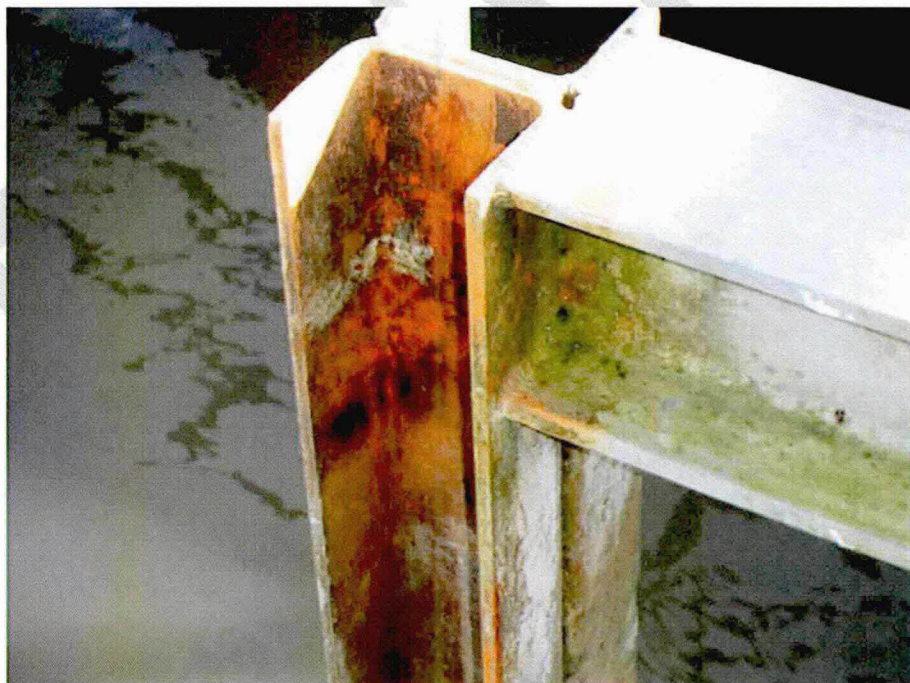
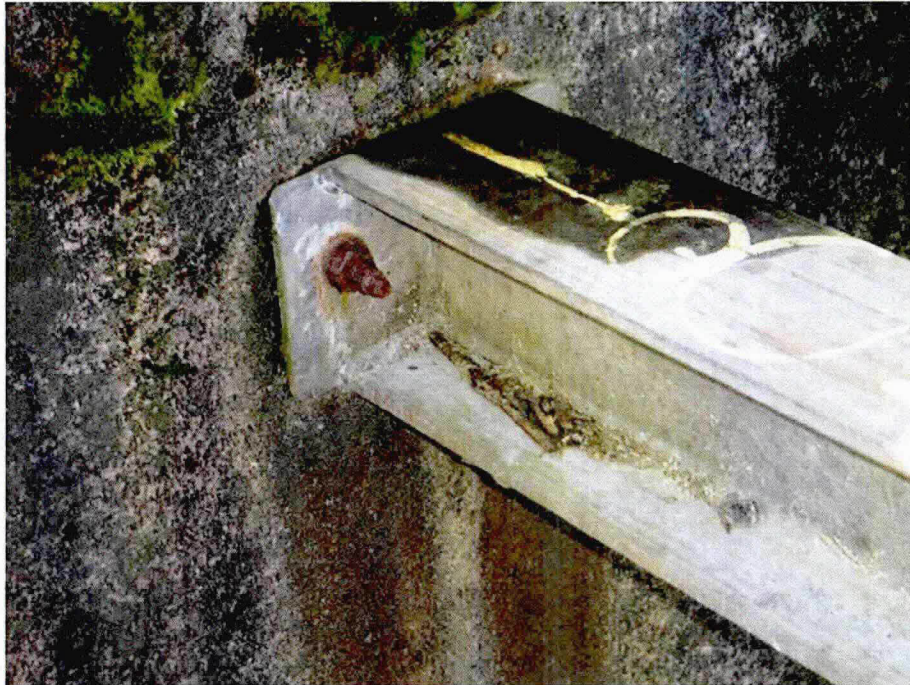
Photo A21: Typical Corrosion on Miscellaneous Metal Framing

Photo A22: Typical Corrosion on Miscellaneous Metal Framing

Photo A23: Typical Corrosion on Miscellaneous Metal Framing

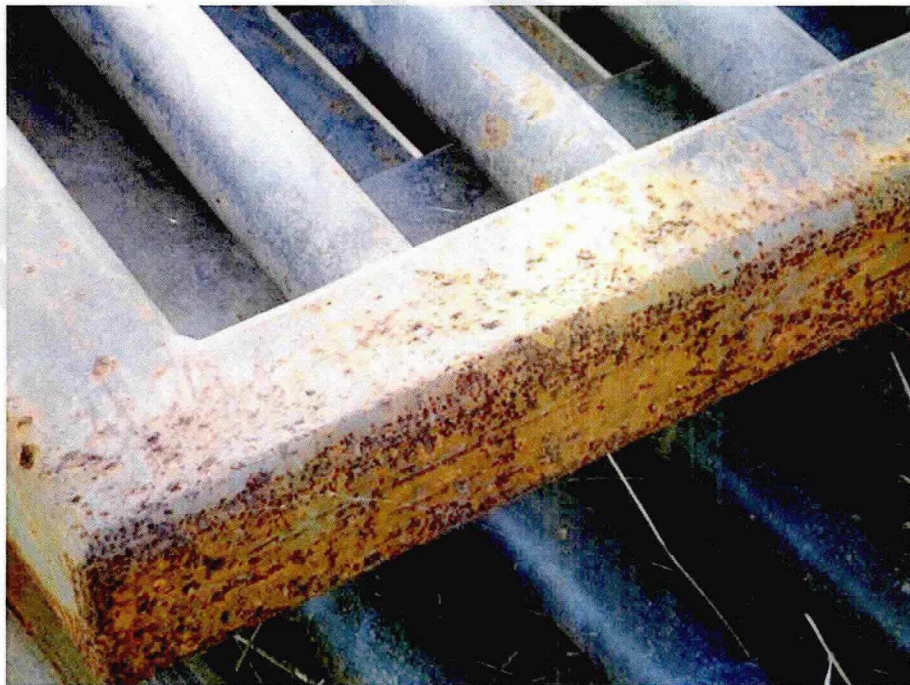
Four steel tube gates were located on grade at the north end of the structure. These gates show signs of corrosion with light pitting on one end of the gate (see photo A24).

Photo A24: Tube Steel Gates – Typical Corrosion and Pitting

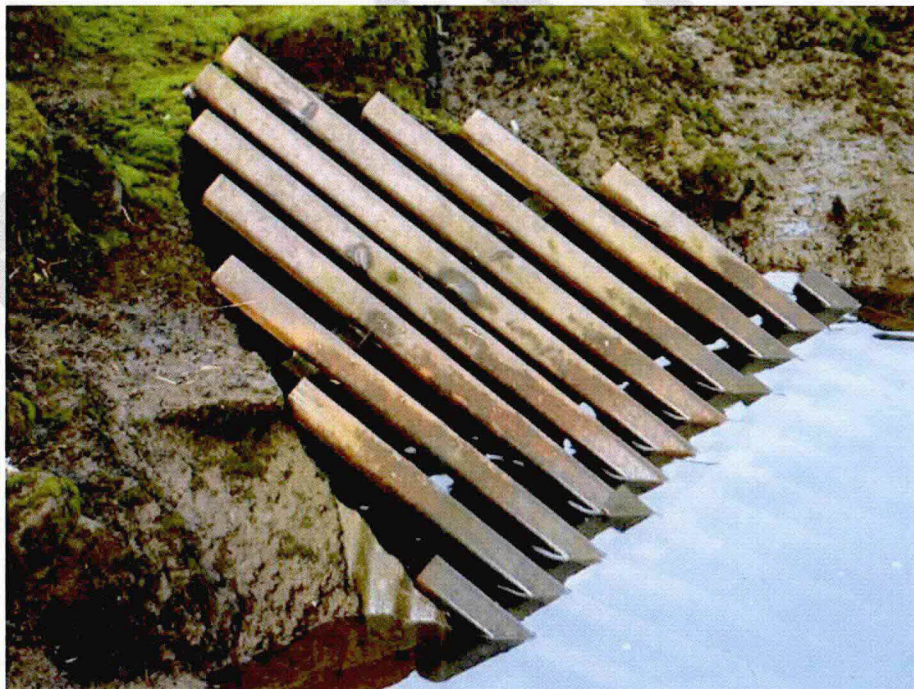
Steel outlet screens over the two culverts on the east face consist of galvanized tube steel framing and appear to be in good condition. Light corrosion is evident on the steel (see photo A30).

Photo A30: Typical Steel Outlet Screen

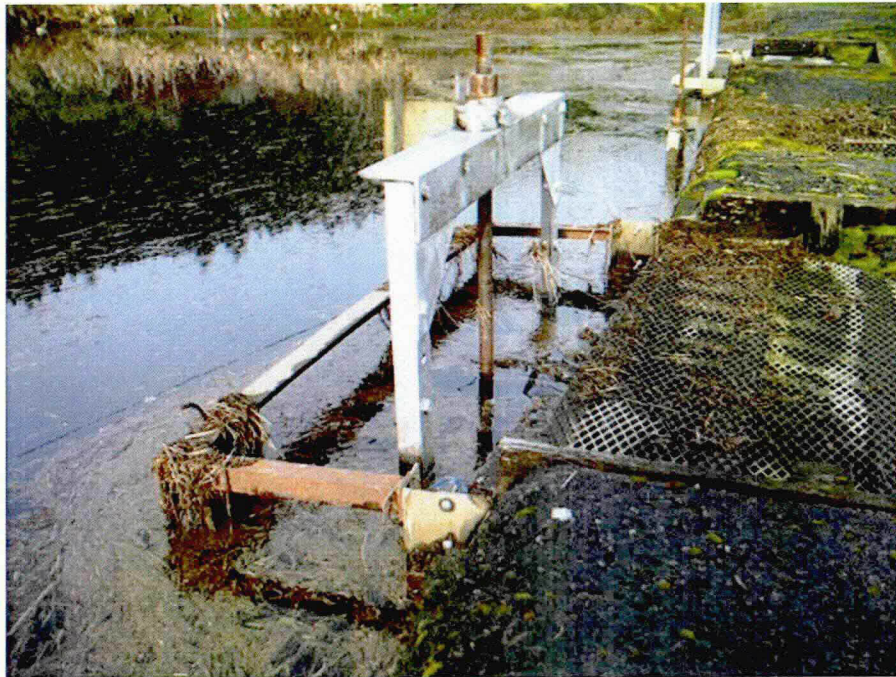
The miscellaneous metal framing appears to be in good condition with light signs of corrosion (see photo A31).

Photo A31: Typical Corrosion on Miscellaneous Metal Framing

- Clean and touch-up coating on miscellaneous metal framing.

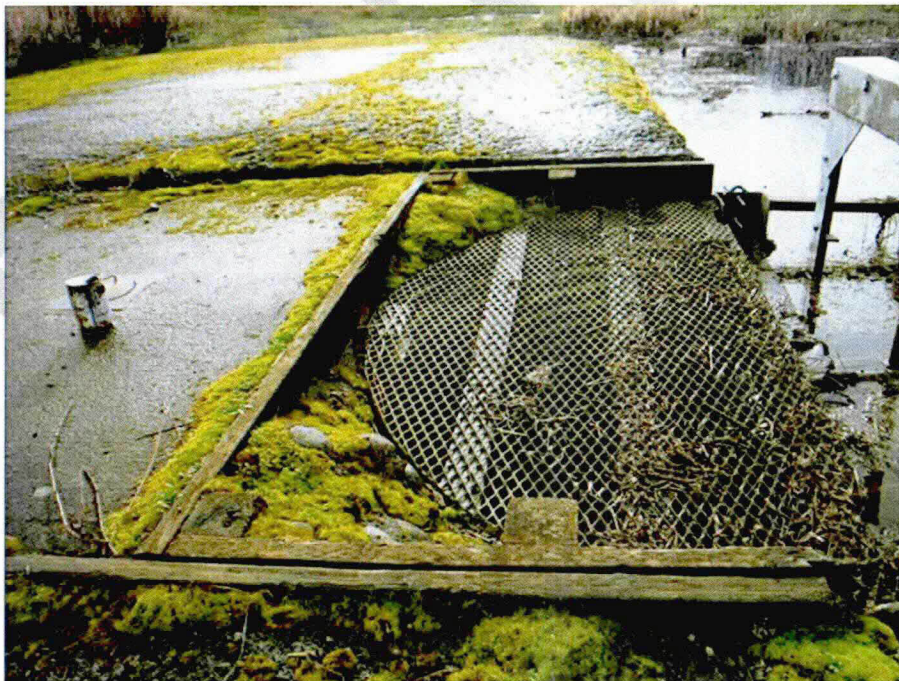
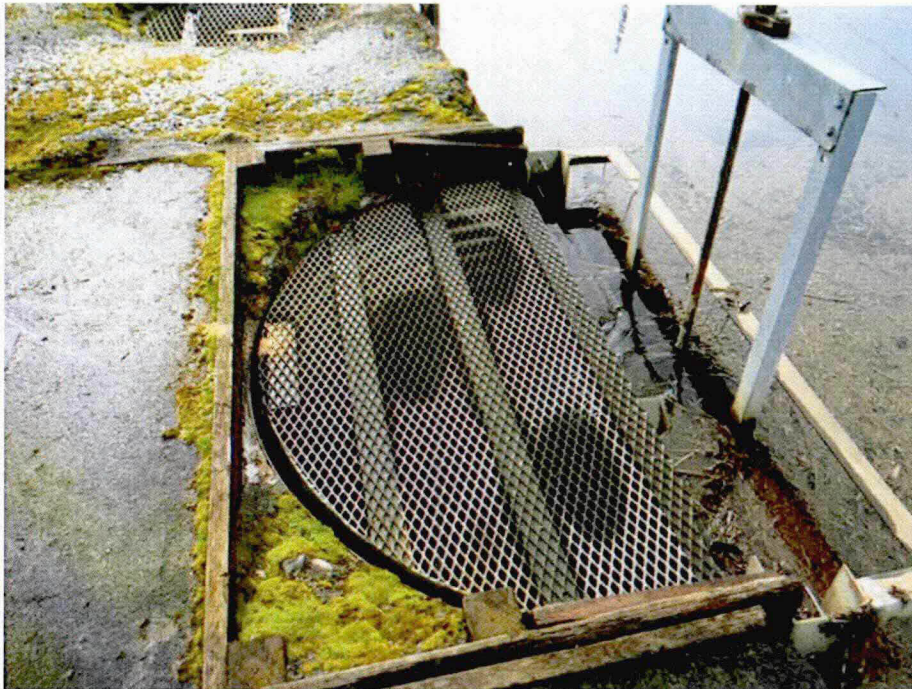
Inlets consist of corrugated metal pipe with grating covers and appear to be in good condition (see photos A32 and A33). At the fish passage pipe, light corrosion occurs on the grating hinges (see photo A34). Concrete pads are placed behind the inlets and appear to be in good condition (see photos A32 and A35).

Around the area of the inlet pipes, 2x wood members are placed between concrete pads and the typical grouted structure surface and appear to be in fair to poor condition. In some areas this wood has fully disintegrated and in other areas can be penetrated with an awl up to approximately ¼ inch (see photos A32, A33, A35 and A36). These members may be left in place forms.

Photo A32: South Inlet

Photo A33: North Inlet

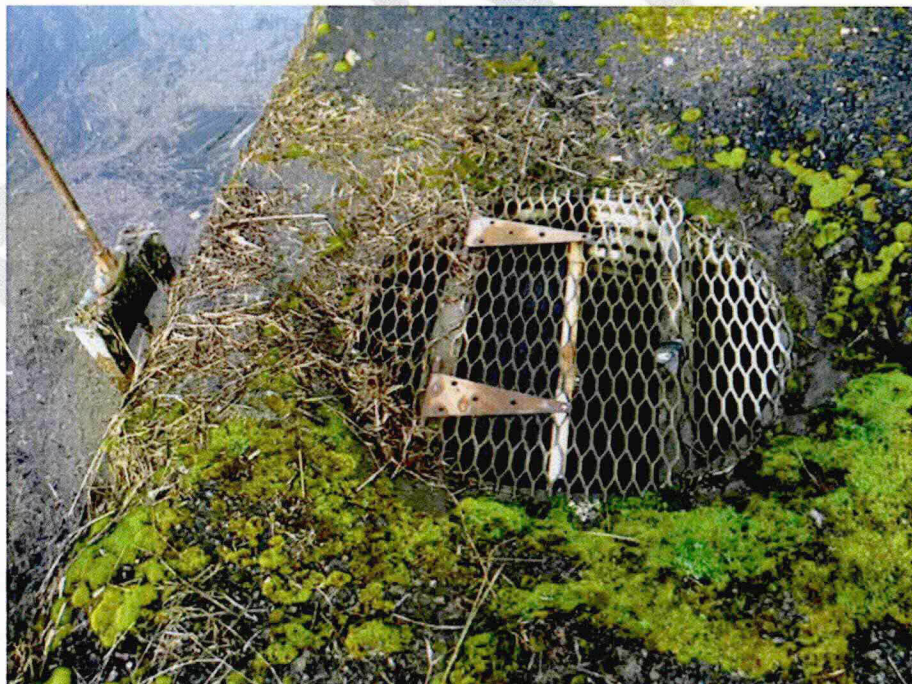
Photo A34: Center Fish Passage

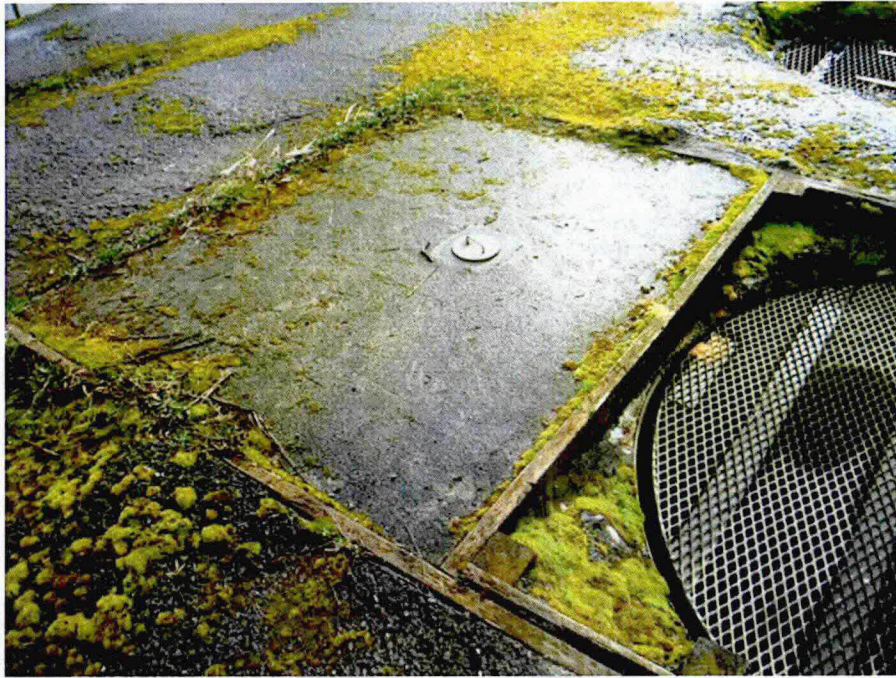
Photo A35: North Inlet – Concrete Pad

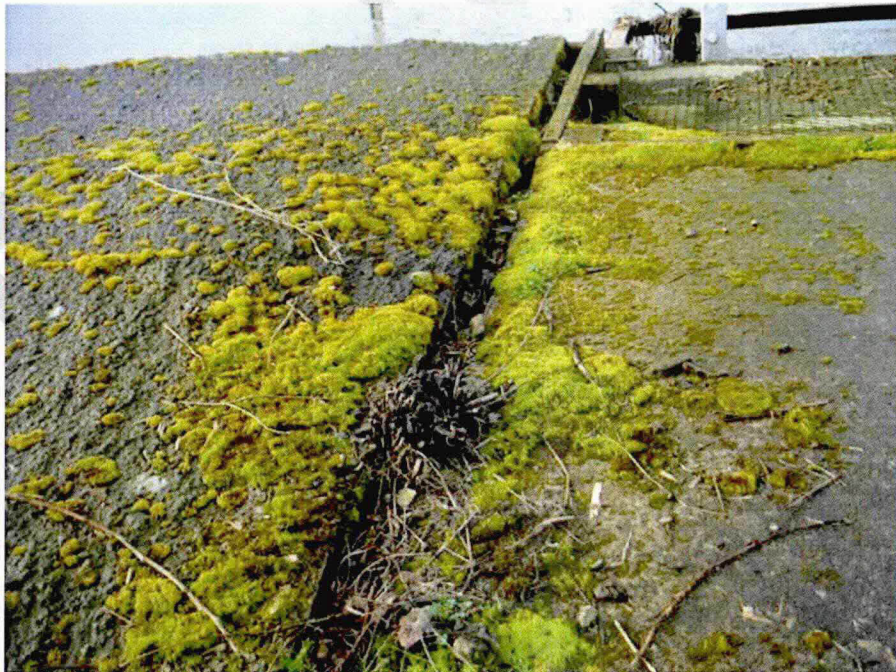
Photo A36: South Inlet – Deteriorated Wood

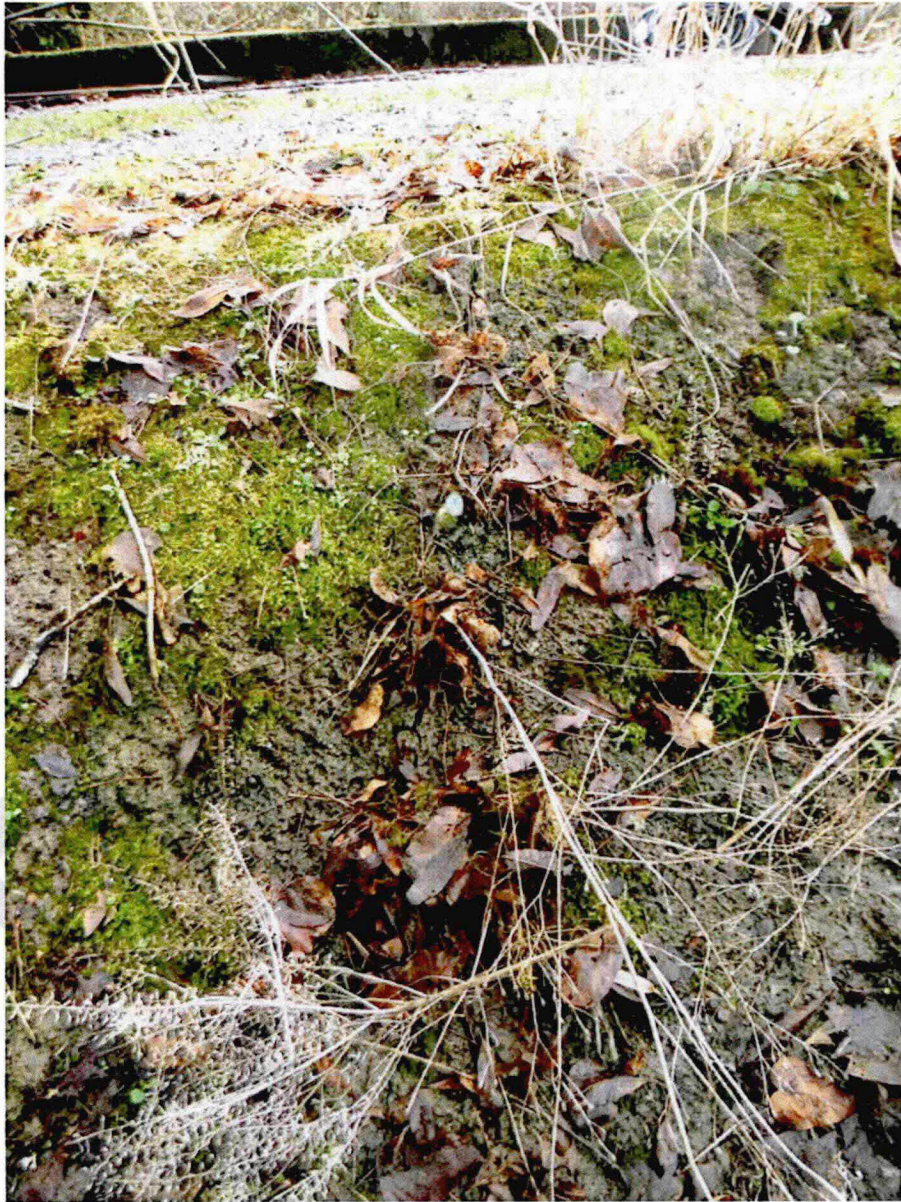
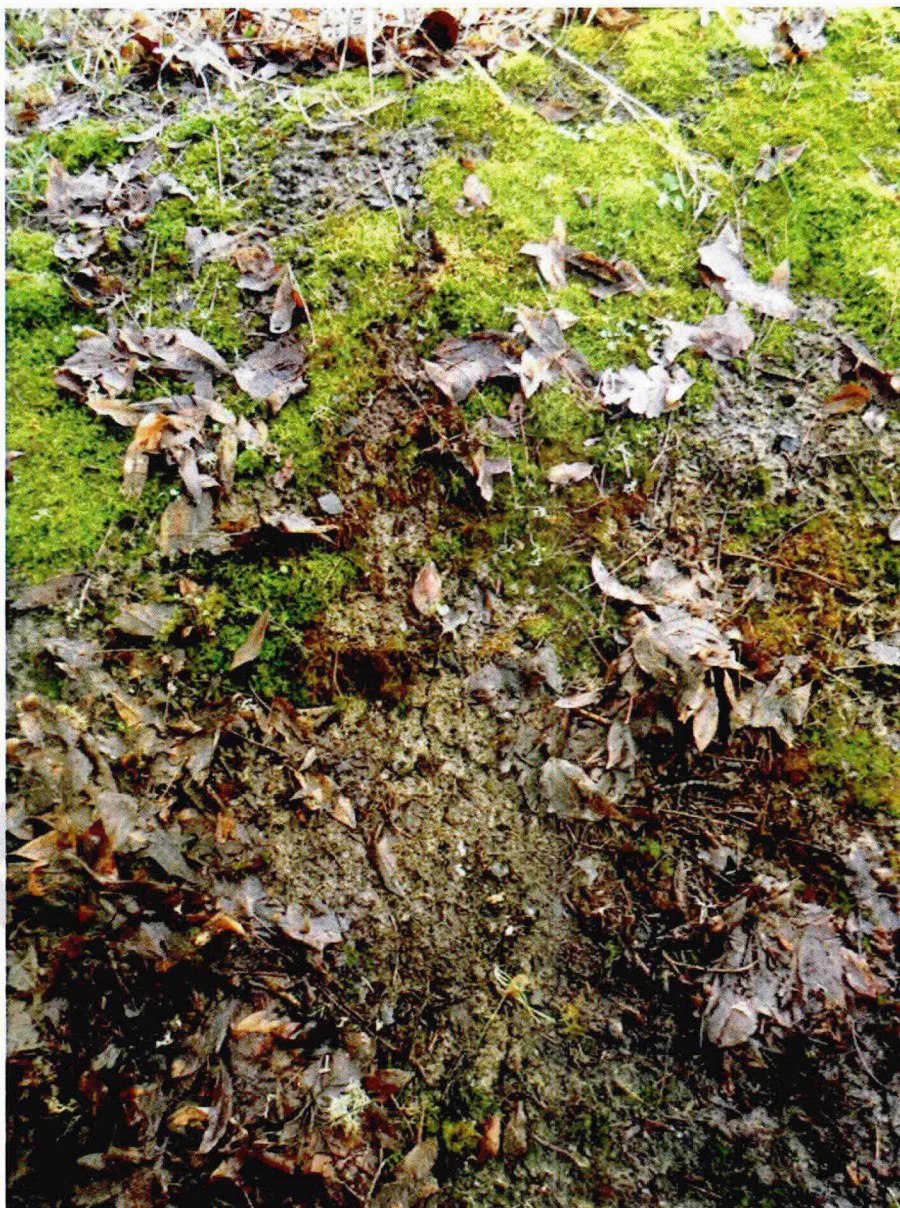
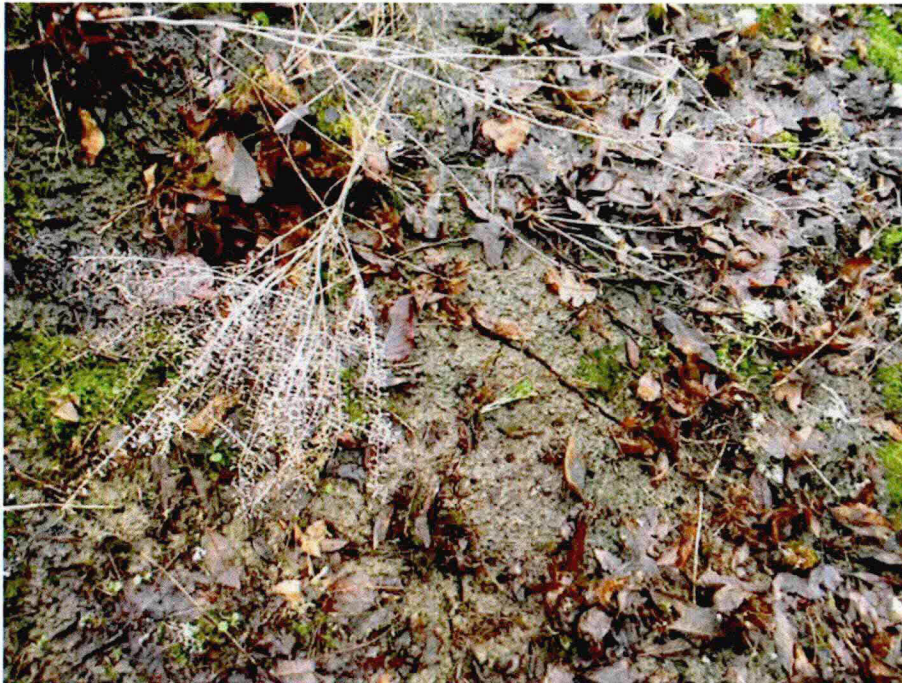
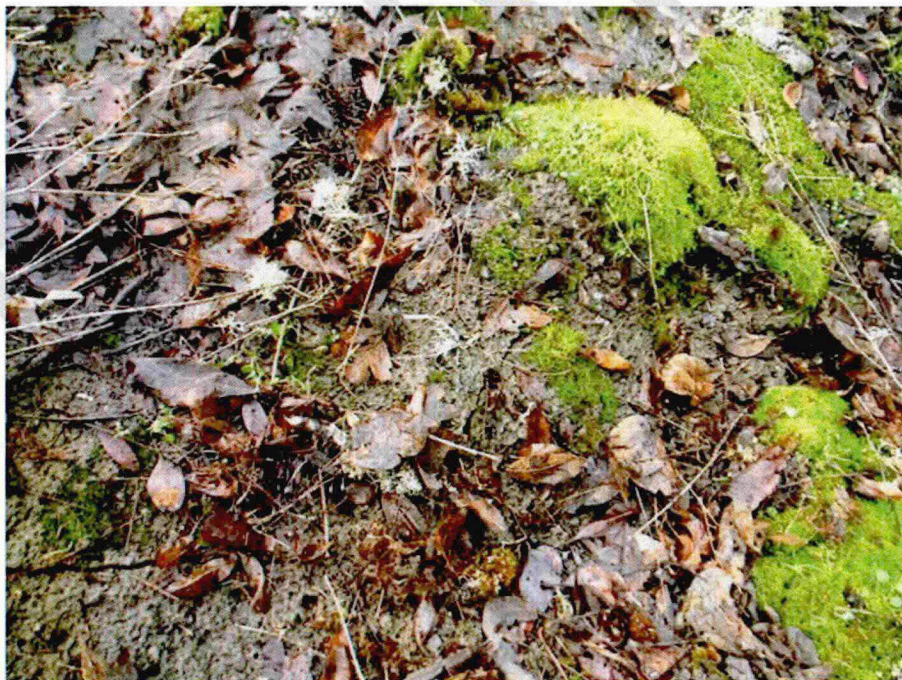
On the north face of the structure, two cracks beginning near the roadway surface run vertically down the face of the slope. The first crack is located approximately 21'-9" from the east end of the structure and the second crack is located approximately 28 feet from the east end of the structure. Cracks are approximately six feet long. A horizontal crack connecting the vertical cracks occurs at approximately 4'-9" down from the top of the slope (see photos A41 through A44). A tree sapling is located adjacent to one of the cracks and may be contributing to the crack propagation.

Photo A41: North Face – Cracks in Slope

Photo A42: North Face – Cracks in Slope

Photo A43: North Face – Cracks in Slope

Photo A44: North Face – Cracks in Slope

- Clean and touch-up coating on miscellaneous metal framing.
- Remove tree sapling on north face.
- Investigate cause of cracks in grouted rip-rap slopes and repair as needed.

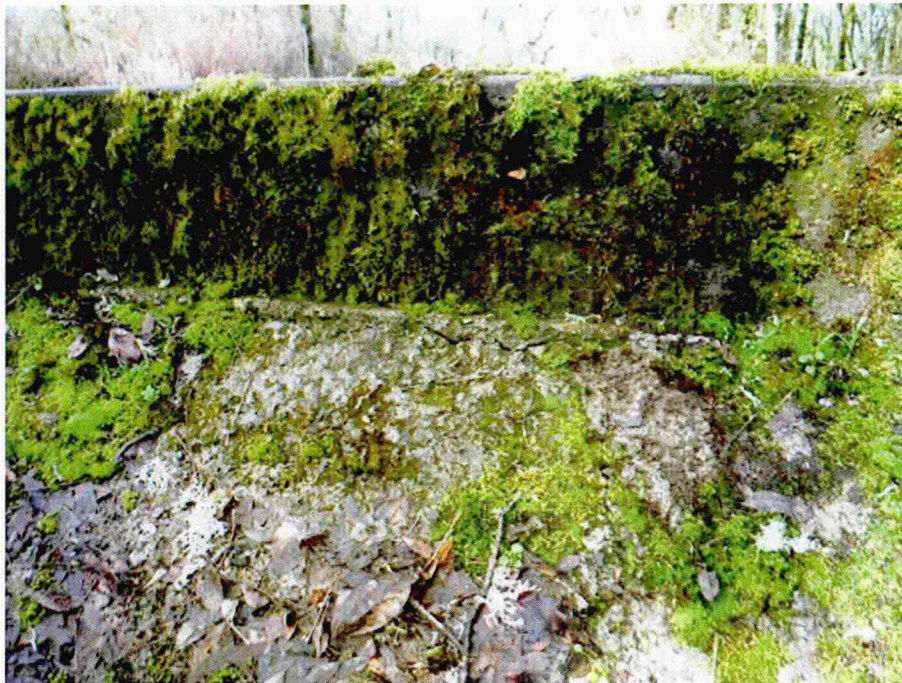
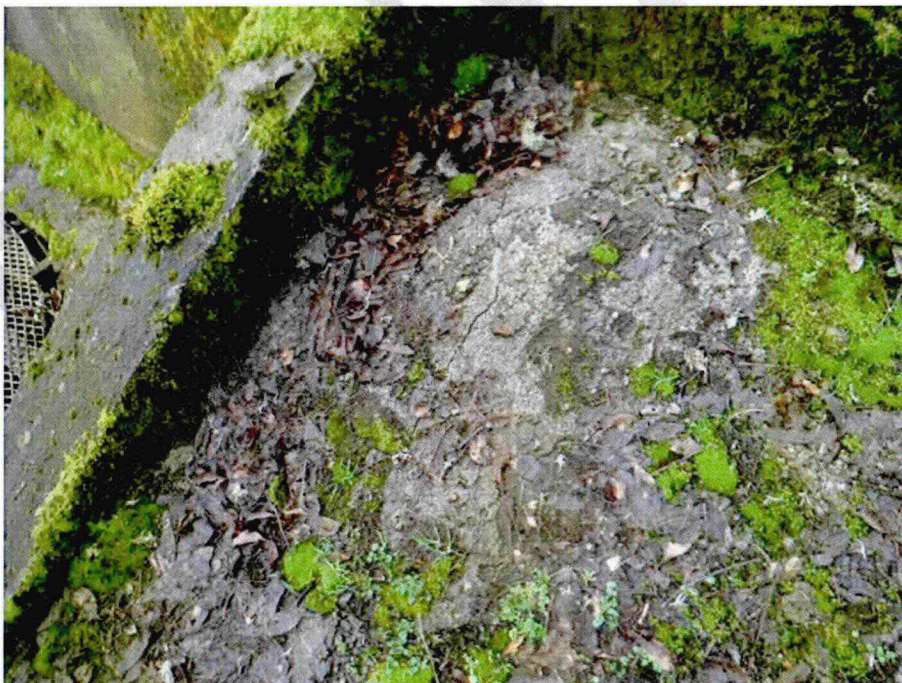
- At the east end, a crack near the top of the slope at the base of the concrete slab-on-grade runs horizontally to approximately one foot of the head wall. Two vertical cracks propagate down the slope from this horizontal crack. The first vertical crack is located approximately one foot off the headwall and the other crack is located approximately 5'-9" off the headwall (see photos 45 and 46).

Photo A45: South Face – Cracks at Top of Slope

Photo A46: South Face – Cracks Adjacent to Headwall
