Metro
Smith and Bybee Wetlands
Multnomah Channel Marsh
Water Control Facilities
Structural Inspection Report
 March 16, 2015

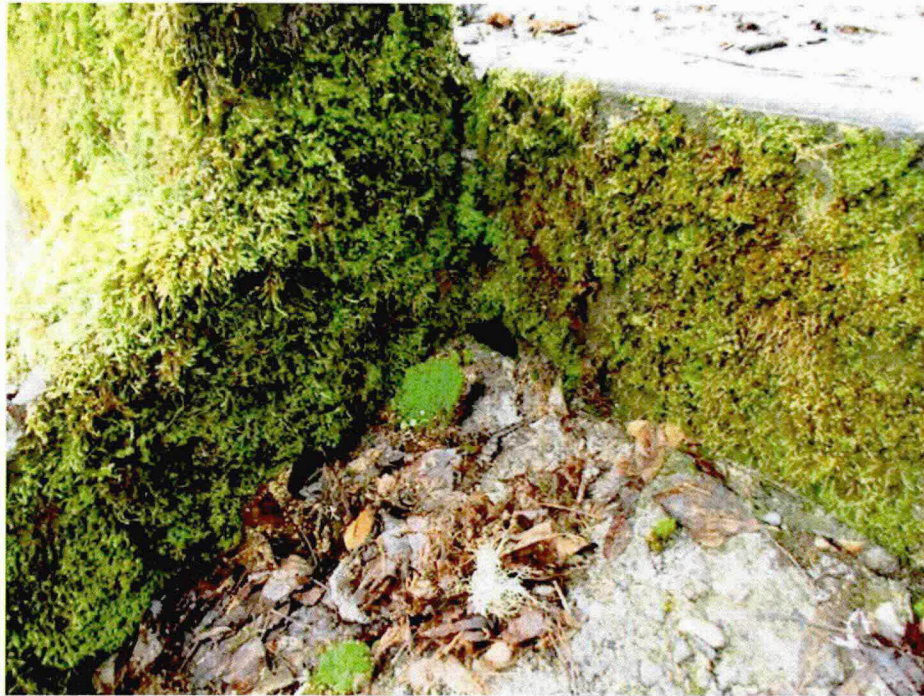
- A void appears to occur at the base of the concrete slab-on-grade near the east end of the headwall, which may allow loss of material from underneath the slab and behind the headwall (see photo A47).
- Between the east culvert and fish passage, cracks appear to occur in the grouted rip-rap slope (see photo A48).

Photo A47: South Face – Void at Base of Slab-On-Grade Near Headwall

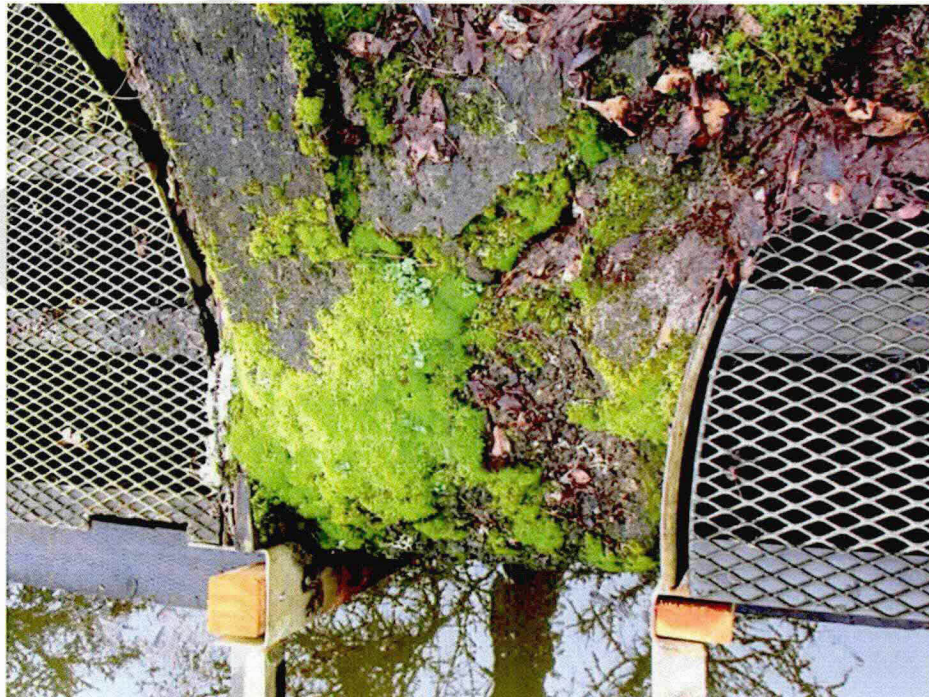
Photo A48: South Face – Cracks Between East Culvert and Fish Passage

- Clean and touch-up coating on miscellaneous metal framing.
- Remove tree sapling on north face.
- Investigate cause of cracks in grouted rip-rap slopes and repair as needed.

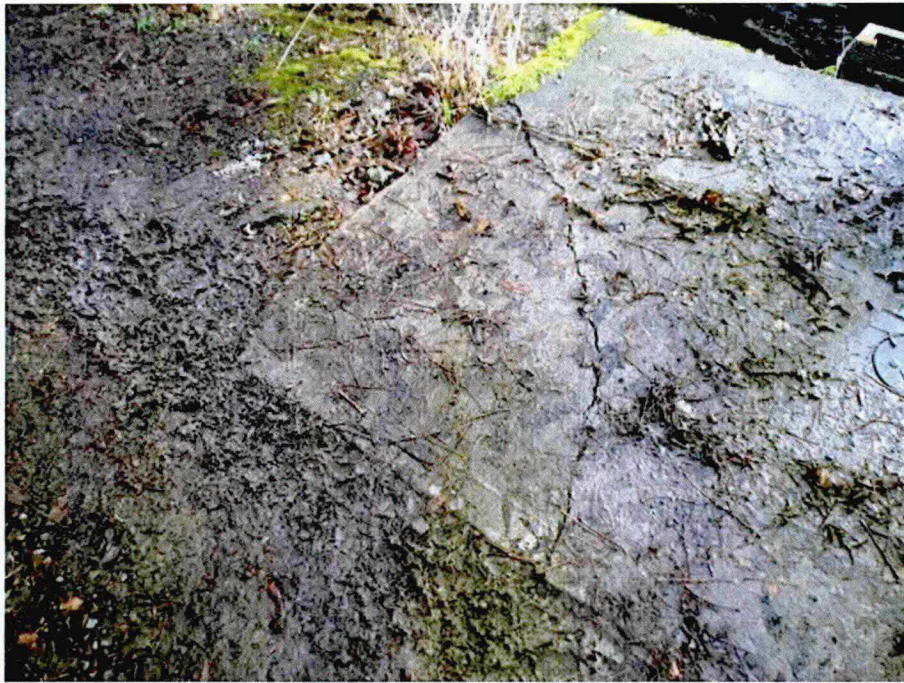
At the east corner of the slab-on-grade, the corner of the concrete is cracked (see photo A49).

Photo A49: Crack at Corner of Slab-On-Grade

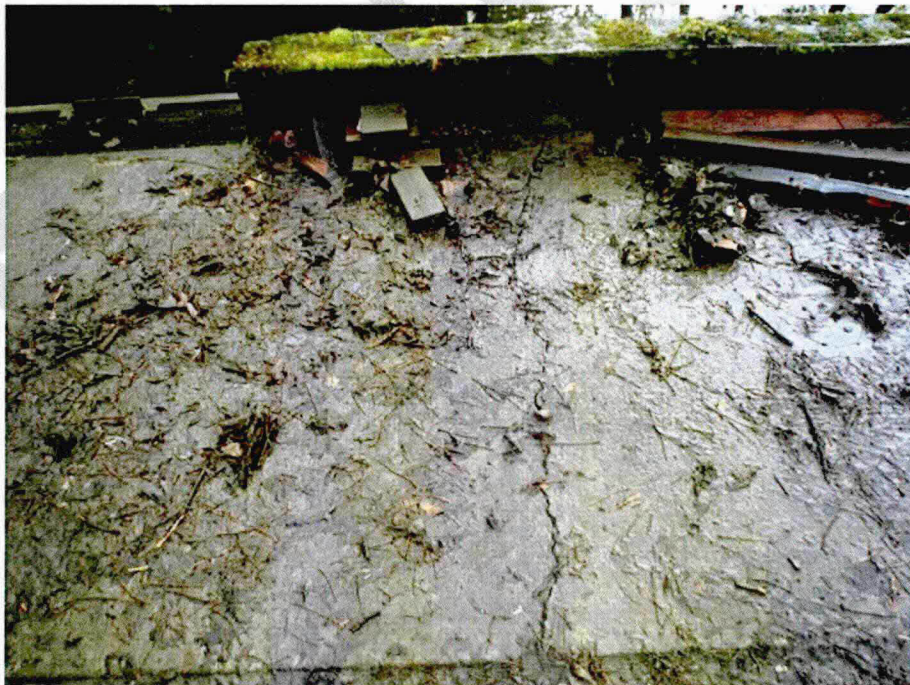
Near the east end of the headwall a crack occurs the full width of the slab-on-grade (see photo A50).

Photo A50: Crack in Slab-On-Grade

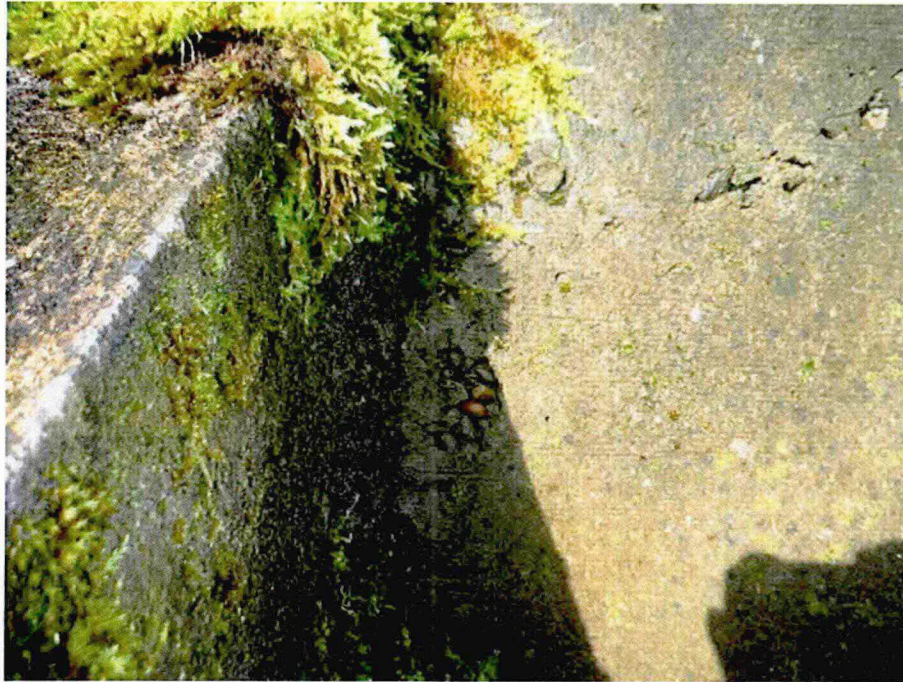
On the south face of the west end of the headwall, a small rock pocket occurs and appears to be part of the original construction (see photo A51).

Photo A51: Rock Pocket in Headwall

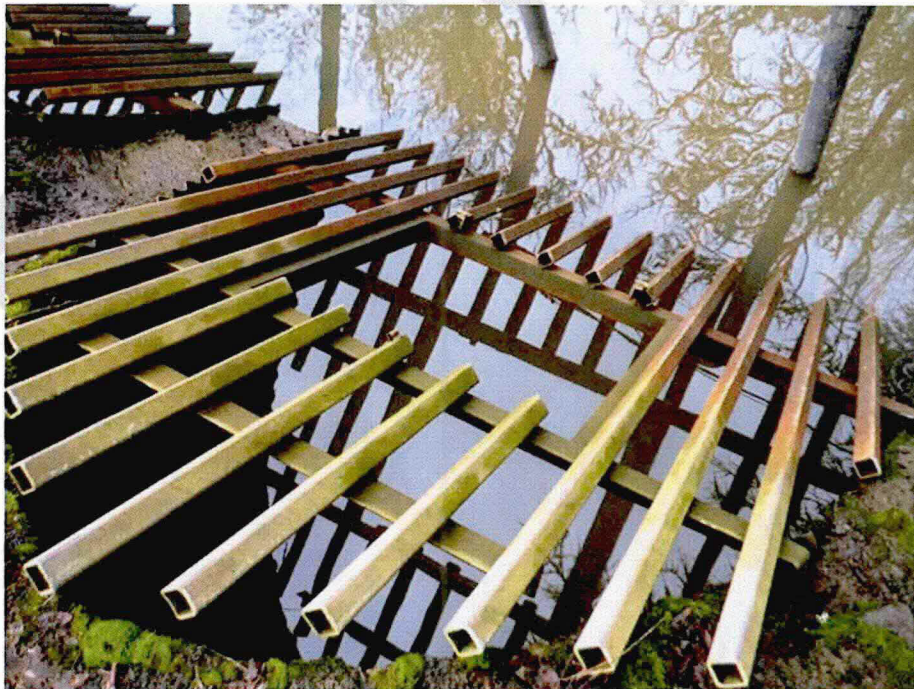
Steel outlet screens over the two culverts on the north face consist of galvanized tube steel framing and appear to be in good condition. Light corrosion is evident on the steel (see photo A52).

Photo A52: Typical Steel Outlet Screen

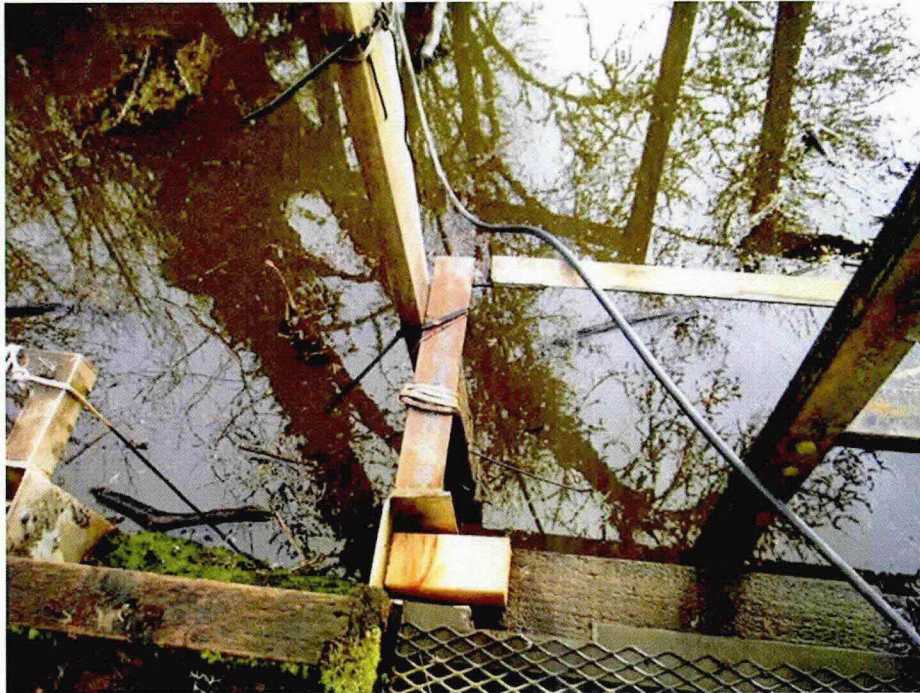
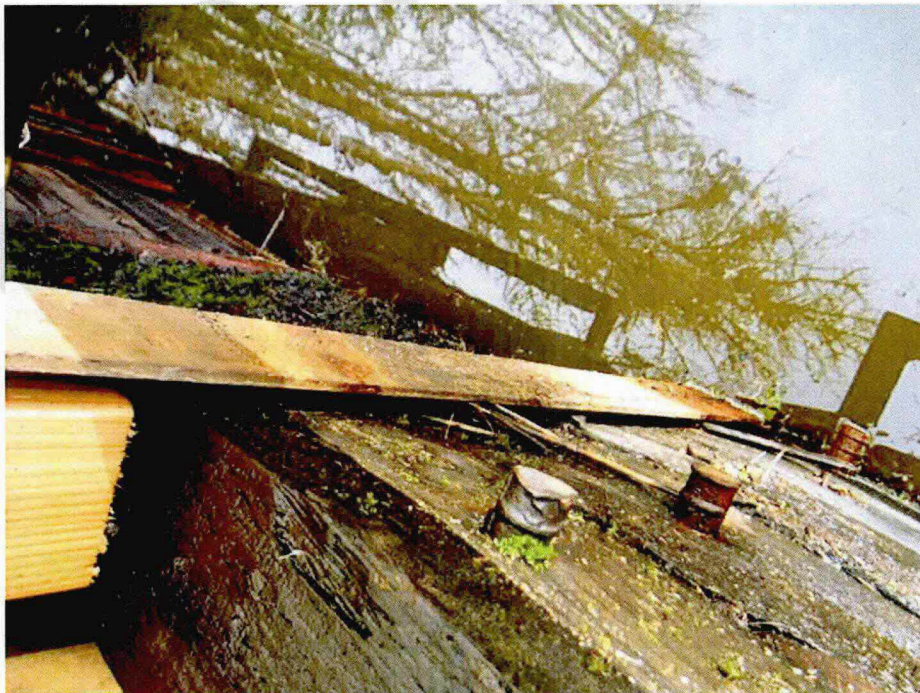
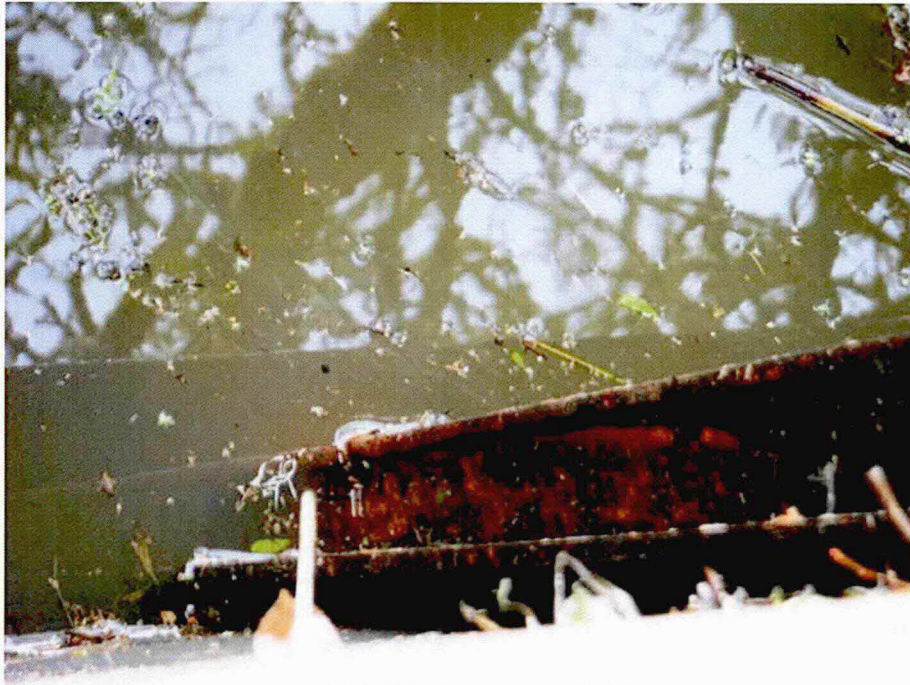
The miscellaneous metal framing appears to be in good condition with light signs of corrosion above the typical water line and slightly heavier corrosion near the water line (see photo A53 through A55).

Photo A53: Typical Corrosion on Miscellaneous Metal Framing

Photo A54: Typical Corrosion on Miscellaneous Metal Framing

Photo A55: Typical Corrosion on Miscellaneous Metal Framing

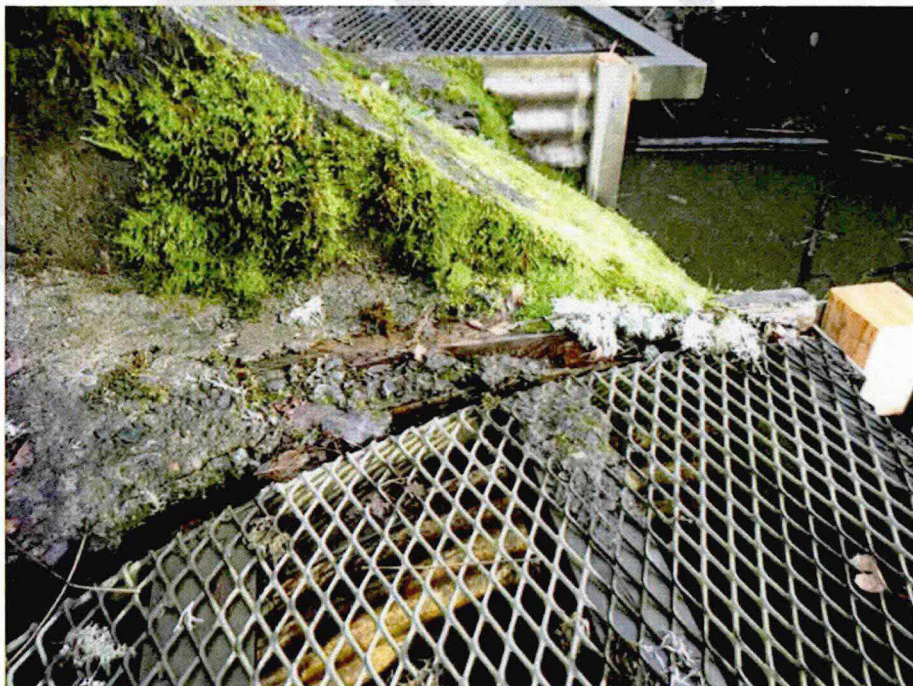
Inlets consist of corrugated metal pipe with grating covering and appear to be in good condition. The grating is supported by angles welded to the corrugated metal pipe. Gaps occur between the inlet pipes and the grouted slope/headwall and appear to be due to forming for the grouted slopes (see photo A56). Wood members occur along the edges of the grouted slope and appear to be left in place forms. At most locations, the wood can be penetrated with an awl up to approximately $\frac{1}{4}$ inch to $\frac{3}{4}$ ". At the center of the structure, the wood member on the south face can be penetrated approximately 3 inches with an awl.

Photo A56: Inset Wood and Gap at Inlet
