PRELIMINARY DIKE STABILIZATION STUDY
ST. JOHNS LANDFILL
PORTLAND, OREGON

APRIL 12, 1999

Cornforth
Consultants Inc.

DRAFT REPORT

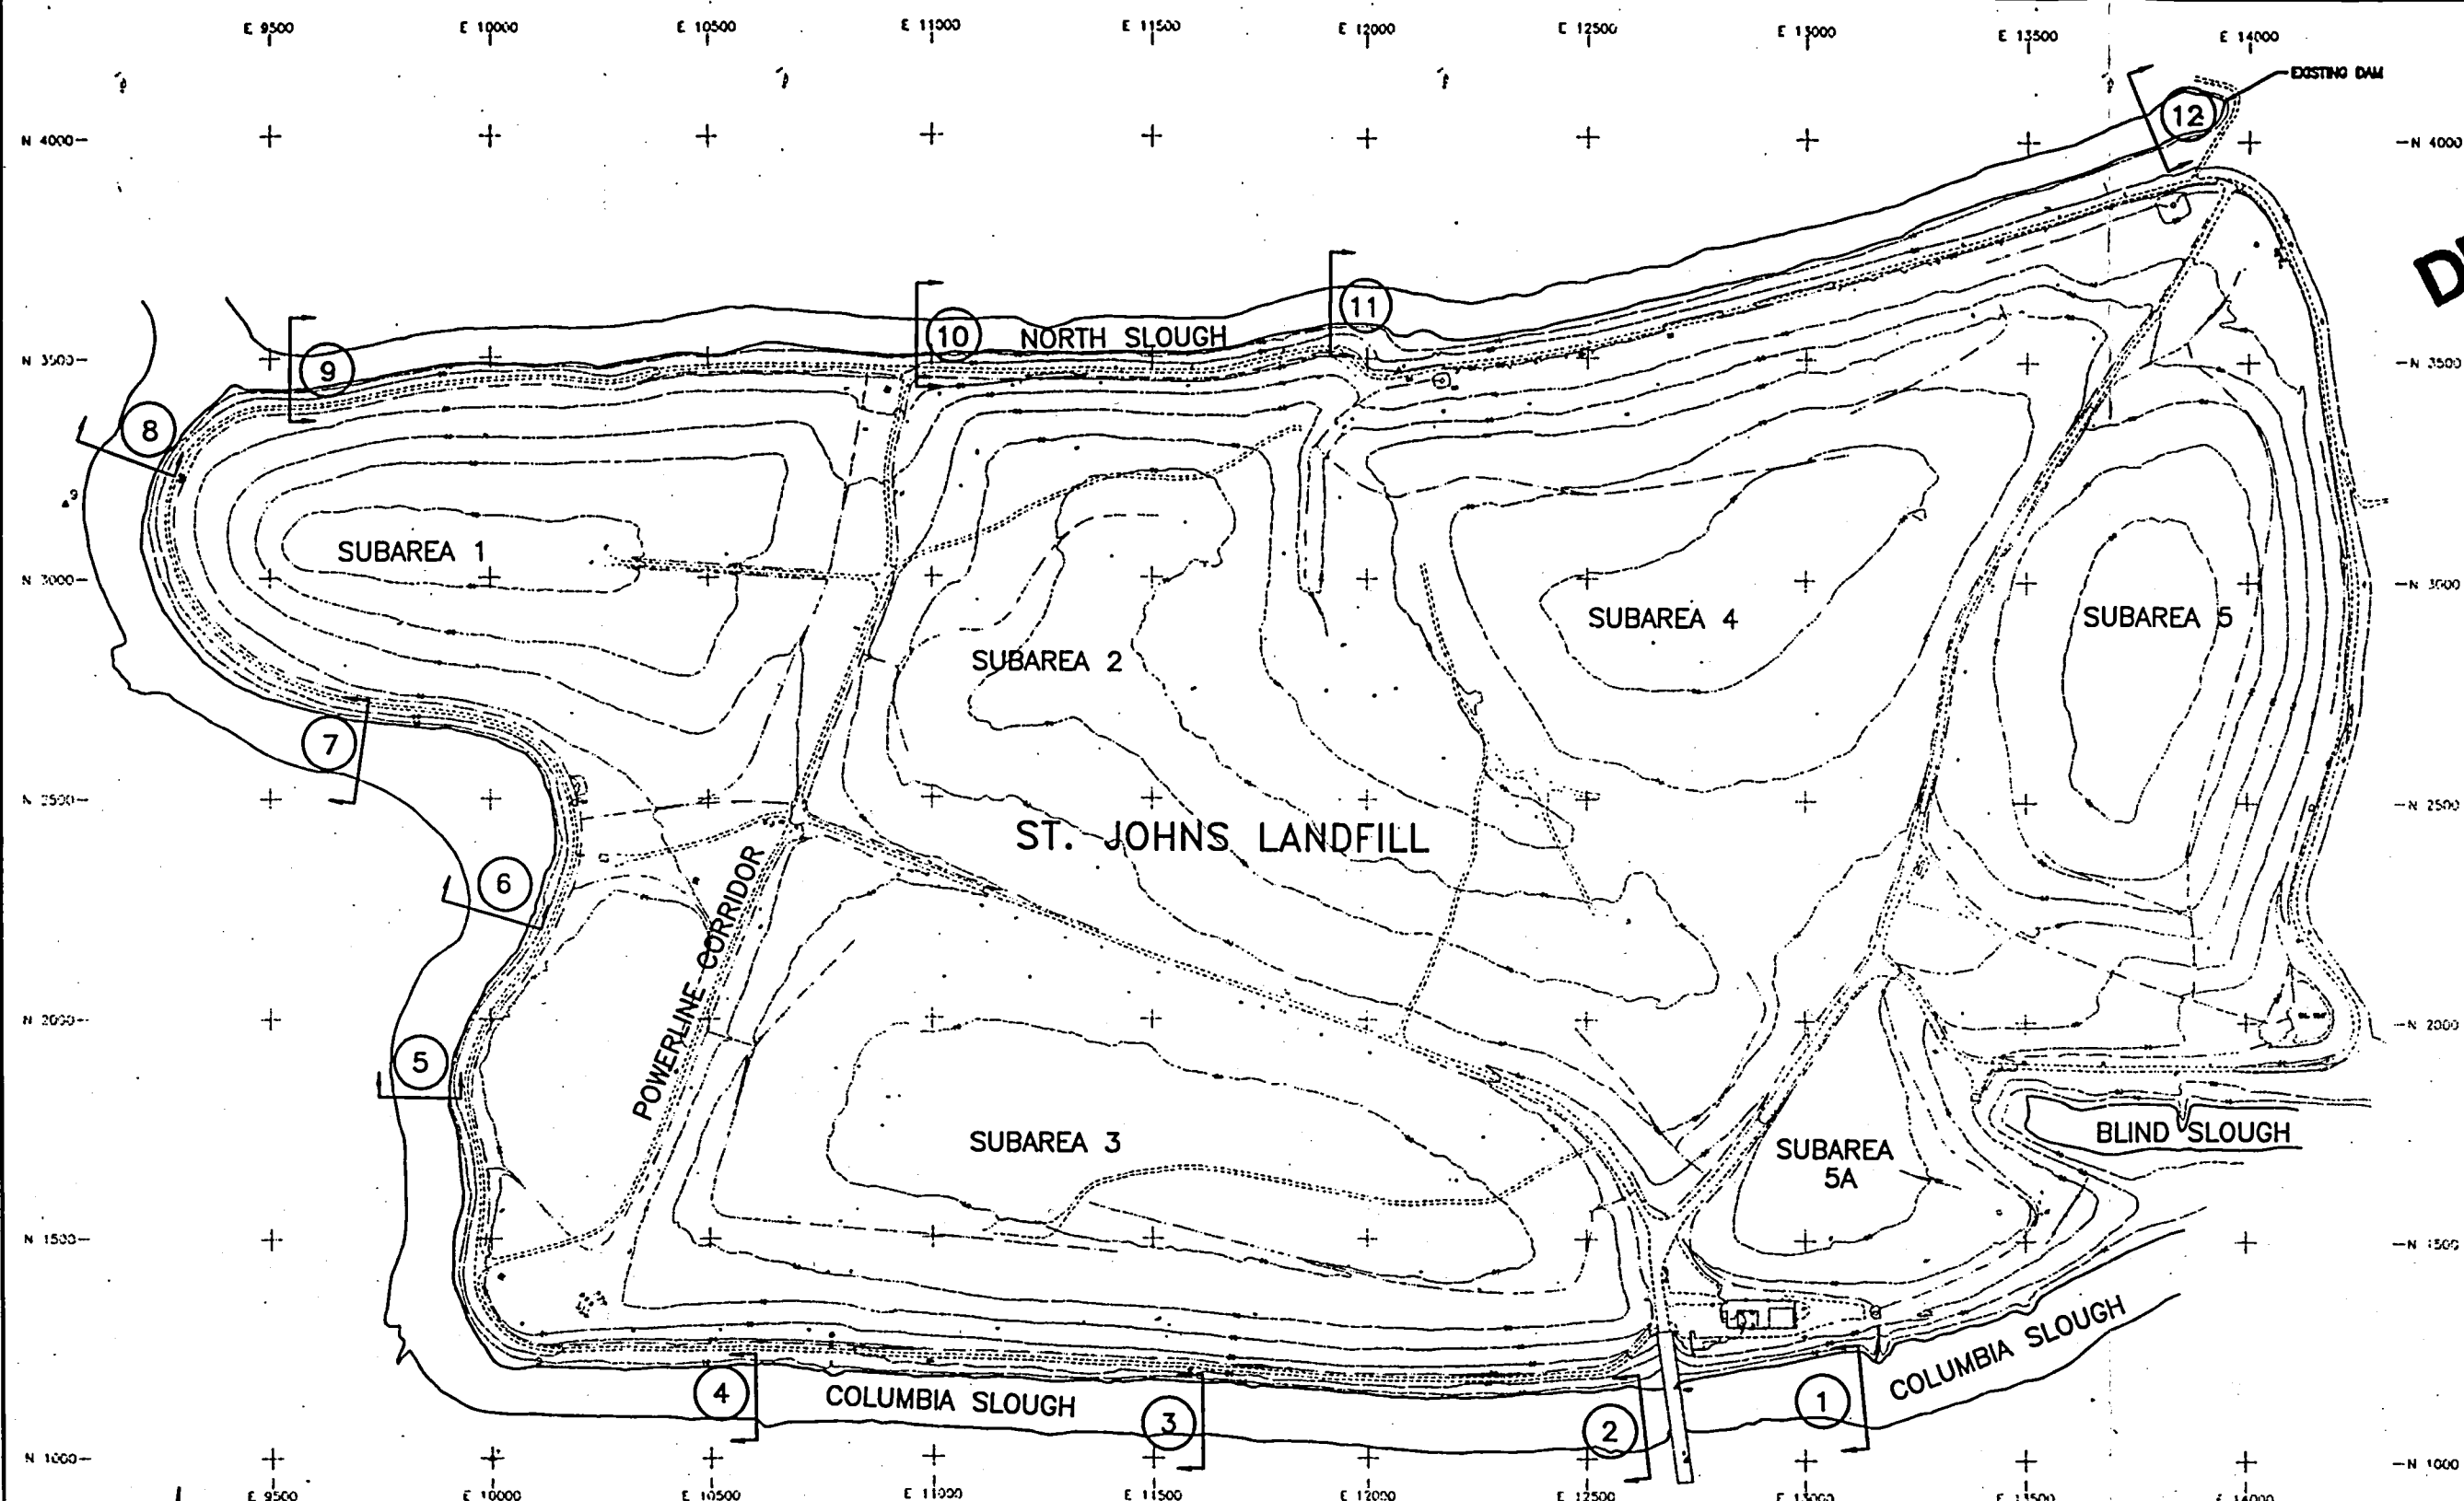
Comforth Consultants, Inc. 10250 S.W. Greenburg Rd. Portland, OR 97223	TITLE	SITE PLAN	DATE	APR 1999
	JOB	DIKE STABILIZATION STUDY ST. JOHNS LANDFILL	JOB NO.	1132-1
			FIG.	1

The maximum flow velocities were calculated for 12 separate slough channel sections around the landfill perimeter using the QUALW2 model. The locations of the sections are shown on Figure 1. These key areas were selected to include: (i) segments of the dike exhibiting more significant erosion or slope failures; (ii) areas likely to have higher flow velocity due to channel geometry (i.e., a tighter cross-sectional area or a constricted bend in the channel); or (iii) areas previously repaired with rockfill or a sand bench. Sections located at the western and eastern limits of the refuse layer in the north perimeter dike were also evaluated to check the scour potential in these areas. Brief descriptions for each of the twelve sections are presented below.

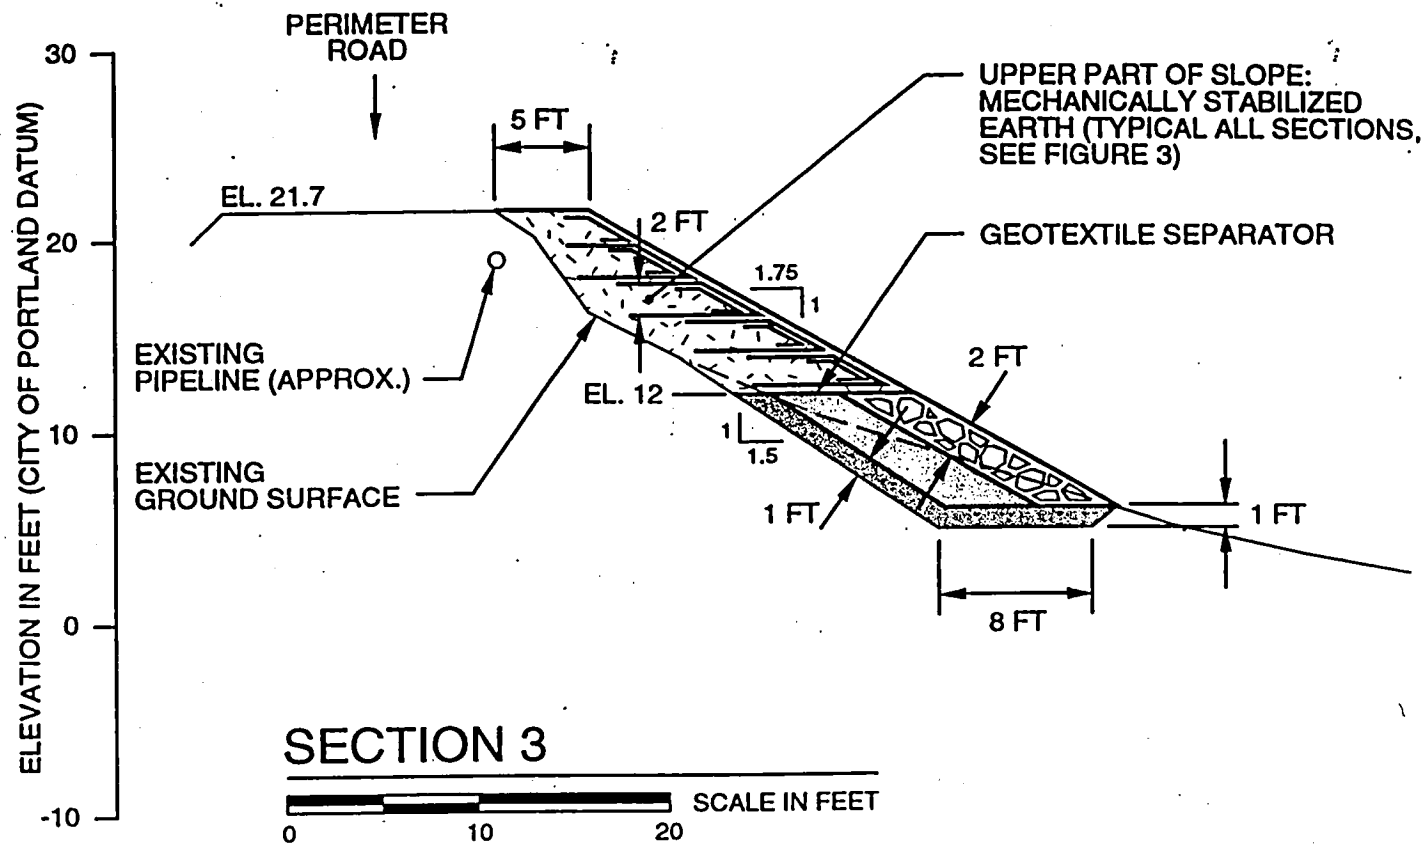
SECTION 3
SCALE IN FEET

Section 3. A failed section of the dike measuring approximately 50 feet in width. The slope failure has removed the outer face of the dike, and left behind an erosional bowl. The headscarp (or uphill edge) of this slide area is located along the outer edge of the gravel road on top of the dike. Based on posted utility signs, it appears that a gas pipeline is buried beneath the outer edge of the road; therefore, the slope failure could be close to undermining the pipeline.

Section 3 is critical because the slope failure has already progressed to the edge of the perimeter access road, and is very close to exposing a gas pipeline. The situation at Section 5 is critical because the slope is actively sliding and the failure appears to be relatively deep-seated. If left untreated, there is a possibility that this segment of the dike could fail catastrophically, which could drop a significant quantity of soil into the Columbia Slough. Furthermore, a large failure at Section 5 would probably impact the perimeter road. As discussed in Section 4.2, stabilization of the segment between Sections 10 and 11 is critical in order to construct a waste cutoff barrier.

Recommended Repair Method. Metro performed cross-section surveys in January and February 1999 for several of the 12 sections analyzed in the hydraulic evaluation. Included among the surveyed sections were Sections 3, 5 and 10, which are representative of the priority treatment areas discussed in Chapter 4. Our recommended method for reconstructing the dike at each of these high priority cross-sections is shown on Figure 2. More specific details for the procedure are given below:

1. While slough stage levels are low in late summer, use a crane with a clam shell or dragline to excavate all water-softened debris, fallen trees and roots from the treatment areas. At the toe of the slope, excavate an 8-foot bench to support the rock materials. The contractor would be required to use great caution when excavating debris at Section 3 to avoid disturbing or damaging the gas pipeline.

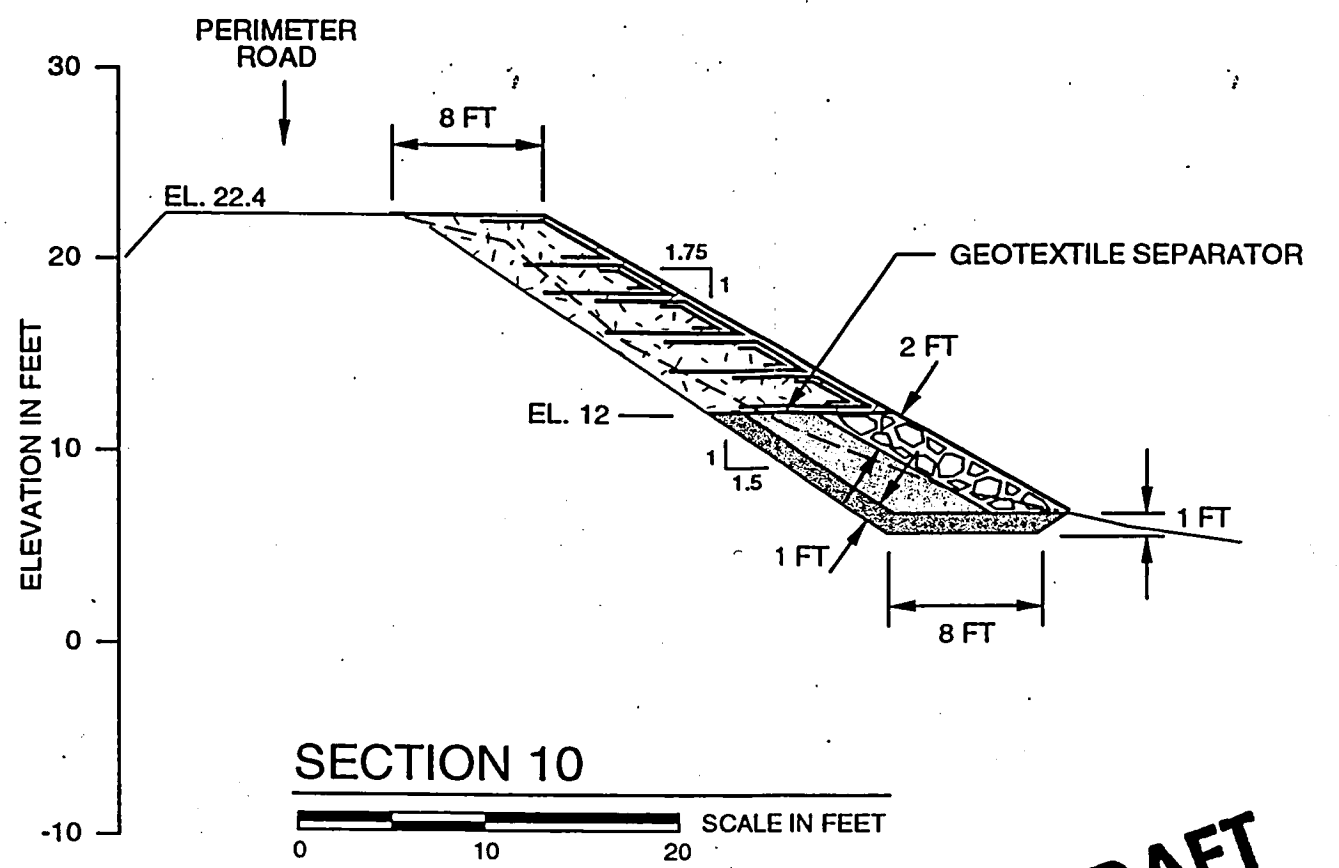
SECTION 10
SCALE IN FEET

Section 10. Western end of the refuse layer within the dike along the North Slough. Observed extensive erosion along the toe, with a near-vertical face below the average high tide waterline. The slope is lightly vegetated.

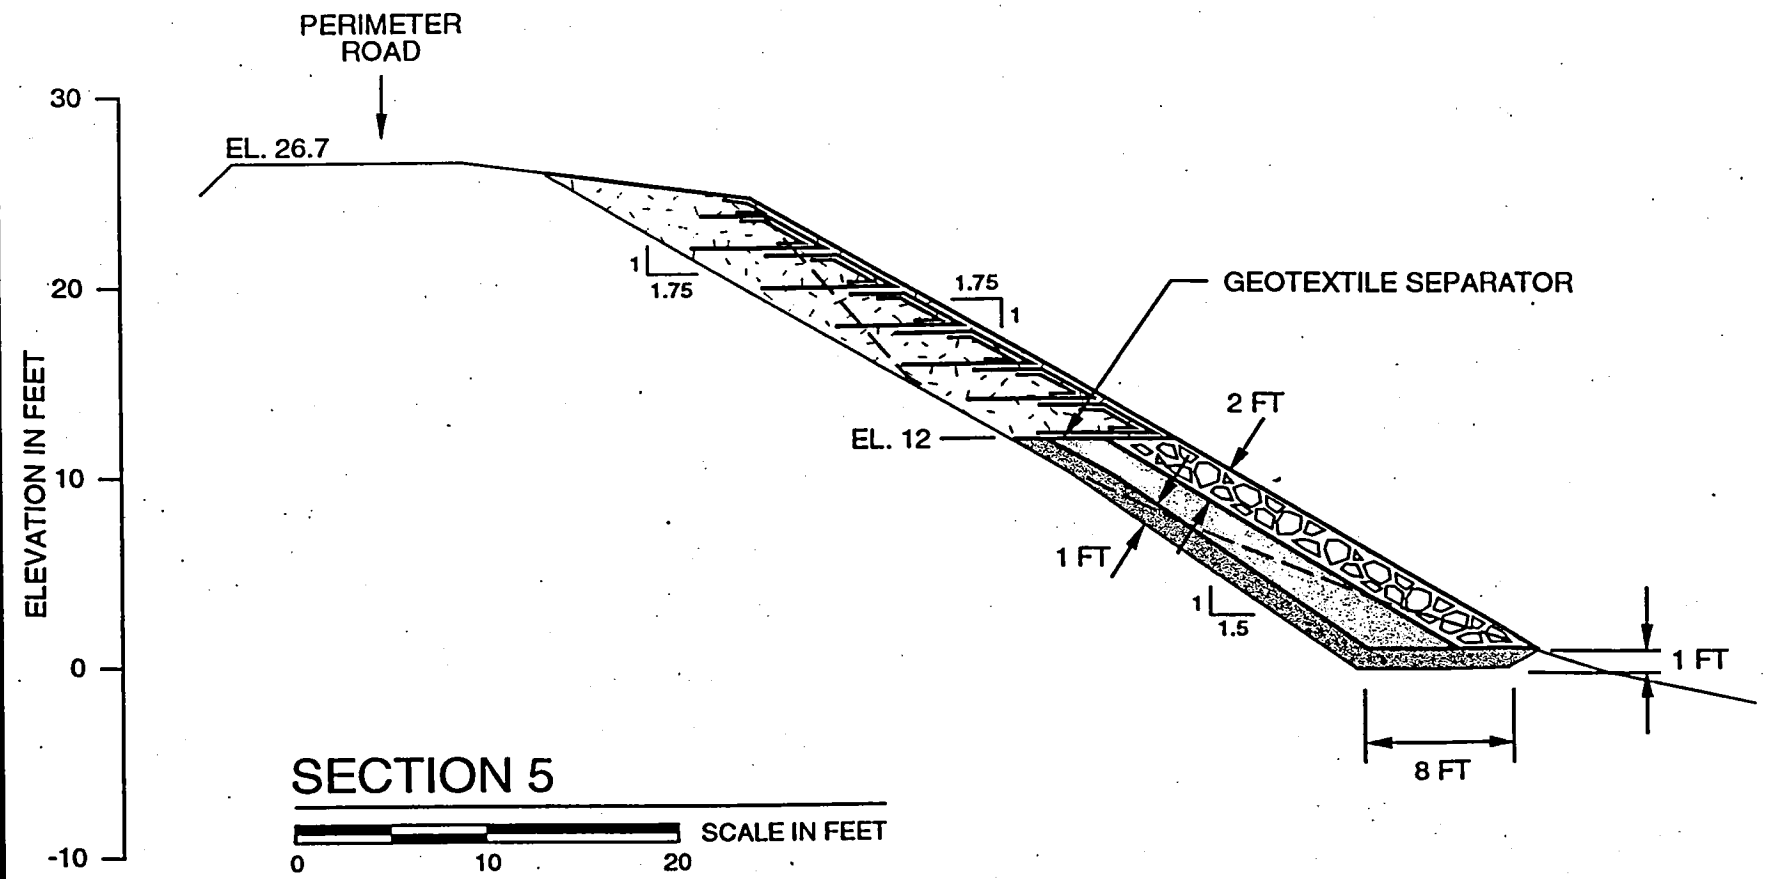
SECTION 5
SCALE IN FEET

Section 5. A tall, very steep, and heavily undermined segment of the dike located at the southwest end of the landfill. Observed the outer face of the dike actively slumping in February 1999, and also observed the trace of a headscarp crack near the crest of the slope. The headscarp crack could signify the development of a larger, or more deep-seated failure within the slope. The eroded face of the slope is encroaching upon the perimeter road. The area is heavily vegetated, with some trees leaning into the slough.
