METRO REGIONAL ENVIRONMENTAL MANAGEMENT

**PRELIMINARY DIKE STABILIZATION STUDY
ST. JOHNS LANDFILL
PORTLAND, OREGON**

TECHNICAL MEMORANDUM

June 1999

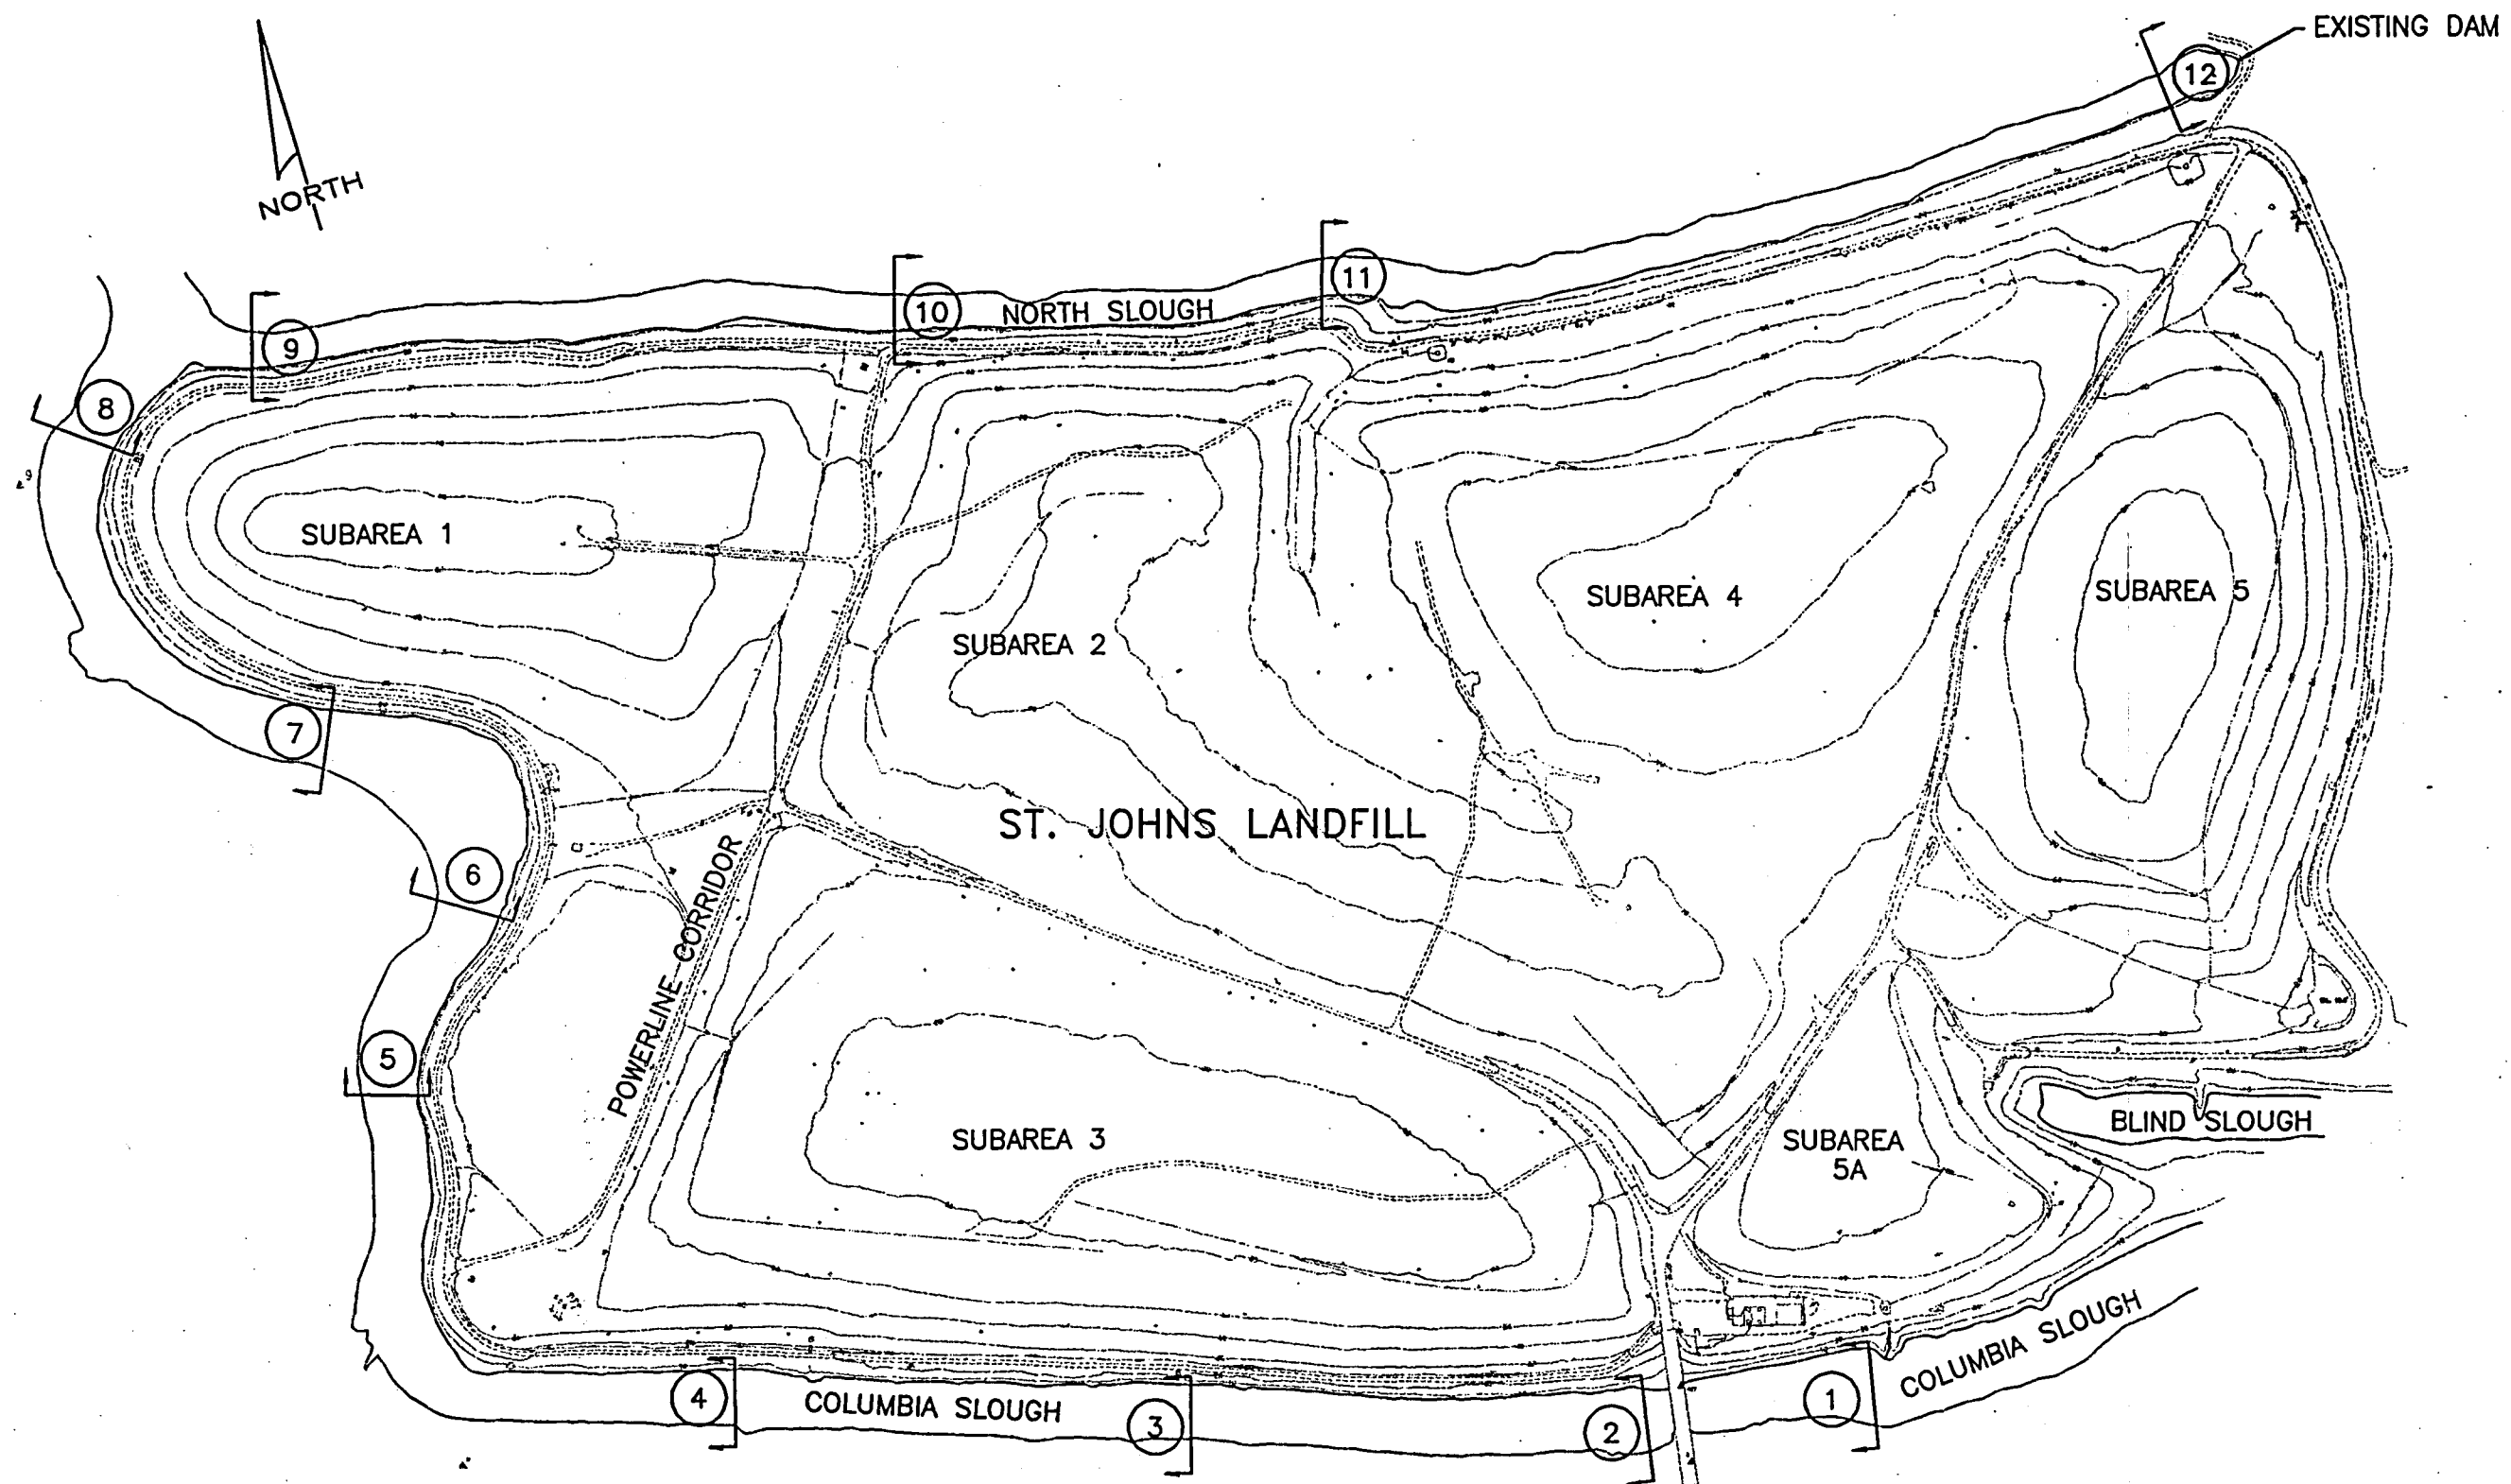
Cornforth Consultants, Inc. 10250 S.W. Greenburg Rd. Portland, OR 97223	TITLE	SITE PLAN	DATE JUN 1999
	JOB	DIKE STABILIZATION STUDY ST. JOHNS LANDFILL	JOB NO. 1132-1
			FIG. 1

Section 1. Significant erosion occurring at the outfall end of a pipe that extends out into the slough from a sedimentation basin. Observed erosion and minor slumping along the toe of the slope. The eroded/failed toe appears to be working its way upslope and may eventually encroach upon the perimeter gas collection trench (located about 18 feet further upslope).

Section 2. Area located approximately 100 feet west of the bridge, and across the Columbia Slough from a combined sewer outfall. Observed extensive erosion and minor slumping along the toe of the slope, with a 3- to 4-foot vertical face below the average high waterline. The area is moderately vegetated.

Section 3. A failed section of the dike measuring approximately 50 feet in width. The slope failure has removed the outer face of the dike, and left behind an erosional bowl. The headscarp (or uphill edge) of this slide area is located along the outer edge of the gravel road on top of the dike. Based on posted utility signs, it appears that a gas pipeline is buried beneath the outer edge of the road; therefore, the slope failure could be close to undermining the pipeline.

Section 5. A tall, very steep, and heavily undermined segment of the dike located at the southwest end of the landfill. Observed the outer face of the dike actively slumping in February 1999, and also observed the trace of a headscarp crack near the crest of the slope. The headscarp crack could signify the development of a larger, or more deep-seated, failure within the slope. The eroded face of the slope is encroaching upon the perimeter road. The area is heavily vegetated, with some trees leaning into the slough.

Section 6. A tall, steep, and heavily undermined segment of the dike located within a constricted bend of the Columbia Slough channel. Observed localized slumping along the toe, and a trace of a headscarp crack in the crest of the slope. The area is heavily vegetated, with some large trees leaning into the slough.

Section 7. A constricted bend in the Columbia Slough channel. Observed extensive erosion along the toe of the slope, with a 3- to 4-foot vertical face below the high tide waterline. The area is heavily vegetated. There were no ground cracks or other signs of slope movement.

Section 10. Western end of the refuse layer within the dike along the North Slough. Observed extensive erosion along the toe, with a near-vertical face below the average high tide waterline. The slope is lightly vegetated.

Section 11. Eastern end of the refuse layer within the dike along the North Slough. Relatively tall and steep slope, with minor slumping and heavy erosion at the toe. The slope is moderately vegetated.

Assuming the North Slough dam would not be removed, our recommended priority areas include Section 3, Section 5, and the dike segment between Sections 10 and 11. Reasons for this priority ranking are presented below.

Section 3 is critical because the slope failure has already progressed to the edge of the perimeter access road, and is very close to exposing a gas pipeline. The situation at Section 5 is critical because the slope is actively sliding and the failure appears to be relatively deep-seated. If left untreated, there is a possibility that this segment of the dike could fail catastrophically, which could drop a significant quantity of soil into the Columbia Slough. Furthermore, a large failure at Section 5 would probably impact the perimeter road. As discussed in Section 4.2, stabilization of the segment between Sections 10 and 11 is critical in order to construct a waste cutoff barrier.

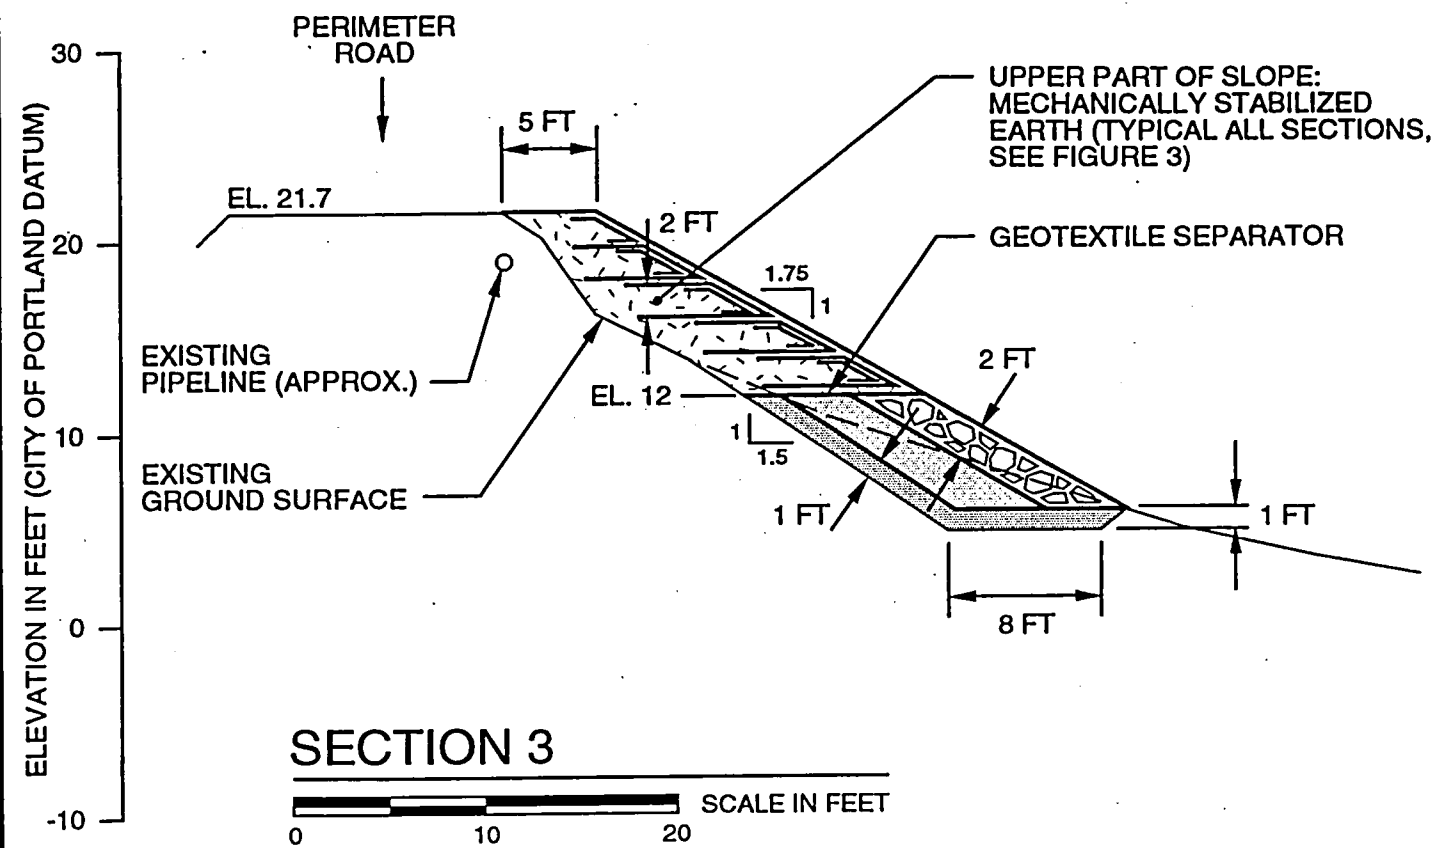
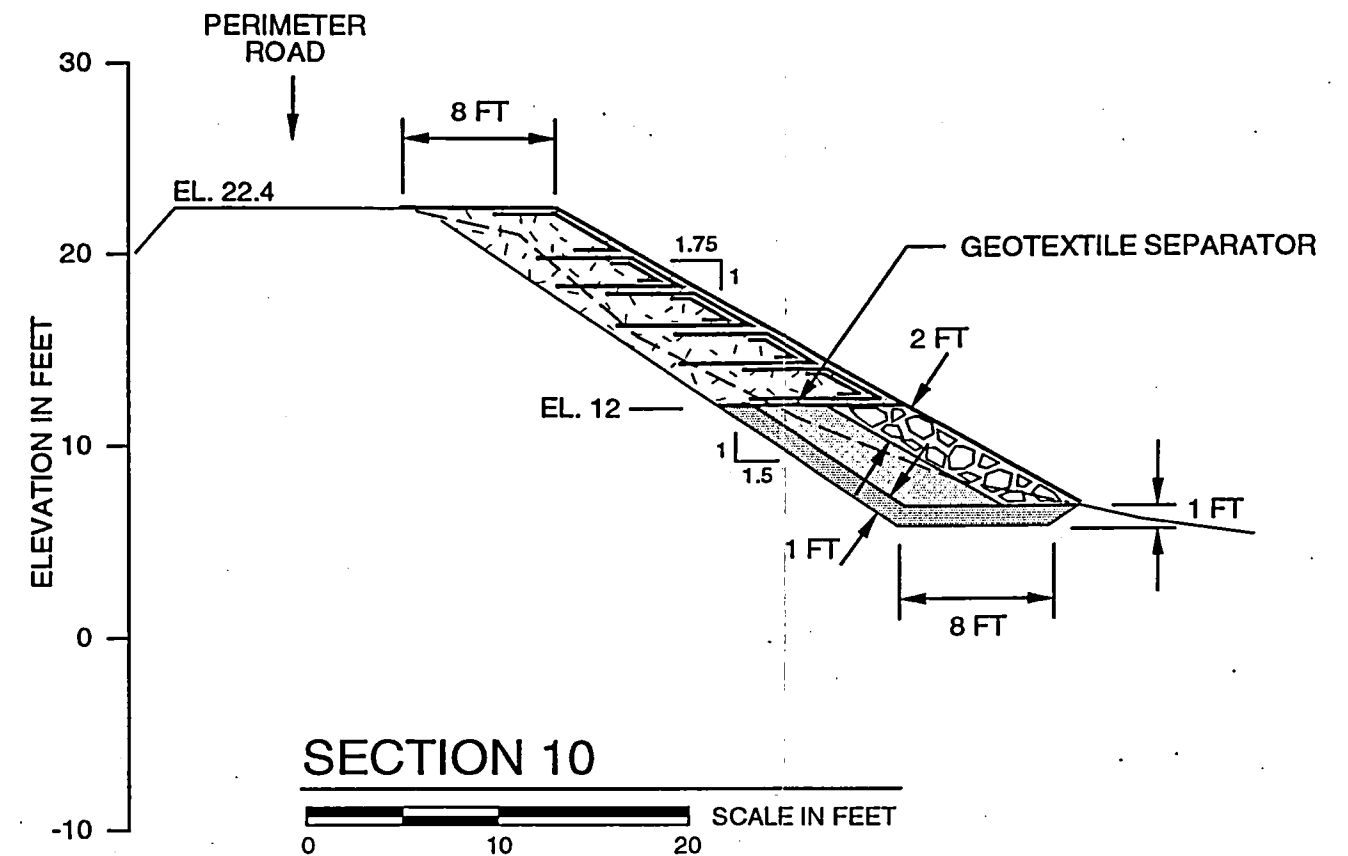
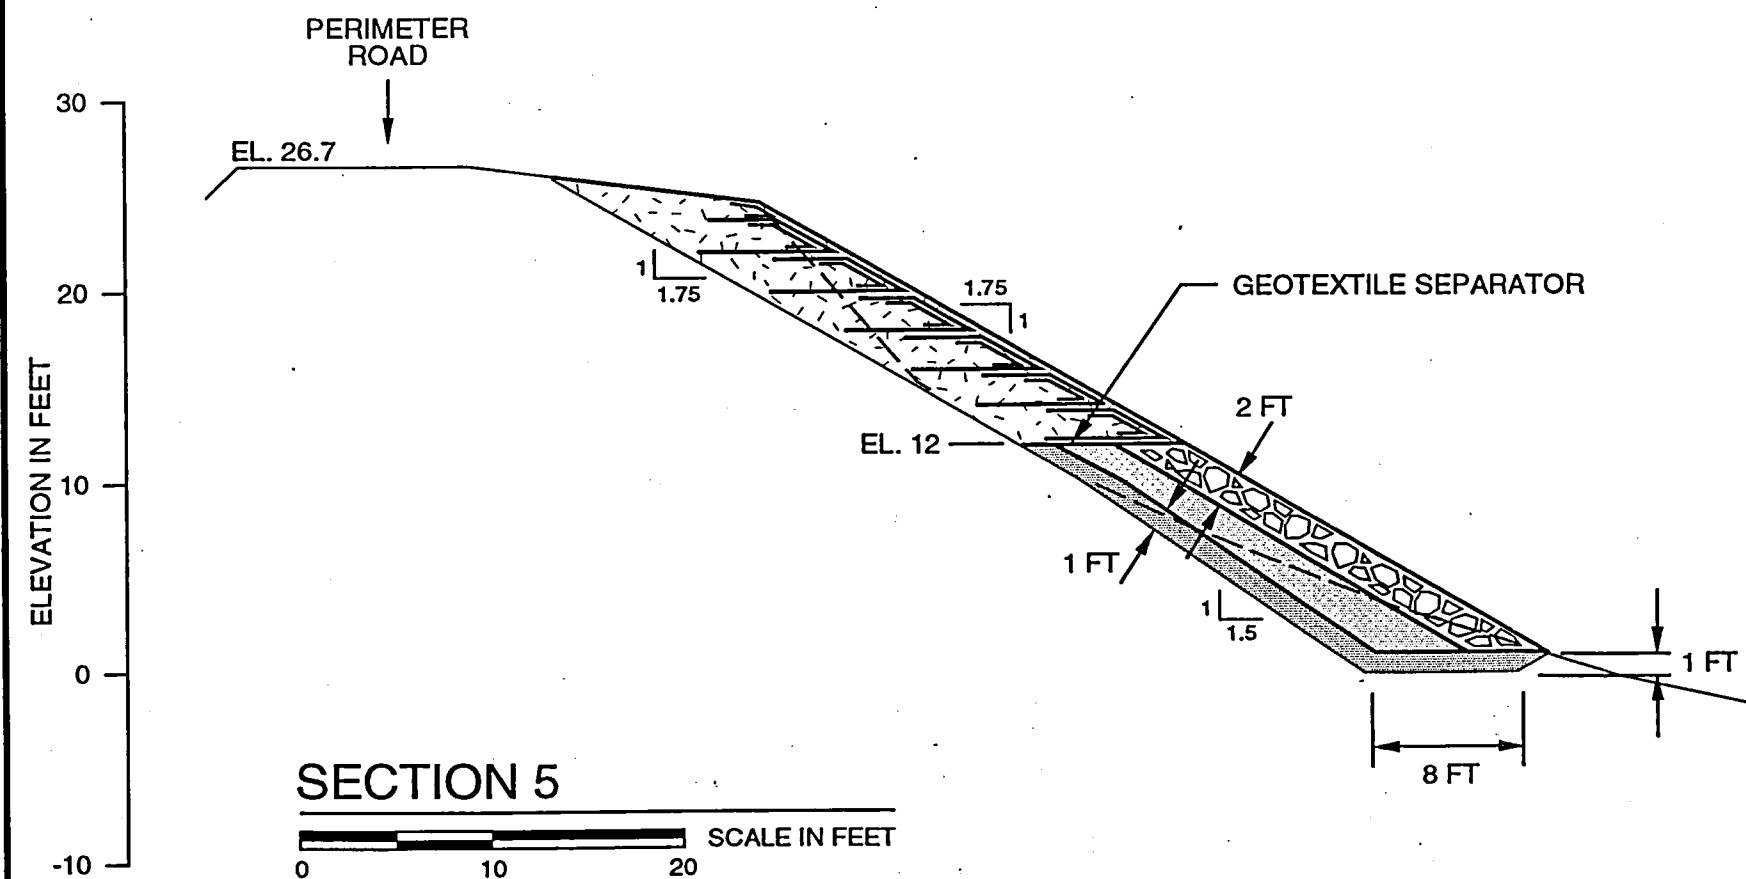
FIG. 3

Recommended Repair Method. Metro performed cross-section surveys in January and February 1999 for several of the 12 sections analyzed in the hydraulic evaluation. Included among the surveyed sections were Sections 3, 5 and 10, which are representative of the priority treatment areas discussed in Chapter 4. Our recommended method for reconstructing the dike at each of these high priority cross-sections is shown on Figure 2. More specific details for the procedure are given below:

3. Complete the lower portion of the slope by placing an intermediate rockfill layer on top of the gravel filter layer, and then armoring the outer face of the slope with a 2-foot layer of riprap. Recommended slope: 1.75H:1V. Tamp the rockfill and riprap materials firmly into place with the clam shell bucket. The rockfill should be well-graded from 4 inches to the U. S. No. 4 sieve. The riprap should be well graded between 12 inches and 3 inches.
