HAZARDOUS MATERIALS SURVEY REPORT

WILLAMETTE FALLS RIVERWALK, PHASE 1—OREGON CITY,
OREGON

Prepared for
METRO REGIONAL GOVERNMENT
April 25, 2018
Project No. 0075.06.02

Prepared by
Maul Foster & Alongi, Inc.
2001 NW 19th Avenue, Suite 200, Portland, OR 97209

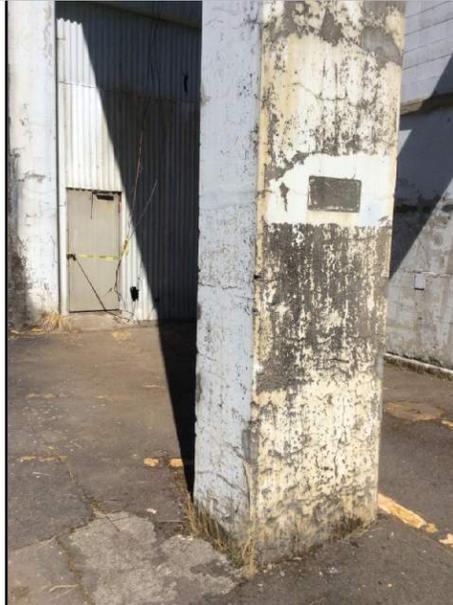
Observation ID:		Detailed Sample Location:	
HBM-AAM-1-ASB-10		Transite on number 4 paper mill	
Type of Sample:		Specify Miscellaneous Material (if applicable):	
ASB			
Is the Sample Friable?:		Sample Condition:	
No		Potential ACBM with potential for damage	
Sample Color:		Sample Quantity:	
		200 sq. ft.	
Sample Photo:

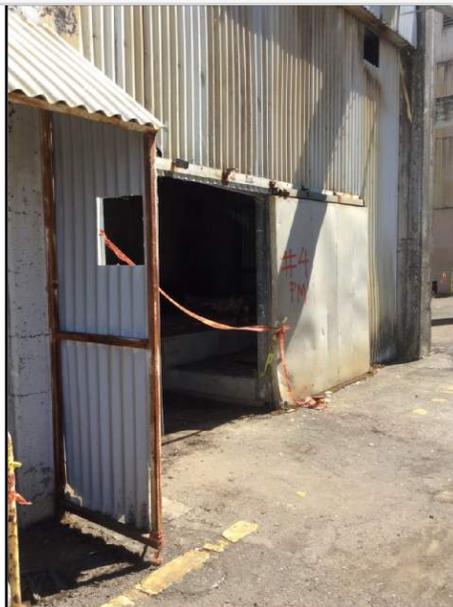
Observation ID:	Detailed Sample Location:
HBM-AAM-1-PB-11	White painted surface of number 4 paper mill
Type of Sample:	Specify Miscellaneous Material (if applicable):
PB	
Sample Color:	Sample Quantity:
White	2,000 sq. ft.

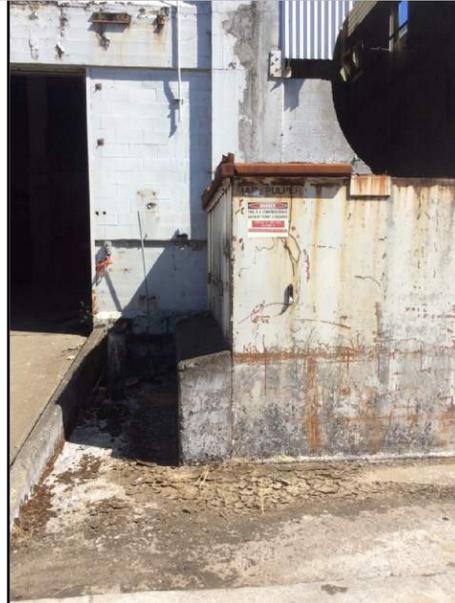
Observation ID:		Detailed Sample Location:	
HBM-AAM-1-ASB-13		Storage cylinder	
Type of Sample:		Specify Miscellaneous Material (if applicable):	
ASB			
Is the Sample Friable?:		Sample Condition:	
No		Potential ACBM with potential for damage	
Sample Color:		Sample Quantity:	
		400 sq. ft.

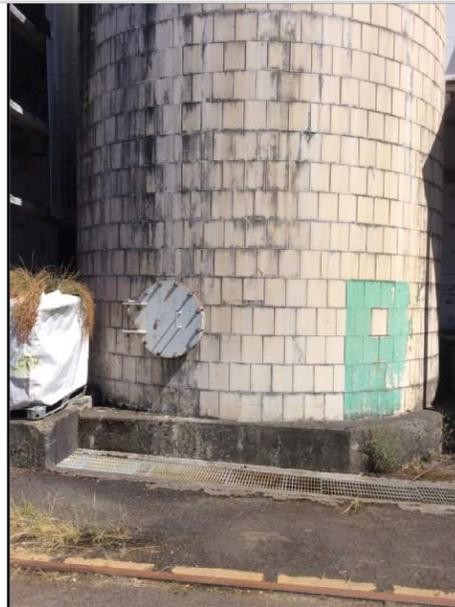
Observation ID:	Detailed Sample Location:
HBM-AAM-1-PB-14	Painted surfaces of Denke repulper
Type of Sample:	Specify Miscellaneous Material (if applicable):
PB	
Sample Color:	Sample Quantity:
White	2,000 sq. ft.

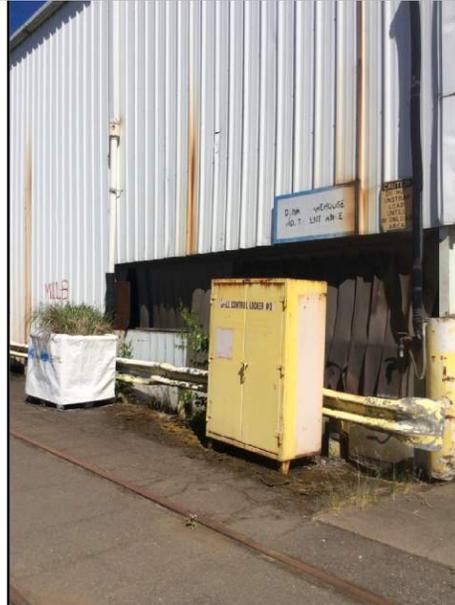
Observation ID:		Detailed Sample Location:	
HBM-AAM-1-ASB-15		Mill D warehouse exterior painted surfaces and transite	
Type of Sample:		Specify Miscellaneous Material (if applicable):	
ASB			
Is the Sample Friable?:		Sample Condition:	
No		Potential ACBM with potential for damage	
Sample Color:		Sample Quantity:	
		5,000 sq. ft.

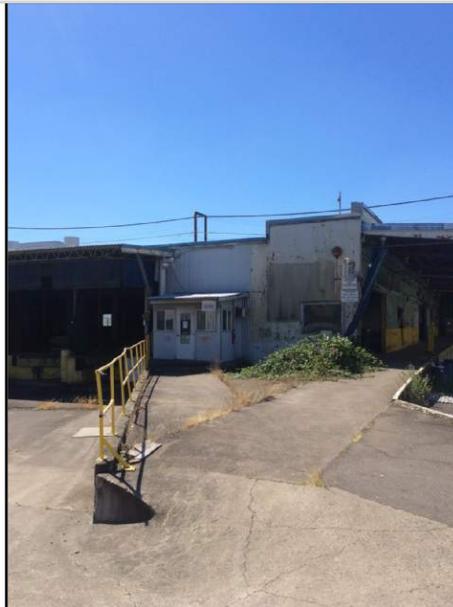
Observation ID:	Detailed Sample Location:
HBM-AAM-1-PB-16	Painted surfaces of number 2 paper mill
Type of Sample:	Specify Miscellaneous Material (if applicable):
PB	
Sample Color:	Sample Quantity:
White	1,000 sq. ft.

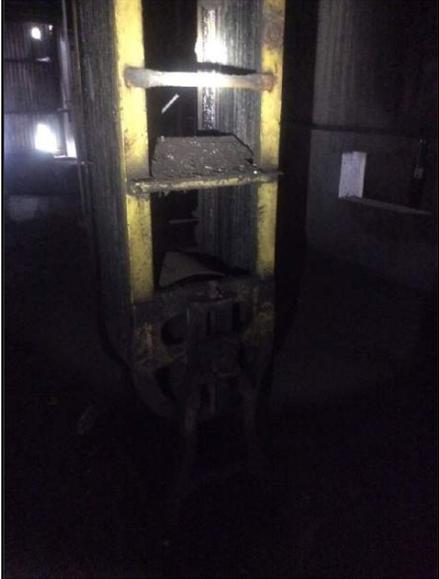
Observation ID:	Detailed Sample Location:
HBM-BPT-2-PB-1	Boilers, 4
Type of Sample:	Specify Miscellaneous Material (if applicable):
PB	
Sample Color:	Sample Quantity:
Gray	4,500 sq. ft. (asbestos containing)
Sample Photo:

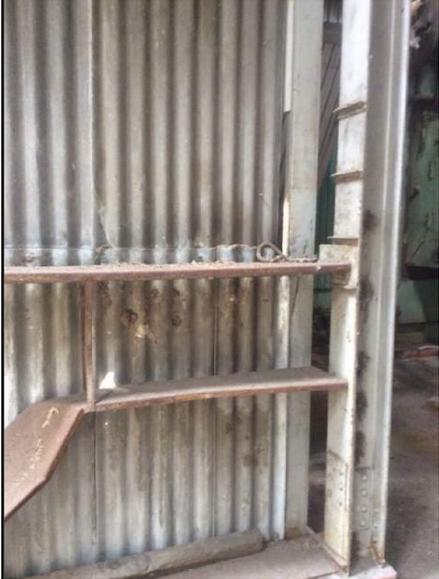
Observation ID:	Detailed Sample Location:
HBM-BPT-2-PB-5	Gray interior painted beams
Type of Sample:	Specify Miscellaneous Material (if applicable):
PB	
Sample Color:	Sample Quantity:
Gray, rusty	20,000 sq. ft.
Sample Photo:

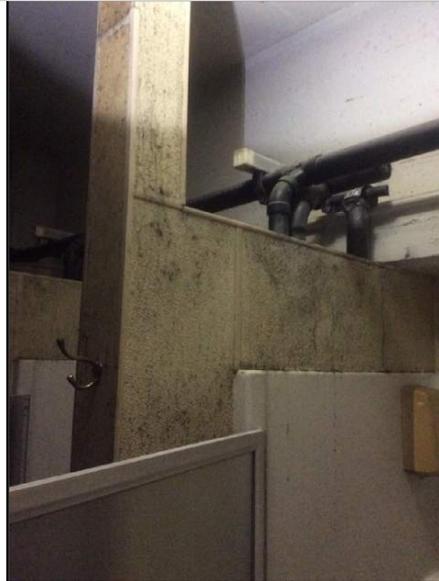
Observation ID:	Detailed Sample Location:
HBM-BPT-1-PB-10	Gray painted surfaces
Type of Sample:	Specify Miscellaneous Material (if applicable):
PB	
Sample Color:	Sample Quantity:
Light gray	2,000 sq .ft.
Sample Photo:

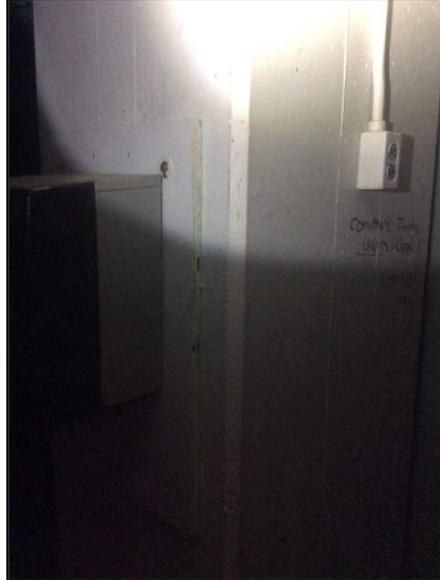
Observation ID:		Detailed Sample Location:	
HBM-BPT-1-ASB-11		HVAC compound	
Type of Sample:		Specify Miscellaneous Material (if applicable):	
ASB			
Is the Sample Friable?:	Sample Condition:		
No	Potential ACBM with potential for damage		
Sample Color:		Sample Quantity:	
		300 linear feet	
Sample Photo:

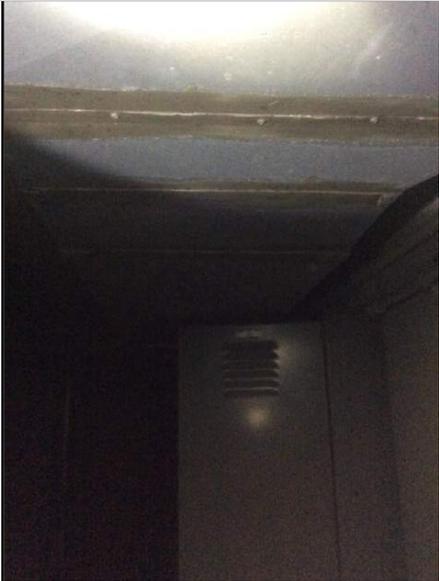
Observation ID:	Detailed Sample Location:
HBM-BPT-1-HGF-12	Locker room, thermostat
Type of Sample:	Specify Miscellaneous Material (if applicable):
HGF	
Sample Color:	Sample Quantity:
	1
Sample Photo:

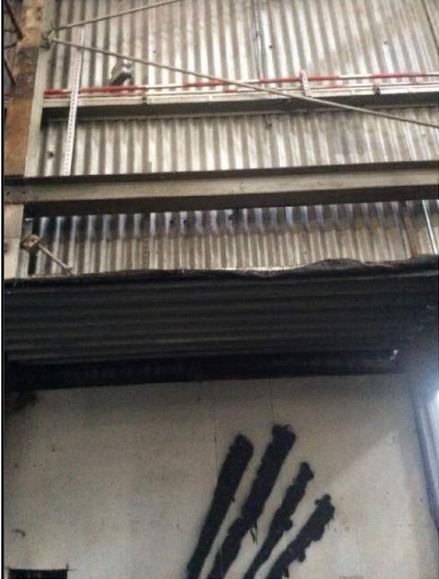
Observation ID:	Detailed Sample Location:
HBM-BPT-1-PB-15	White painted surfaces
Type of Sample:	Specify Miscellaneous Material (if applicable):
PB	
Sample Color:	Sample Quantity:
White	1,500 sq. ft.
Sample Photo:

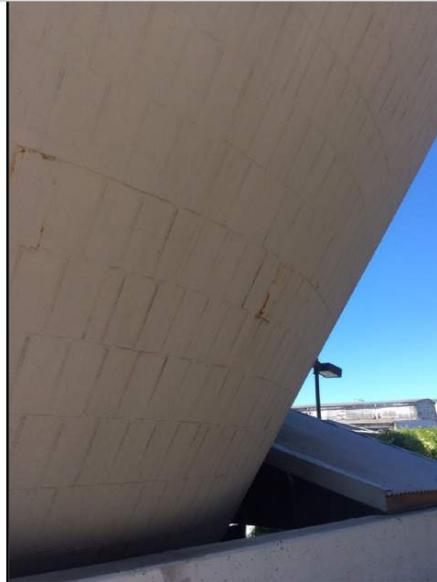
Observation ID:		Detailed Sample Location:	
HBM-HSC-1-ASB-2		Concrete block	
Type of Sample:		Specify Miscellaneous Material (if applicable):	
ASB			
Is the Sample Friable?:		Sample Condition:	
No		Potential ACBM with potential for damage	
Sample Color:		Sample Quantity:	
		10,000 sq. ft.	
Sample Photo:

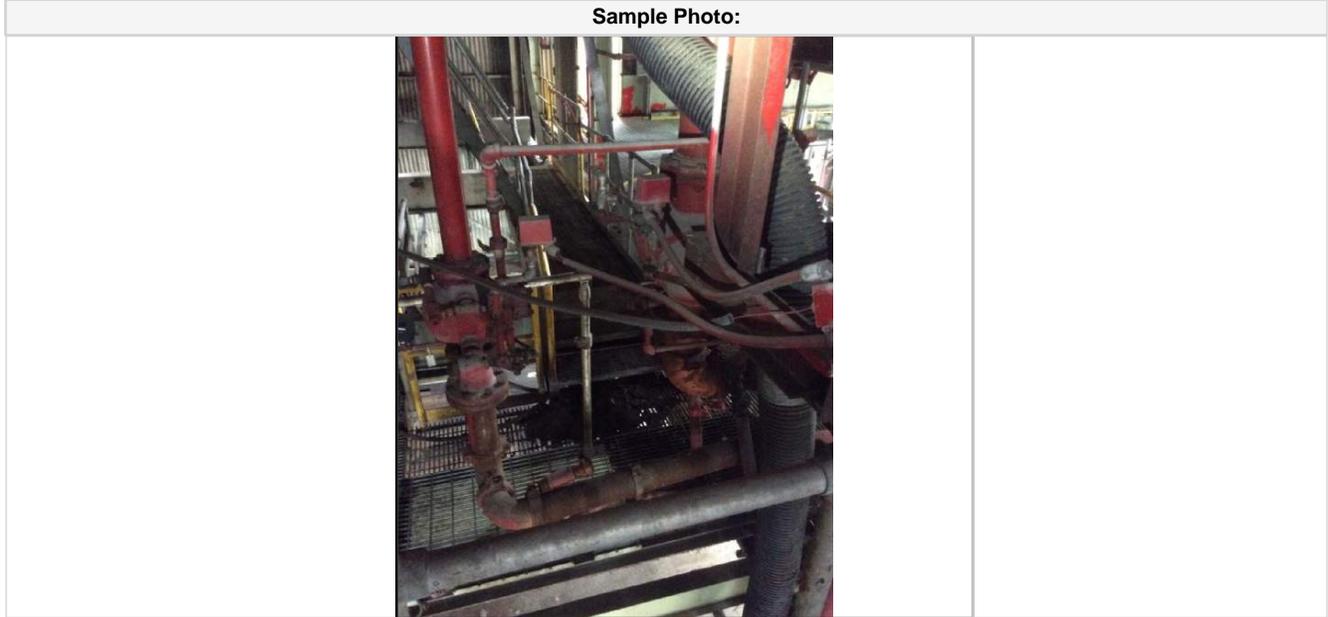
Observation ID:		Detailed Sample Location:	
HBM-MHR-2-ASB-6		4" pipe insulation	
Type of Sample:		Specify Miscellaneous Material (if applicable):	
ASB			
Is the Sample Friable?:		Sample Condition:	
Yes		Damaged or significantly damaged	
Sample Color:		Sample Quantity:	
		24 linear feet	
Sample Photo:

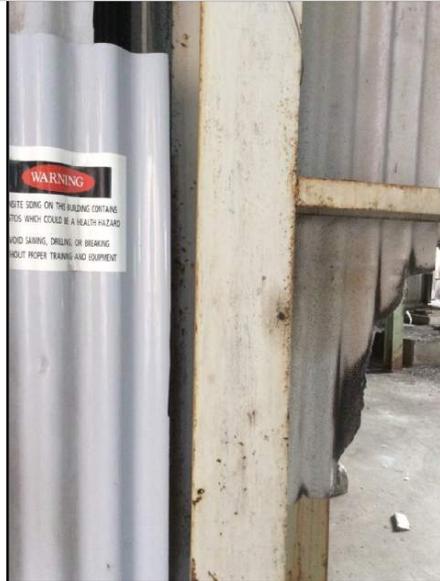
Observation ID:	Detailed Sample Location:
HBM-MLH-1-PB-4	Green painted interior beams
Type of Sample:	Specify Miscellaneous Material (if applicable):
PB	
Sample Color:	Sample Quantity:
Light green	2,000 sq. ft.
Sample Photo:

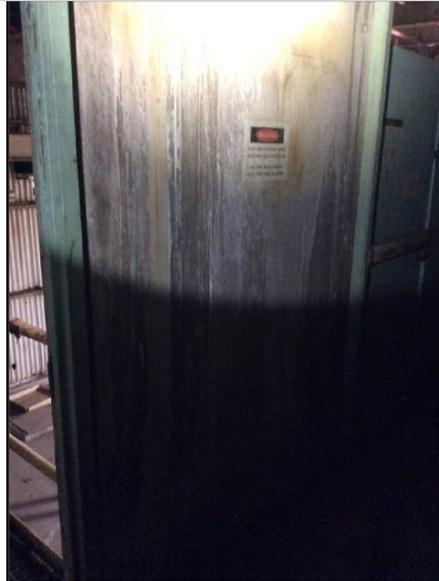
Observation ID:	Detailed Sample Location:
HBM-MLH-1-PB-8	Control center exterior surfaces, white
Type of Sample:	Specify Miscellaneous Material (if applicable):
PB	
Sample Color:	Sample Quantity:
White	400 sq. ft.

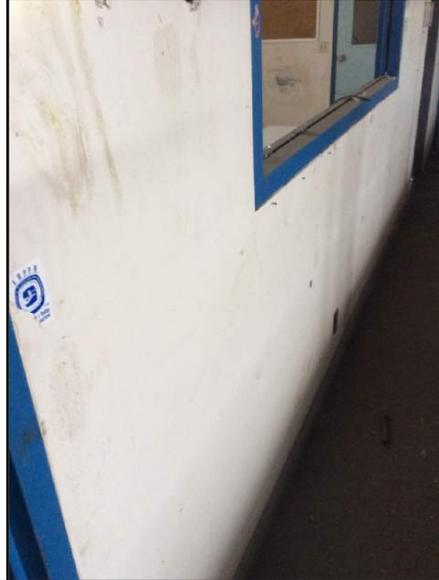
Observation ID:		Detailed Sample Location:	
HBM-MLH-1-ASB-11		Wallboard	
Type of Sample:		Specify Miscellaneous Material (if applicable):	
ASB			
Is the Sample Friable?:		Sample Condition:	
Yes		Potential ACBM with potential for significant damage	
Sample Color:		Sample Quantity:	
		3,000 sq. ft.	
Sample Photo:

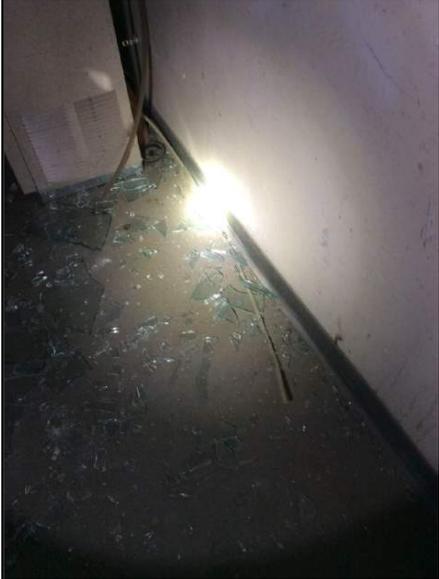
Observation ID:		Detailed Sample Location:	
HBM-MLH-1-ASB-17		Blue poured flooring	
Type of Sample:		Specify Miscellaneous Material (if applicable):	
ASB			
Is the Sample Friable?:		Sample Condition:	
No		Potential ACBM with potential for damage	
Sample Color:		Sample Quantity:	
		300 sq. ft.	
Sample Photo:
