**PHASE 2 STABILIZATION
PLANNING AND DESIGN ANALYSIS**

ST. JOHNS LANDFILL - PORTLAND, OREGON

REPORT July 2005

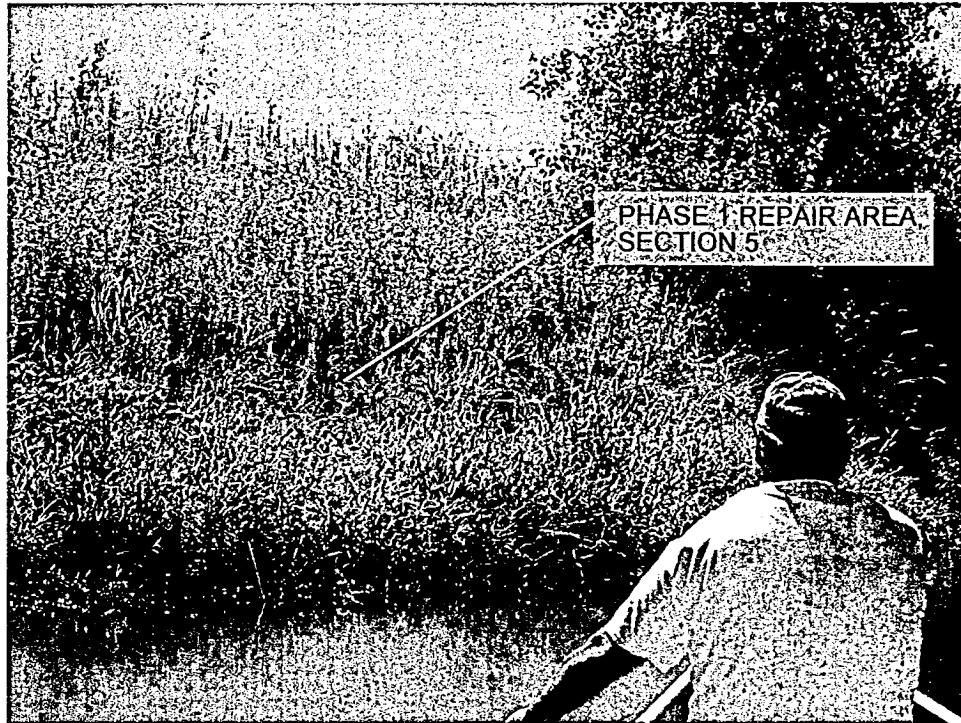
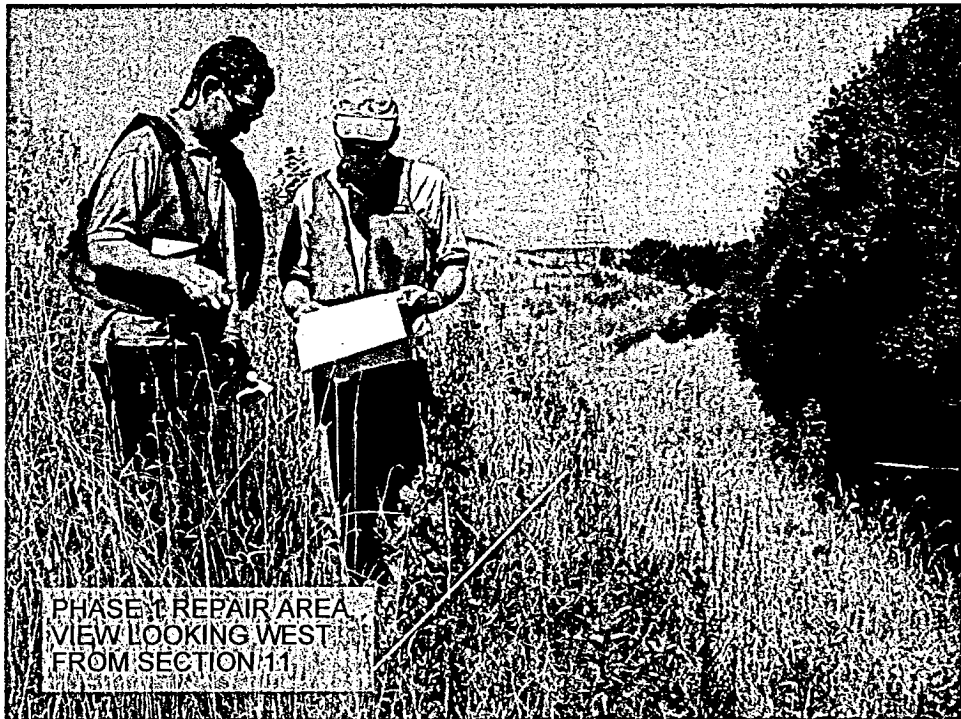
FIG. 3

In general, the perimeter dike continues to show signs of erosion and shallow slumping. However, the previously repaired segments (Sections 3, 4, 5, 8, and 10 through 11) show no signs of erosion, and appear to be stable. Representative photographs of the Phase 1 repair areas are shown on Figure 3.

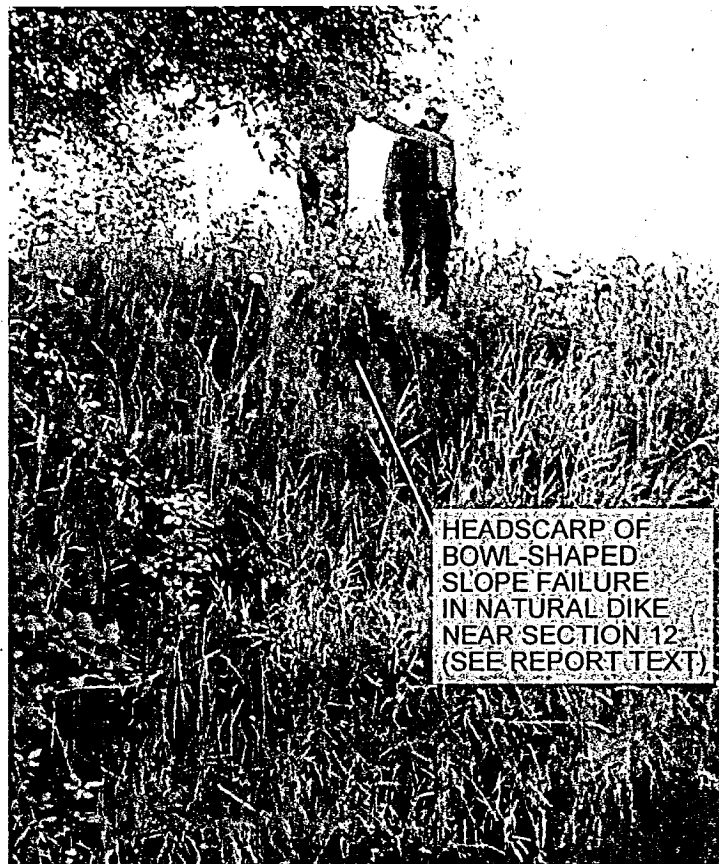
FIG. 4

Similar to previous reconnaissances of the site, the erosion appears to be most severe below the average high tide waterline. The eroded toe condition is essentially continuous around the non-repaired areas, and there are indications of isolated minor shallow slumps. The most notable scour and slumping appears to be between Sections 9 and 10, and also near Section 12 (Fig. 2). The dike segment between Section 9 and 10 exhibits heavy undercutting of the toe, which has exposed the root masses of numerous trees. Several of the trees have fallen into the slough in this area. The inspection team also observed a few isolated bowl-shaped depressions in the upper portion of the slope through this area, which suggests that some shallow slumping has occurred. As discussed previously, the prioritized Phase 2 repair area lies within this segment of the dike. A photograph of existing shoreline conditions between Sections 9 and 10 is shown on Figure 4.

The dike in the vicinity of Section 12 shows signs of significant erosion and recent slope failures. A photograph of a slope failure near Section 12 is shown on Figure 4. We observed headscarp cracks near the crest of the dike and relatively large bowl-shaped slump features. The ongoing erosion and slumping through this area are occurring in a segment of the naturally formed dike. The engineered dike for the landfill is setback approximately 100 feet through this area, which indicates that it is in no immediate danger of failure. On that basis, the dike segment around Section 12 is not considered a priority repair area.
