**Greenspaces Restoration Projects
Final Report
to Metro and USFWS
from the Audubon Society of Portland
re: Balch Creek Channel Demonstration Restoration Project
Funding Year: 1996
Report Date: November 1997**

Inventory of and Recommended Habitat Modifications for Balch Creek in the Portland Audubon Society Sanctuary

Inventory of and Recommended Stream Modifications for Woodpecker Creek in the Portland Audubon Society Sanctuary

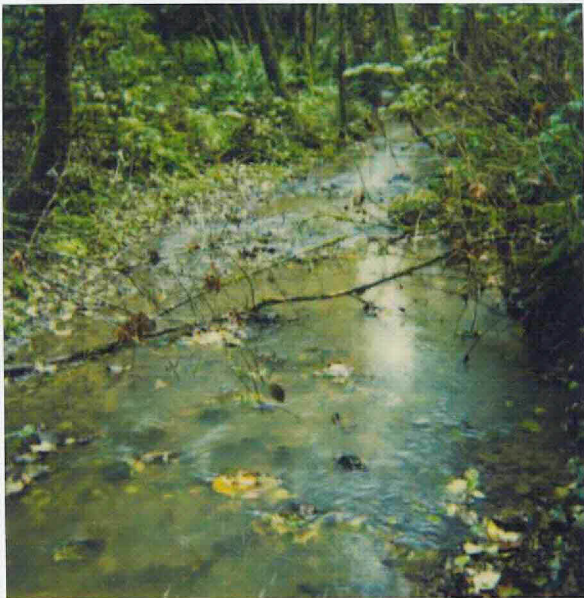
Photos Site #3 Area with low pool/riffle ratio

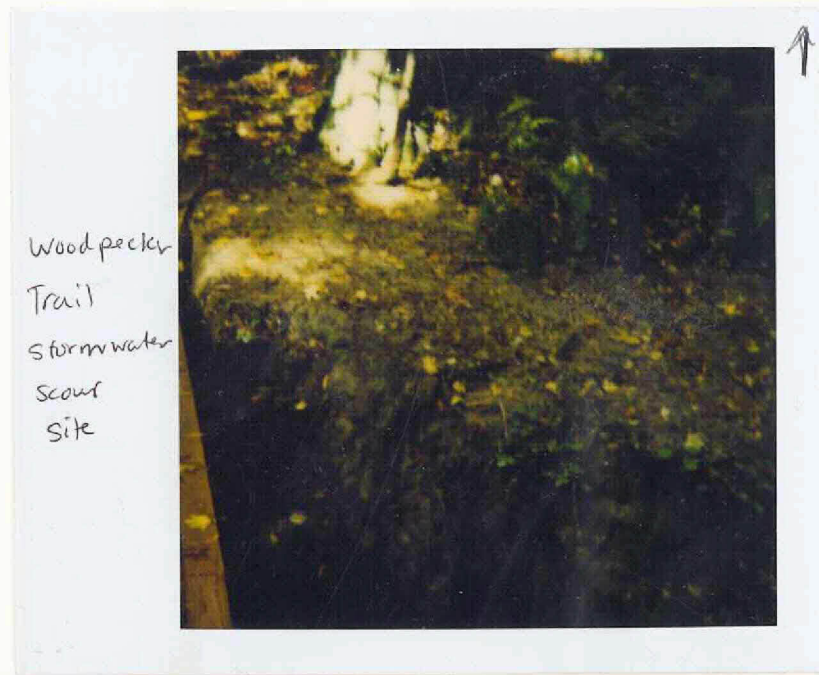
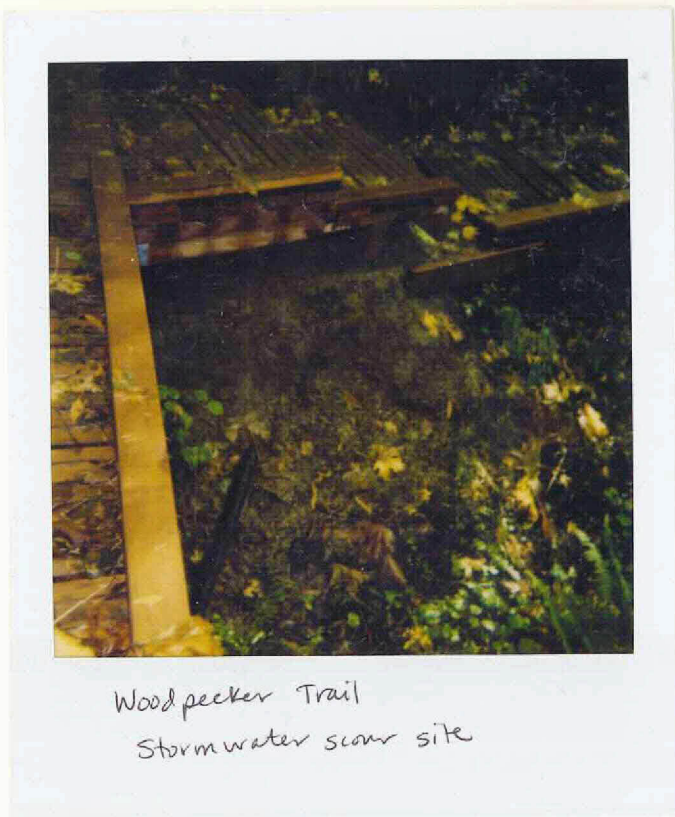
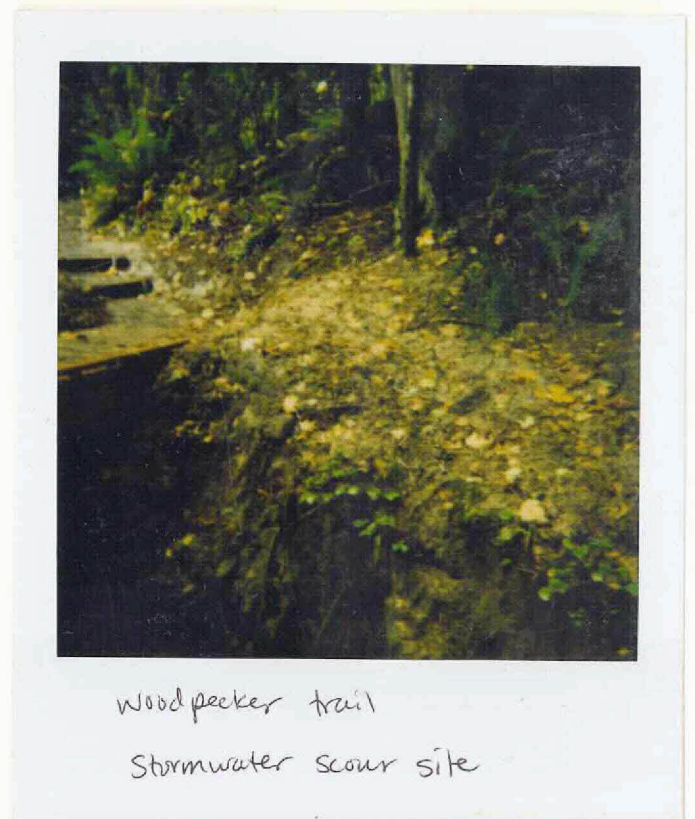
Photos: Site #1 Incised channel, threatening footbridge

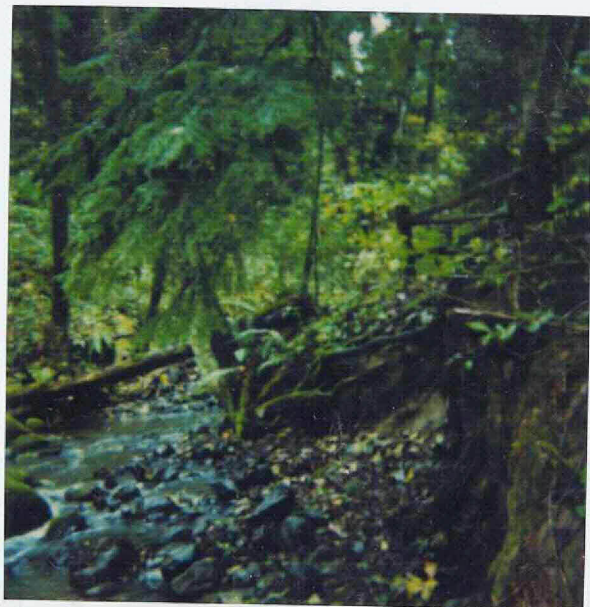
Photos: Site #2 Streambank erosion/slope instability

Hiker erosion site #2

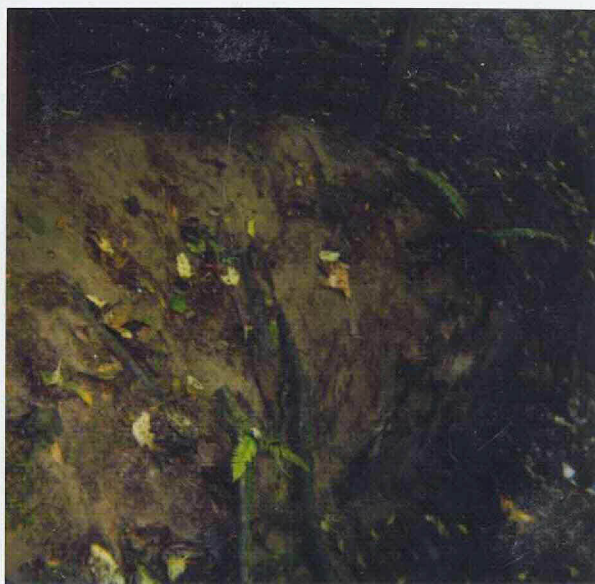
Hiker
erosion
site #2

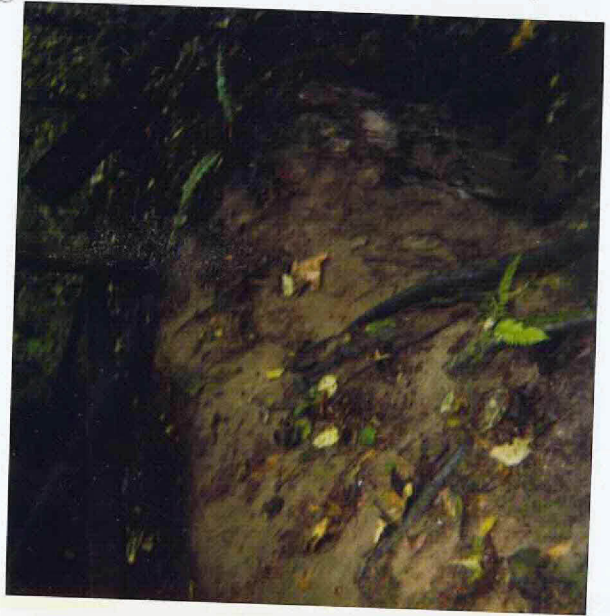
Hiker erosion site

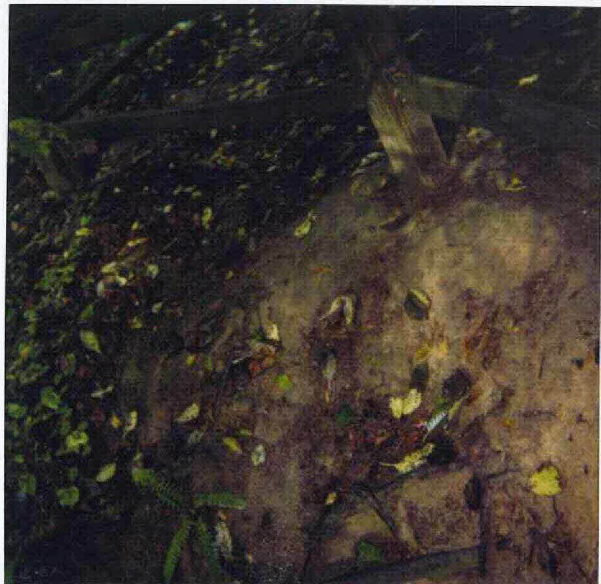
Hiker
Erosion
site #2

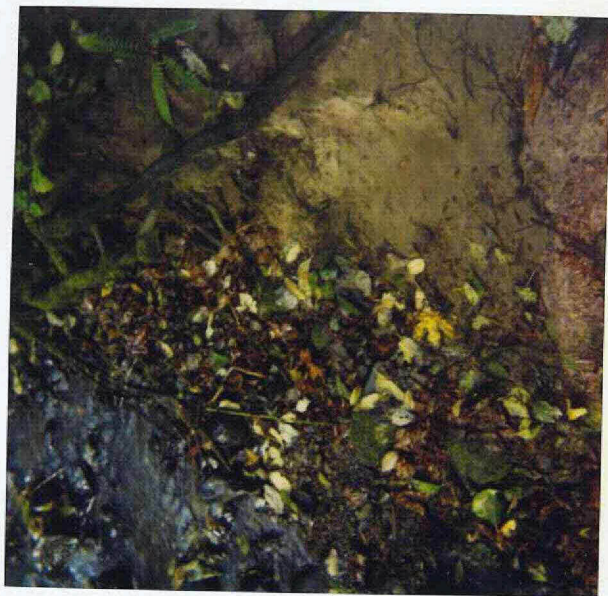
Hiker
Erosion
site
looking
down

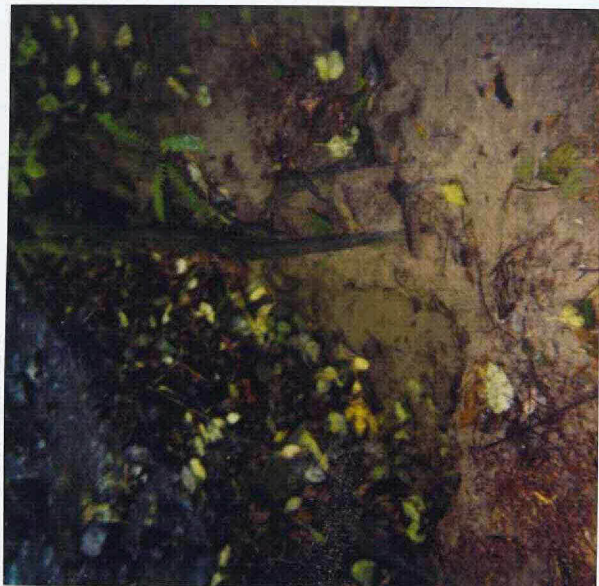
Hiker
Erosion
Site
Looking
down

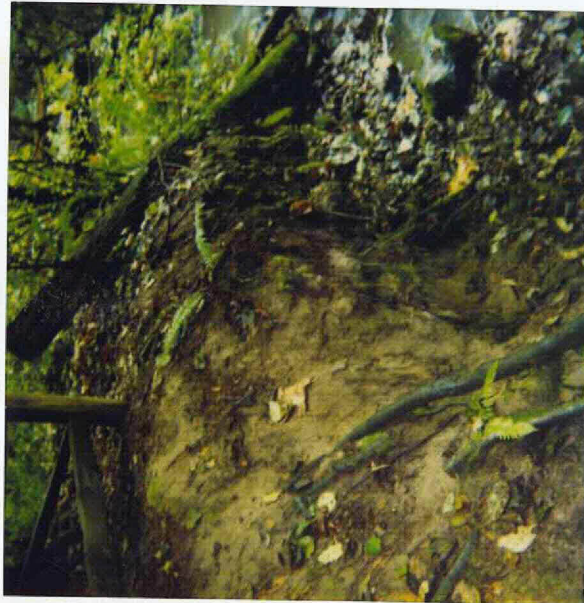
Hiker Erosion site #2

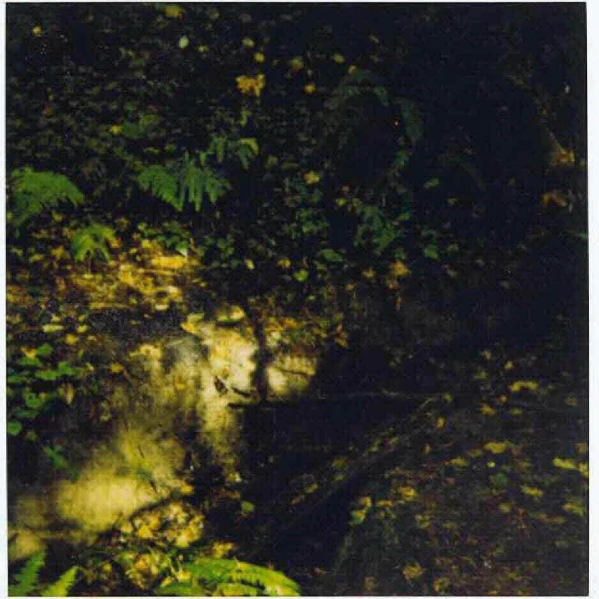
Woodpecker Trail
Stormwater Scour site

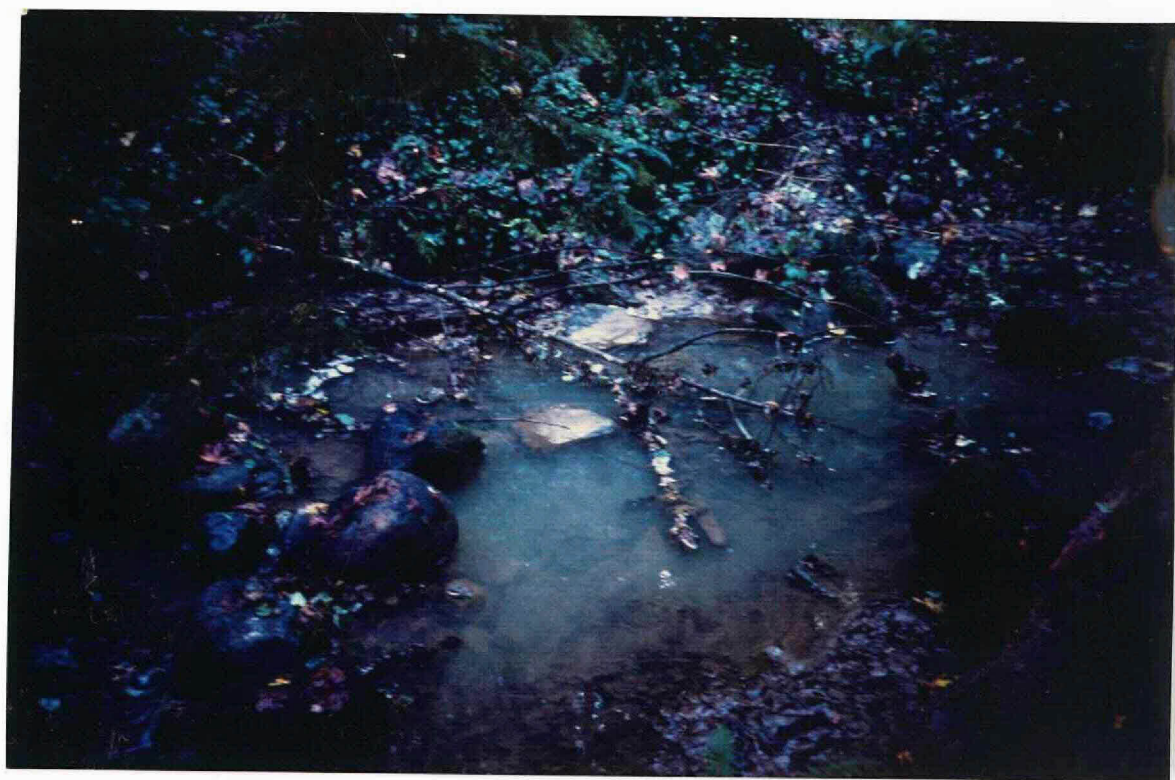
New-weir site, taken from overlook.

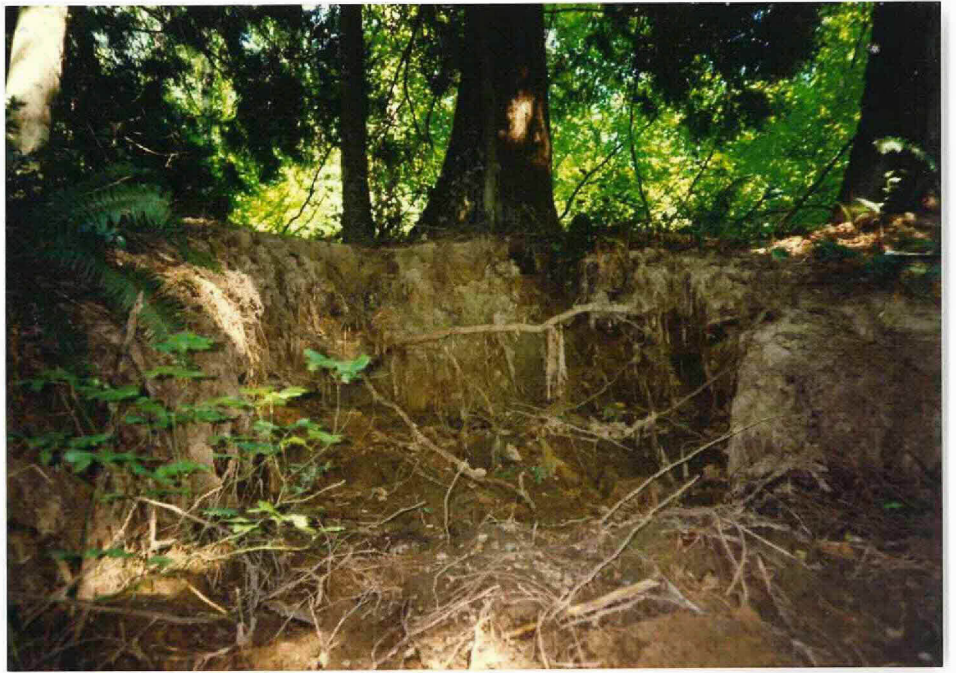
There are several sources of sediment in the project area. In the lower approximate 300 feet of the project area, there are several bank slumps or failures. In this area, there are also five knickpoints or drops in the channel bed.

"Mass Wasting site on lower WP Creek

The bank failures near stations 125 and 400 should be terraced with bank logs and revegetated with native plant species. The Eagle Scout bridge should be removed and relocated in a more stable area. Bank drainage should be conveyed to the stream through facines constructed with either live or dead material. The choice of material will depend on the type and quantity of available plant material.

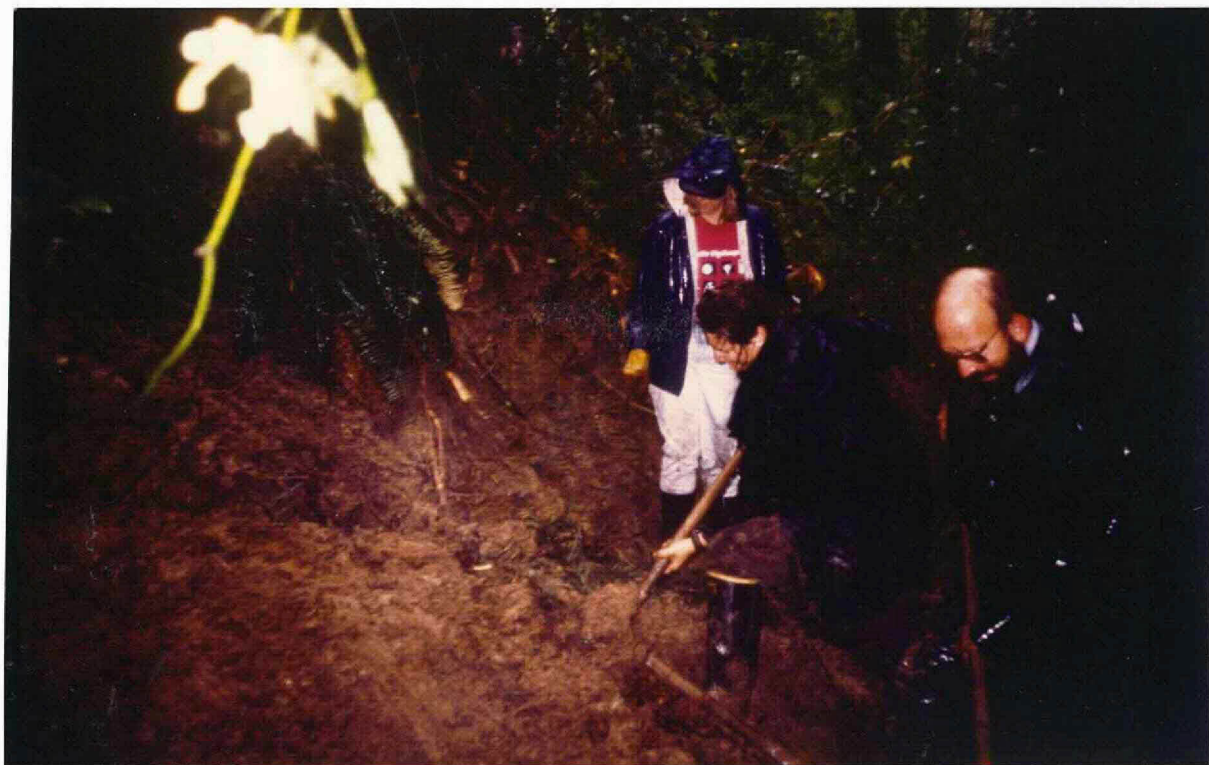
Restoration workers on woodpecker creek slump.
