# Volume 3: Technical Appendices

## REGIONAL INDUSTRIAL SITE READINESS PROJECT

Prepared by Group Mackenzie, Ash Creek Associates, Inc., and Johnson Reid

Volume 3 is one of four documents for the Regional Industrial Site Readiness Project. This volume presents the technical appendices that support Volumes 1 and 2. Volume 1 presents the complete Project analysis and findings. Volume 2 presents site specific details and results of the Project. The Project Executive Summary is the fourth document.

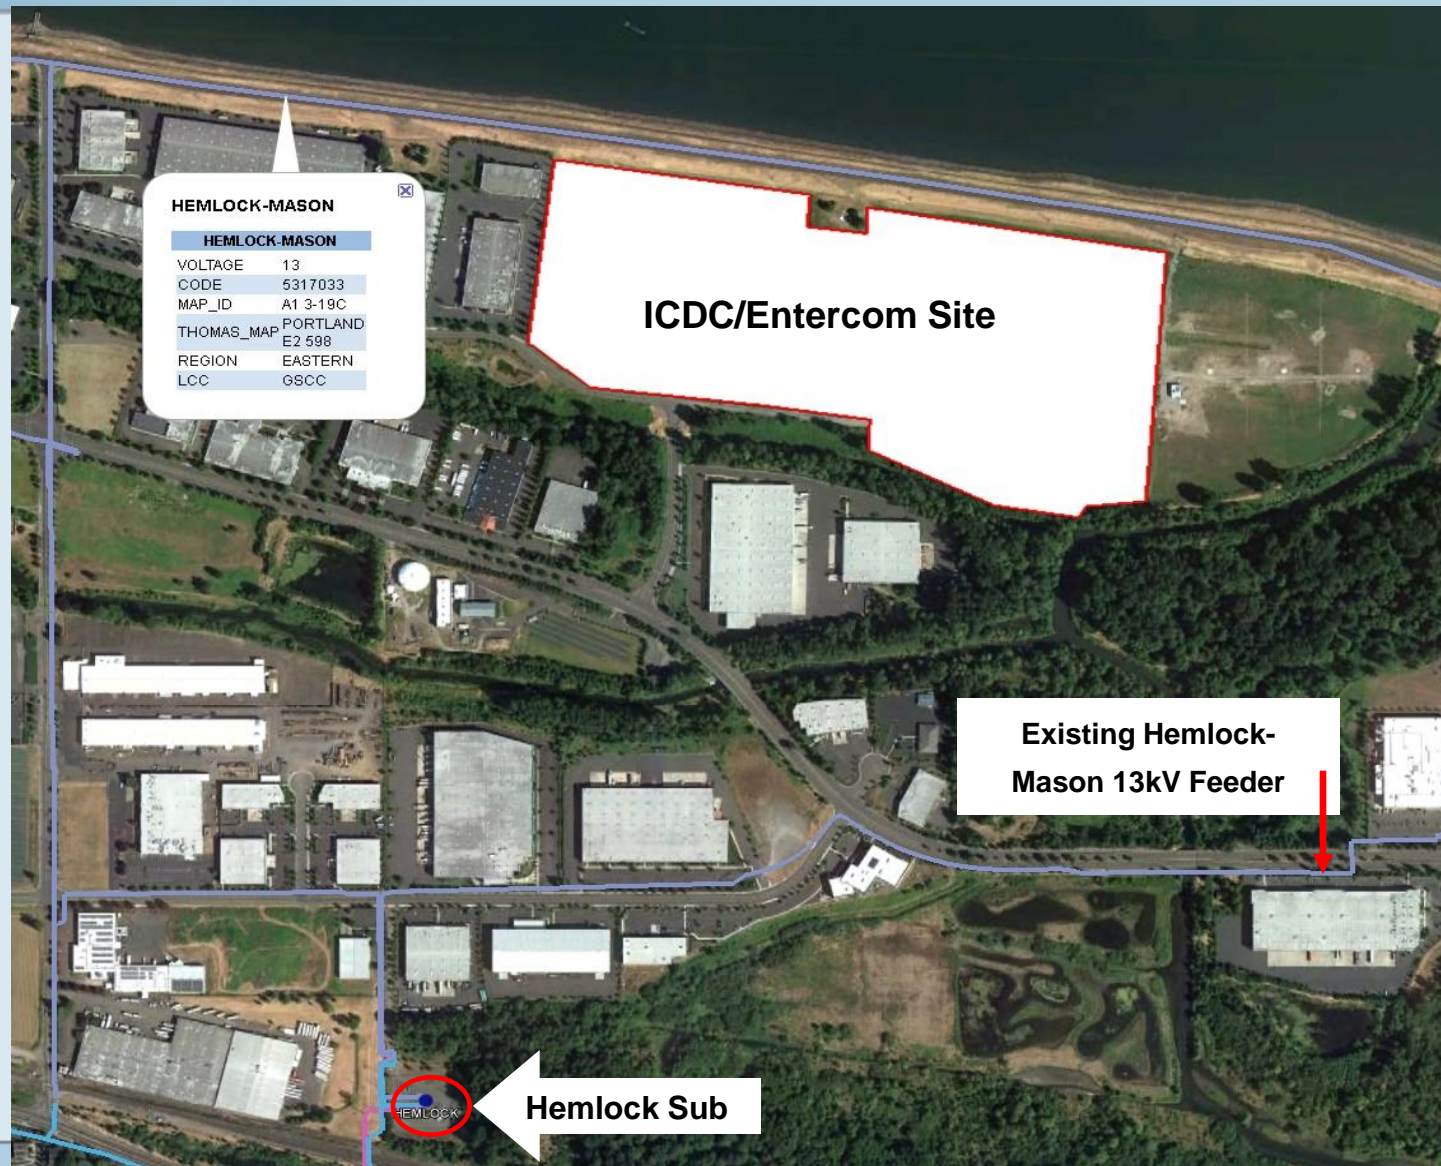
# Proposed Service for ICDC/Entercom Site

- Projected use: Warehouse/ Distribution
- Projected demand: 1.5 MW
- Currently served by Hemlock Substation
- Existing transformer capacity up to 3 MW
- Existing feeder capacity up to 2 MW
- A tap line from the existing Hemlock-Mason 13kV feeder will provide preferred service to the site
- Project grade = 1

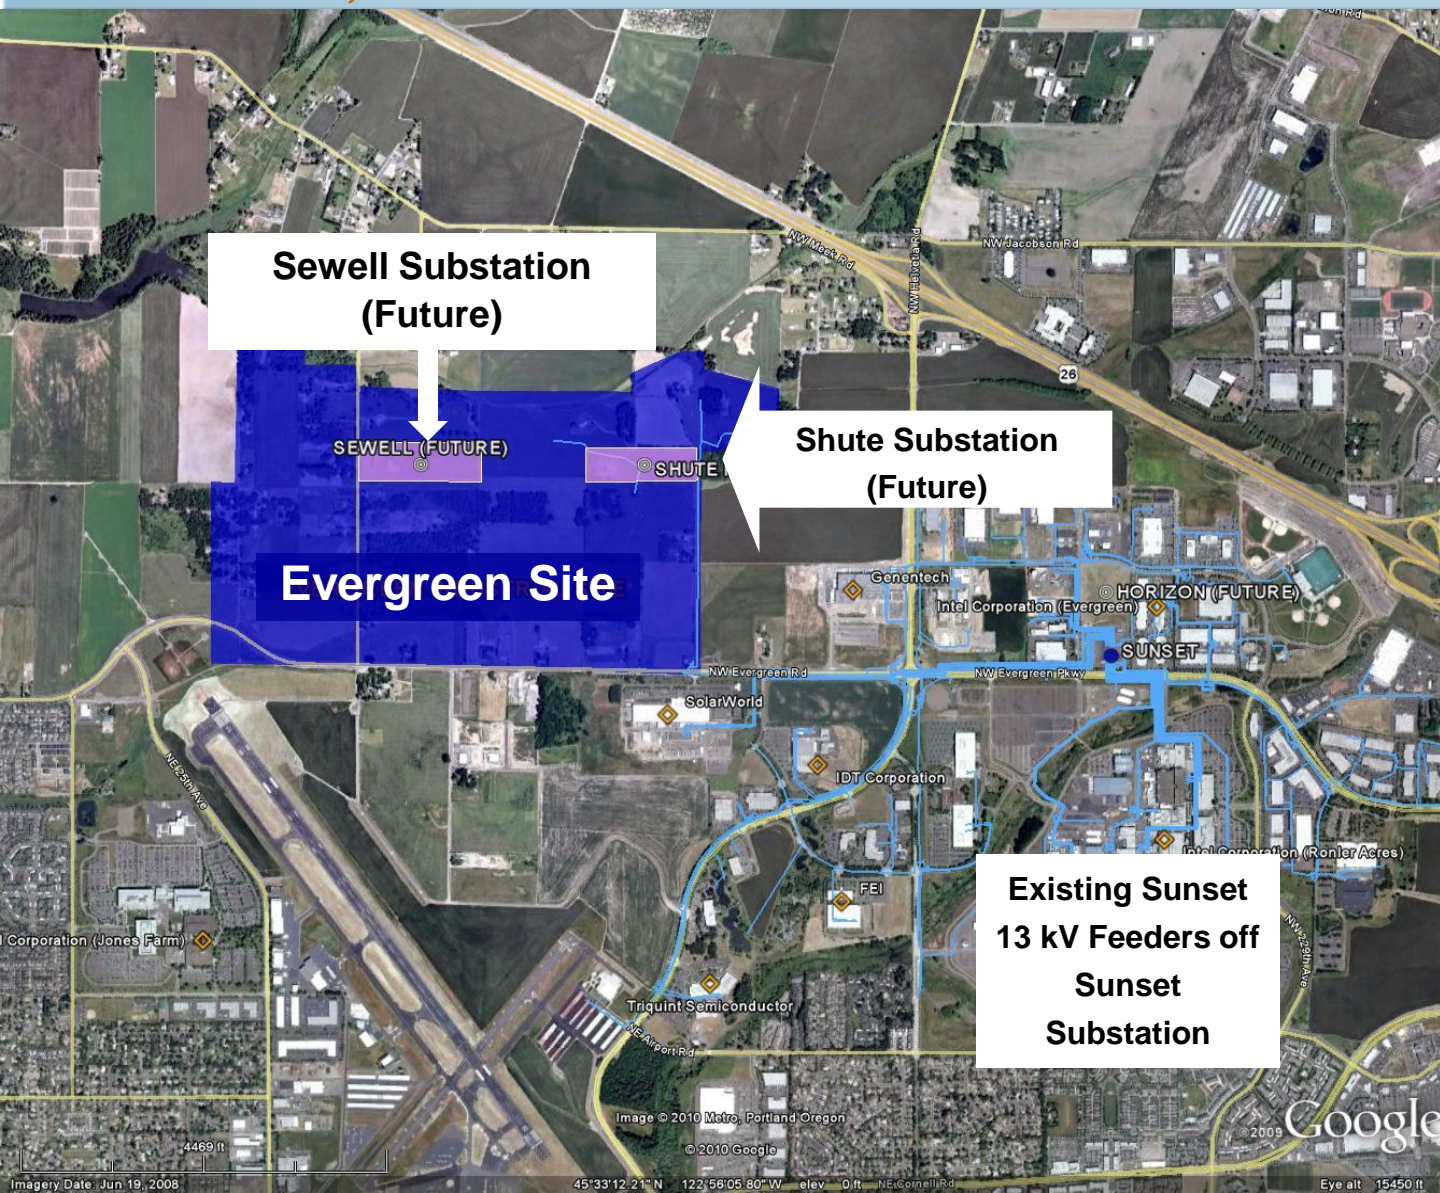
# Proposed Service for Evergreen Site

- Projected use:  
Globally scaled clean tech campus
- Projected demand:  
20 MW
- Site will be served by the future Shute Substation
- Will be served by the future Shute Substation at 35kV distribution voltage
- Projected to have two 115 kV transmission sources
- Project grade = 3

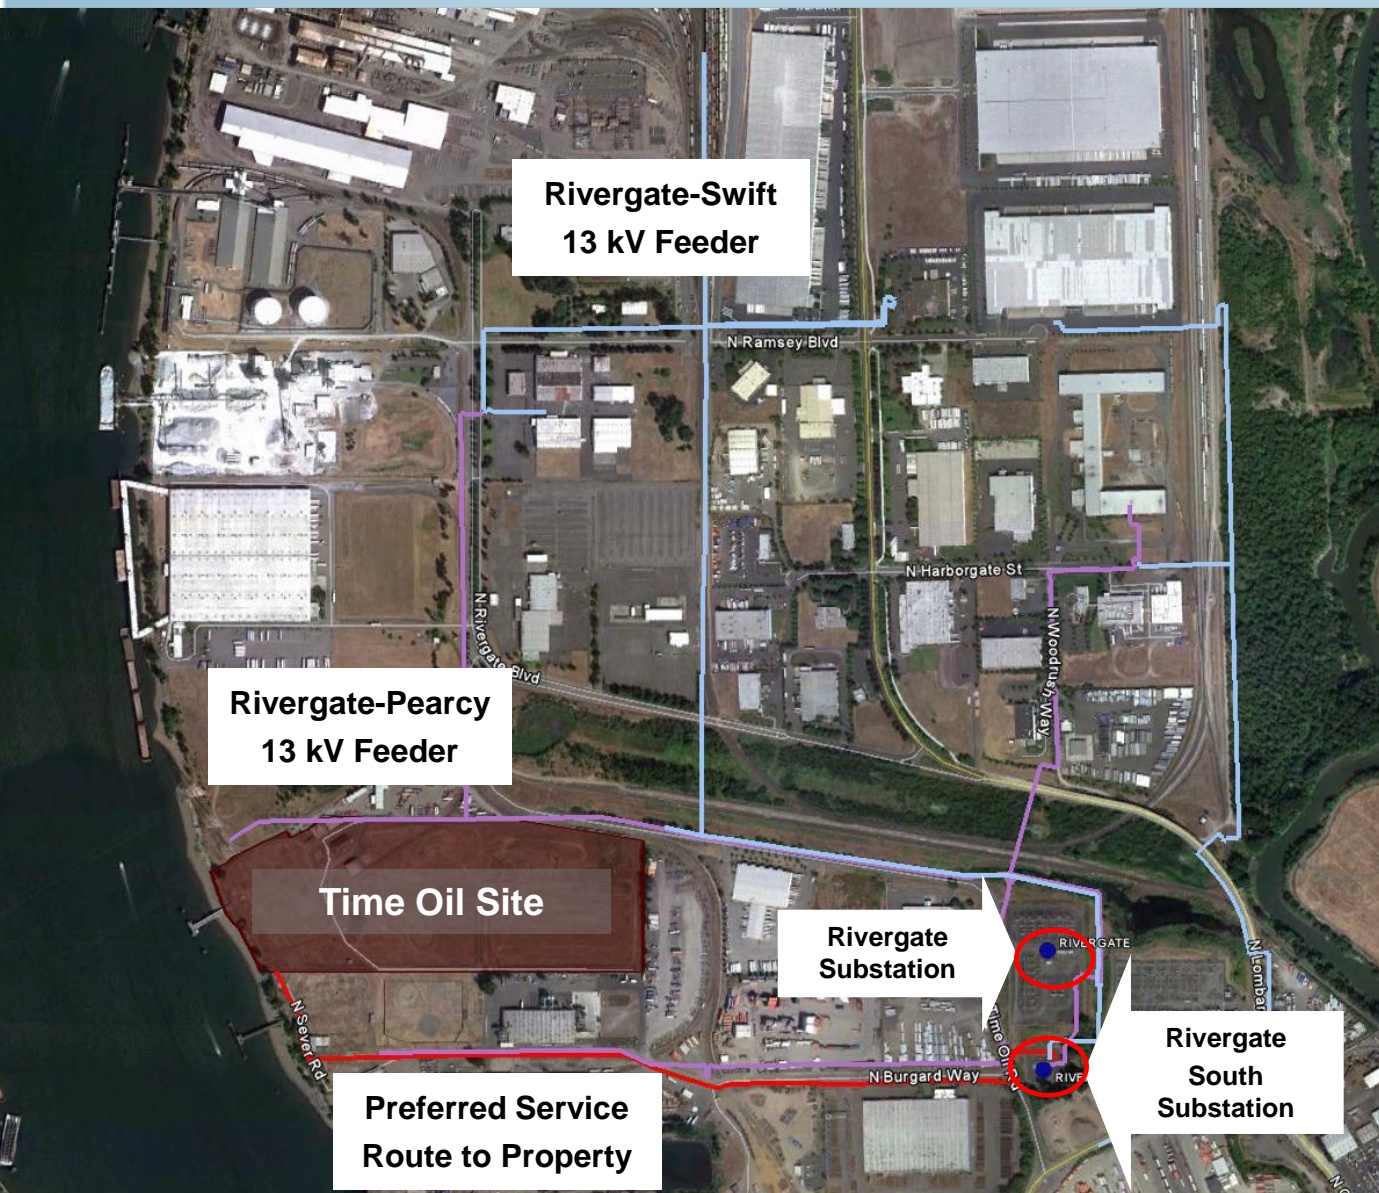
# Proposed Service for Time Oil Company Site

- Projected use: Heavy industrial/ Manufacturing with Strategic Marine
- Projected demand: 8-12 MW
- Currently served by Rivergate South Substation
- Existing transformer capacity up to 10 MW
- Existing feeder capacity up to 6 MW
- In order to reach 12 MW of estimated load, the substation transformer will need to be upgraded
- Project grade = 2

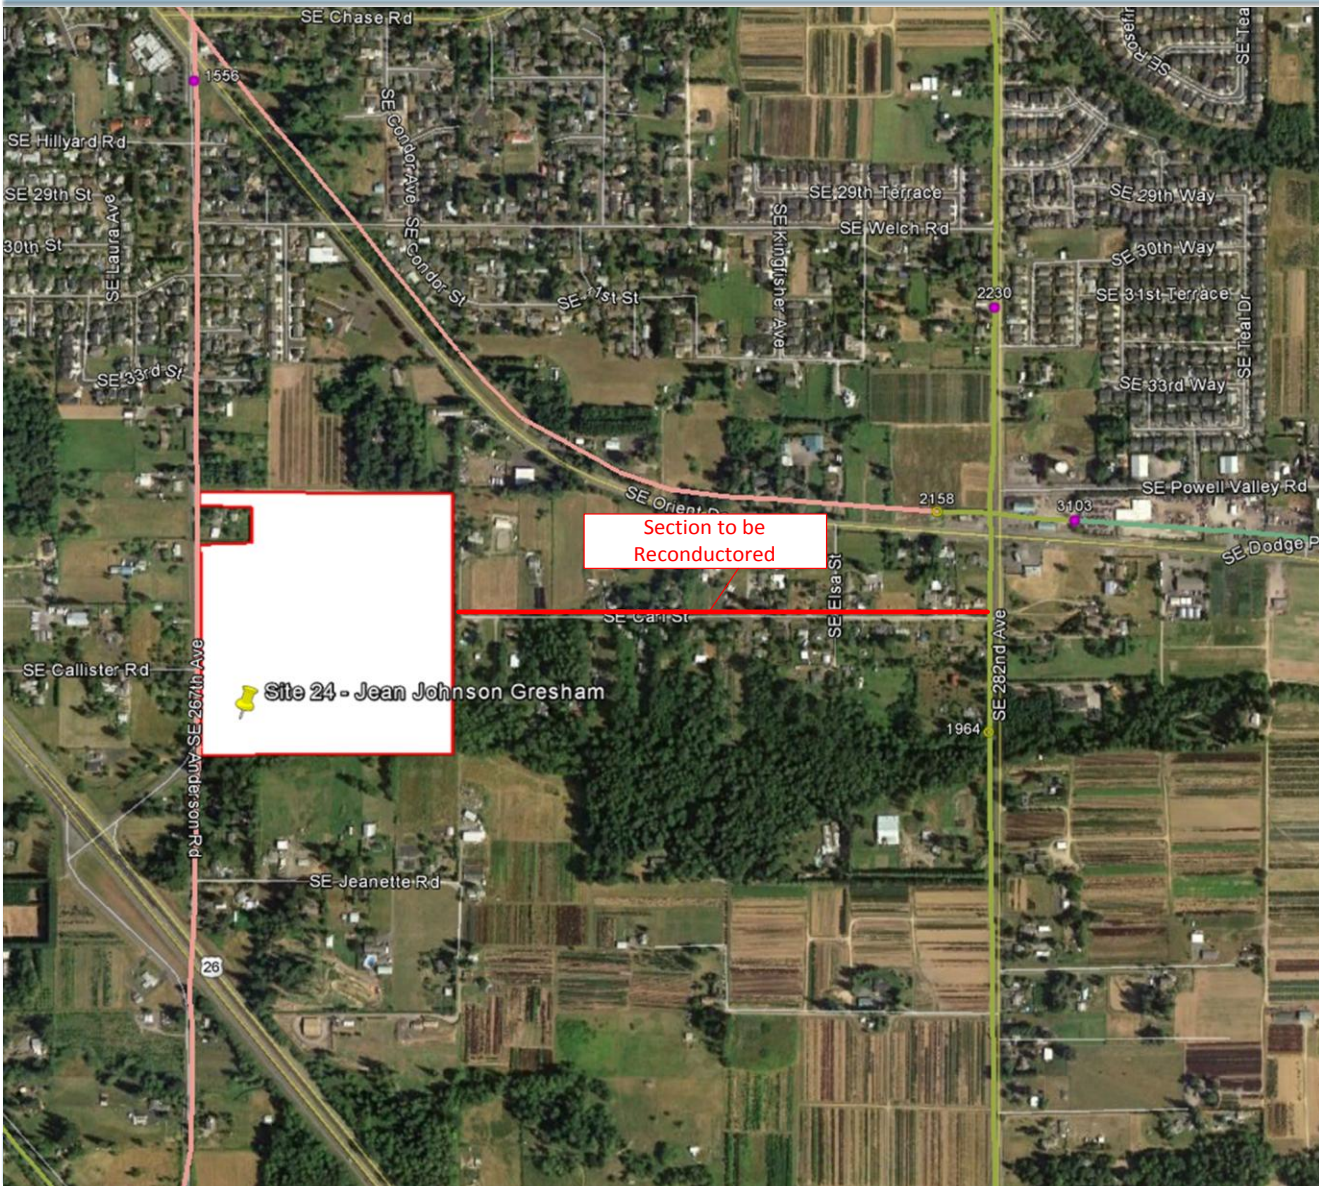
# Proposed Service for Jean Johnson Site

- Projected use: High tech Manufacturing or Campus Industrial
- Projected demand: 4 MW
- Currently served by Hogan North Substation; approx. 2 miles NE of the property
- Existing transformer capacity up to 11 MW
- Existing feeder capacity up to 1 MW
- Hogan North-Salquist 13 kV feeder mainline will be reconfigured to provide preferred service to the property.
- Project grade = 2

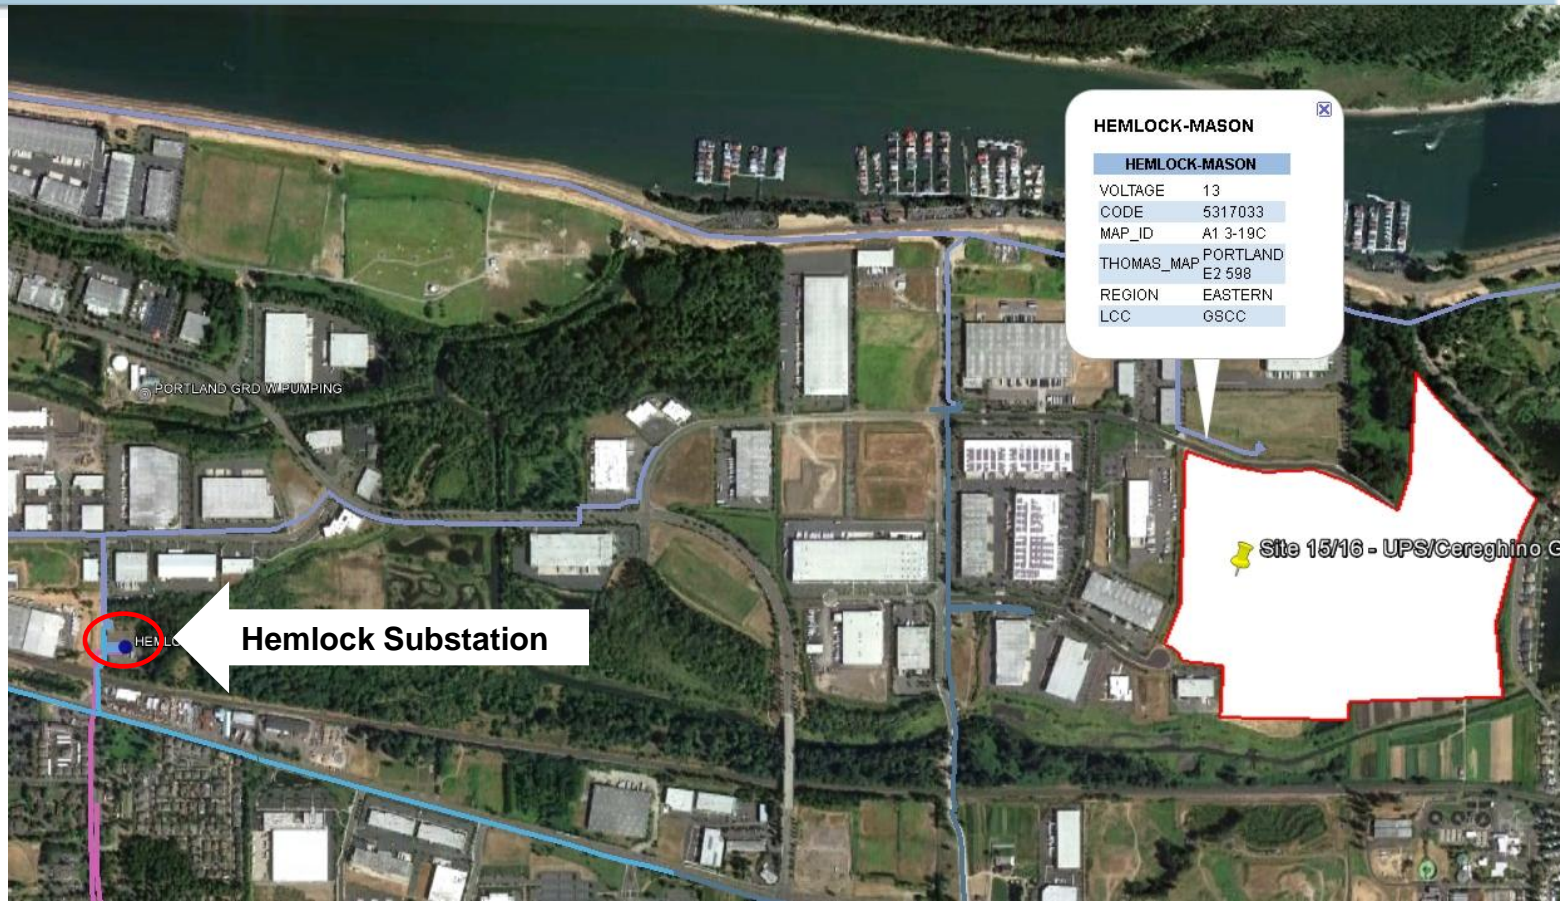
# Proposed Service for UPS & Cereghino Sites

- Projected use: General Manufacturing
- Projected demand: 5-10 MW
- Currently served by Hemlock Substation
- Existing transformer capacity up to 3 MW
- Existing Hemlock-Mason 13kV feeder capacity up 2 MW
- In order to reach 10 MW of estimated load, transformer and feeder upgrades are required
- Project grade = 3

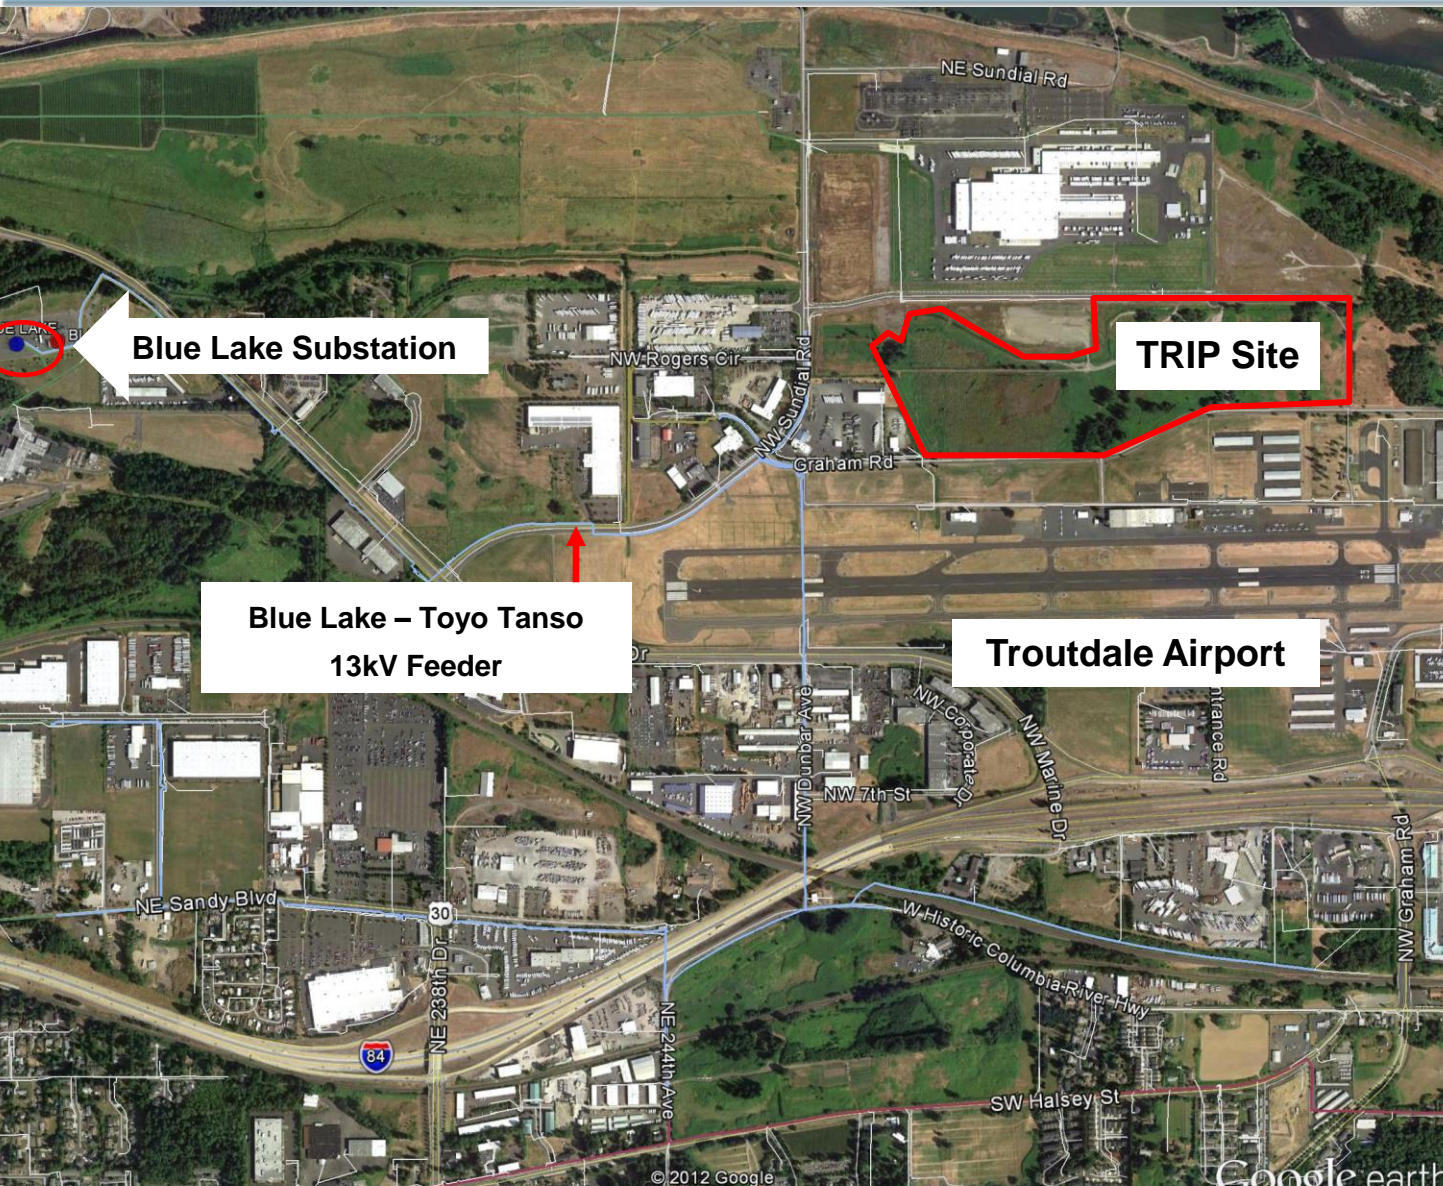
# Proposed Service for TRIP Site

- Projected use:  
Portland Regional Distribution Center
- Projected demand: 3 MW
- Currently served by Blue Lake Substation
- Existing transformer capacity up to 5 MW
- Existing feeder capacity up to 7 MW
- The Blue Lake-Toyo Tanso 13kV feeder will be extended to provide preferred service to the property.
- Project grade = 1

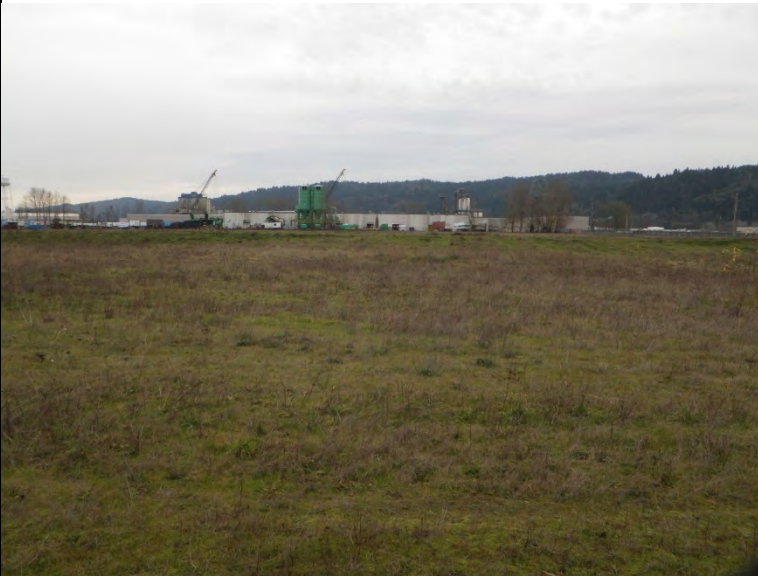
<b>Photo No:</b> 1

<b>Photo Date:</b> Jan. 31, 2012	
<b>Orientation:</b> South	
<b>Description:</b>  Field at site, viewed from North Time Oil Road. View to the south.	
<b>Photo No:</b> 2

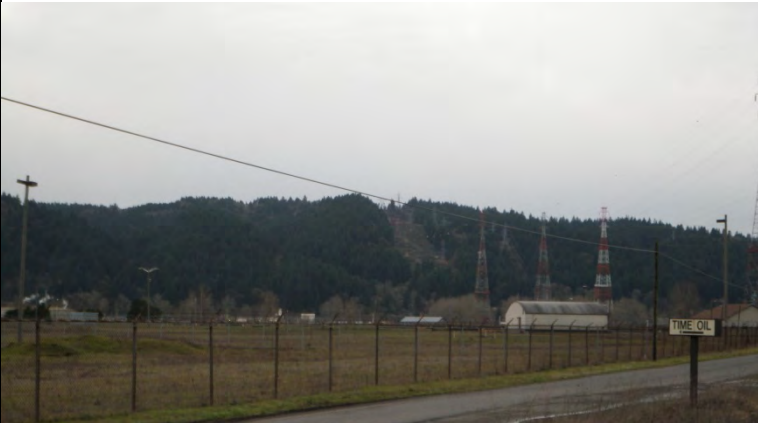
<b>Photo Date:</b> Jan. 31, 2012	
<b>Orientation:</b> West	
<b>Description:</b>  Field at site, along with several on-site structures, viewed from North Time Oil Road. View to the west.

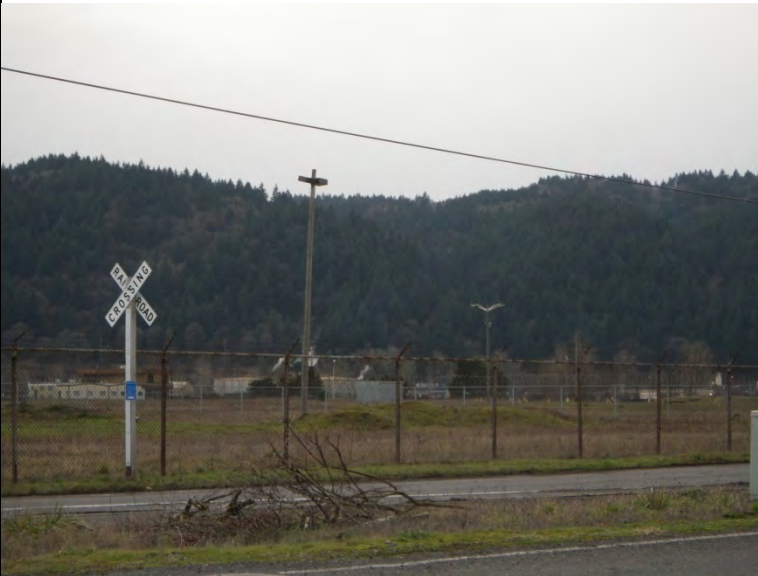
<b>Photo No:</b> 3

<b>Photo Date:</b> Jan. 31, 2012	
<b>Orientation:</b> Southwest	
<b>Description:</b>  Field at site, viewed from North Time Oil Road. View to the southwest.	
<b>Photo No:</b> 4

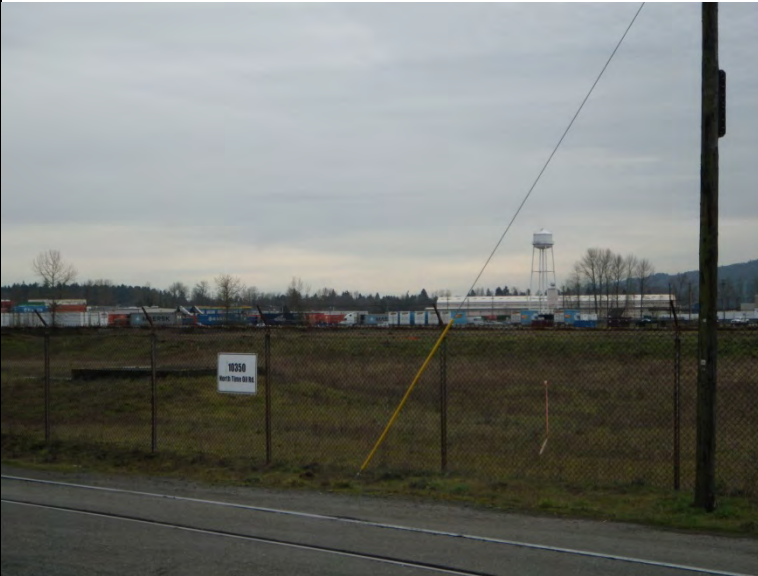
<b>Photo Date:</b> Jan. 31, 2012	
<b>Orientation:</b> Southeast	
<b>Description:</b>  Field at site, viewed from North Time Oil Road. View to the southeast.

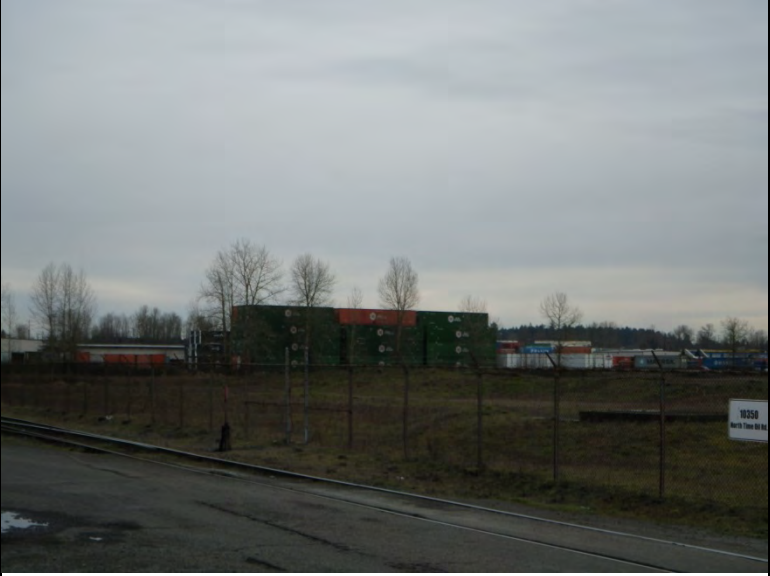
<b>Photo No:</b> 5

<b>Photo Date:</b> Jan. 31, 2012	
<b>Orientation:</b> East	
<b>Description:</b>  Field at site, viewed from North Time Oil Road. View to the east.

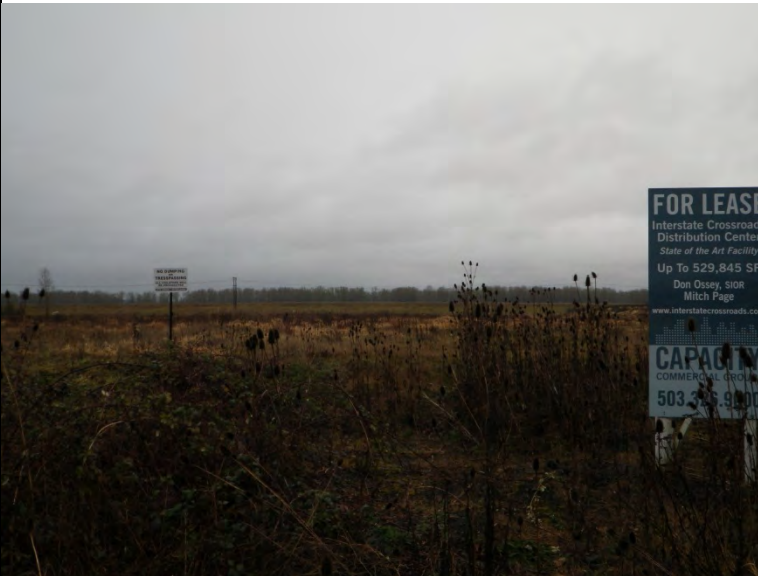
<b>Photo No:</b> 3	
<b>Photo Date:</b> Jan. 17, 2012

<b>Orientation:</b> North	
<b>Description:</b>  Field at site, viewed from intersection of NE 166 <sup>th</sup> Avenue and NE Cameron Boulevard. View to the north.	
<b>Photo No:</b> 4	
<b>Photo Date:</b> Jan. 17, 2012

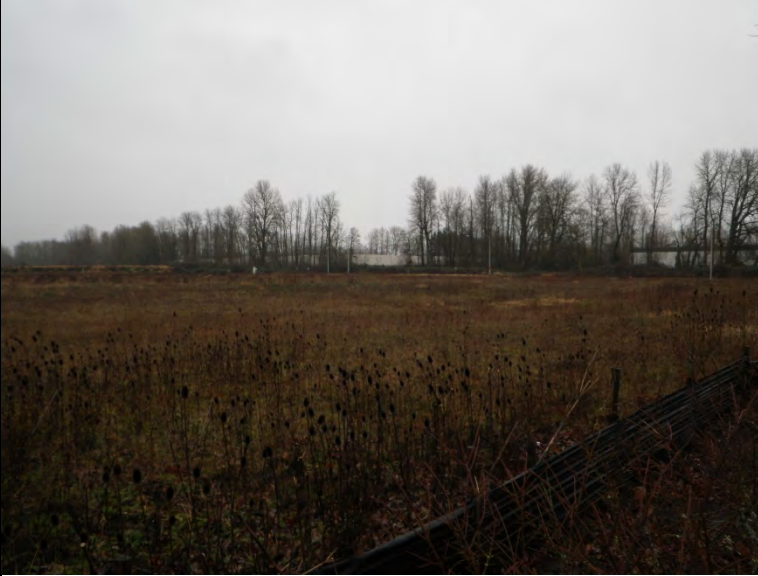
<b>Orientation:</b> Southeast	
<b>Description:</b>  Field at site, viewed from off-site property adjacent and west of the site. View to the east.

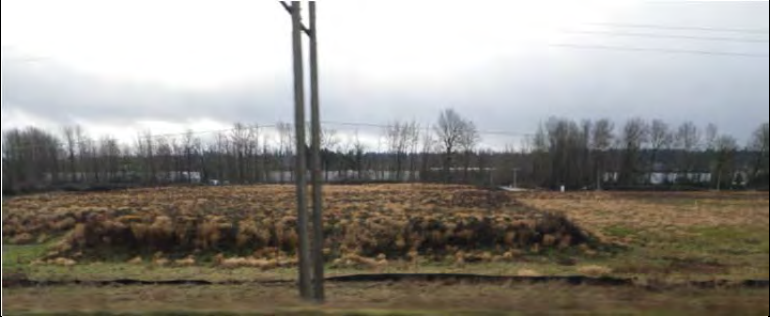
<b>Photo No:</b> 5

<b>Photo Date:</b> Jan. 17, 2012	
<b>Orientation:</b> South	
<b>Description:</b>  Field at site, viewed from NE Marine Drive. View to the south.	
<b>Photo No:</b> 6

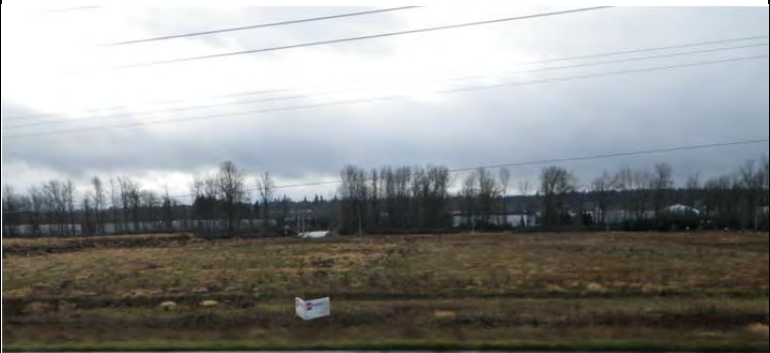
<b>Photo Date:</b> Jan. 17, 2012	
<b>Orientation:</b> South	
<b>Description:</b>  Field at site, viewed from NE Marine Drive. View to the south.

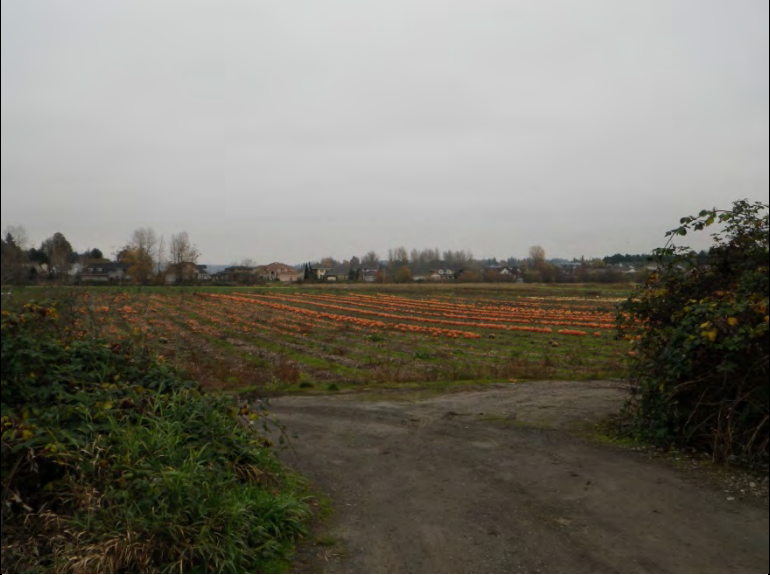
<b>Photo No:</b> 5

<b>Photo Date:</b> Dec. 7, 2011	
<b>Orientation:</b> East	
<b>Description:</b> Pumpkin field viewed from NE Riverside Parkway.	
<b>Photo No:</b> 6

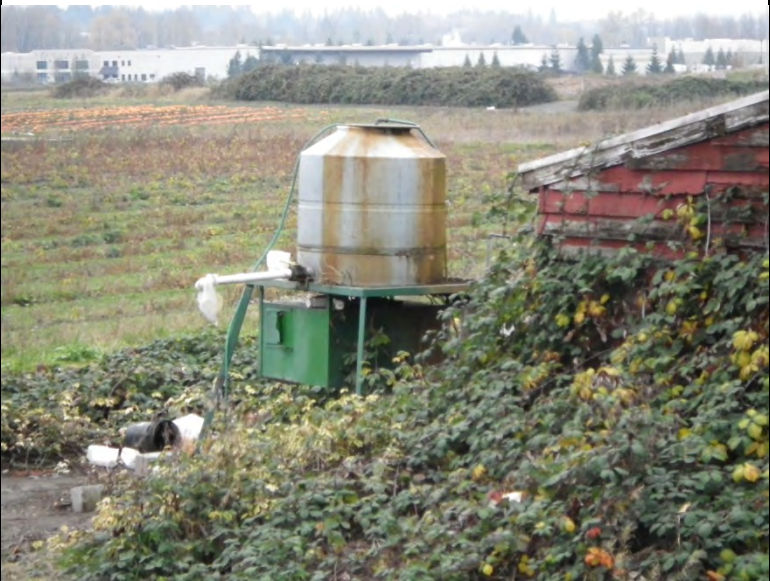
<b>Photo Date:</b> Dec. 7, 2011	
<b>Orientation:</b> Southwest	
<b>Description:</b> Irrigation shed and water tank near NE Interlachen Lane.

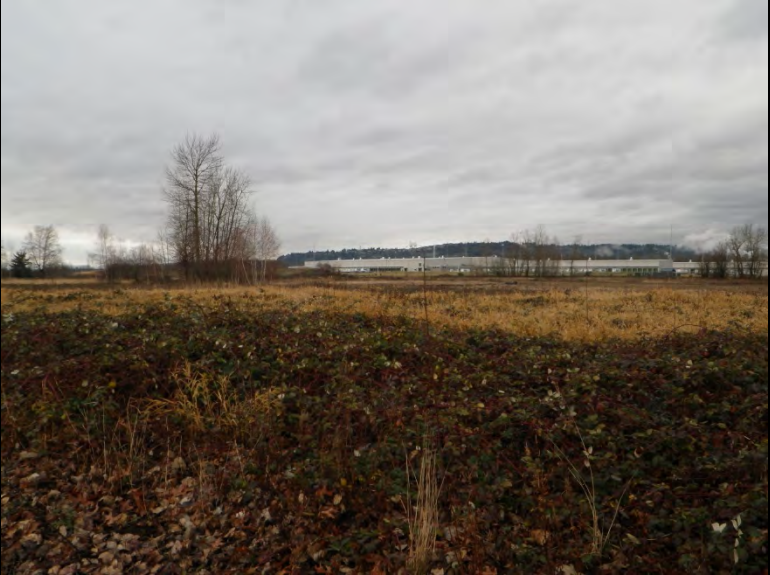
<b>Photo No:</b> 1

<b>Photo Date:</b> Dec. 27, 2011	
<b>Orientation:</b> Northwest	
<b>Description:</b>  Field viewed from NW Graham Road.	
<b>Photo No:</b> 2

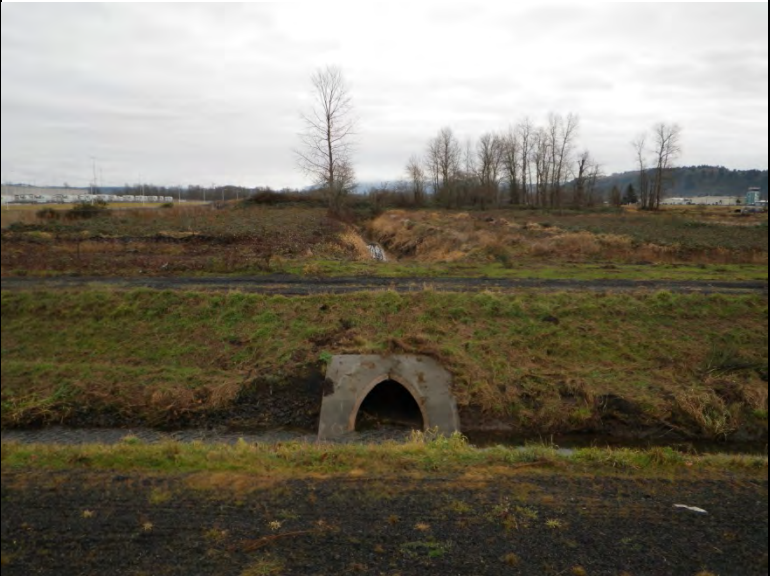
<b>Photo Date:</b> Dec. 27, 2011	
<b>Orientation:</b> East	
<b>Description:</b>  Field and drainage channels viewed from NW Sundial Road.

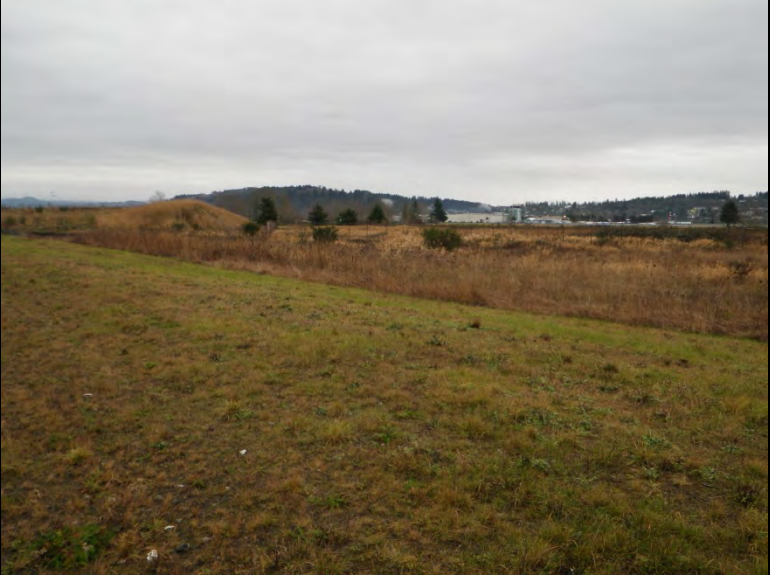
<b>Photo No:</b> 3

<b>Photo Date:</b> Dec. 27, 2011	
<b>Orientation:</b> Southeast	
<b>Description:</b> Field viewed from NW Swigert Way.	
<b>Photo No:</b> 4

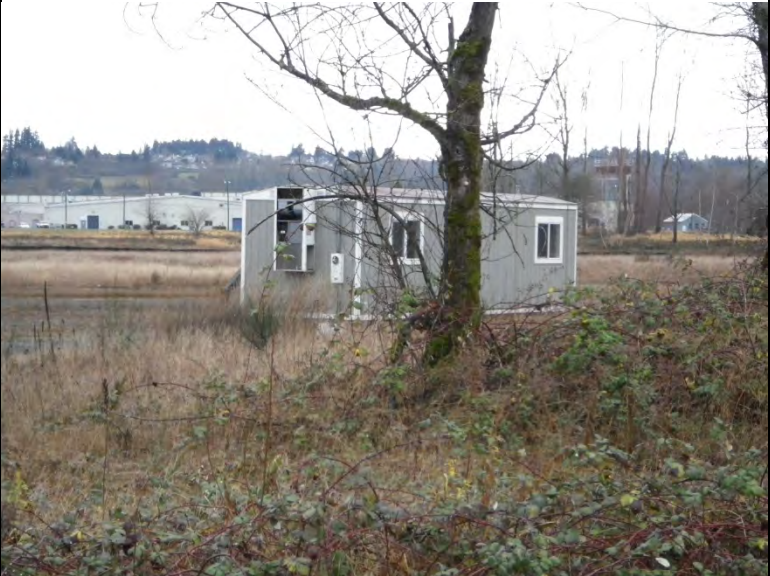
<b>Photo Date:</b> Dec. 27, 2011	
<b>Orientation:</b> Southwest	
<b>Description:</b> Job trailer, viewed from NW Swigert Way.

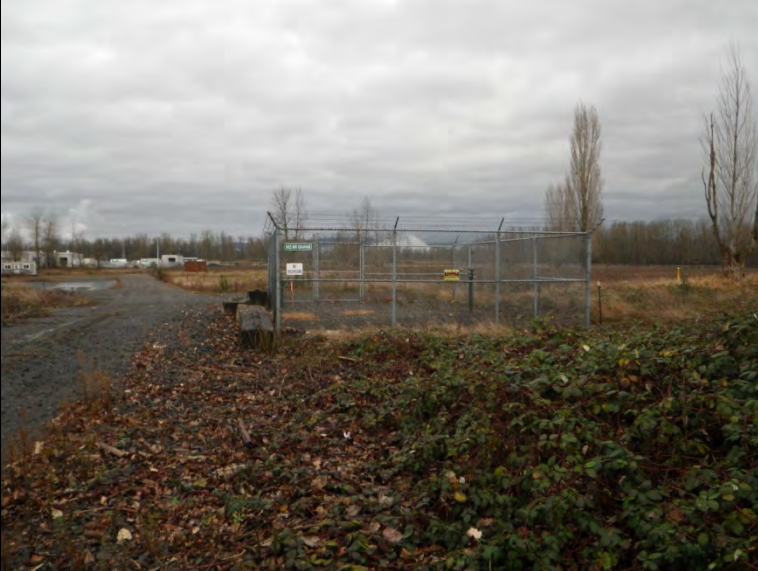
<b>Photo No:</b> 5	
<b>Photo Date:</b> Dec. 27, 2011

<b>Orientation:</b> North	
<b>Description:</b>  Field viewed from NW Graham Road. A natural gas pipeline valve is located in the fenced area.	
<b>Photo No:</b> 6	
<b>Photo Date:</b> Dec. 27, 2011

The site was observed on December 27, 2011 from public rights of way. The site is currently undeveloped and generally vacant. A natural gas pipeline valve structure is present at the south side of the site near NW Graham Road. It appears that the buried natural gas pipeline traverses a portion of the site. A drainage ditch, which generally runs in a west-east alignment, is present at the central portion of the site. The property north of the site (also part of the former Reynolds/Alcoa facility) is occupied by a Federal Express distribution center. The Troutdale airport is present south of the site. Vacant parcels are present west and east of the site. A photograph log is included in Attachment B.

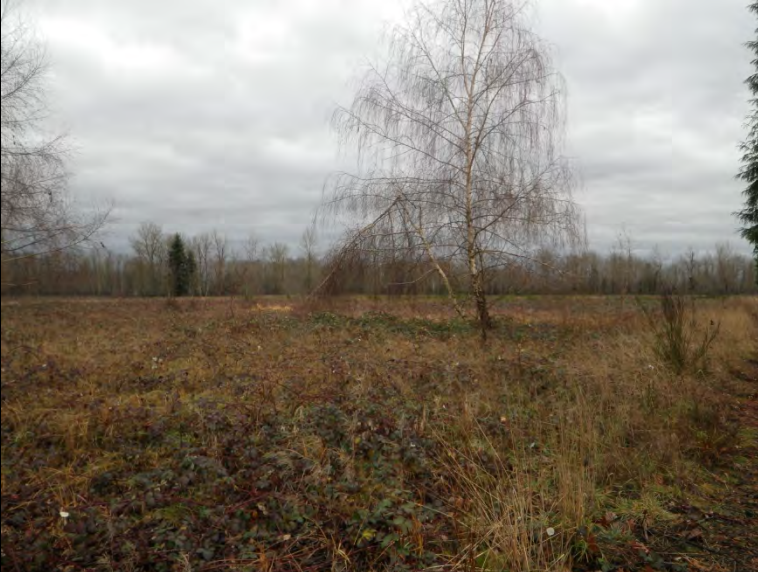
<b>Orientation:</b> Northeast	
<b>Description:</b>  Field viewed from NW Graham Road.

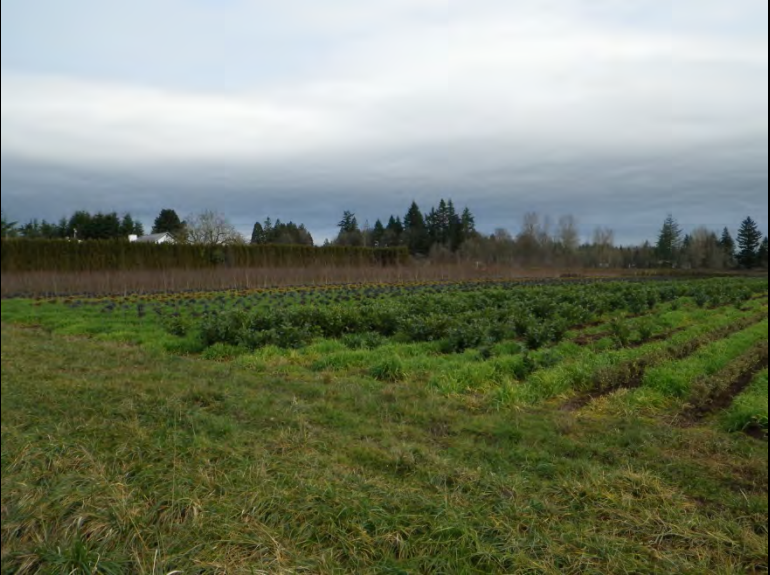
<b>Photo No:</b> 1

<b>Photo Date:</b> Dec. 27, 2011	
<b>Orientation:</b> Northeast	
<b>Description:</b> Agricultural area viewed from SE 267 <sup>th</sup> Avenue.	
<b>Photo No:</b> 2	 
<b>Photo Date:</b> Dec. 27, 2011	
<b>Orientation:</b> East	
<b>Description:</b> Agricultural area viewed from SE 267 <sup>th</sup> Avenue.

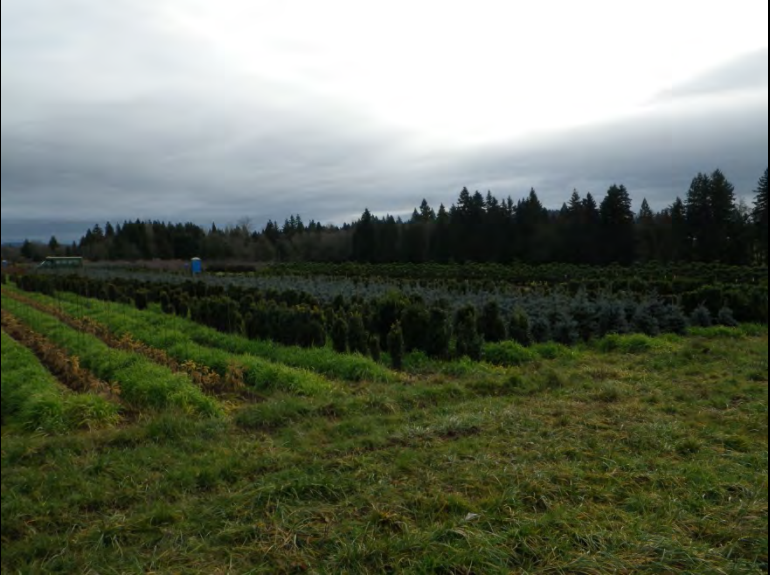
<b>Photo No:</b> 3

<b>Photo Date:</b> Dec. 27, 2011	
<b>Orientation:</b> Southeast	
<b>Description:</b> Agricultural area viewed from SE 267 <sup>th</sup> Avenue.	
<b>Photo No:</b> 4

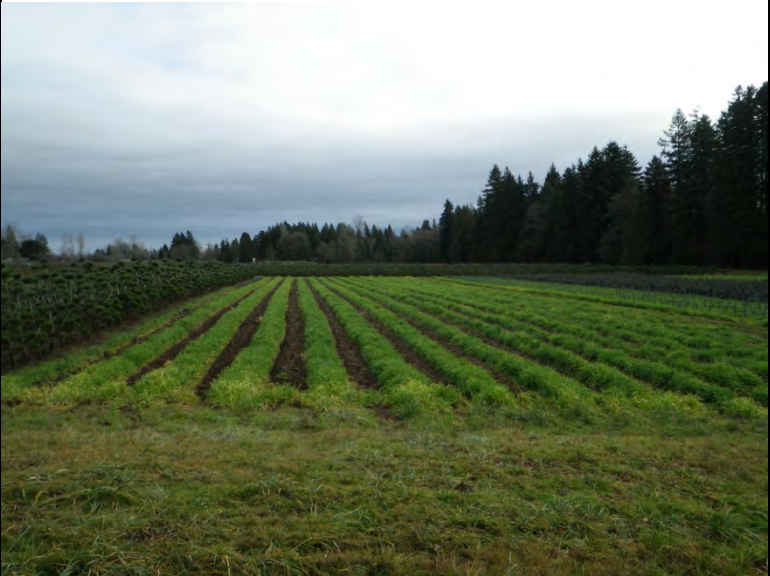
<b>Photo Date:</b> Dec. 27, 2011	
<b>Orientation:</b> East	
<b>Description:</b> Agricultural area viewed from SE 267 <sup>th</sup> Avenue.

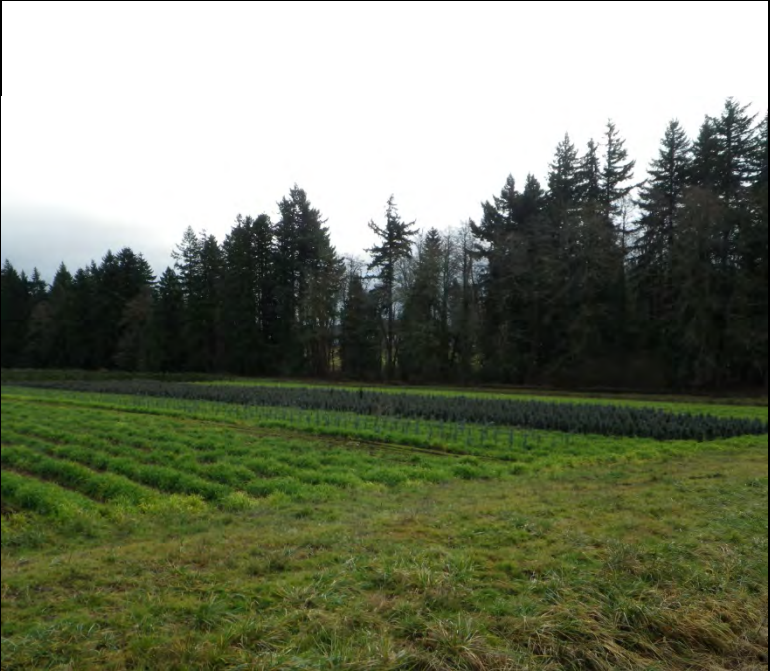
<b>Photo No:</b> 5

<b>Photo Date:</b> Dec. 27, 2011	
<b>Orientation:</b> Southeast	
<b>Description:</b> Agricultural area viewed from SE 267 <sup>th</sup> Avenue.	
<b>Photo No:</b> 6

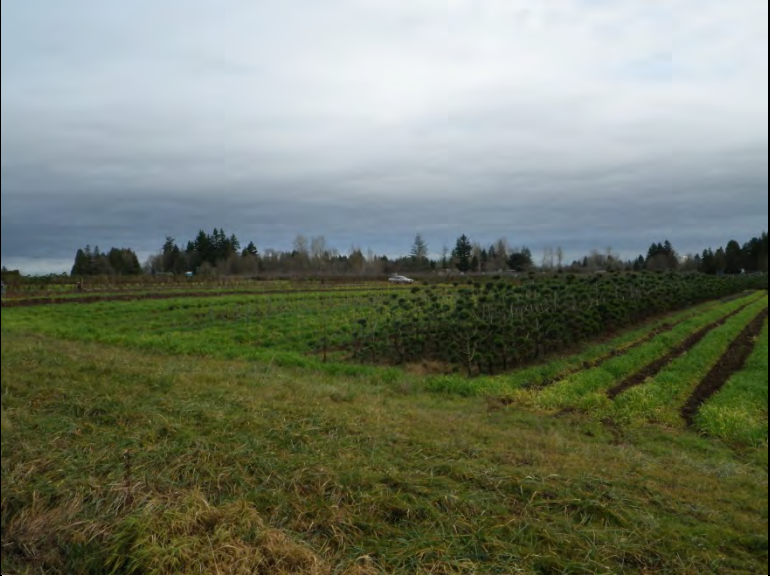
<b>Photo Date:</b> Dec. 27, 2011	
<b>Orientation:</b> Northeast	
<b>Description:</b> Agricultural area viewed from SE 267 <sup>th</sup> Avenue.

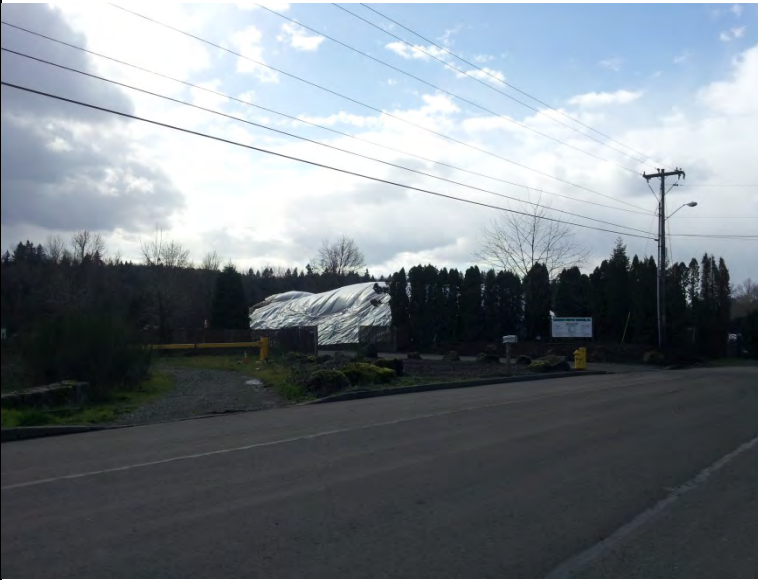
<b>Photo No:</b> 3

<b>Photo Date:</b> March. 6, 2012	
<b>Orientation:</b> Southwest	
<b>Description:</b>  Clackamas Compost Products facility, at southwest portion of the site.	
<b>Photo No:</b> 4

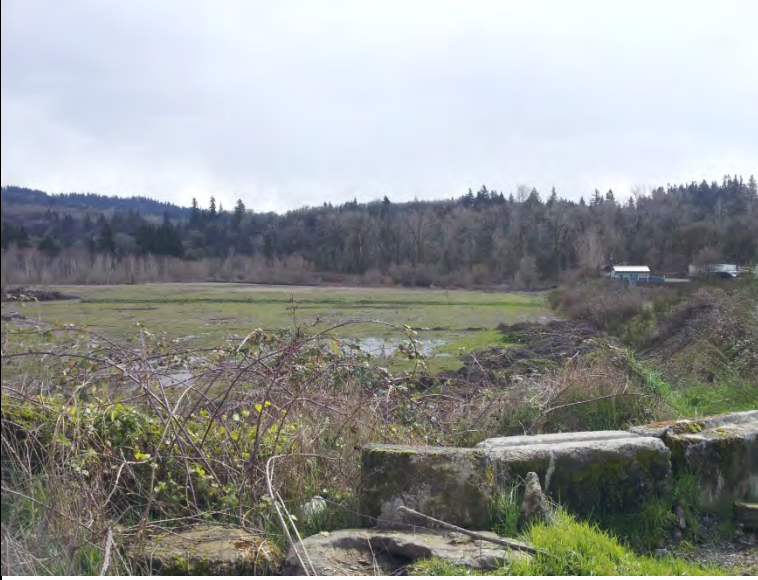
<b>Photo Date:</b> March. 6, 2012	
<b>Orientation:</b> West-southwest	
<b>Description:</b>  Former Clackamas Sand and Gravel pit, viewed from SE Wilde Road.

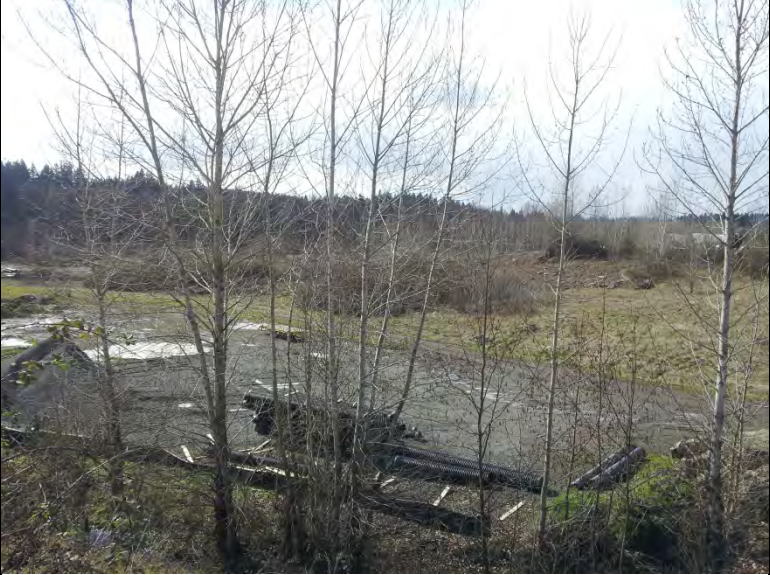
<b>Photo No:</b> 5	
<b>Photo Date:</b> March. 6, 2012

<b>Orientation:</b> Southwest	
<b>Description:</b>  Former Clackamas Sand and Gravel pit, viewed from SE Wilde Road.	
<b>Photo No:</b> 6	
<b>Photo Date:</b> March. 6, 2012	 
<b>Orientation:</b> West	
<b>Description:</b>  Former Clackamas Sand and Gravel pit, viewed from SE Wilde Road.

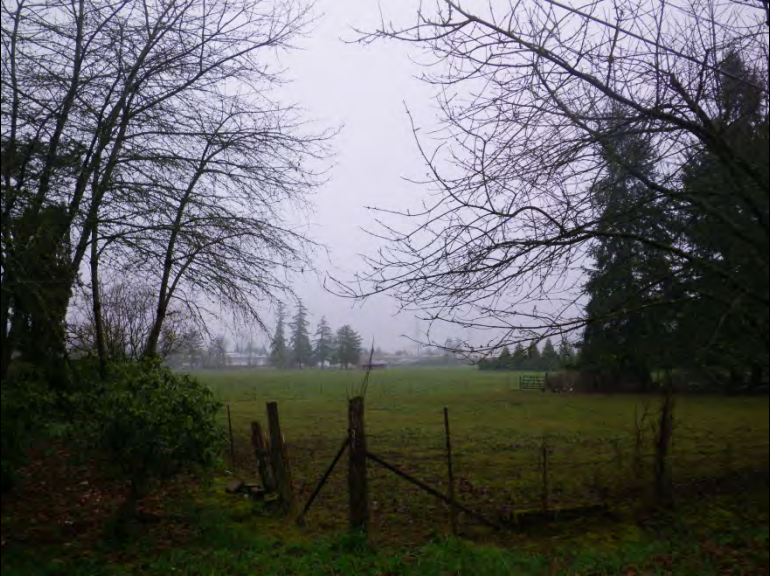
<b>Orientation:</b> Southeast	
<b>Description:</b>  Horse pasture at the east side of Garden Acres Road.
