# Volume 3: Technical Appendices

## REGIONAL INDUSTRIAL SITE READINESS PROJECT

Prepared by Group Mackenzie, Ash Creek Associates, Inc., and Johnson Reid

Volume 3 is one of four documents for the Regional Industrial Site Readiness Project. This volume presents the technical appendices that support Volumes 1 and 2. Volume 1 presents the complete Project analysis and findings. Volume 2 presents site specific details and results of the Project. The Project Executive Summary is the fourth document.

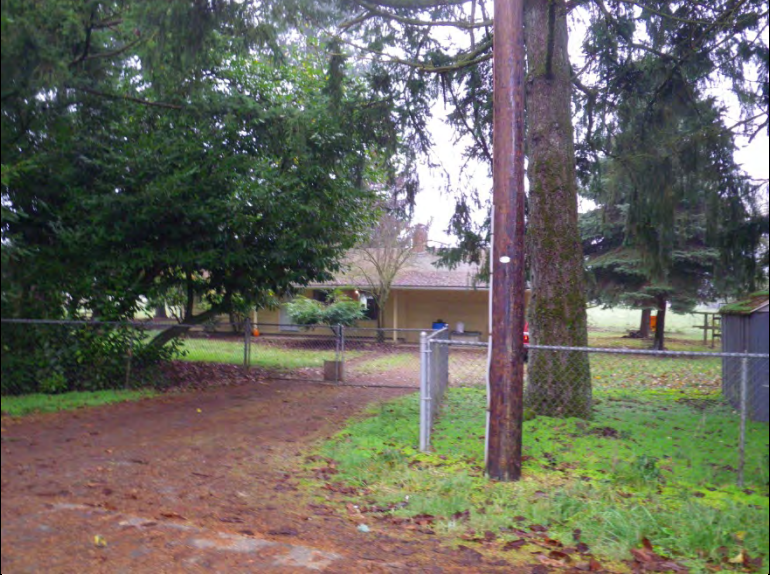
<b>Photo No:</b> 5	
<b>Photo Date:</b> Dec. 7, 2011

<b>Orientation:</b> East	
<b>Description:</b>  Dwelling at the east side of Garden Acres Road.	
<b>Photo No:</b> 6	
<b>Photo Date:</b> Dec. 7, 2011

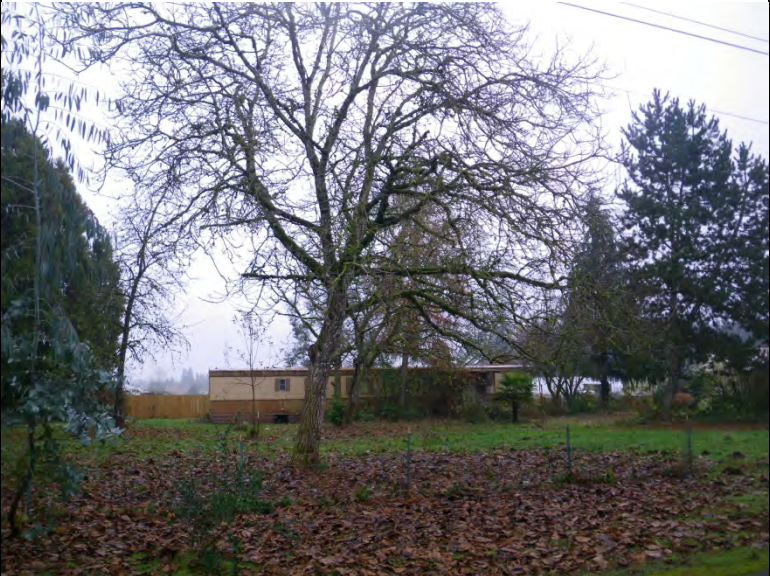
<b>Orientation:</b> Southeast	
<b>Description:</b>  Dwelling at the southeast side of Garden Acres Road.

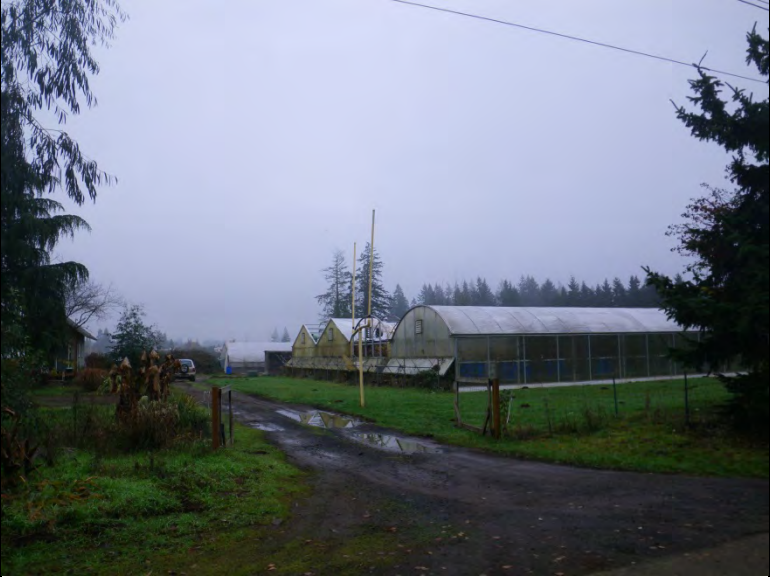
<b>Photo No:</b> 7	
<b>Photo Date:</b> Dec. 7, 2011

<b>Orientation:</b> Southeast	
<b>Description:</b>  Greenhouses at the east side of Garden Acres Road.	
<b>Photo No:</b> 8	
<b>Photo Date:</b> Dec. 7, 2011

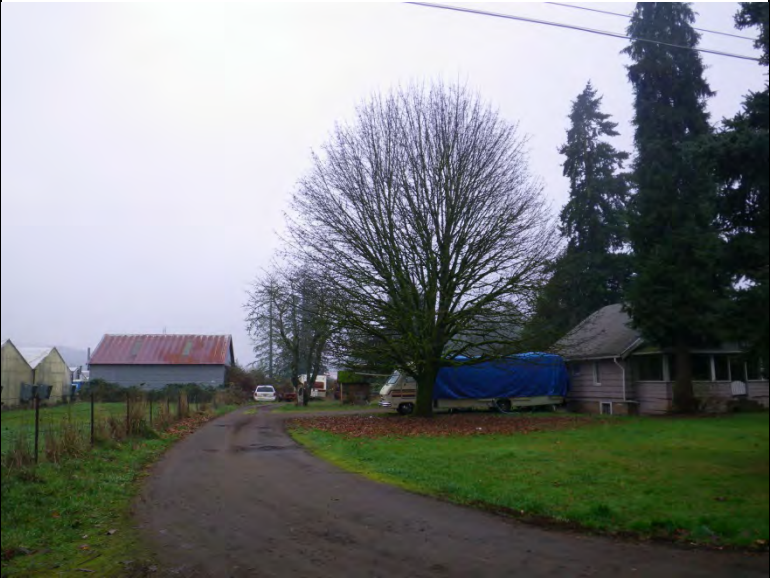
<b>Orientation:</b> East	
<b>Description:</b>  Barn and dwelling at the east side of Garden Acres Road.

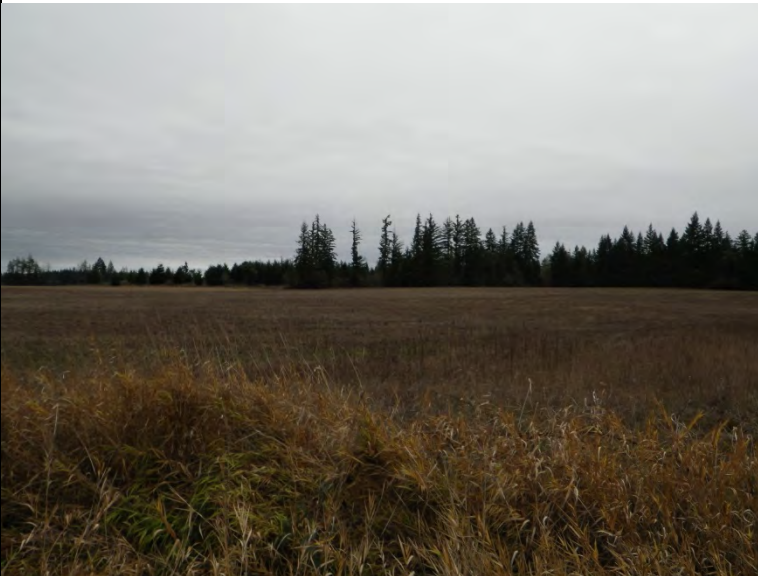
<b>Photo No:</b> 5	
<b>Photo Date:</b> Dec. 27, 2011

<b>Orientation:</b> South	
<b>Description:</b> Agricultural area viewed from SW Tualatin-Sherwood Road.	
<b>Photo No:</b> 6	
<b>Photo Date:</b> Dec. 27, 2011

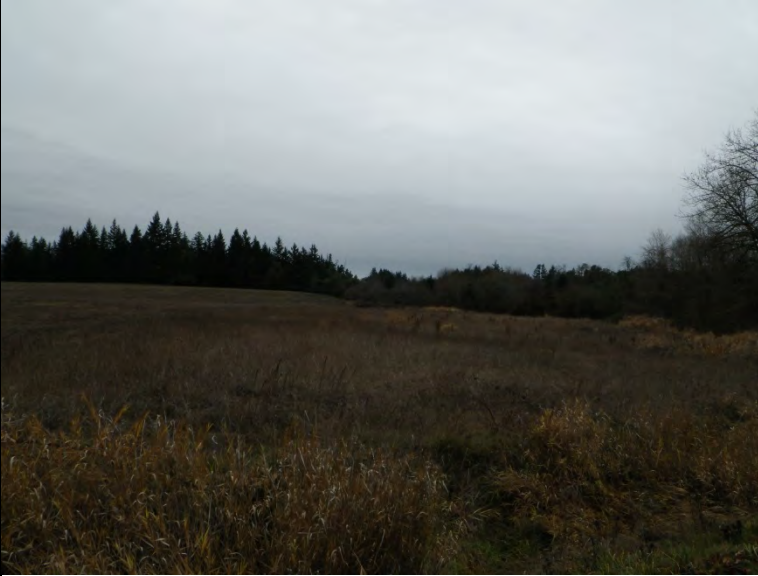
<b>Orientation:</b> Southwest	
<b>Description:</b> Agricultural area viewed from SW Tualatin-Sherwood Road.

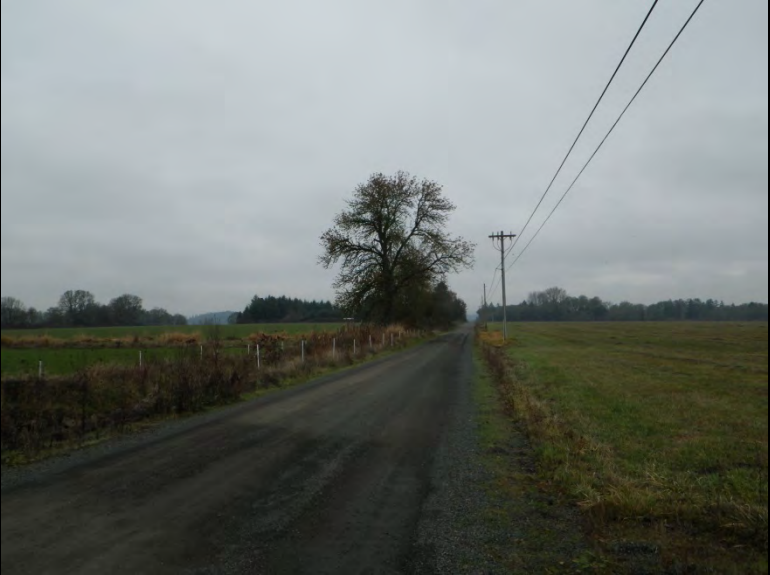
<b>Photo No:</b> 1

<b>Photo Date:</b> Dec. 7, 2011	
<b>Orientation:</b> North	
<b>Description:</b> Agricultural fields viewed from NW 253 <sup>rd</sup> Avenue.	
<b>Photo No:</b> 2

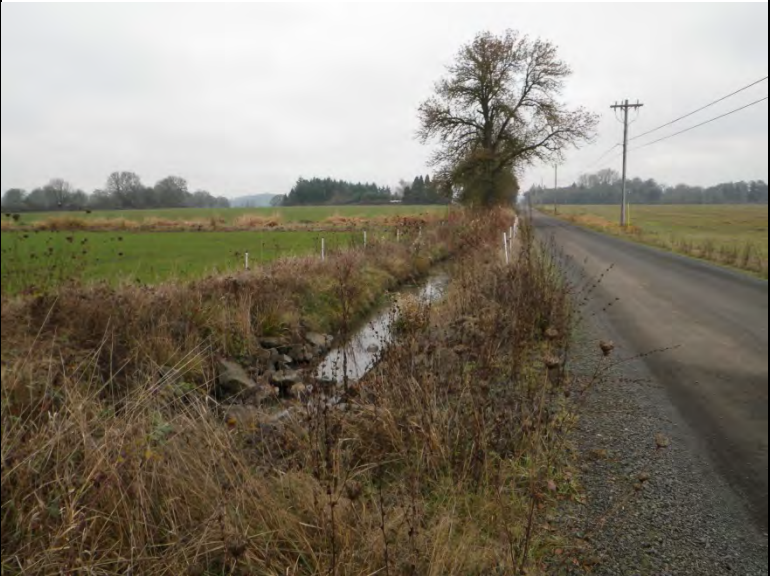
<b>Photo Date:</b> Dec. 7, 2011	
<b>Orientation:</b> North	
<b>Description:</b> Agricultural fields and a stormwater ditch viewed from NW 253 <sup>rd</sup> Avenue..

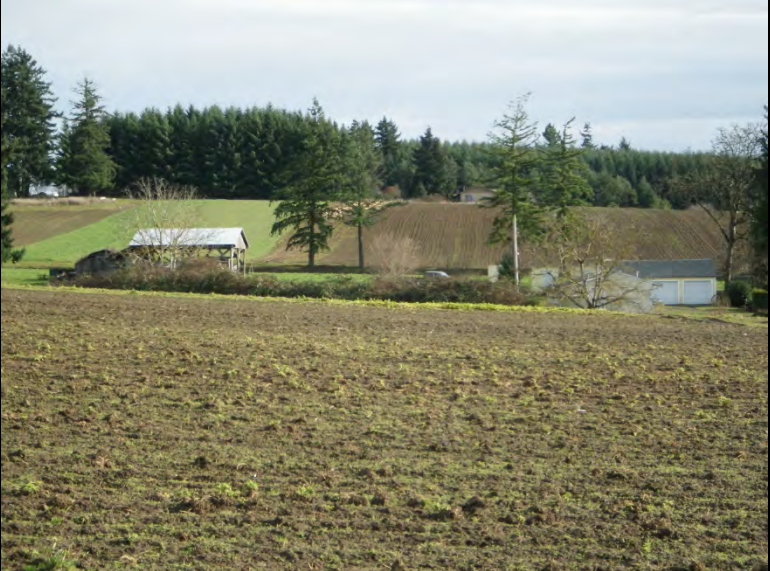
<b>Photo No:</b> 3	
<b>Photo Date:</b> Dec. 27, 2011

<b>Orientation:</b> East	
<b>Description:</b>  Agricultural area and accessory structures viewed from SE 162 <sup>nd</sup> Avenue.	
<b>Photo No:</b> 4

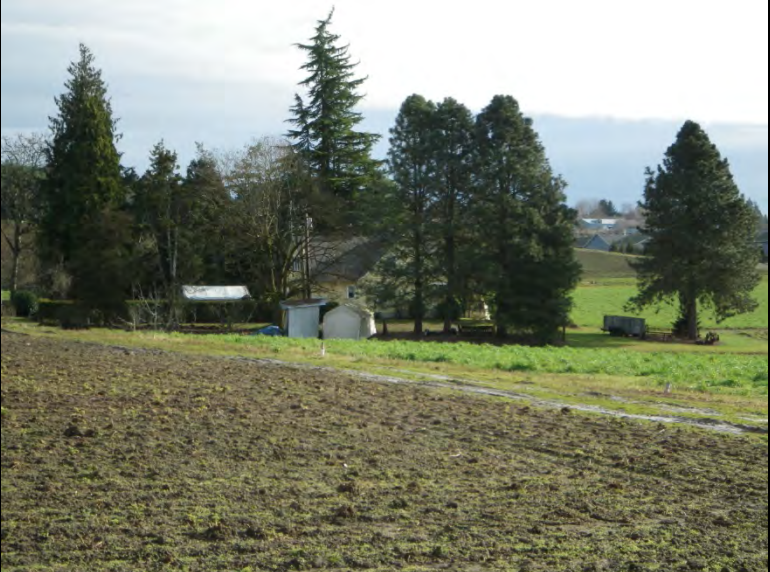
<b>Photo Date:</b> Dec. 27, 2011	
<b>Orientation:</b> East	
<b>Description:</b>  Agricultural area, dwelling, and accessory structures viewed from SE 162 <sup>nd</sup> Avenue.

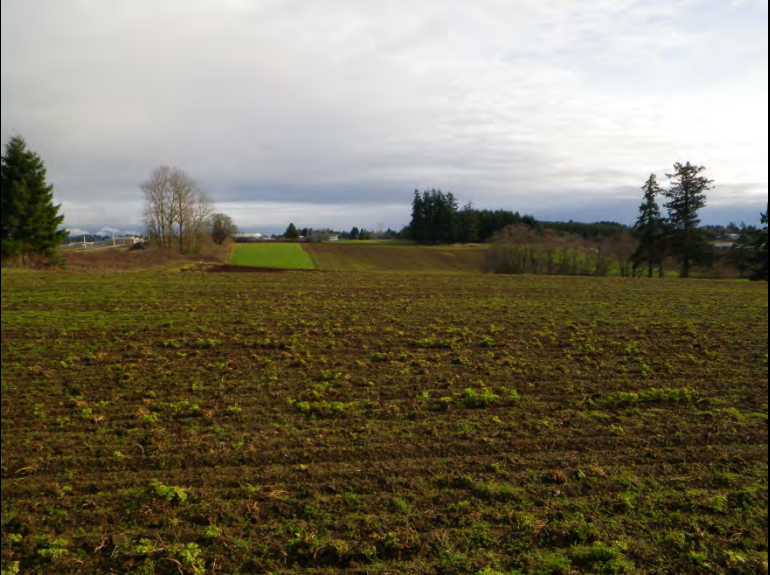
<b>Photo No:</b> 5

<b>Photo Date:</b> Dec. 27, 2011	
<b>Orientation:</b> East	
<b>Description:</b>  Agricultural area viewed from SE 162 <sup>nd</sup> Avenue.	
<b>Photo No:</b> 6

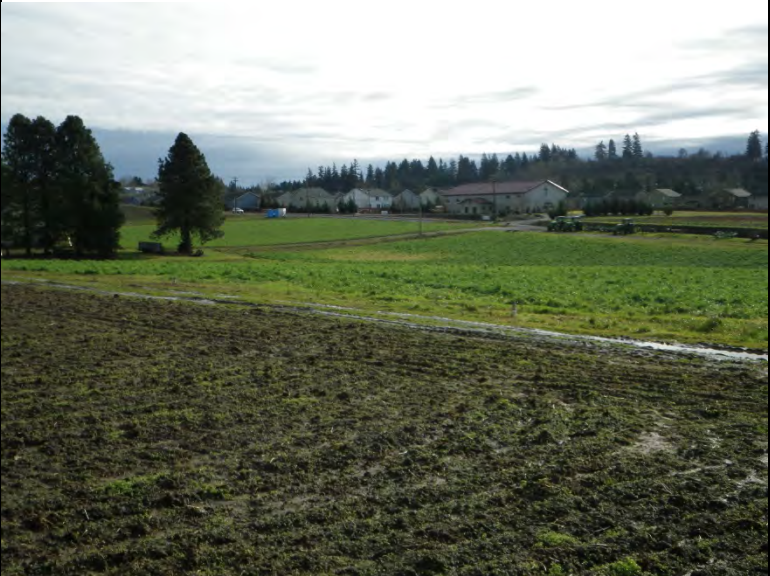
<b>Photo Date:</b> Dec. 27, 2011	
<b>Orientation:</b> Southeast	
<b>Description:</b>  Agricultural area viewed from SE 162 <sup>nd</sup> Avenue.

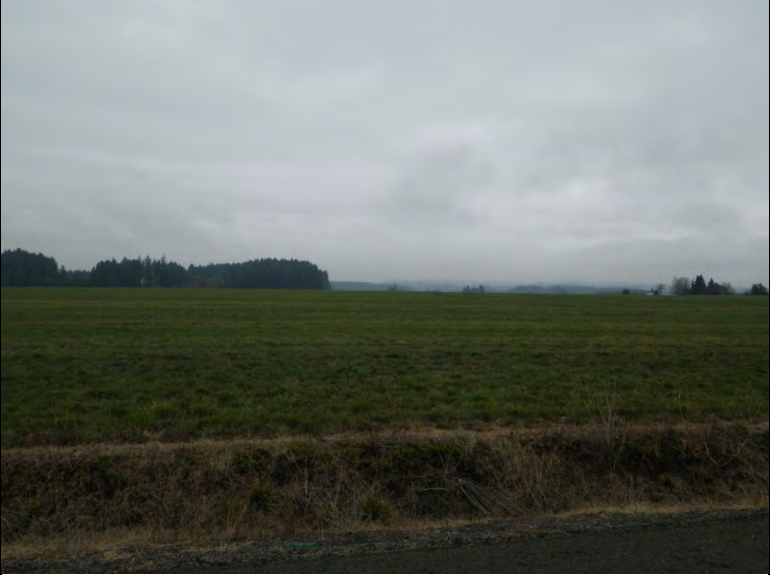
<b>Photo No:</b> 3	
<b>Photo Date:</b> Dec. 7, 2011

<b>Orientation:</b> Northwest	
<b>Description:</b>  Agricultural fields at the west side of the site, viewed from NW Meek Road.	
<b>Photo No:</b> 4	
<b>Photo Date:</b> Dec. 7, 2011

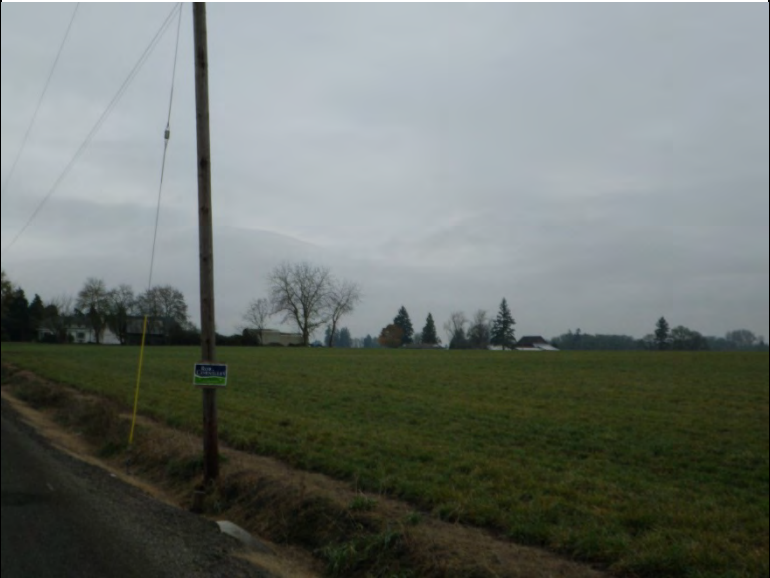
<b>Orientation:</b> East	
<b>Description:</b>  Agricultural fields, a dwelling, and accessory structures at the central portion of the site, viewed from NW Meek Road.

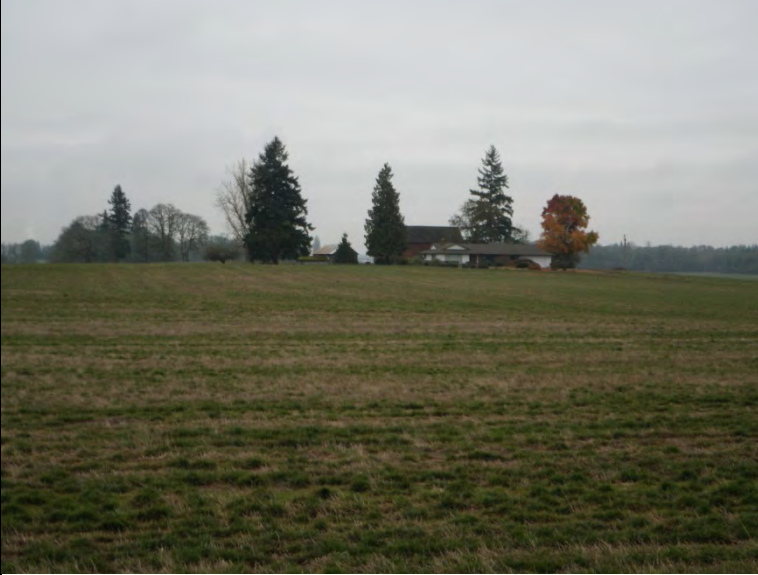
<b>Photo No:</b> 5	
<b>Photo Date:</b> Dec. 7, 2011

<b>Orientation:</b> South	
<b>Description:</b>  Agricultural fields, a dwelling, and accessory structures at the central portion of the site, viewed from NW Meek Road.	
<b>Photo No:</b> 6	
<b>Photo Date:</b> Dec. 7, 2011

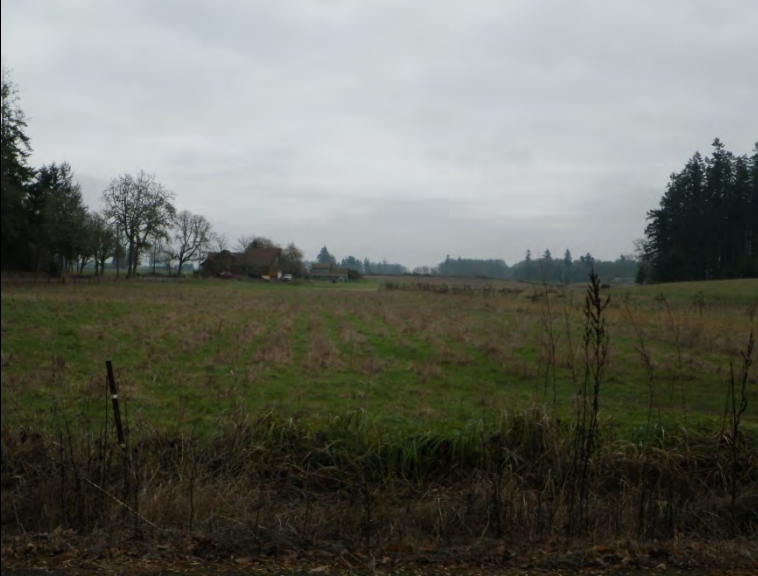
<b>Orientation:</b> East	
<b>Description:</b>  Agricultural fields, a dwelling, and accessory structures at the southwest portion of the site, viewed from NW Sewell Road.
