SITE CONSERVATION PLAN

Wapato View Natural Area

May 2015

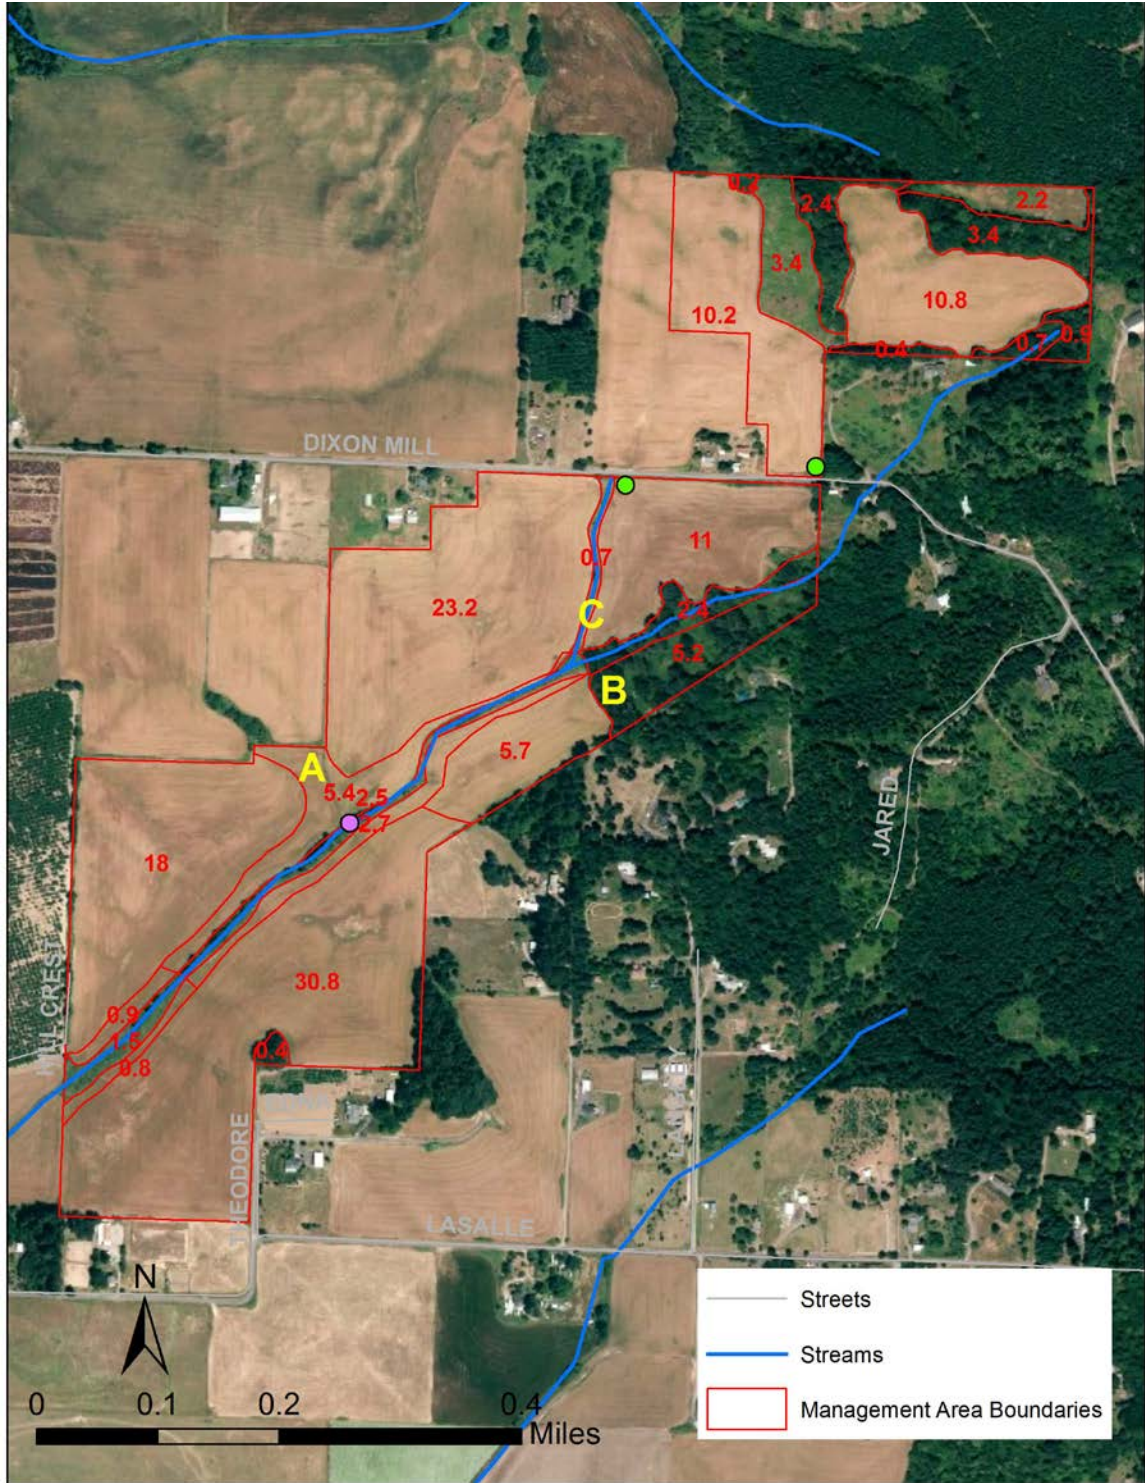
MAP 2

Wapato View Natural Area management units showing acreages, local roads, streams and key property features (magenta marker shows location of farm access road crossing the stream; green markers show location of road access locations to the north and south properties; yellow letters show location of swales A, B and C)

In addition to the main stream, there are three swales, draining to the main creek (Map 2, locations A, B and C). These include two swales that lack developed channels (A and B) as well as one (C) with an incised channel that conveys runoff from a ditch along Dixon Mill Road to the main creek below. Swale A drains an isolated remnant forest patch on a neighboring property and swale B conveys drainage from forested uplands on private properties to the east.

The stream bankfull channel width is 5-7 ft. A farm access road crosses the main creek near the confluence with swale A (shown as a magenta marker on Map 2), through a culvert that represents at least a partial barrier to the upstream movement of aquatic fauna. The upstream half of culvert is a 2.5 ft-diameter corrugated steel pipe and the downstream half is a 2.2 ft-diameter pre-cast concrete pipe. During baseflow conditions in September and October 2014, flow was observed passing down the steel pipe, through an internal break between the pipes, and then under (not through) the downstream precast concrete pipe. At higher flows, there may be continuous flow through both culverts but the estimated slope of the two pipes together is approximately two percent, which likely creates a velocity barrier for aquatic fauna at higher flows.

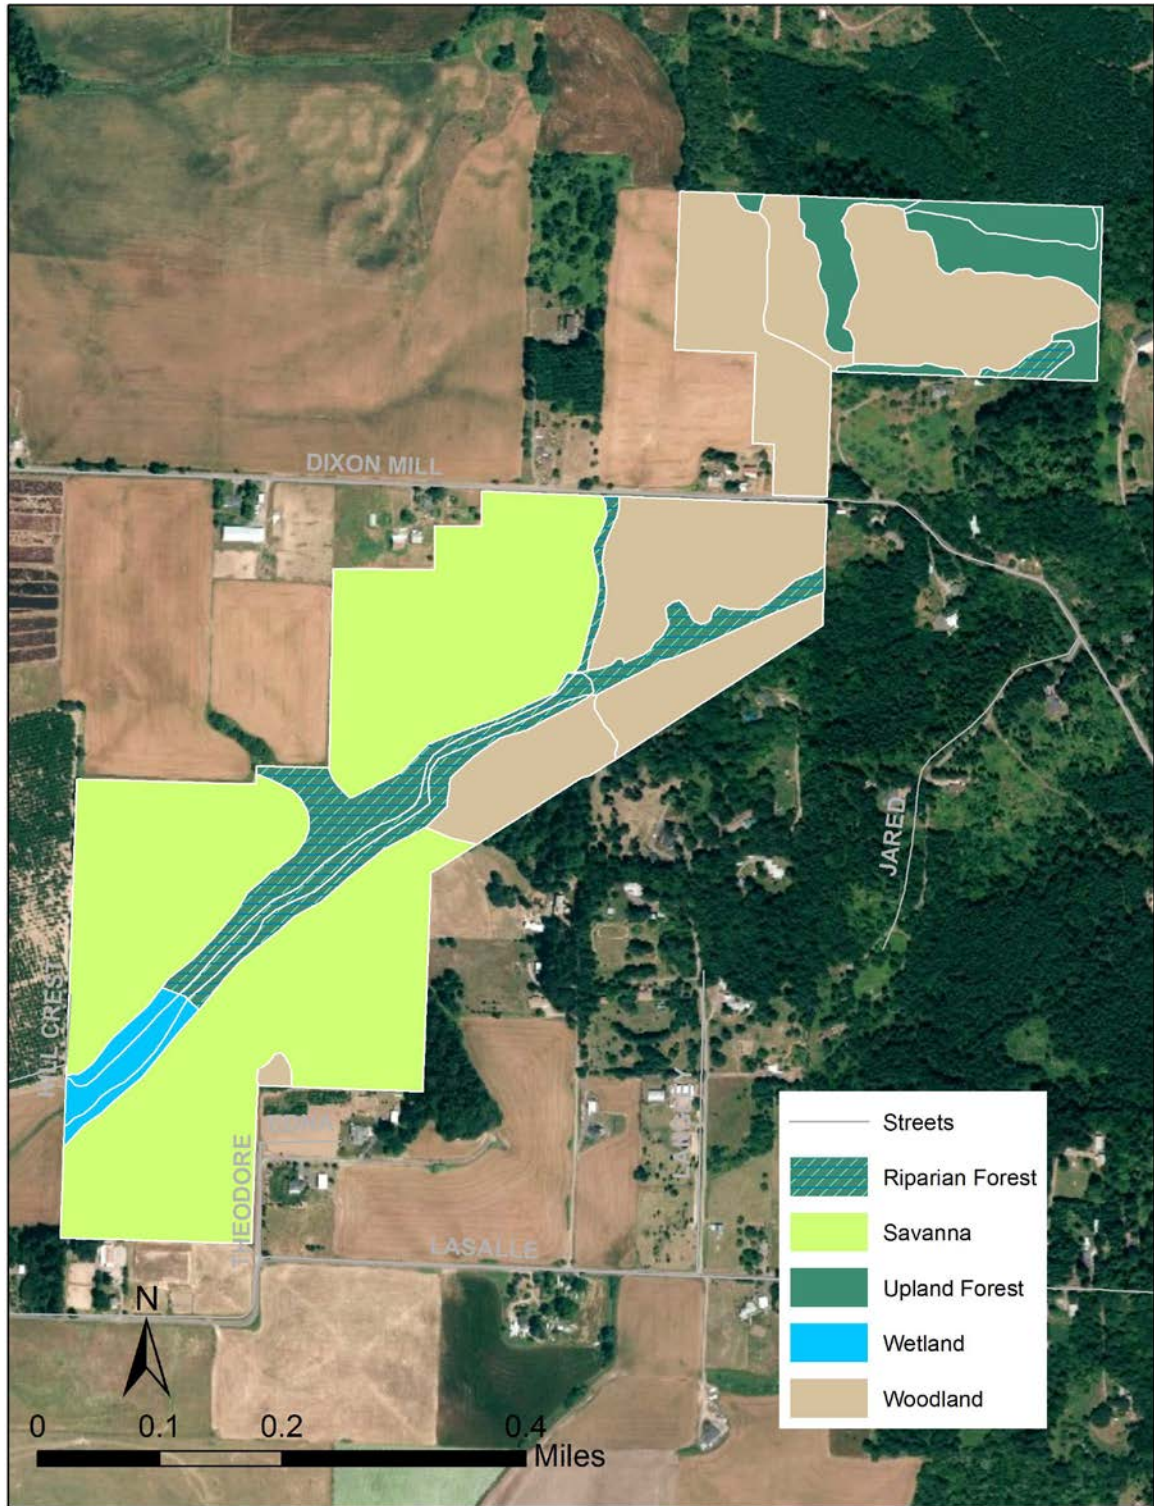
MAP 7
Wapato View Natural Area stewardship classes

Maps 7 and 8 show the distribution of natural area stewardship classes and present-day management status at Wapato View, respectively. Stewardship class is a high-level, generalized land cover classification of all Metro properties, reflecting desired future conditions. Stewardship classes are not as specific as conservation target classes, and they include both natural and non-natural land covers.

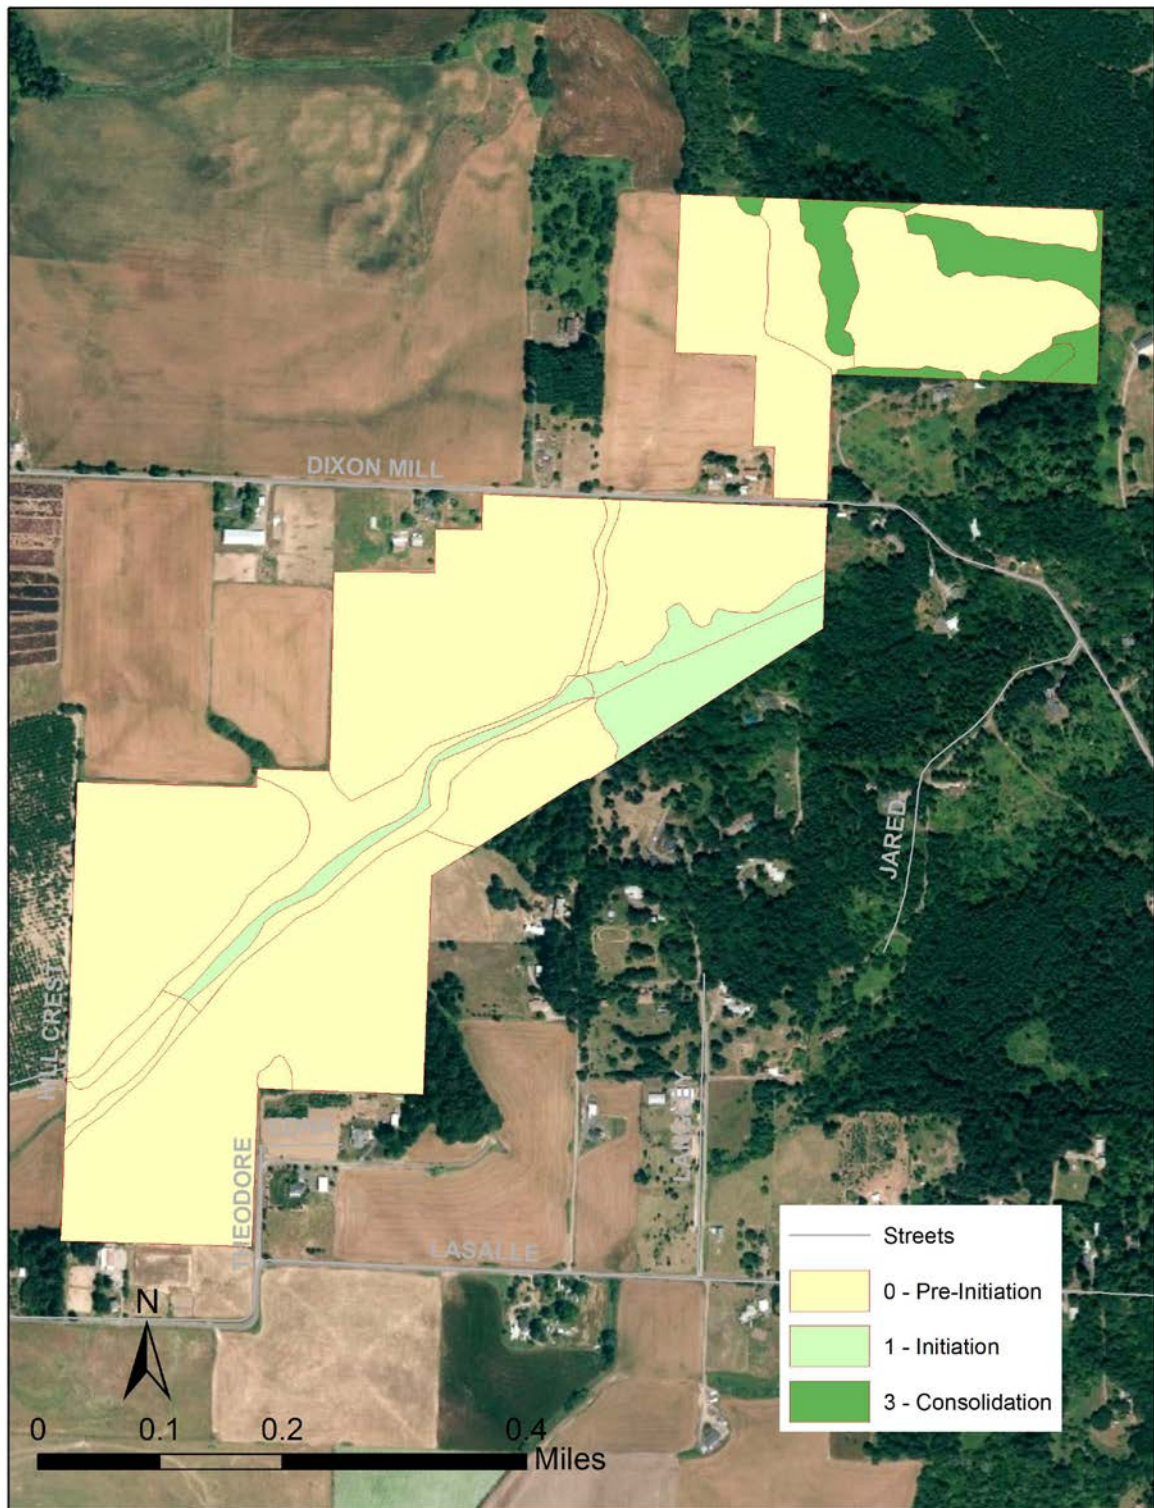
MAP 8
Wapato View Natural Area management status

Management status describes how far a given portion of a site is from desired future condition, with a score of “0” for those that are the farthest away, and “4” for areas currently at desired future condition. Areas lacking a conservation target are scored as “9” (unclassified). Table 8 defines Metro’s management status categories.

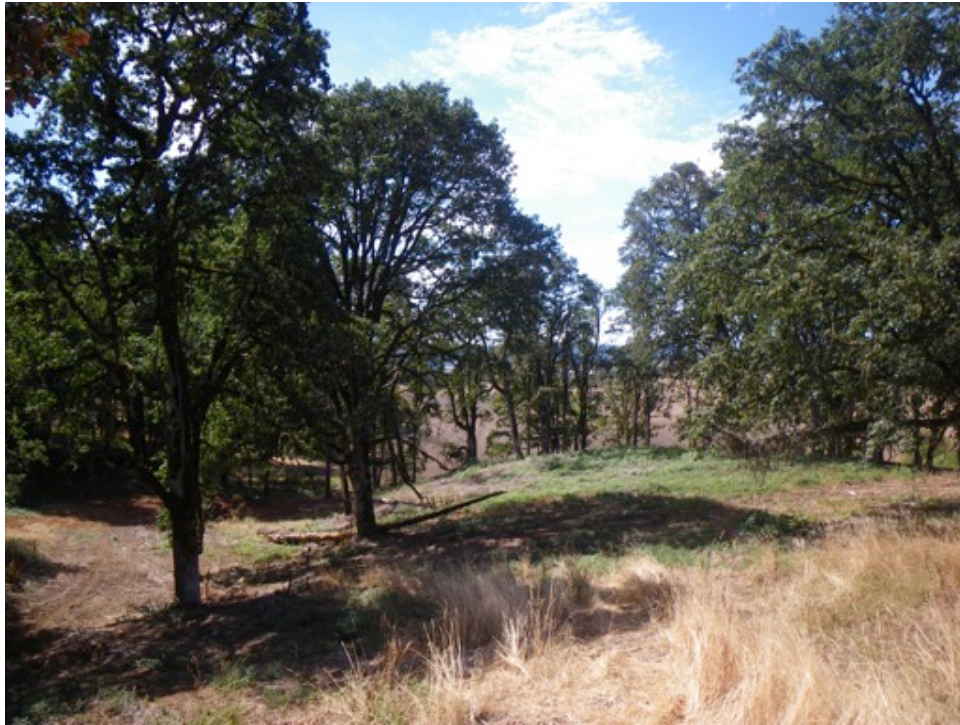
Two remnant Oregon white oak woodland stands are found on the south parcel, measuring 0.4 and 5.2 acres in size. Other tree species present within these oak-dominated stands include Douglas-fir and bigleaf maple, with an understory of invasive blackberry, snowberry, sword fern and poison-oak. Upland forests are dominated by Douglas-fir, bigleaf maple and non-native cherry, with sword fern, snowberry and beaked hazelnut in the understory.

Looking into the 5.2-acre remnant oak stand

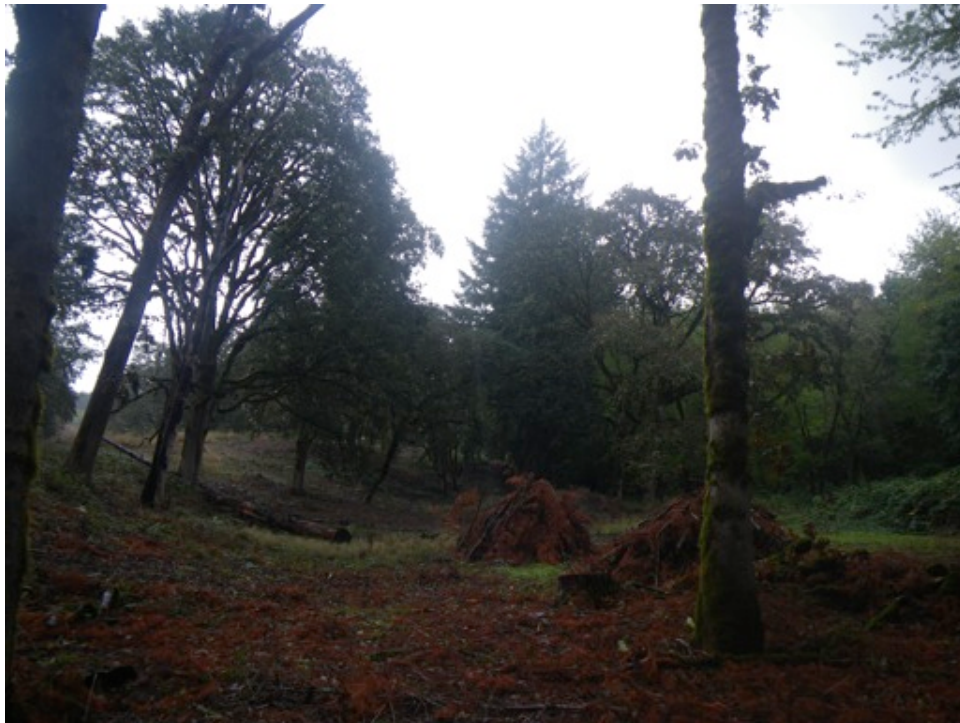
Brush piles from recent understory treatment in 5.2-acre remnant oak stand

Wapato View Natural Area was acquired by Metro in 2012. Site management to date has focused on the Oregon white oak stand on the south property, where approximately 20 mature Douglas-fir were topped or felled, and understory blackberry was cut and treated with herbicide. In addition, old vehicles and garbage were removed from the north property as a condition of the land sale to Metro. No other restoration activities have been completed to date.

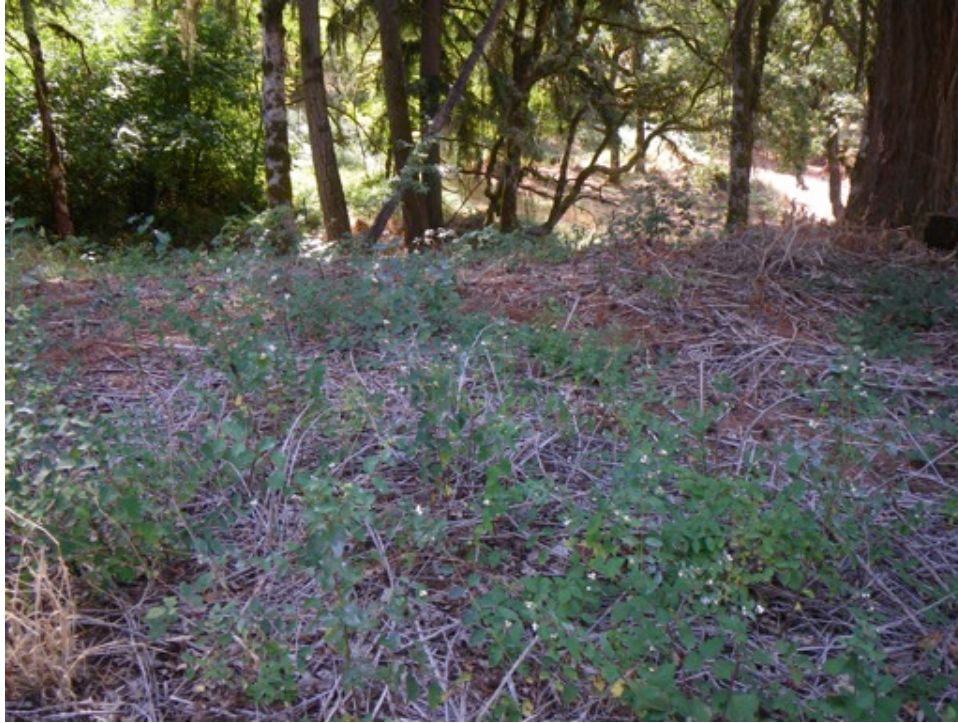
Snowberry regenerating in the understory of the 5.2-acre remnant oak stand where understory treatments of invasive blackberry were recently completed

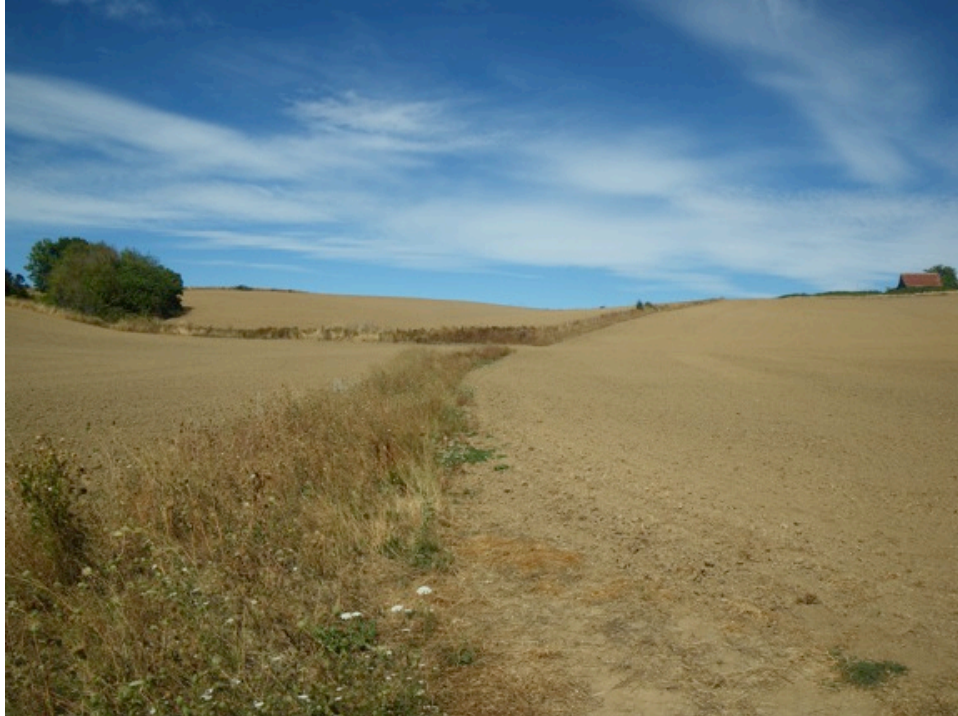
Looking up swale A from the main creek

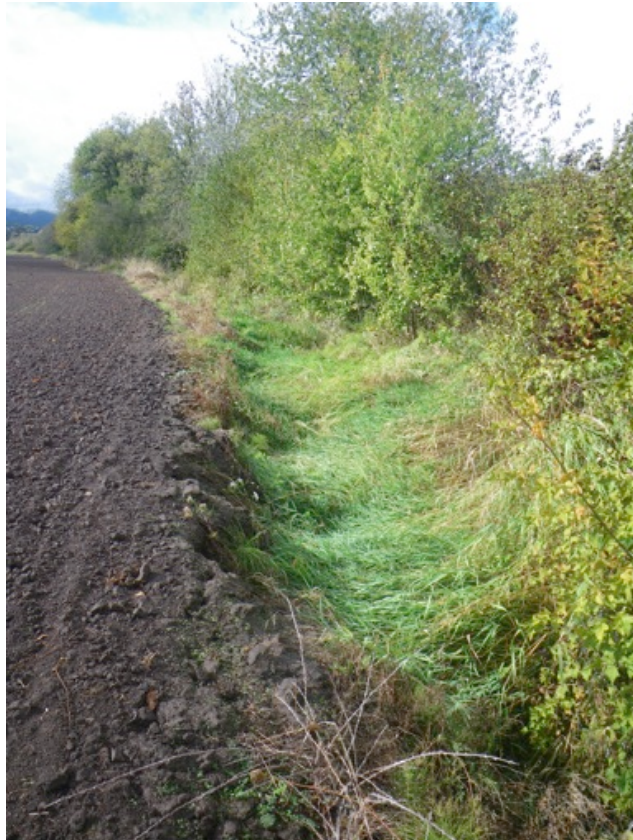
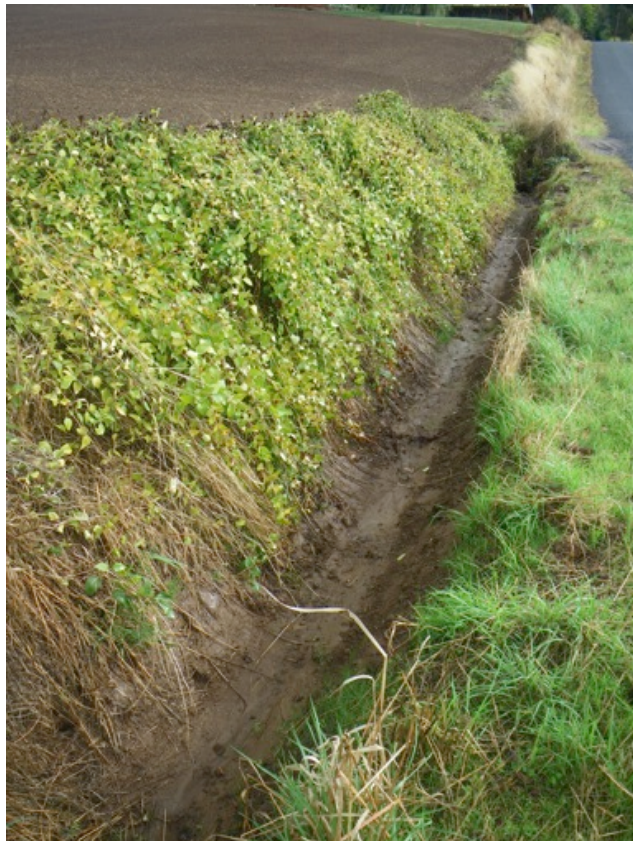
Eroding stream banks along tilled field on main creek

The lower 1,000 feet of stream has a channel gradient of 1-1.5 percent and is incised approximately five feet below the top of bank. The channel was apparently ditched and straightened, with dredge spoils deposited in a series of hummocks on the south bank. The stream banks here have sparse tree and shrub cover and reed canarygrass dominates. Historically, this portion of the stream may have functioned more as a wetland.

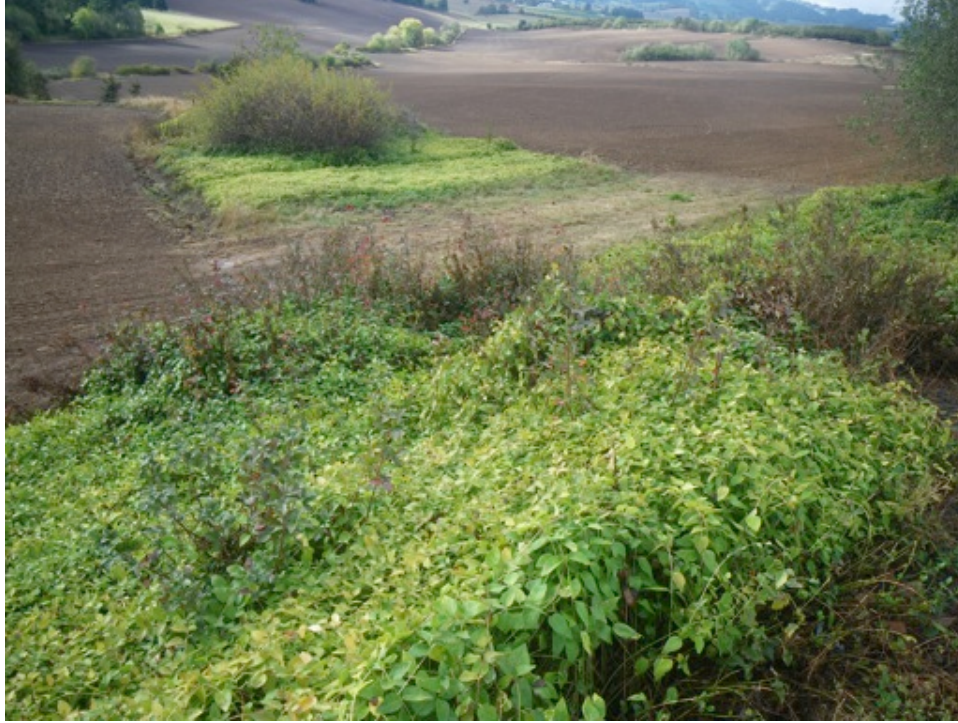
Another view of swale C, looking towards the main stream at distance and showing *V. major* infestation at top of swale (close to Dixon Mill Rd.)

A number of invasive plants are present at Wapato View. Himalayan blackberry is widespread in streamside, upland forest and oak woodland habitats. The stream-riparian corridor harbors reed canarygrass, non-native hawthorn, holly, sweet cherry and English ivy. English ivy, holly and sweet cherry are also present in upland forests. The latter is particularly abundant in the upland forest stands bordering the uppermost farm field, which was formerly a commercial cherry orchard. Large patches of *Vinca major* are found along Dixon Mill Road, and downslope along the course of swale C.

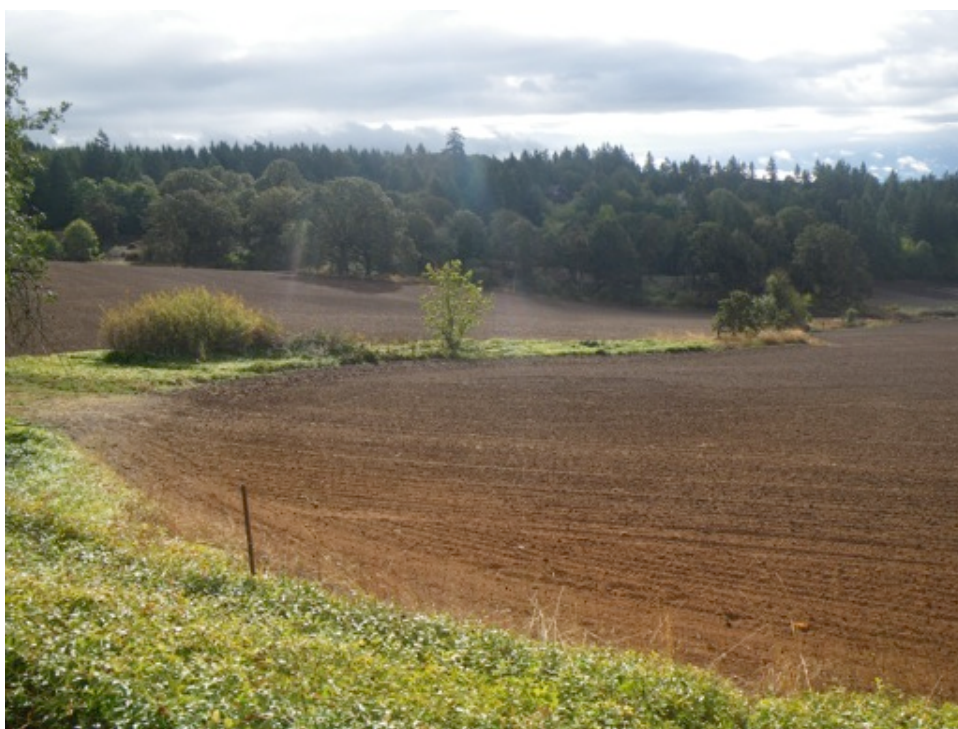
Looking down swale C from Dixon Mill Rd. with large *V. major* infestation in foreground

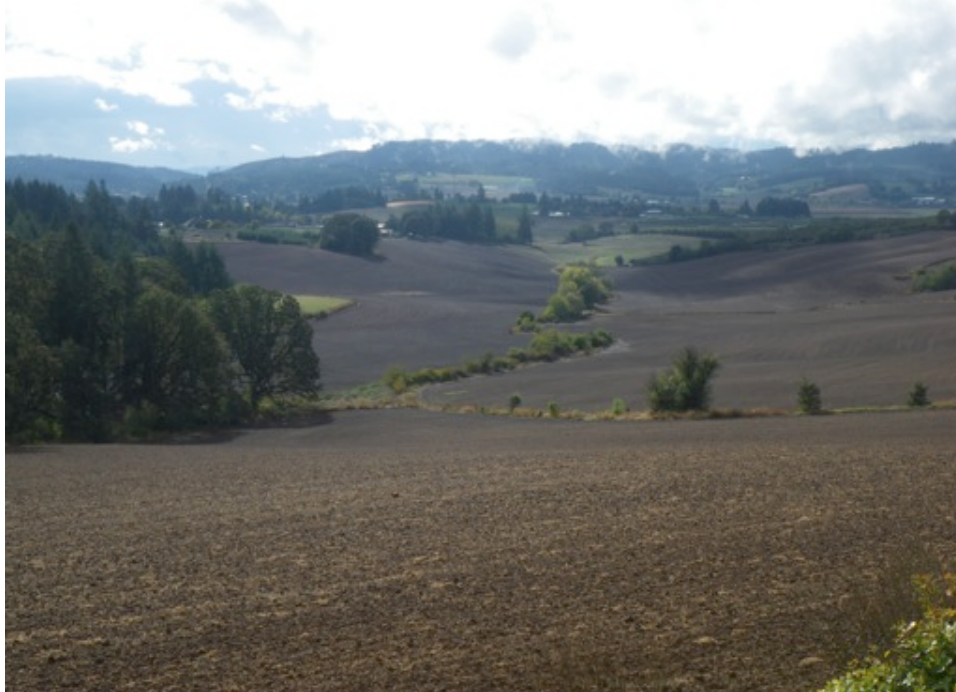
Looking down main creek course from Dixon Mill Rd. with 5.2-acre remnant oak stand on left

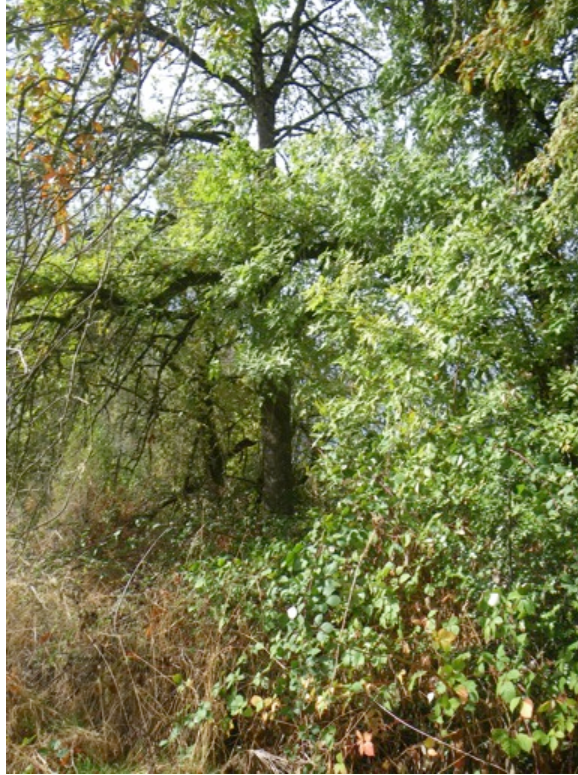
English ivy on bigleaf maple tree with invasive blackberry in foreground in upland forest on north property

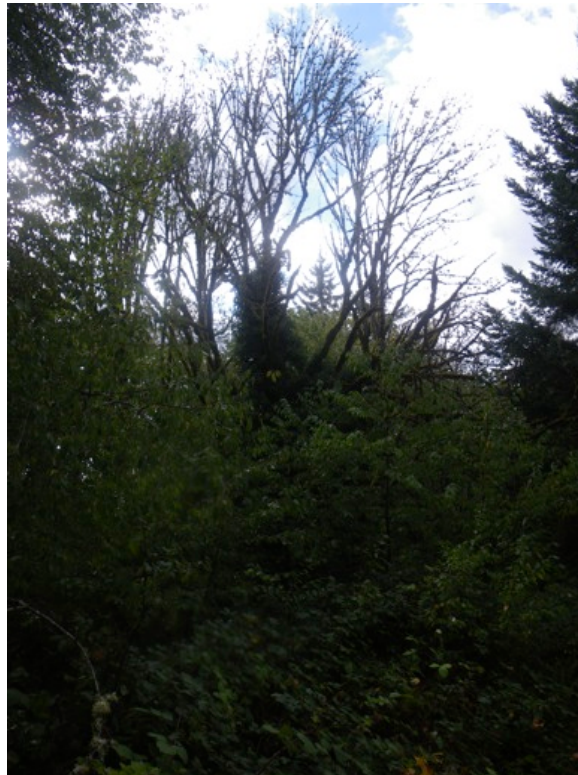
Invasive blackberry and holly in the ash-dominated riparian zone of main creek

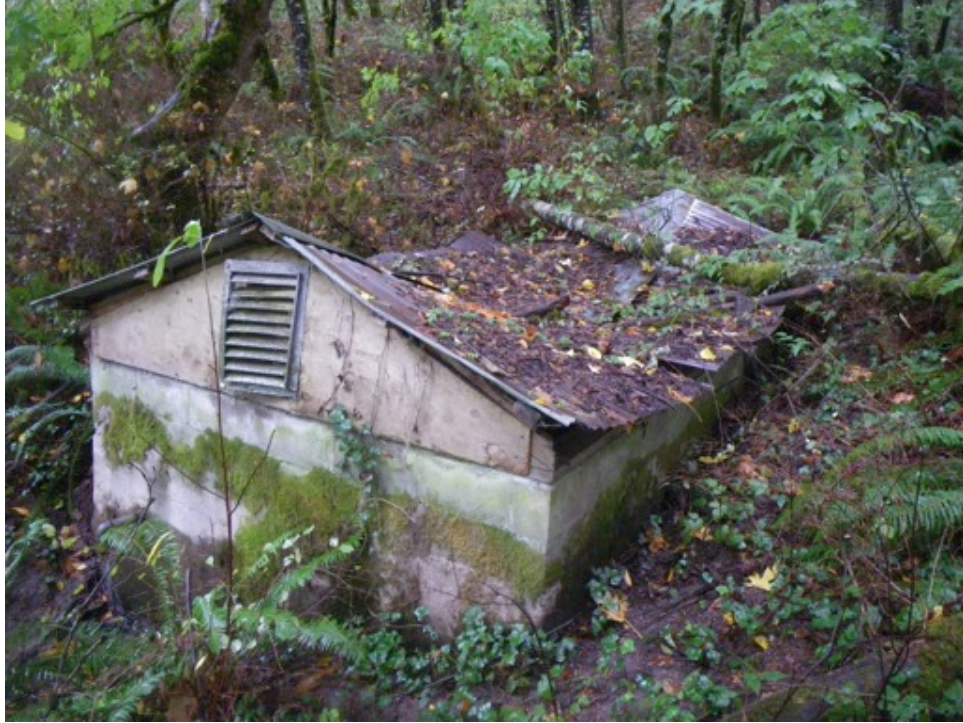
Collapsed springhouse at the top of main stream on north property

The stream-riparian corridor downstream of the confluence with swale B is dominated by Oregon ash (including 2-3 ft.-diameter trees) and Pacific willow, with a mixed shrub community of Pacific ninebark, domestic apple, non-native cherry, native and non-native hawthorn and blackberry. At the channel head of the perennial stream, on the north property is a spring, with a collapsed springhouse.

- Remove culvert under farm access road crossing and replace with adequately sized culvert.
- Remove collapsed springhouse at creek headwaters on north parcel.
