**First Monitoring Report
for the North Portland Road
Restoration and Mitigation Site
in Portland, Oregon**

LU 03-100430 EN EF

**Prepared for
Metro
Regional Environmental Management
Portland, Oregon**

**Prepared by
Pacific Habitat Services, Inc.
Wilsonville, Oregon
(503) 570-0800**

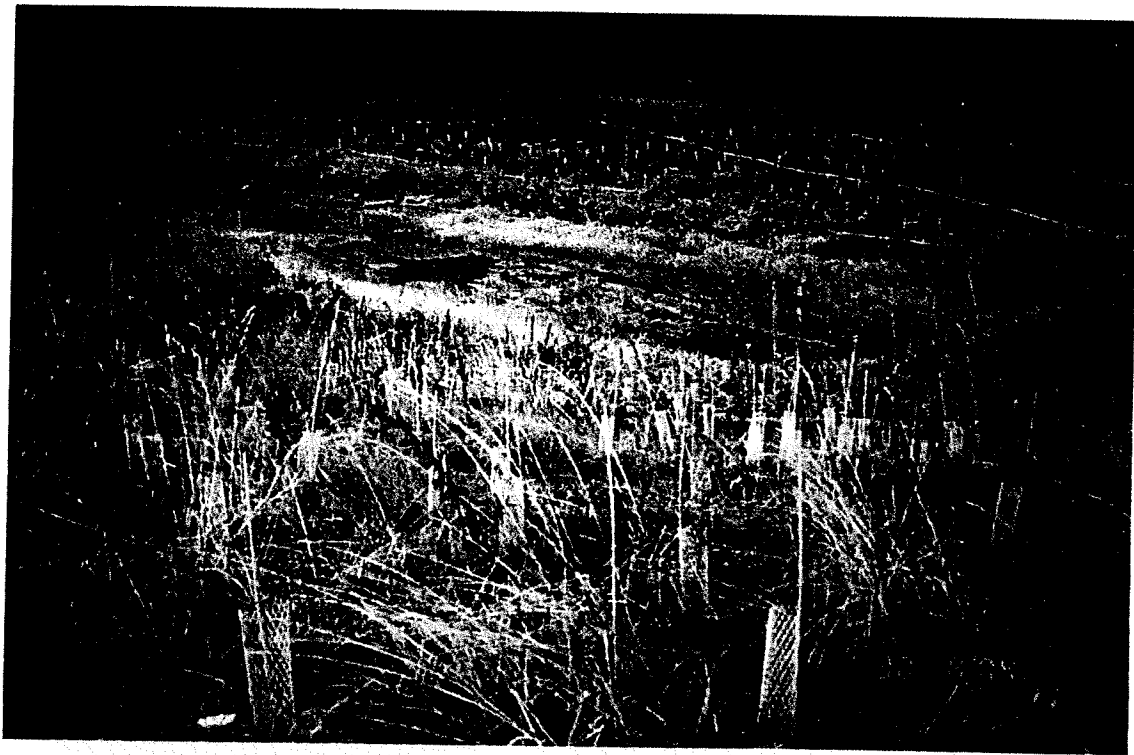
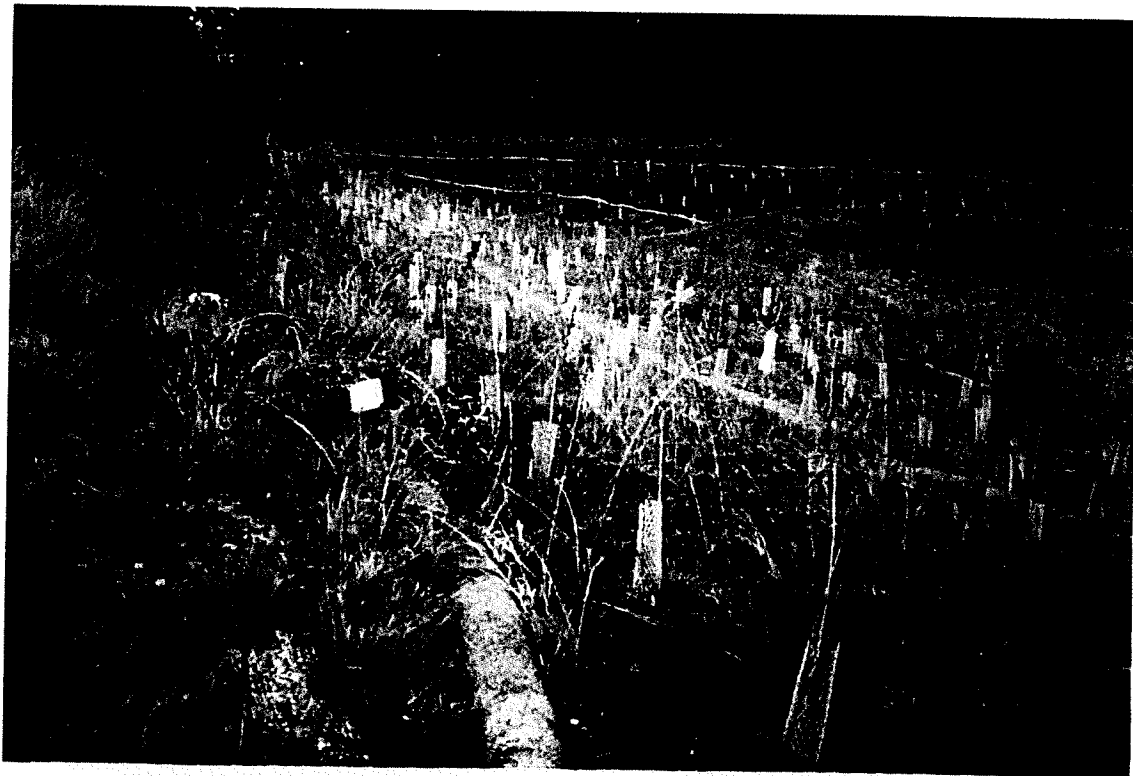
FIGURE
3

Photodocumentation of the Smith Lake restoration and mitigation site on N. Portland Rd. in Portland, Oregon. Top photo looks north from Photodocumentation Point 1. Bottom photo looks northwest from Photodocumentation Point 2. Both photos taken on 8/30/04.

Photodocumentation of site conditions is intended to provide a visual record of vegetation changes over time. The photos that accompany this report (Figures 3 through 5) show site conditions one week before the monitoring visit. Photos in subsequent years will continue to show plant community development.

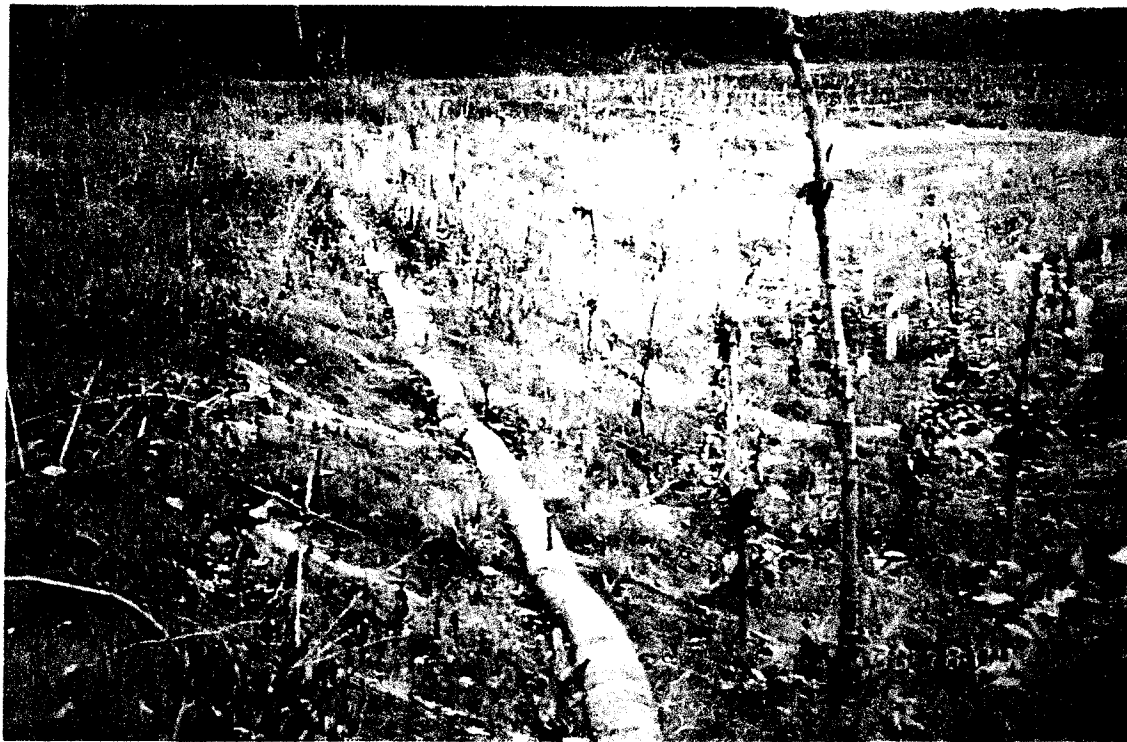
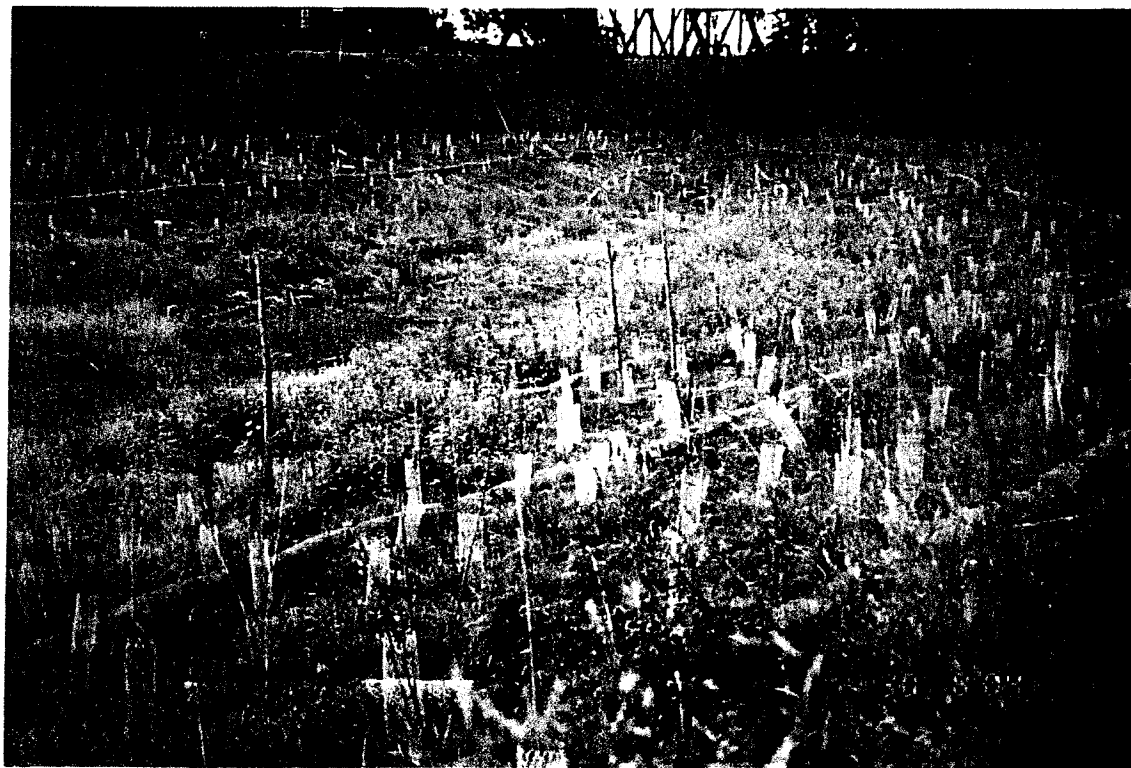
FIGURE
4

Photodocumentation of the Smith Lake restoration and mitigation site on N. Portland Rd. in Portland, Oregon. Top photo looks east from Photodocumentation Point 3. Bottom photo looks southeast from Photodocumentation Point 4. Both photos taken on 8/30/04.

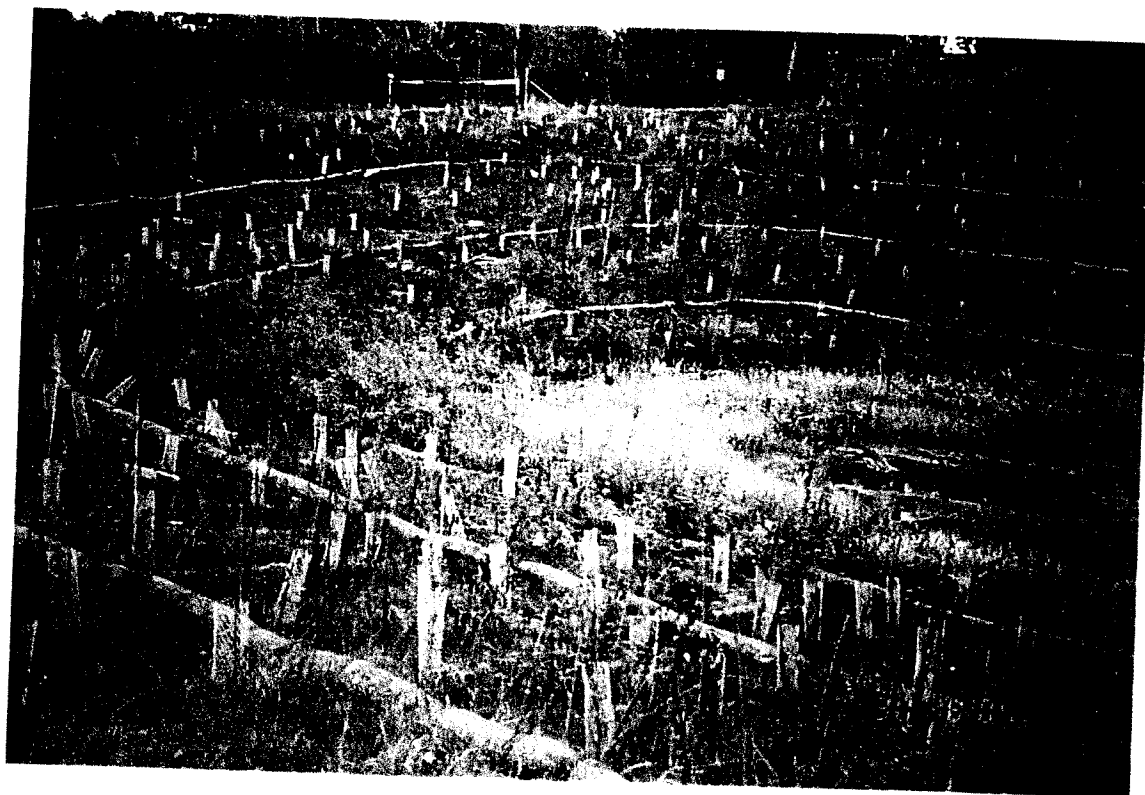
FIGURE
5

Photodocumentation of the Smith Lake restoration and mitigation site on N. Portland Rd. in Portland, Oregon. Photo looks south from Photodocumentation Point 5. Photo taken on 8/30/04.
