# **Second Monitoring Report for the North Portland Road Mitigation Site in Portland, Oregon**

City of Portland: LU 03-100430 EN EF

**Prepared by**  
**Pacific Habitat Services, Inc.**  
**Wilsonville, Oregon**  
**(503) 570-0800**

February 28, 2006

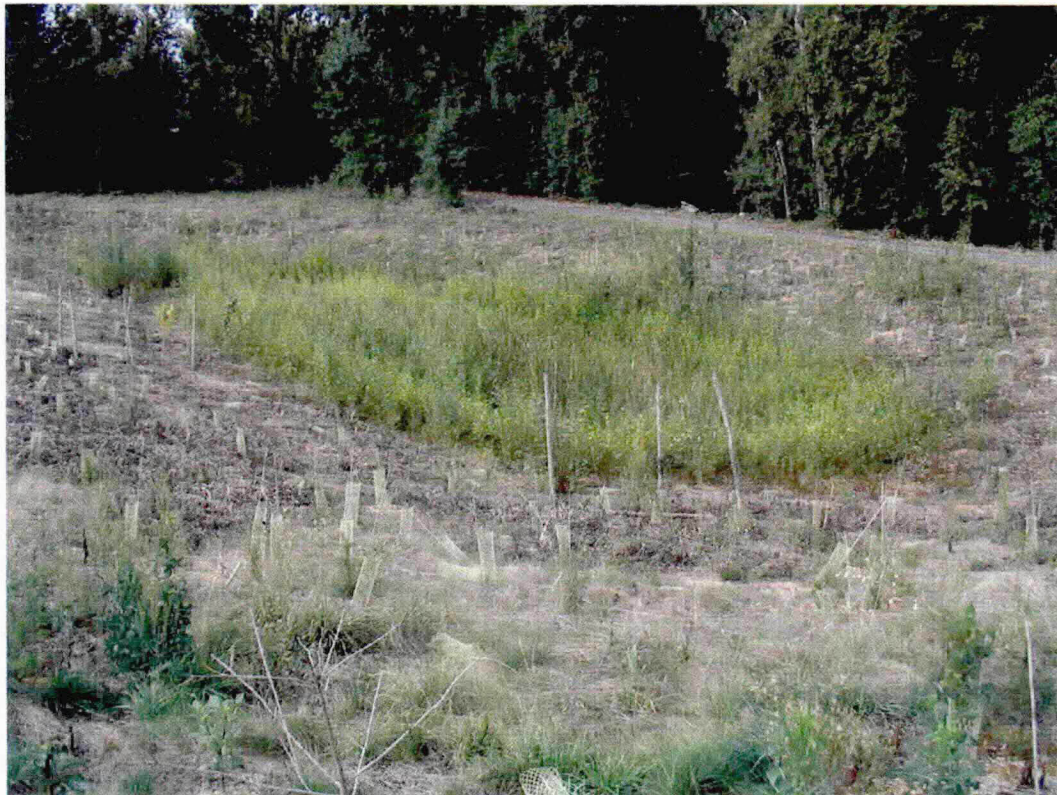
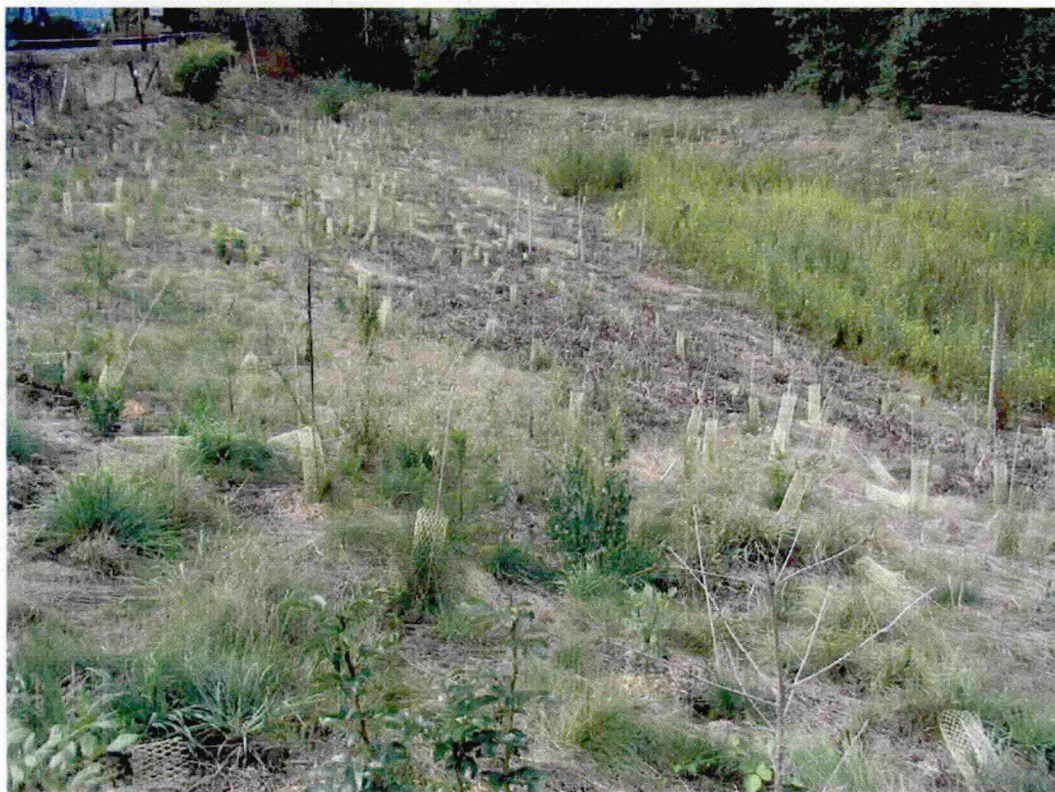
FIGURE  
4

Photodocumentation of the Smith Lake restoration and mitigation site on N. Portland Rd. in Portland, Oregon. Top photo looks west from Photodocumentation Point 1. Bottom photo looks southwest from Photodocumentation Point 2. Both photos taken on 10/05/05.

Photodocumentation of site conditions is intended to provide a visual record of vegetation changes over time. The photos that accompany this report (Figures 4 through 6) show site conditions on the October 5, 2005, site visit. Photodocumentation points on the past year's report were placed incorrectly on Figure 2. Therefore, this year's location of photodocumentation points will be different than last year's, but the photos will represent the same approximate location of last year's photos. Photos in subsequent years will continue to show plant community development from the correct photo location and photodocumentation point.

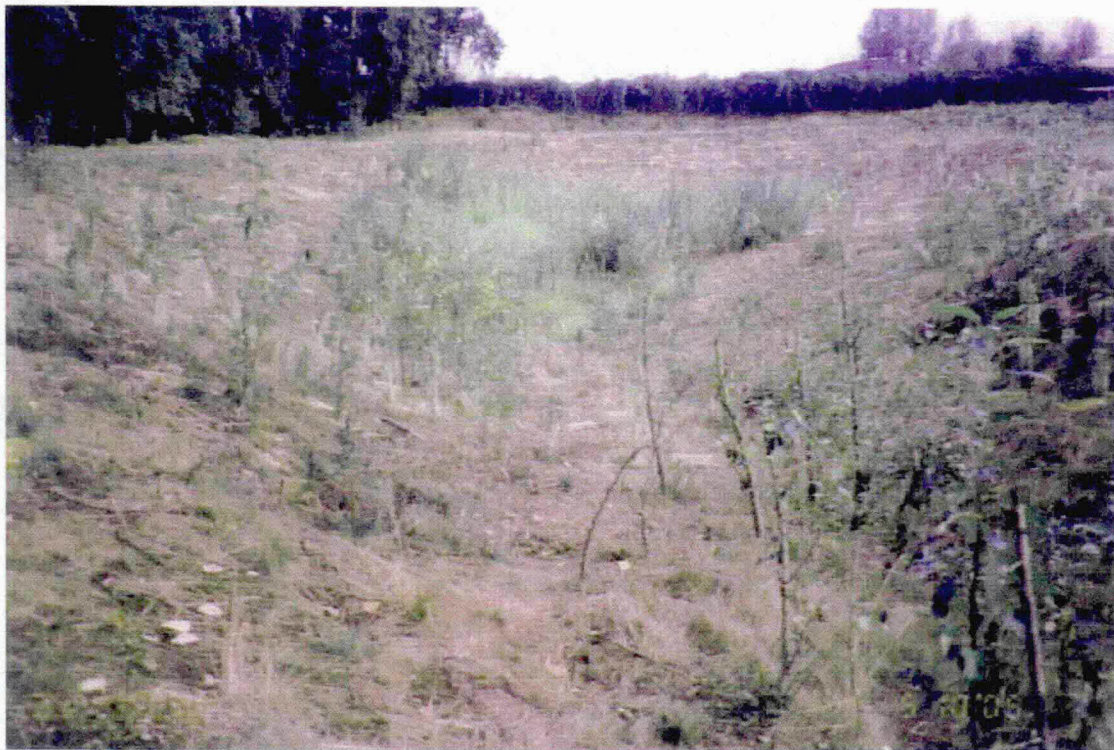
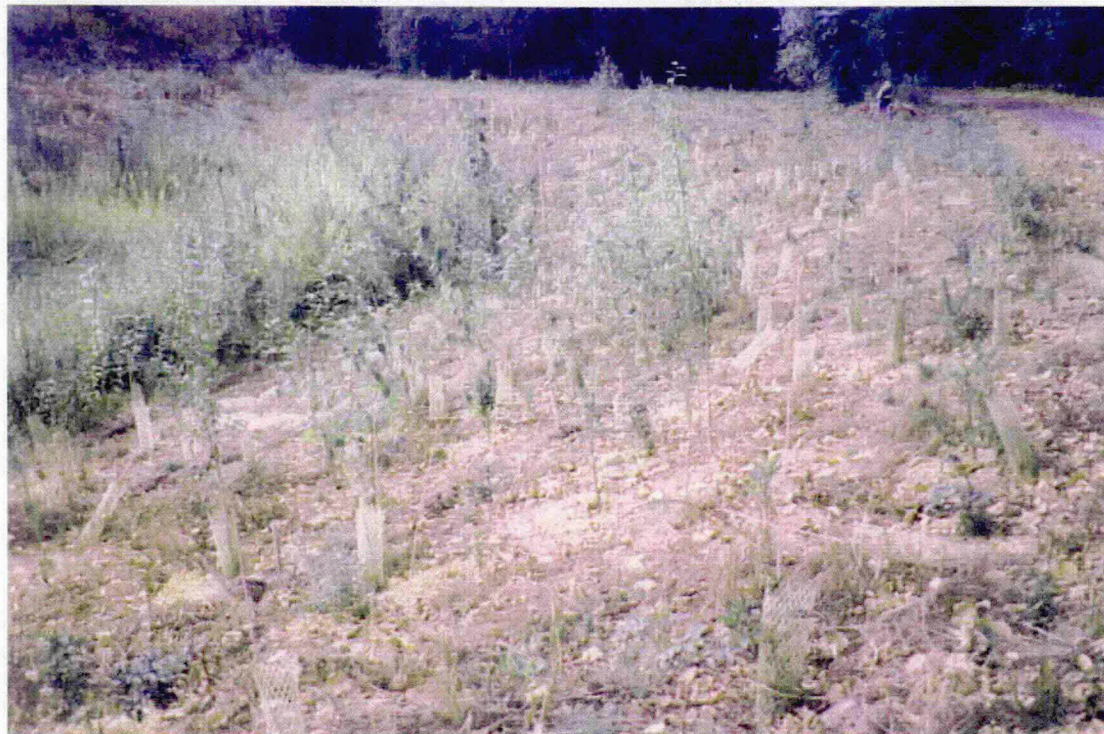
FIGURE  
5

Photodocumentation of the Smith Lake restoration and mitigation site on N. Portland Rd. in Portland, Oregon. Top photo looks east from Photodocumentation Point 3. Bottom photo looks southwest from Photodocumentation Point 4. Both photos taken on 10/05/05.

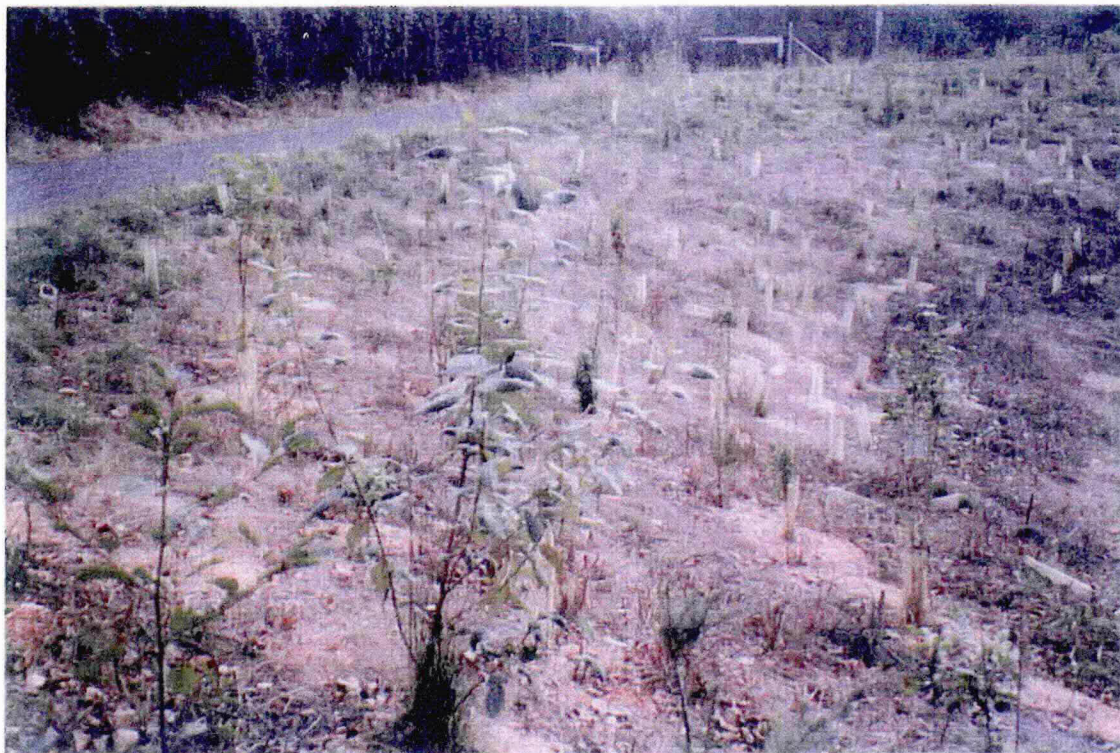
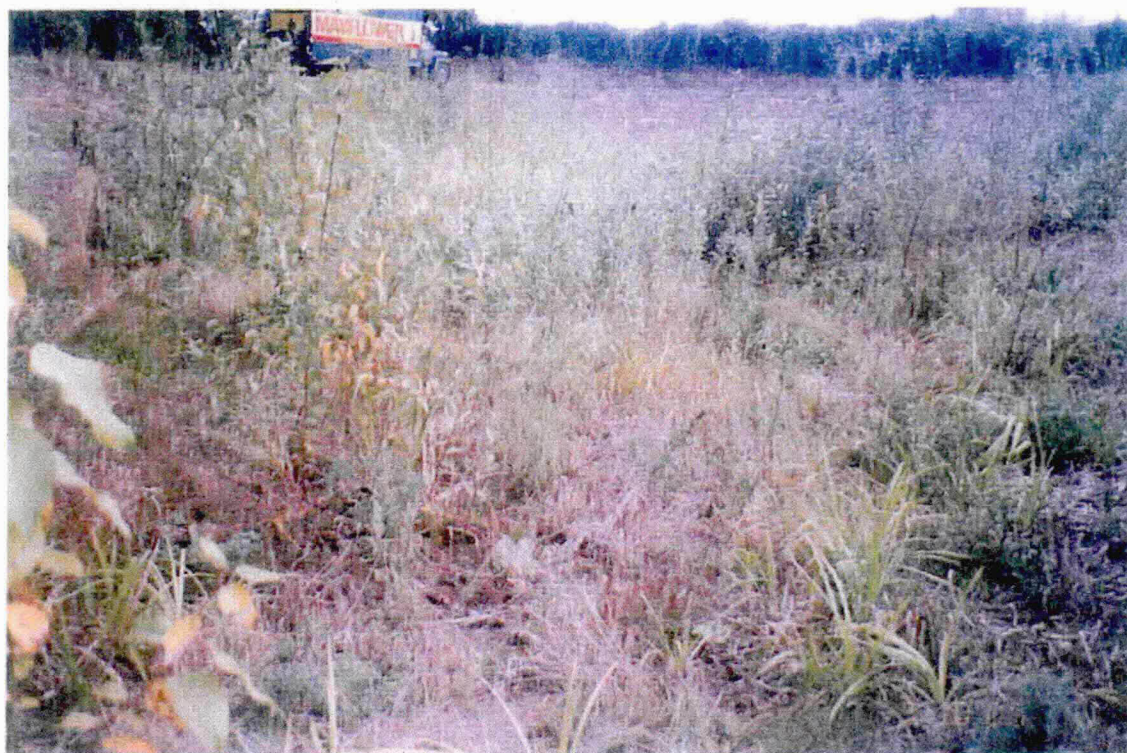
FIGURE  
6

Among tree species, red alder and hawthorn have fared poorly, which is likely due to drought stress in the excessively drained sandy soils. By contrast, the wetter soils lower in the basin have been especially conducive to cottonwood and willow seedling establishment, with thousands of seedlings now over 12 inches in height. The overall tree counts thus, exceed the 100% overall survival rate required by the City, even without inclusion of the majority of the seedling recruits.

Photodocumentation of the Smith Lake restoration and mitigation site. Upper photo looks southeast from Photodocumentation Point 5. The lower photo shows established willows and cottonwood recruits from Photodocumentation Point 6. Photos taken on 10/05/05.
