**Third Monitoring Report
for the North Portland Road
Mitigation Site in Portland, Oregon**

City of Portland: LU 03-100430 EN EF

Prepared for
Metro Regional Environmental Management
Portland, Oregon

Prepared by
Pacific Habitat Services, Inc.
Wilsonville, Oregon
(503) 570-0800

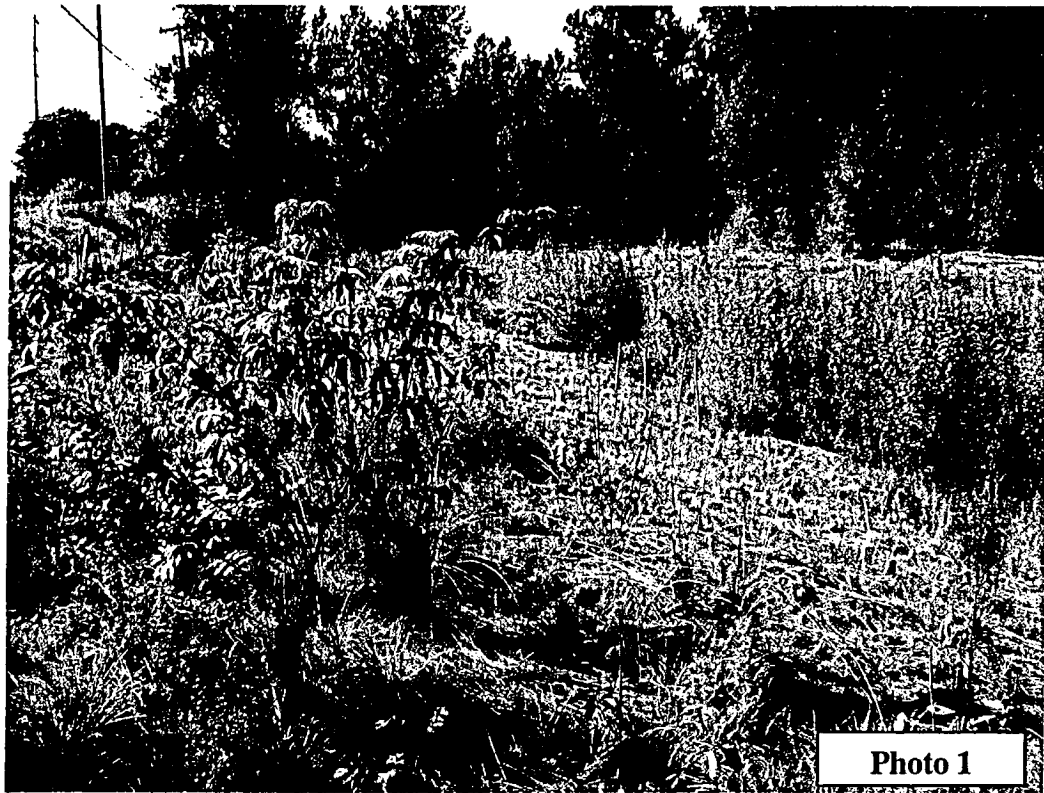
Photo documentation of the Smith Lake Restoration and Mitigation Area North Portland Road, Portland, Oregon. Photo 1 shows the south side of the mitigation area, looking west. Photo 2 shows the south side of the mitigation area, closer to tax lot 600. Photos taken on 9/27/06.

Photodocumentation of site conditions is intended to provide a visual record of vegetation changes over time. The photos that accompany this report (Photos 1-6, Figures 4-6) show site conditions on the September 27, 2006 site visit. The north side of the site has plant species that are taller and more vigorous than the southeast side of the property (Photos 1, 2, 4 and 5).

This may be attributable to the steepness of the southeast side of the site, resulting in less water penetrating the soil. However, the lower portion of the excavated area is doing very well with large cottonwood and willow recruits (Photos 3 and 6).
