# TUALATIN HILLS PARK & RECREATION DISTRICT

SUBJECT: **Final Report**  
on  
Beaverton Creek (Tech Ctr) Wetlands Park Restoration  
Metro Contract Number: 904239

# 1999 Monitoring Report

## Beaverton Creek Wetlands Park (Beaverton Creek Tech Center Park)

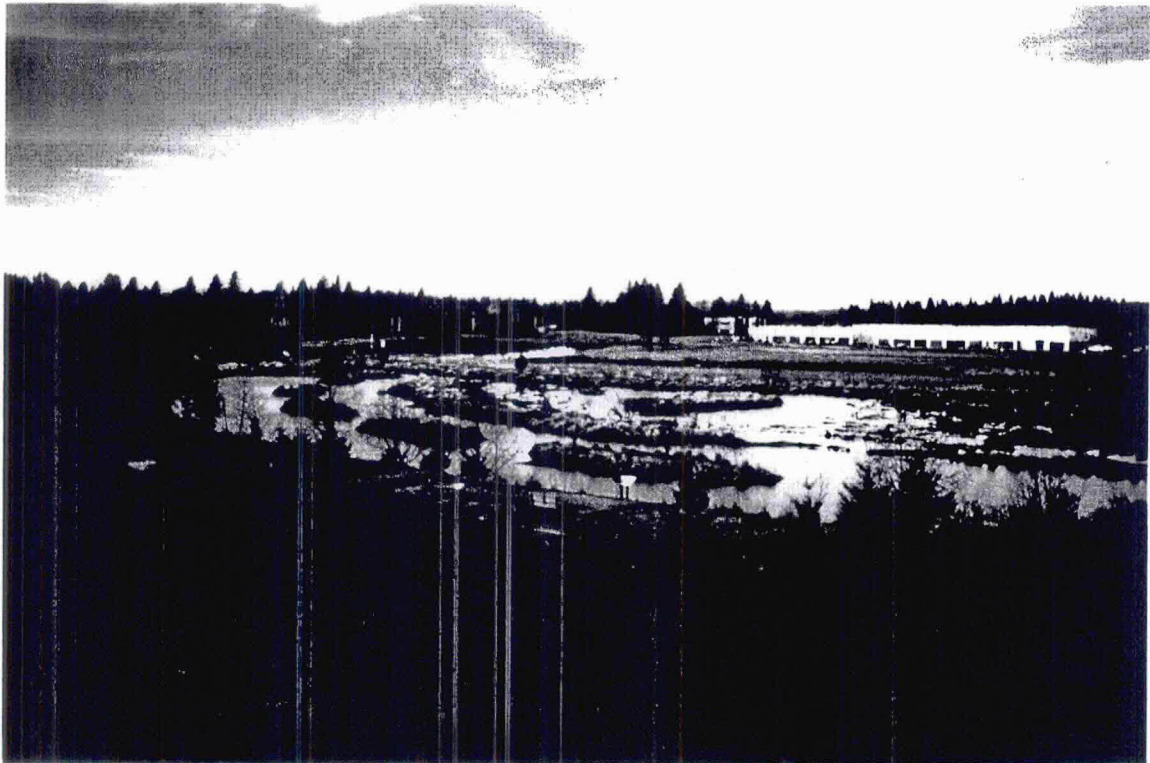
This photo, taken December 18th 1996 shows Beaverton Creek Wetlands Park from the same angle as the previous photo.

Alder trees edge the water. An interpretive sign has been installed. Snags have been "planted" and basking logs "moored" on the islands.

This shot reveals the snags on Island No. 5. They are seen immediately behind the interpretive sign.

We chose to "plant" cut, live western redcedars. Our reason for this was derived from our first experience "planting" snags at Beacon Hill Park. The dead snags we cut and planted there were too readily broken in the shipping and handling process. Our contractor, David Halstead of Halstead's Arboriculture Consultants (who did both projects with us), rationalized that if we cut live trees they would remain supple and be less damaged in the project. No effort was made to preserve rootballs and keep the trees live, but they stayed green for several months because the holes in which they were planted reached well below the water table of the islands.

The basking logs (one barely visible at the left edge of the island) were moored at the edges of the islands with "duck bill anchors" used by our Park District to secure picnic tables.

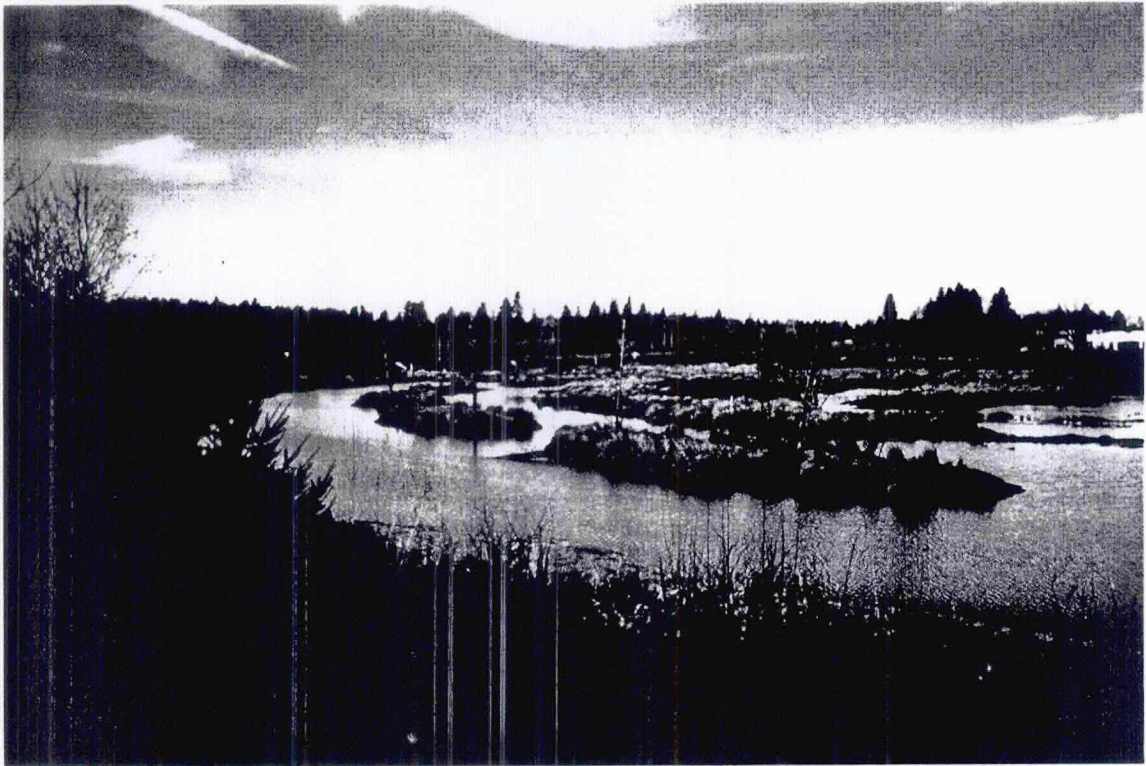
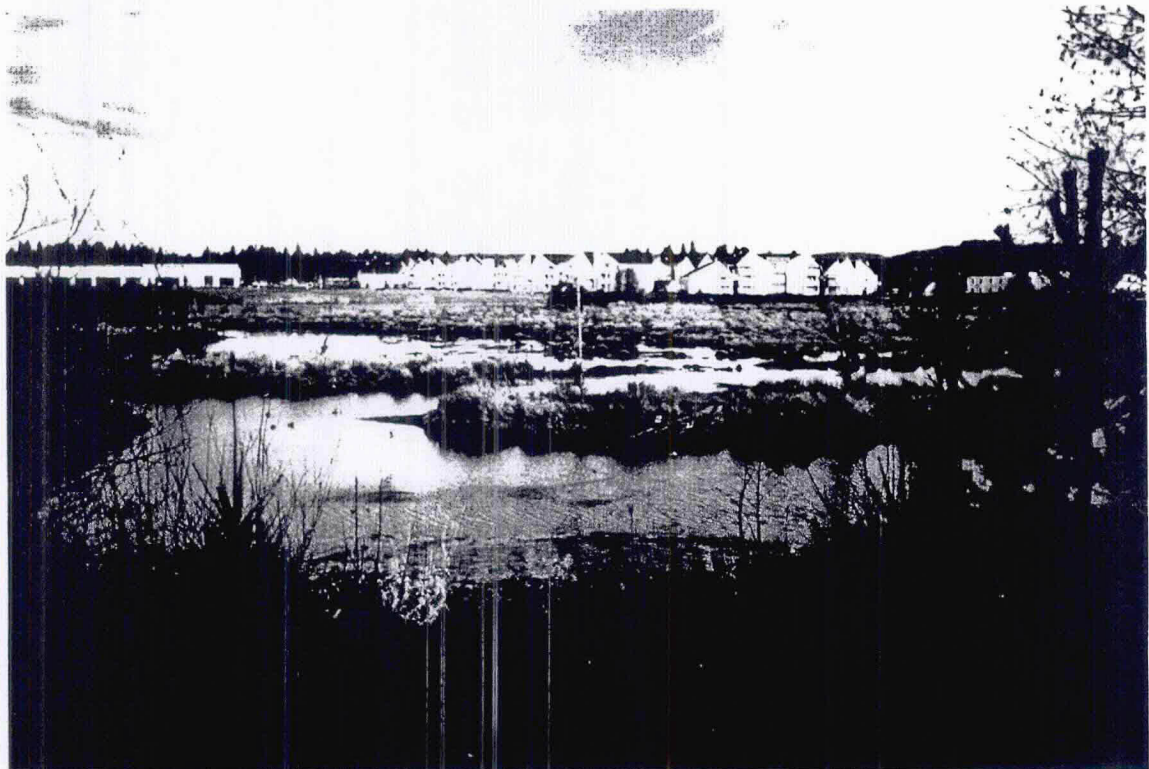
These two photographs better reveal the snags and basking logs placed on the islands. Stoplogs in the weir have been removed for the winter, rainy season. Consequently the water level has dropped and mud bars are exposed in the foreground. Red-stemmed dogwood, alder, Oregon white oaks, and small-fruited bulrush line the water's edge. Although winter's high water impacted the Reed canarygrass, it still dominates these wetlands. Notice the high-density housing in the background.

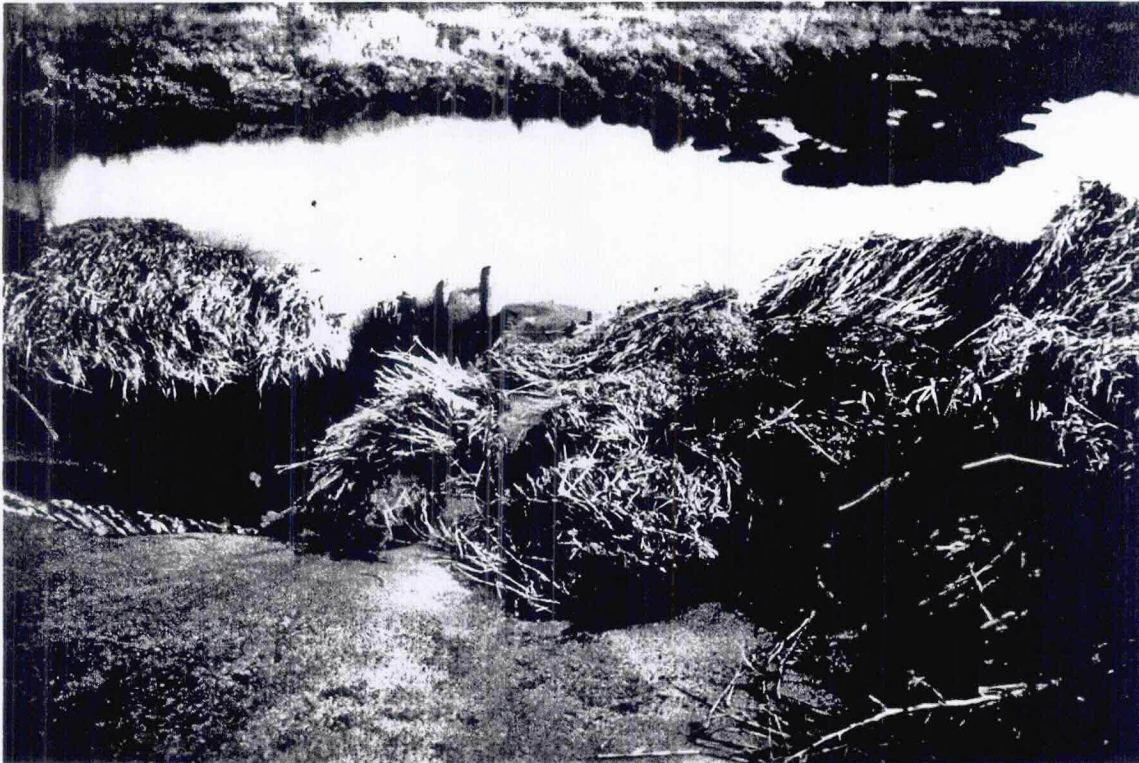
This park bench, paid for by volunteers, "looks out" on the basking log where Park District Naturalist, Elayne Barclay, discovered a Western painted turtle basking. Below, clumps of Reed canarygrass broken loose by last winter's freshets are lodged against the weir structure.

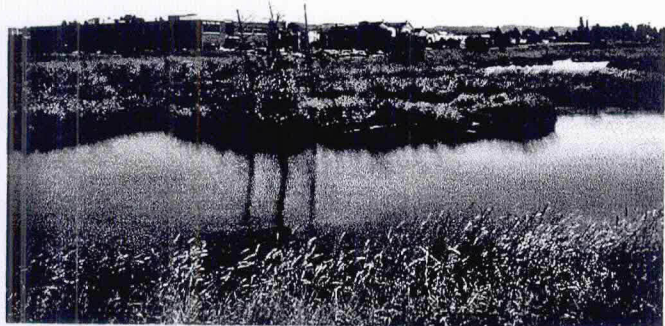
### **Photo Point 3**

Island 1

Not only are the three snags and the one basking log in place, but with binoculars a small cluster of *Spiraea douglasii* (Part of our planting or volunteer plants?) can be seen between the basking log and the right-most snag.

The downstream movement of Reed canarygrass biomass is evident at the left of this photo. A peninsula of canarygrass extends upstream from the weir nearly to Island 1.

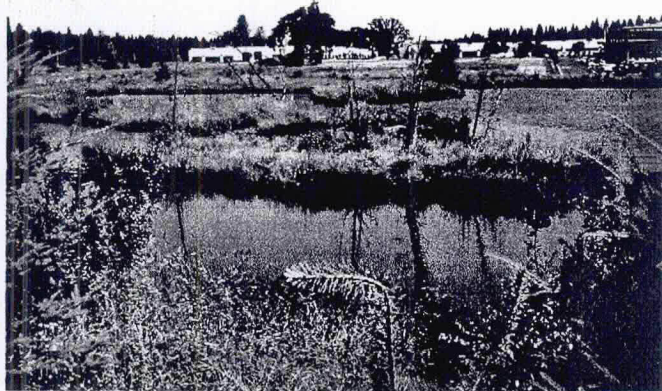
### Photo Point 8

Island 5: The snag at the west end of the island and the three at the east and the basking log at the west end are all in place. The yellow flowers in the foreground, on the islands, and in the background include Hairy cat's-ear (*Hypochaeris radicata*), Bird's-foot trefoil (*Lotus corniculatus*) and Common tansy (*Tanacetum vulgare*).

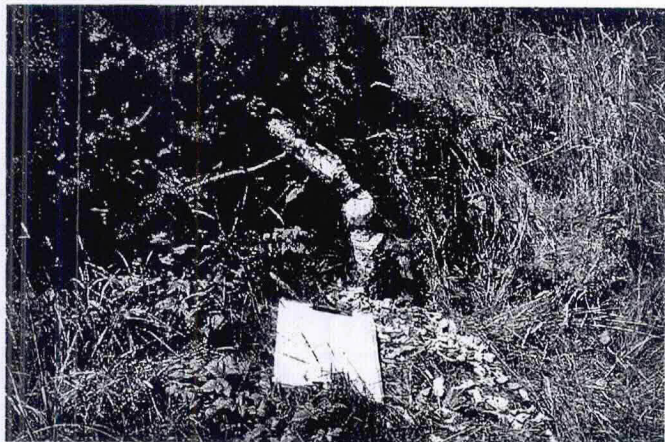
### A frustrated beaver?

Beavers are not supposed to eat pines or firs, but here is a 5-inch fir that has been fallen presumably by a beaver. Reliable citizens have reported seeing nutria building dams and consuming woody material. The tooth marks on this tree are rather narrow. A juvenile beaver or a nutria?
