JOHNSON CREEK IMPROVEMENTS AT MAIN CITY PARK

METRO GREENSPACE RESTORATION PROJECT

FINAL REPORT AND BILLING FORM

JANUARY 9, 1997

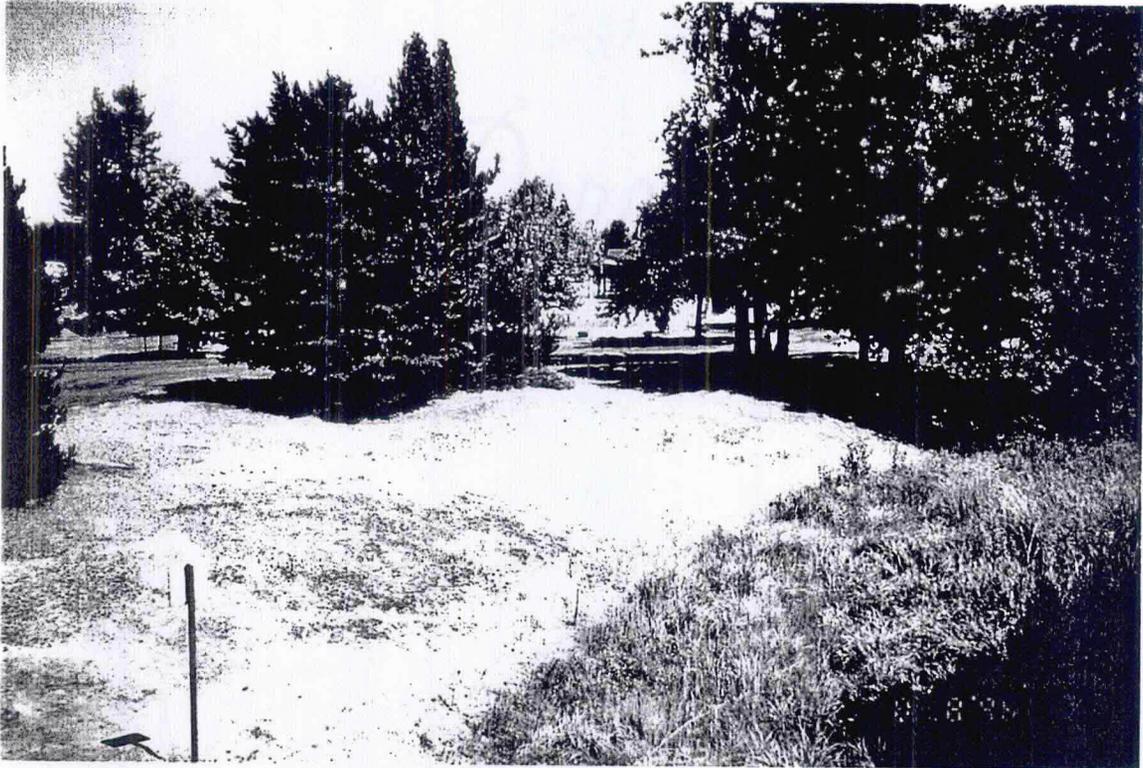
Water Quality Wetland Treatment Pond area before construction. Area is covered with large gravel which was a maintenance headache in addition to providing no habitat along the creek.

To address the two stormwater outfalls a wetland water quality pond was created to intercept and filter the runoff before it enters the creek. The two outfalls are diverted into the pond and then flow into the creek at a spillway point. The main benefit of this pond will be to capture oil films and sediments. The banks around the pond will be planted with riparian trees and shrubs in phase II of this project.

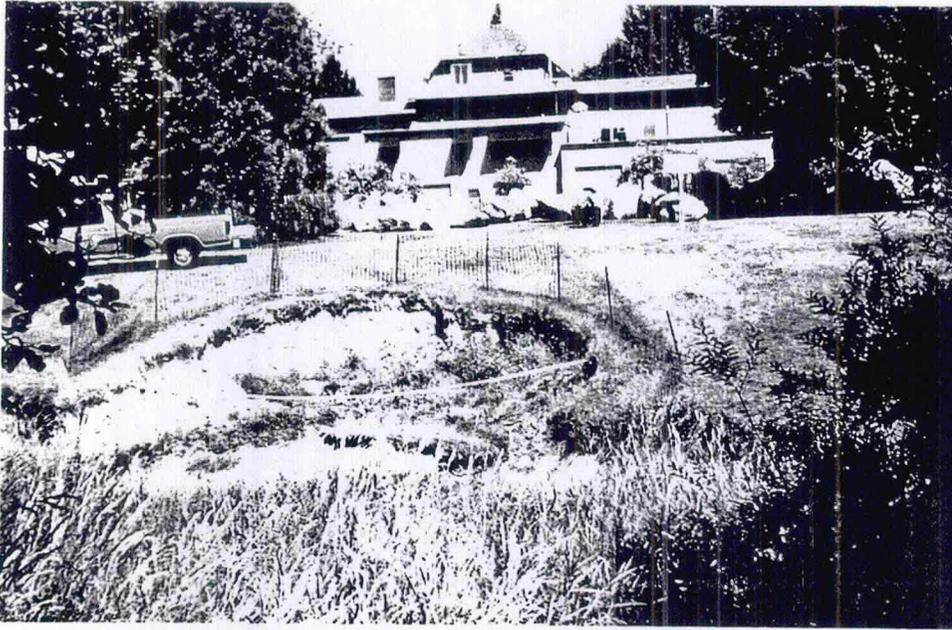
View of bank failure and erosion before stabilization work.

To address the eroded bank which was approximately 130 feet long and 12ft high at its worst point, a boulder terraced bank was constructed which incorporated over 200 boulders ranging in size from 4 1/2 to 6 feet in diameter. The boulder toe was placed several feet beneath the stream bed, and 4 large root wads were incorporated into the toe to provide underwater fish habitat. The remainder of the bank is being converted from a turf zone to a natural zone. An erosion control seed mix was planted and trees and shrubs will be planted in phase II of this project.

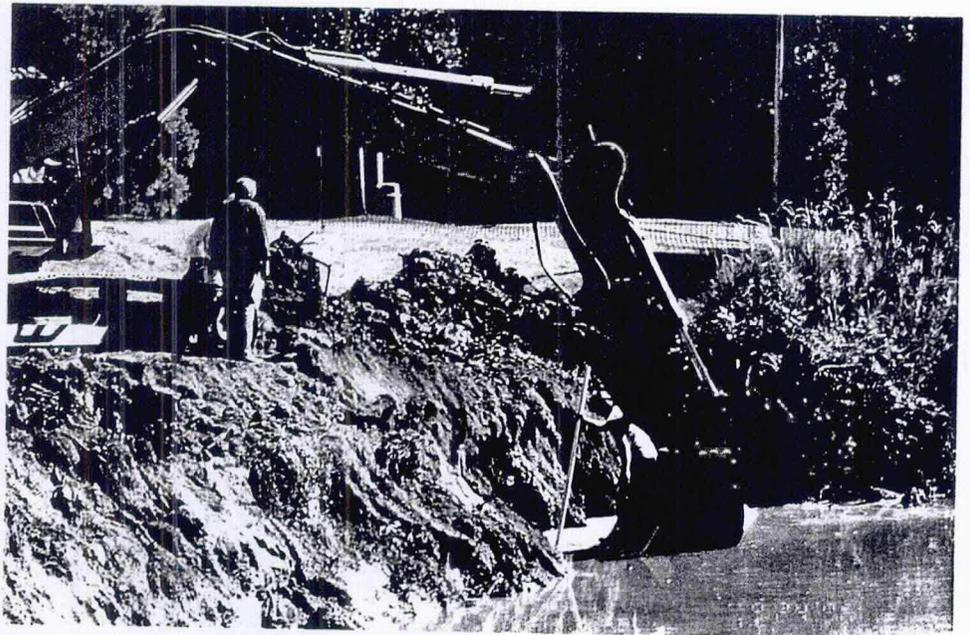
Toe of boulder terraced bank being installed two feet below stream bed.

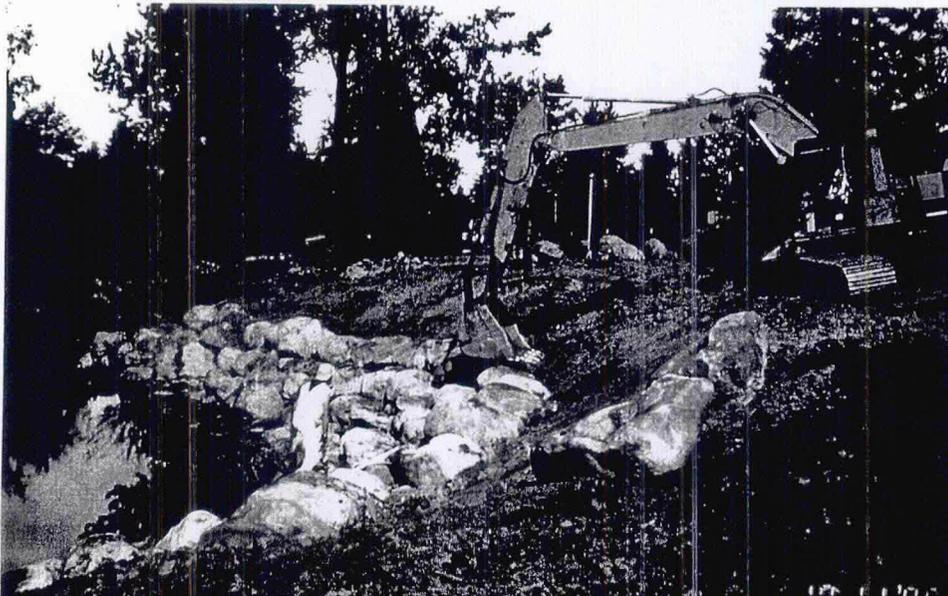
Boulder reinforced bank at 75% completion. Four large root wads are incorporated into toe of bank. Riparian plantings will be established in phase II.
