**Moonshadow Park/ Ash Creek  
Metro Habitat Restoration Project  
Final Report**

**Submitted by:  
Tualatin River Watershed Council  
Contract # 905415  
July 1998**

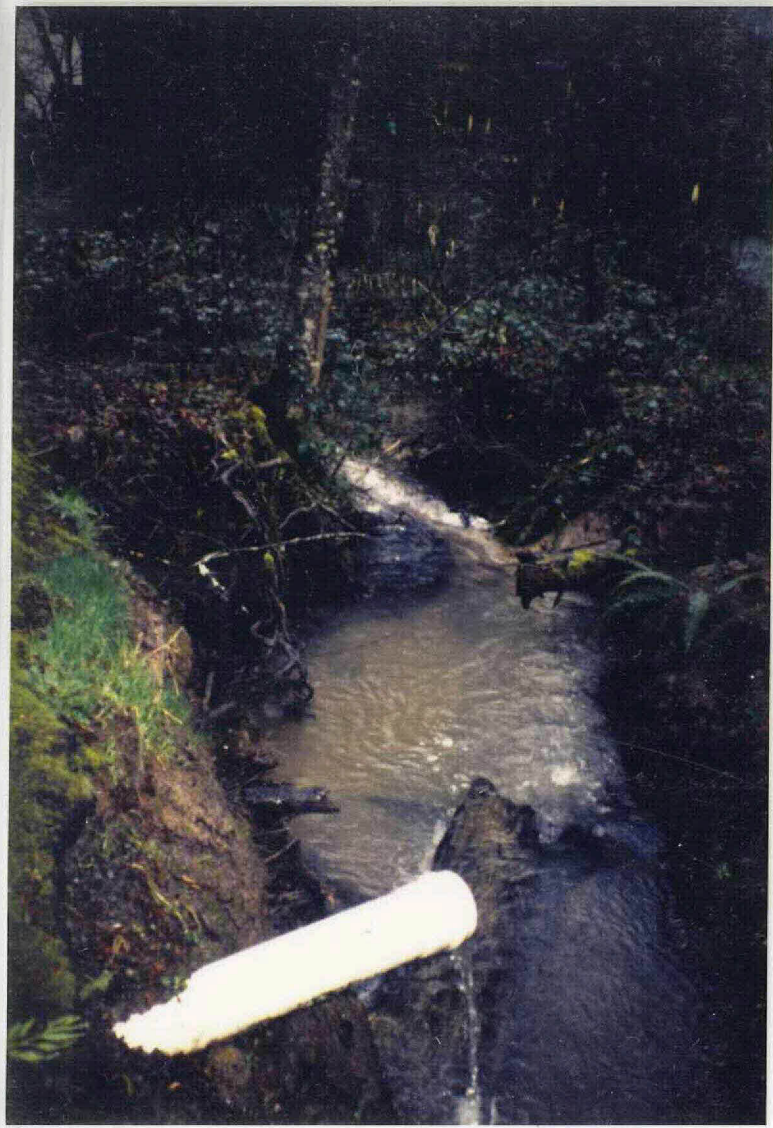
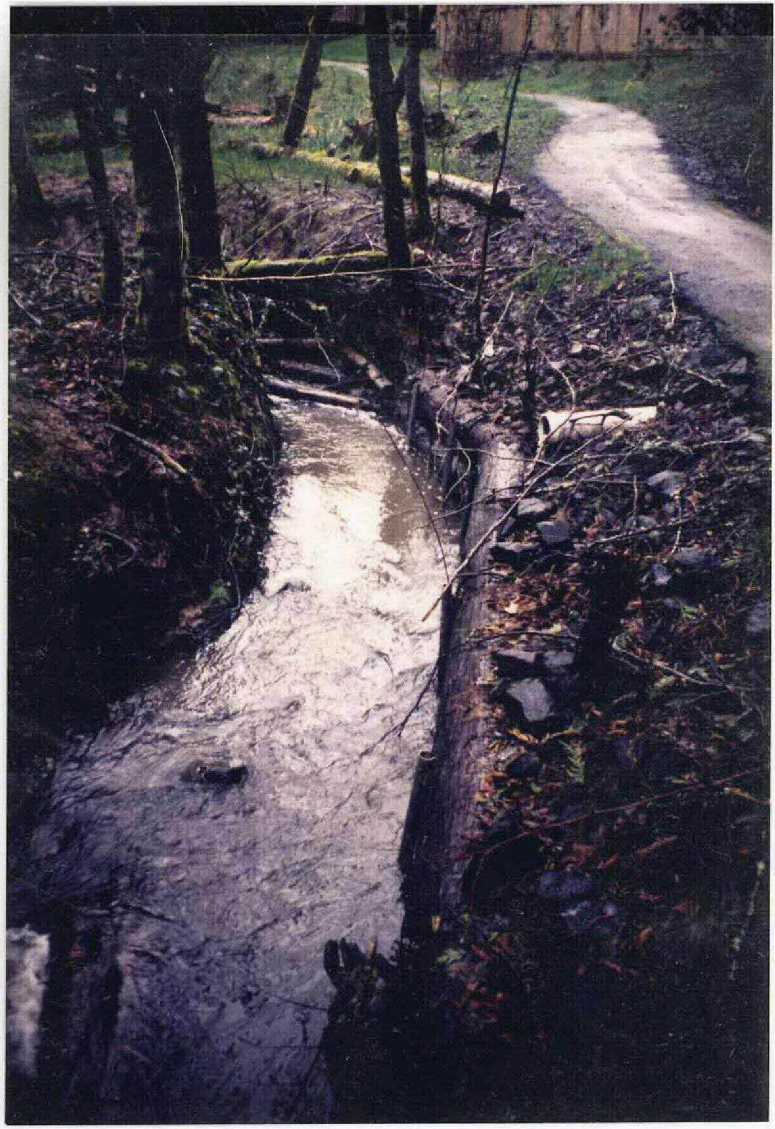
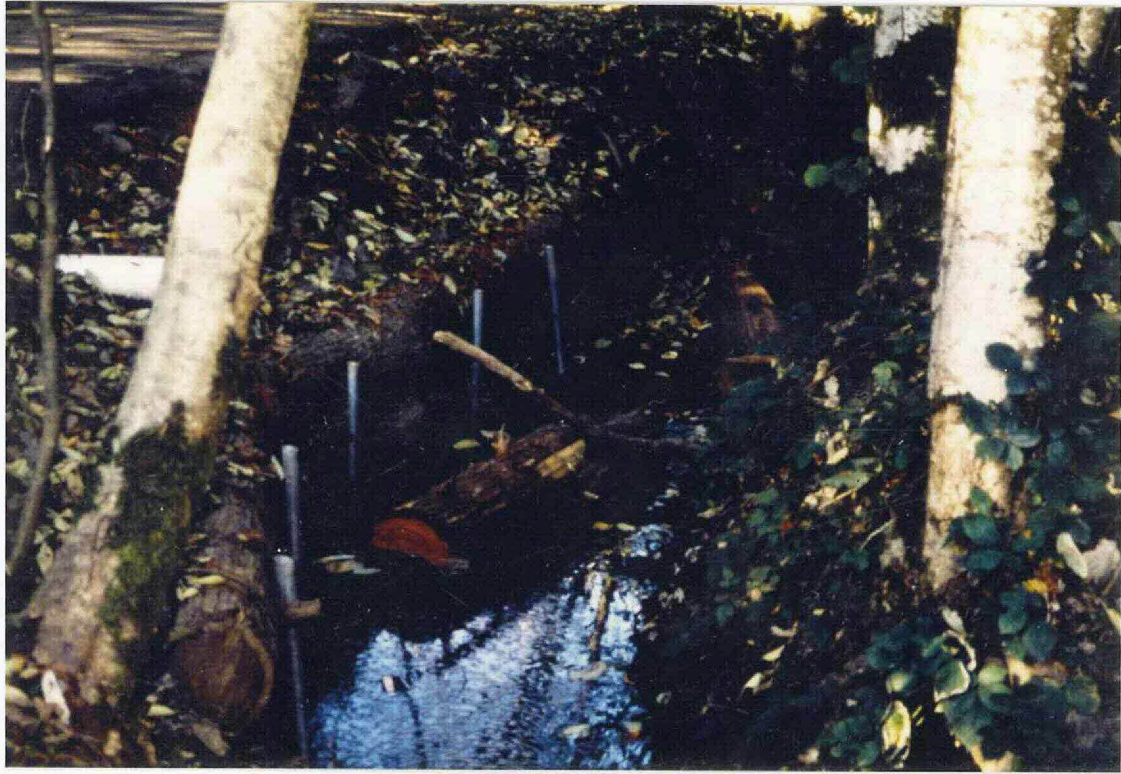
Photo Point 1

After completion of  
in-stream work

October 1997

Before streambank stabilization

March 1997

Large Woody Debris & Gravel  
Placement location

Oct 1997

Walk 720' from the southeast entrance to the white PVC drainage pipe. From the drainage pipe walk upstream 40' along the bank of Ash Creek and face downstream. Using a wide angle lens center the drainage pipe in the viewfinder. The paved pathway should be in the lowers left corner and an 8" DBH red alder trunk forms the left side of the frame.

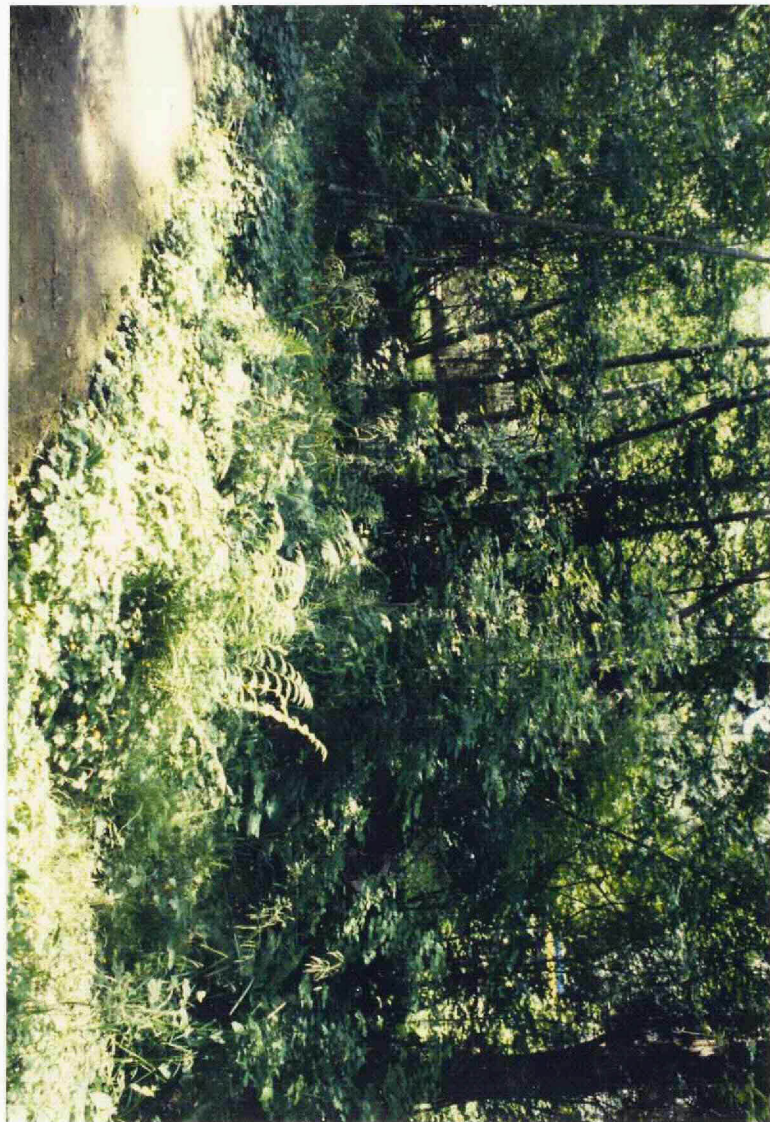
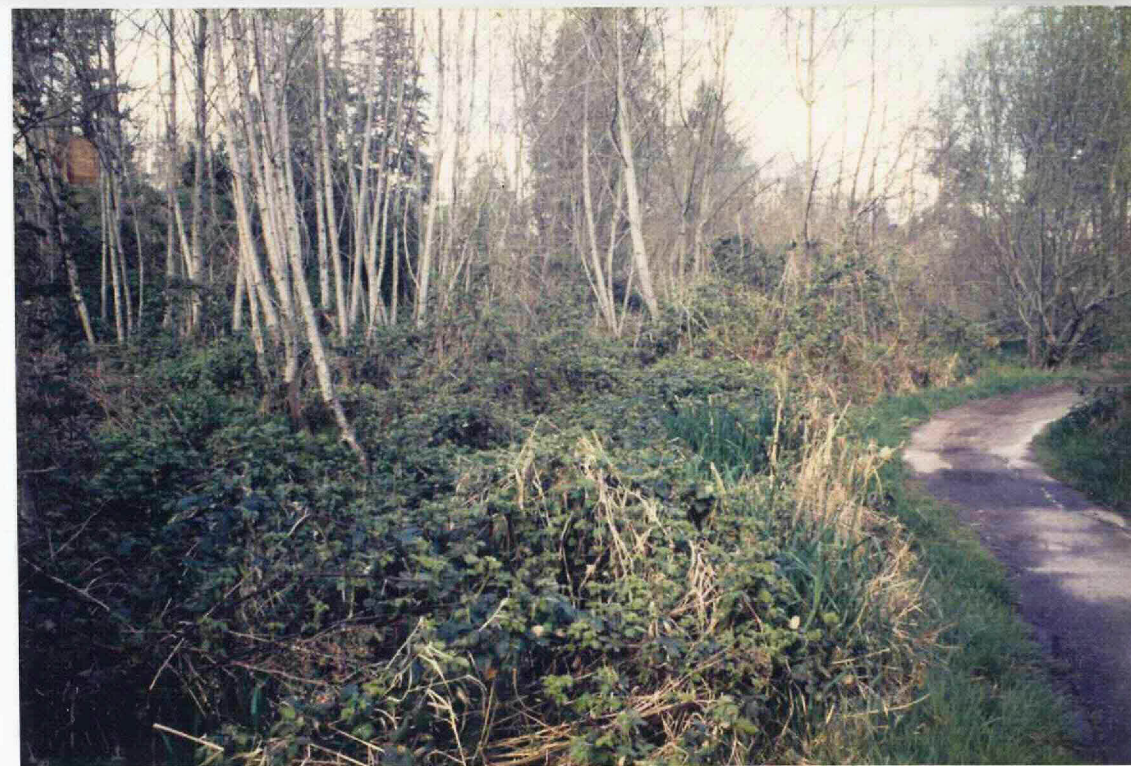
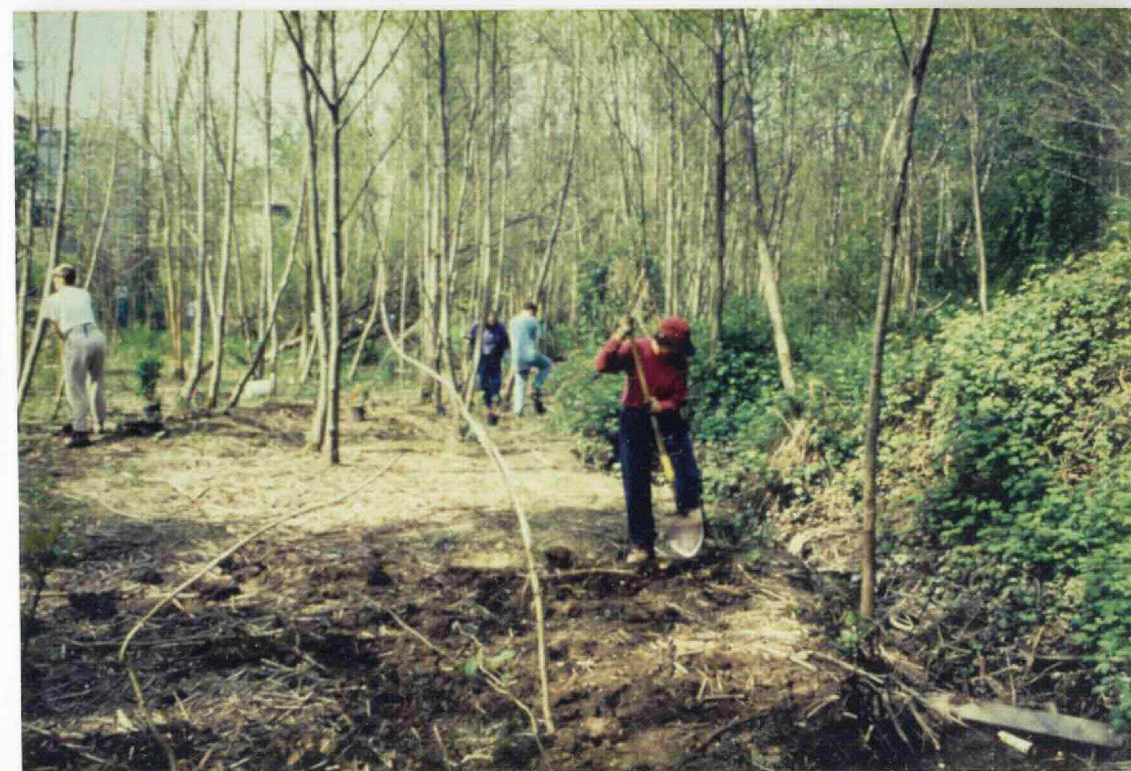
Photo Point 2

Prior to blackberry removal

Feb 1997

During Community Work Party  
to plant native plants

May 1997

June 1997

One month after plantings with new  
spring growth

Walk 226' from the southeast entrance to a 4' DBH stump to the right of the path. Face downstream. Frame the shot to get the stump just outside the bottom right of the shot with creek bank visible on the right and the path just out of view on the left. They is a large black pipe just to the left of center.

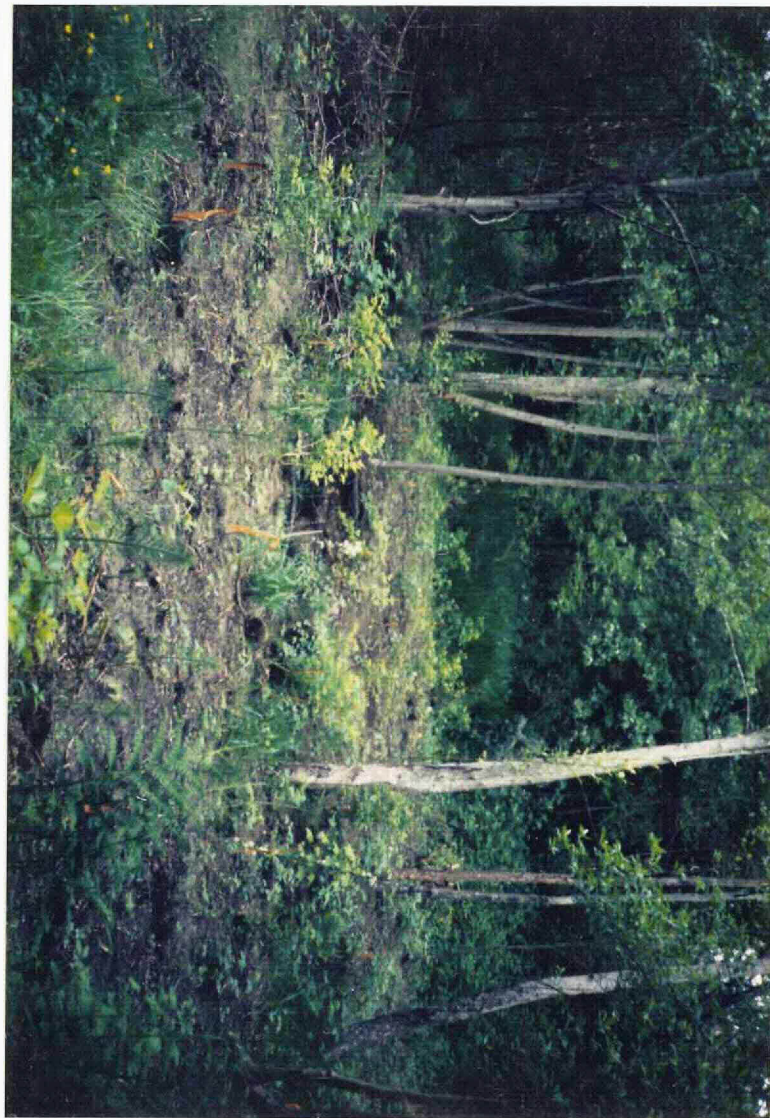
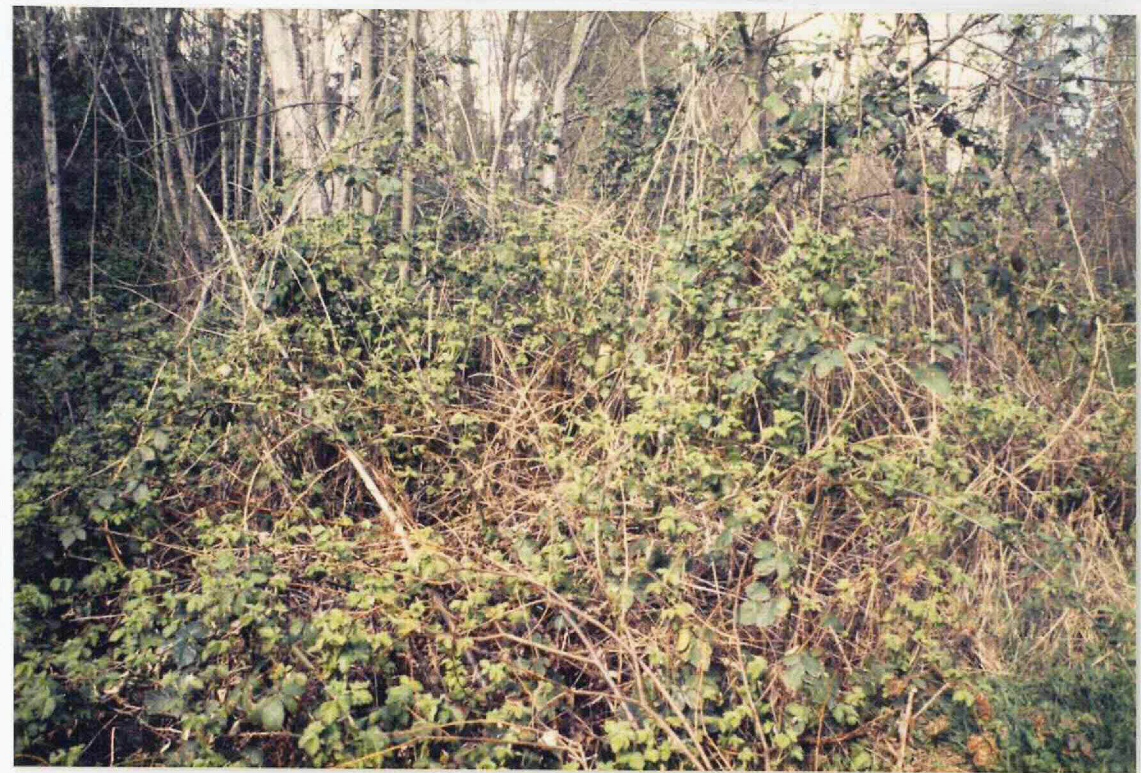
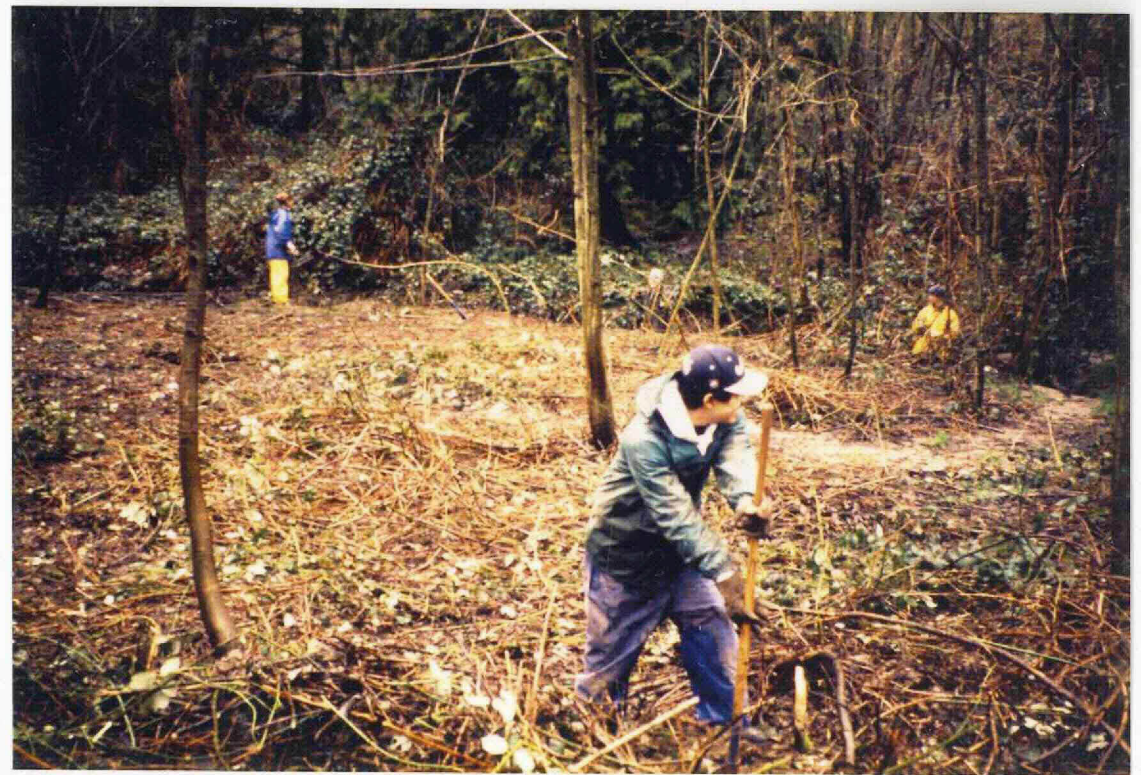
Photo Point 3

Himalayan Blackberries prior to  
removal

March 1998

Cascade Education Corps removing  
blackberries

June 1998

Post-blackberry removal, with new  
native plants tagged w/ red-tape

Walk 130' from the southeast entrance. Frame the shot to have a Douglas-fir stump in the center and the edge of the path in the lower left corner. The roof of the riding stable is visible along the upper right half of the shot.
