WILLAMETTE FALLS LEGACY PROJECT

Habitat and Water Resources Opportunities

Prepared for
Metro
Regional Services

October 2012

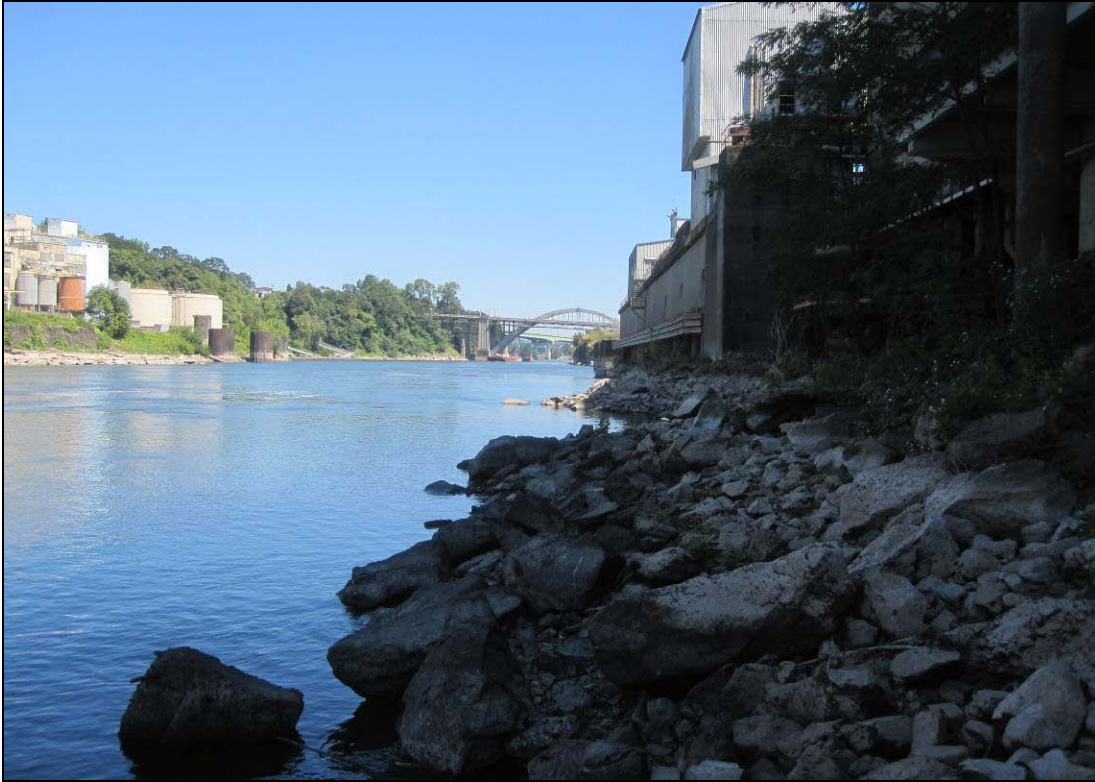
Photo 2. Looking downstream at the rocky shoreline and adjacent structures (08/03/2012).

The Blue Heron site occupies approximately 4,500 feet (0.85 miles) of shoreline on the right bank of the Willamette River (Photo 2). Five outfalls and three tailraces emerge at the shoreline. Much of the naturally steep shoreline has been modified by years of development and industrial uses and is now lined with fill, pipes, and other structures.

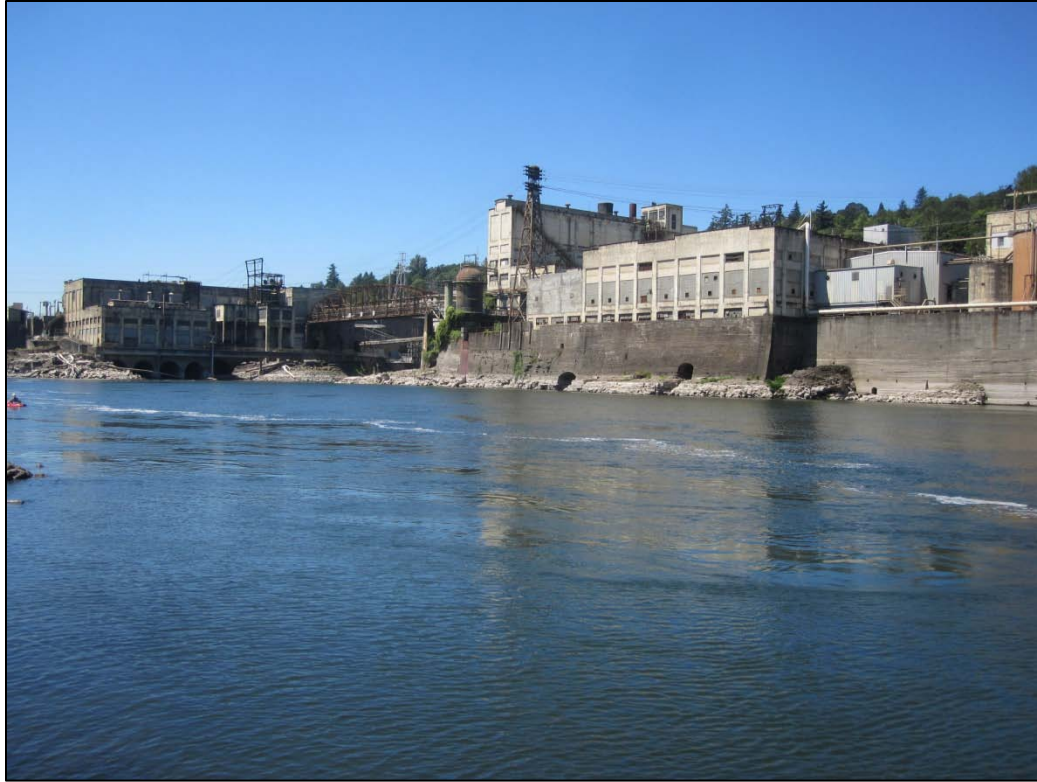
Photo 3. View of left bank of Willamette River across from project area (08/03/2012).

Development close to the shoreline on this site in combination with development of the left bank of the Willamette River across from the project site, provides limited opportunities for fish resting in this reach of the river and no connectivity of habitat along the shoreline (Photos 2 & 3). Resting places are important for migrating fish as fatigue is one of the major stressors affecting pre-spawning mortality. Having resting places below major passage challenges, such as the Willamette Falls, could help reduce fatigue. Some fish use of the shoreline for resting during migration may be expected during the out-migration of smolts in the spring and fall. With the exception of the backwater lagoon, there are few side channels or alcoves in this reach of the river that could serve as refugia for juvenile salmon during high flows in the mainstem. Downstream passage is provided at the T.W. Sullivan development and used to be provided at the Blue Heron Paper Company (BHPC) powerhouse over 16 weeks of the peak outmigration period when BHPC shut down its turbines. BHPC sometimes shut the turbine down in the fall as well.

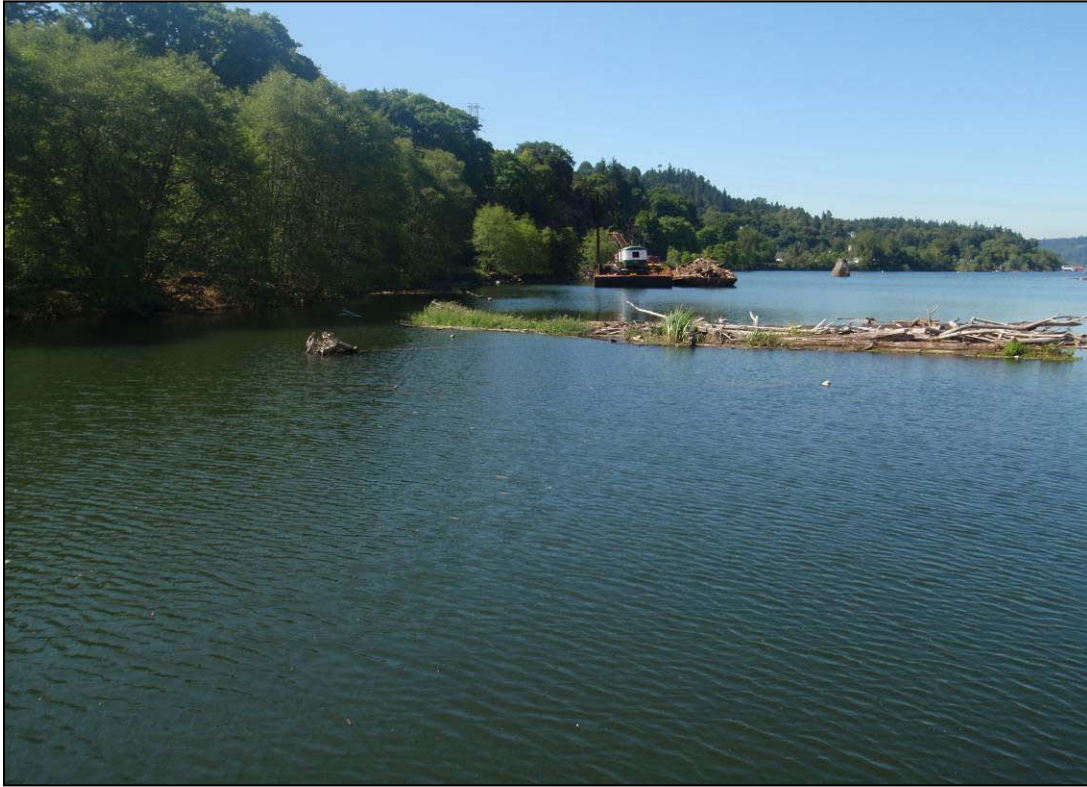
Photo 4. Looking southeast at the shoreline upstream of the dam (08/03/2012).

Lagoon Overflow - Algae blooms and stagnant water in the lagoon can be addressed by providing more circulation of water through the lagoon (Figure 3). Blue Heron mill used 50 cfs for process water from the lagoon. This flow rate is more water than necessary for returning the lagoon to a flow-through backwater instead of a pond-like water body; therefore calculation of turnover rate and residence time of water could provide an estimate of the amount of flow needed to enhance circulation through the lagoon. The flashboard weir on the dam can be incrementally lowered to spill water and increase movement of water through the lagoon (Photo 15). A study of the water turnover rates in the lagoon would be necessary to determine how much water would need to be spilled to promote adequate circulation of water. Spilled water from the dam would also provide flow over the rocky outcroppings below (Photo 4).

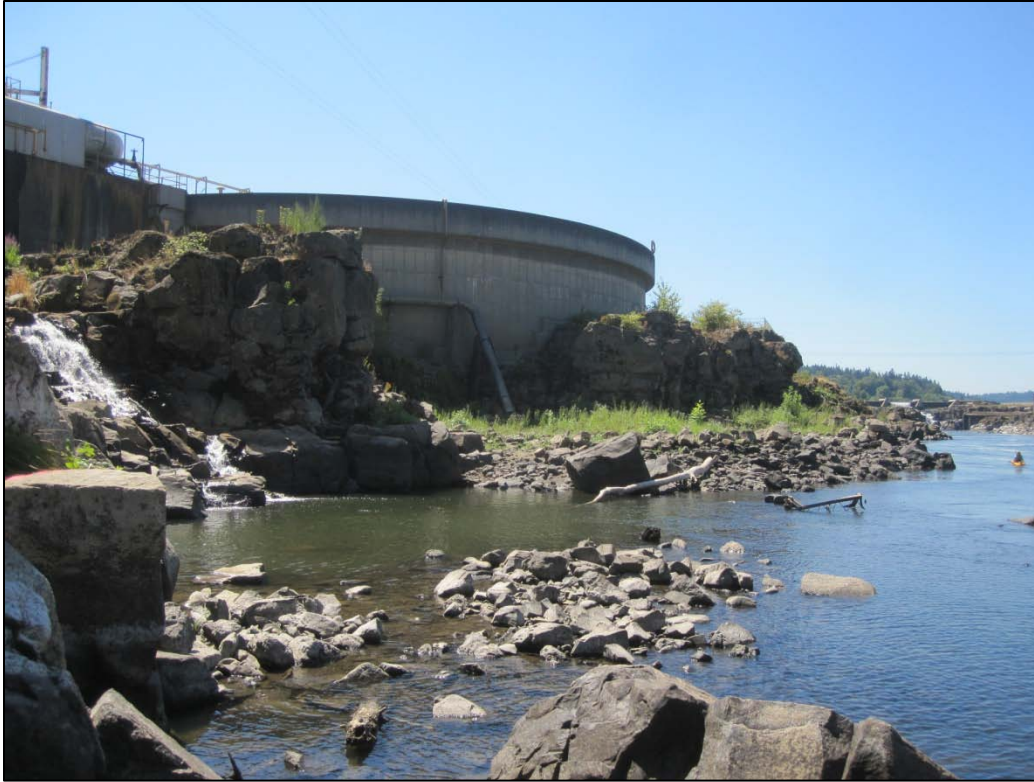
Photo 5. Rocky outcroppings between Building 31 and the clarifier (08/03/2012).

Removal of the clarifier would restore unique basalt rock outcroppings along the falls (Photos 5 & 6). With removal of industrial structures, there may be opportunities to promote shorebird habitat and local native wildflower species diversity on the outcroppings. Birds would be provided with undisturbed habitat. Invasive plant species found on the site, such as Armenian blackberry and English ivy should be removed and replaced with native plants with a higher habitat value.

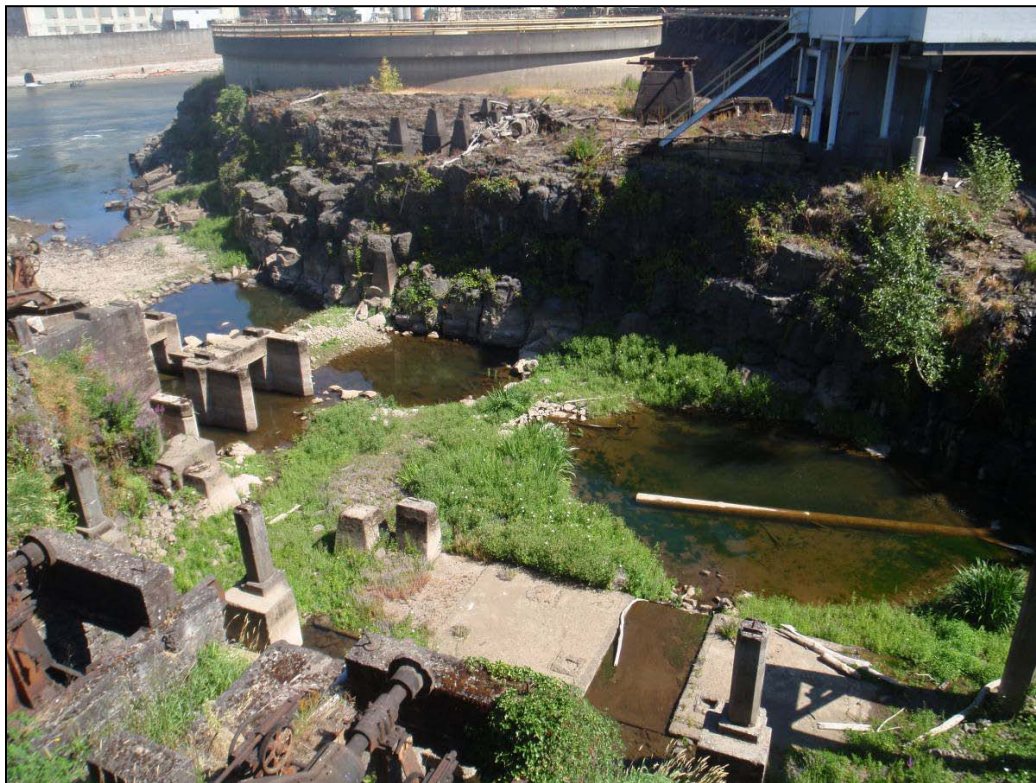
Photo 6. Rocky shoreline habitat between the clarifier and dam taken from upstream of the clarifier looking downstream (08/03/2012).

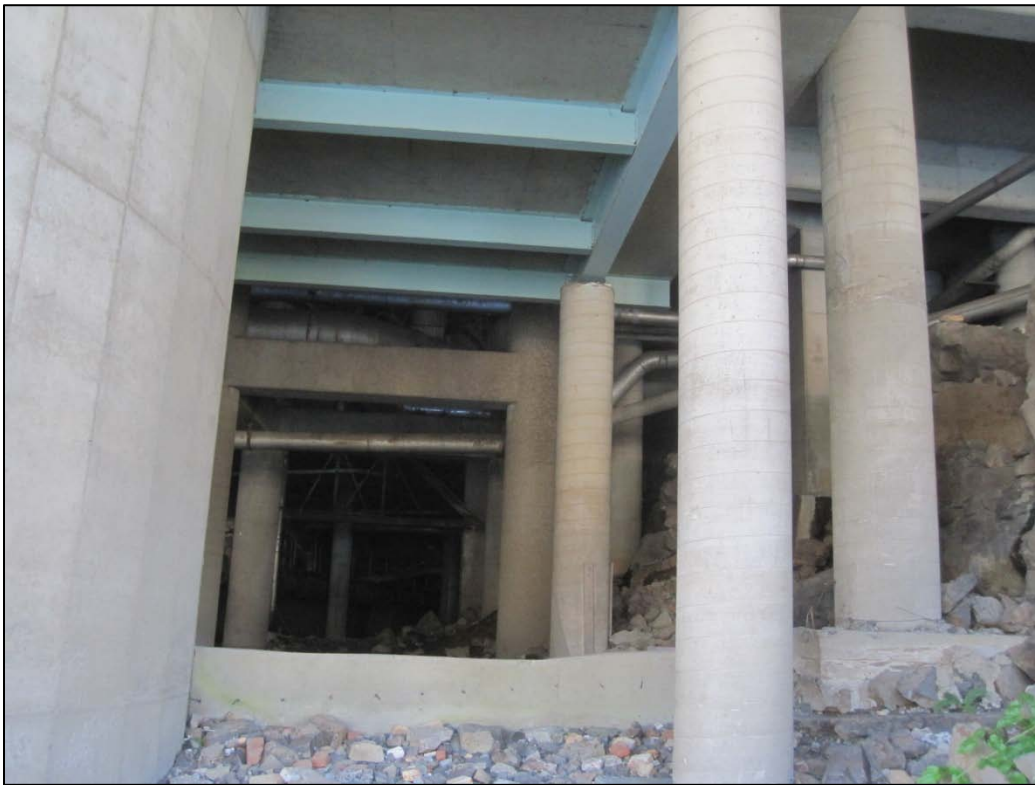
Photo 7. Tailrace H, where it exits the site at the shoreline (08/03/2012).

Under Building 31 is a unique rocky outcropping and the end of Tailrace H (Photo 7). Daylighting the end of the tailrace provides additional habitat for fish as well as opportunities for infiltration with the addition of a swale. Depending on the amount of water traveling through the tailrace and daylighting plans, the type of swale or channel created at the end of the tailrace, and protection needed from destabilizing the shoreline will vary. If some of the fill at the end of the tailrace is excavated, exposing a short length of channel, it would provide an alcove from the main channel and diversify the shoreline.

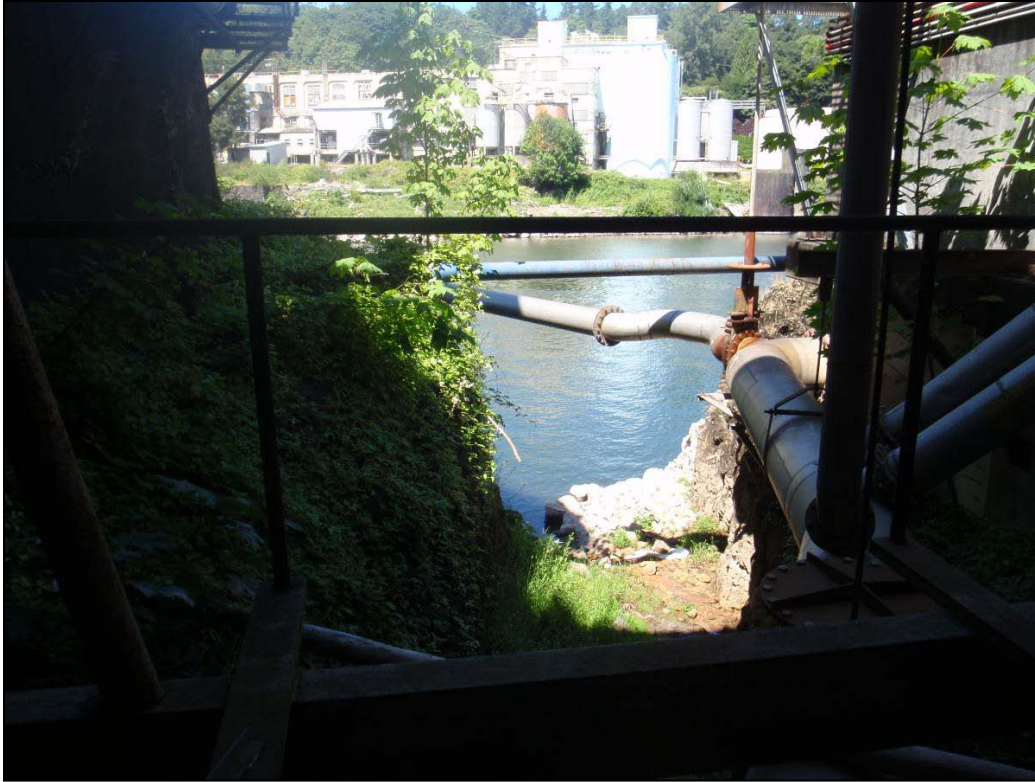
Photo 9. Small alcove at the end of Tailrace #2 (08/03/2012).

Removal of Building 14 would allow for the daylighting of Tailrace #2 back from the shoreline and the establishment of a riparian community and swale at the end of the tailrace. Tailrace #2 is already the location of a small alcove, which can be enhanced to provide resting places for fish, as well as habitat for small mammals, amphibians, and invertebrates (Photo 9).

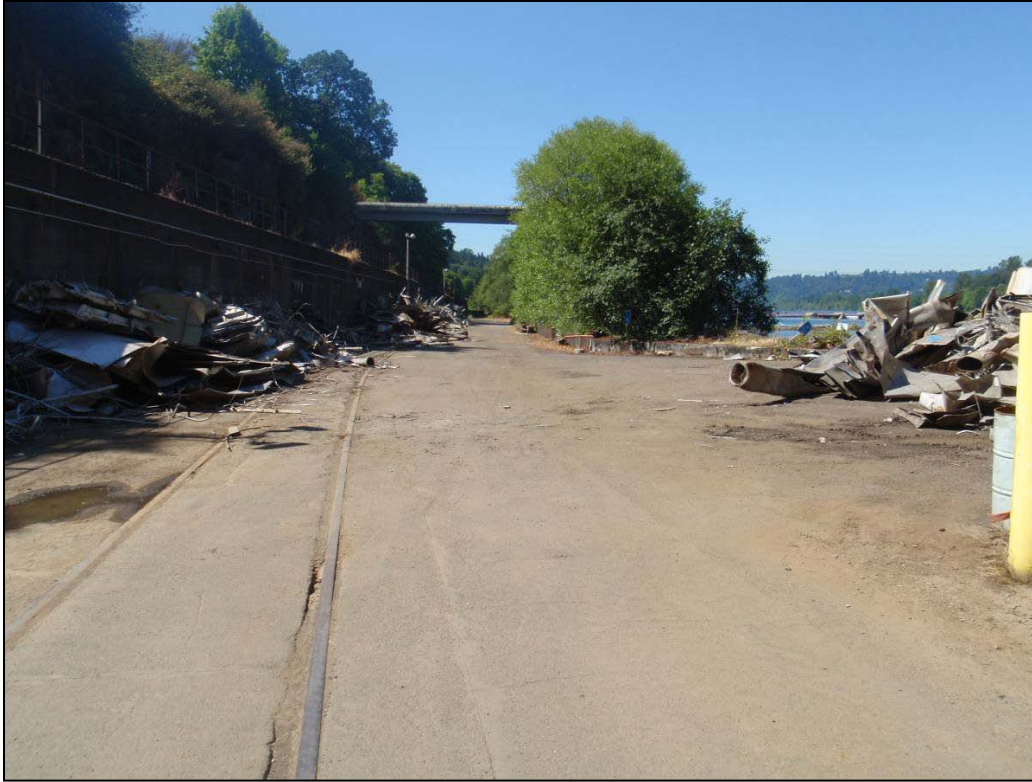
Photo 10. Shoreline upstream of the lagoon, looking upstream (08/03/2012).

Revegetate Shoreline Upstream of Falls – Upstream of the falls, the narrow band of shoreline vegetation can be widened where possible, with non-natives removed and a native shrub layer encouraged (Figure 3, Photo 10). Industrial trash should be removed and pavement disassembled. Opportunities for improving future raptor habitat are available on-site and include installing native trees along the upper shoreline or erecting a nesting platform for use by osprey. Increasing the shrub and tree layer along the shoreline would also improve foraging and stop-over habitat for songbirds such as Wilson’s warbler, yellow warbler, evening grosbeak, and western tanagers.

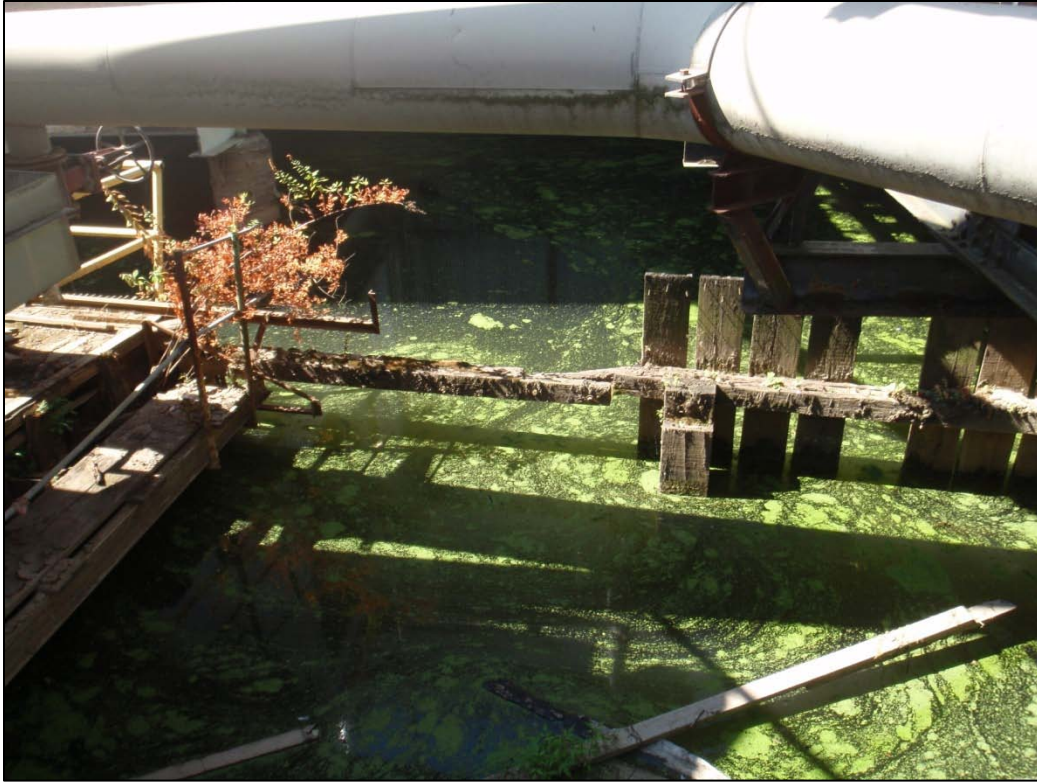
Photo 12. Algae in lagoon viewed from downstream end of PGE dam (08/03/2012).

An approximately 14.7 acre settling lagoon is located on the upstream end of the project site (Figure 1). Historically, the lagoon was constructed for and used to collect logs for floating downriver. More recently, Blue Heron used the lagoon for mill operations by opening Intake 2, 3, 4. Additionally, water flows over the dam spillway. Depths are estimated to be approximately 5-6 feet and there is not significant circulation of flows. Shallow depths leading to warm temperatures and use by waterfowl may be responsible for algae blooms in the lagoon (Photo 12).

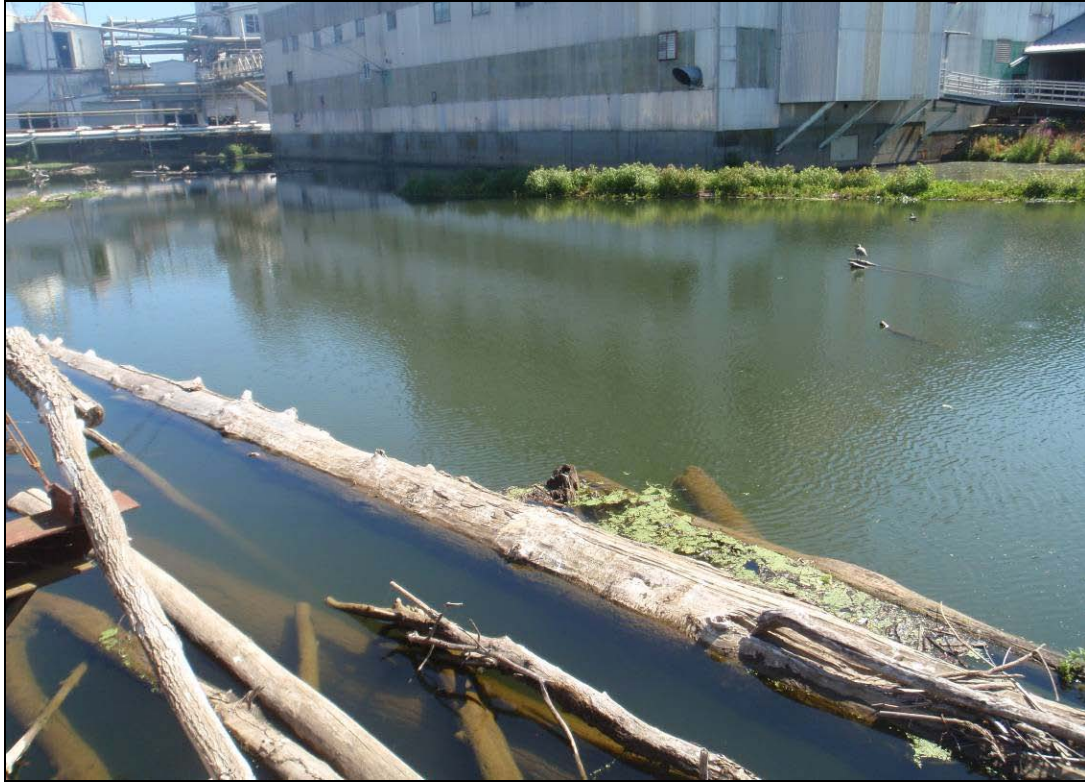
Photo 13. Lagoon, looking downstream, with partially submerged logs (08/03/2012).

The lagoon provides slow-moving, open-water habitat for ducks, geese and other waterbirds (Photos 13 & 14). Clusters of wood and debris as well as tufts of vegetation are scattered along the periphery of the lagoon. Vegetation covers an estimated 5 to 10 percent of the lagoon and is a mix of floating aquatic plants, algae, and weedy herbs and forbs along the fringes as well as a few shrubs and saplings growing out of a berm in the lagoon. A dense mat of vegetation has formed at the north end of the lagoon and consists of marsh pennyroyal (*Hydrocotyle ranuncuuloides*), an introduced aquatic perennial; water-parsley (*Oenanthe sarmentosa*), a semi-aquatic plant; bitter nightshade (*Solanum dulcamara*), an invasive plant; and yellow touch-me-not (*Impatiens Capensis*).

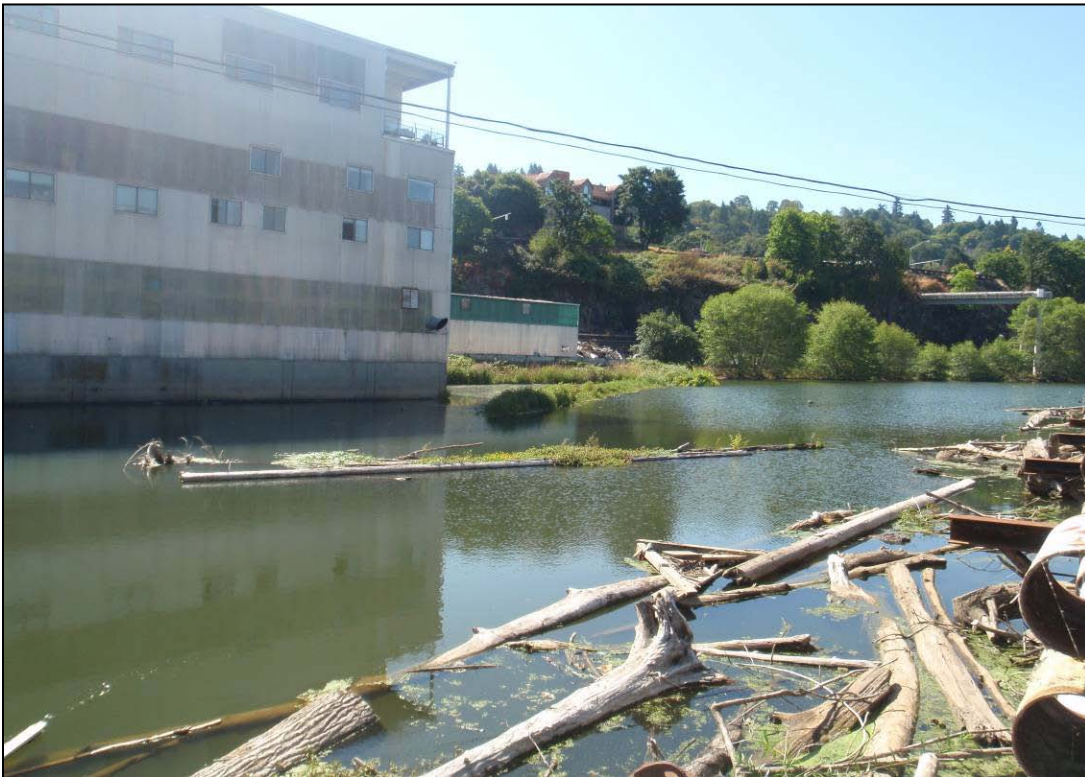
Photo 14. Lagoon, looking upstream at partially submerged wood, spit of land extending in to lagoon, and trees along shoreline at upstream end (08/03/2012).

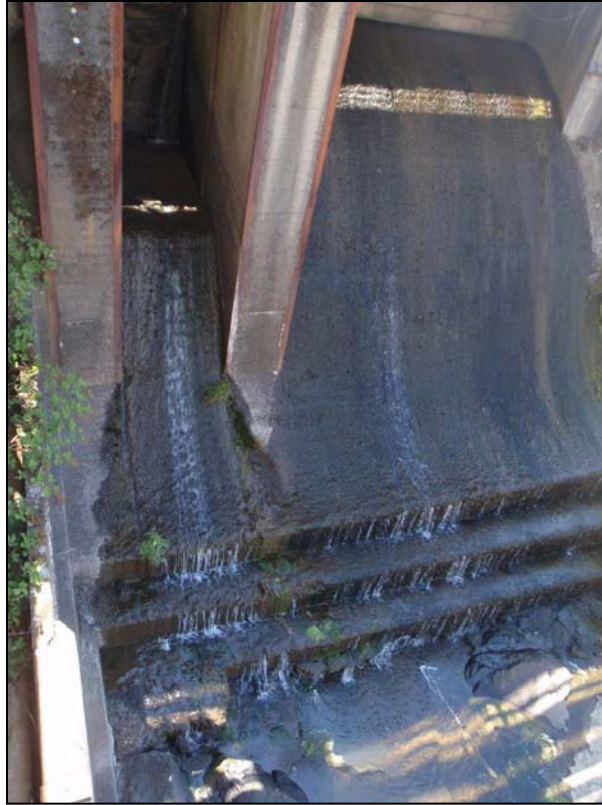
Photo 15. Flashboard weir on the PGE dam (08/03/2012).

Though spilling over the flashboard weir will promote movement of water, the primary build-up of algae is between the dam on the downstream end of the lagoon and Buildings 36, 37 and other associated structures. If buildings are not to be removed, circulation can be promoted in this part of the lagoon by releasing water into Intake 2, 3, 4 at the dam. This water would be routed down one of the tailraces, such as Tailrace #1 and can flow through the grotto or otherwise down the tailrace. Though the majority of migratory fish do not use the lagoon, the entrance to Intake 2, 3, 4 should be properly screened to prevent fish passage.

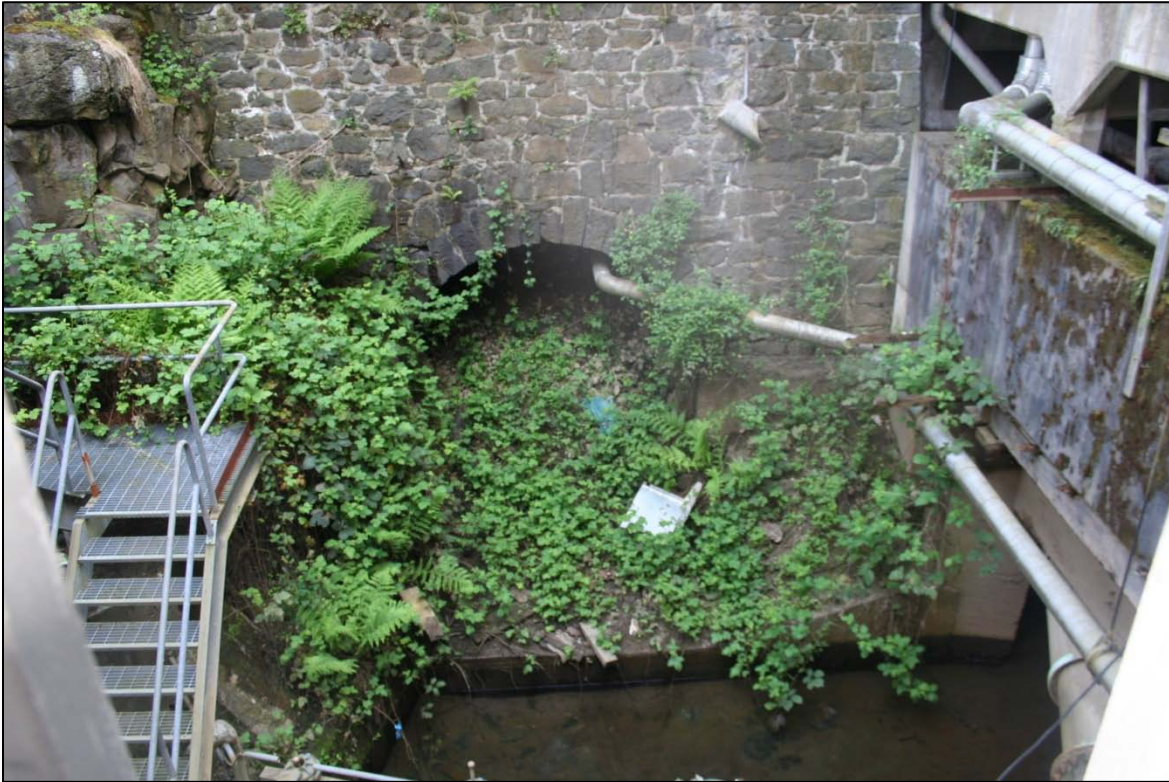
Photo 16. Looking down at grotto from street level (05/14/2012).

Adjacent to Tailrace #1, there remains a grotto with shallow standing water at the base, approximately 20 feet x 20 feet in shape (Photo 16). The grotto remains in place likely acting as stormwater catchment, with drainage piped to the shoreline. Information is lacking on the water quality and accumulated sediments of the grotto. Given its location along natural drainage flow lines, the grotto could be retrofitted to provide water quality treatment. This option is explored further in ESA's Interim Stormwater Management Plan.

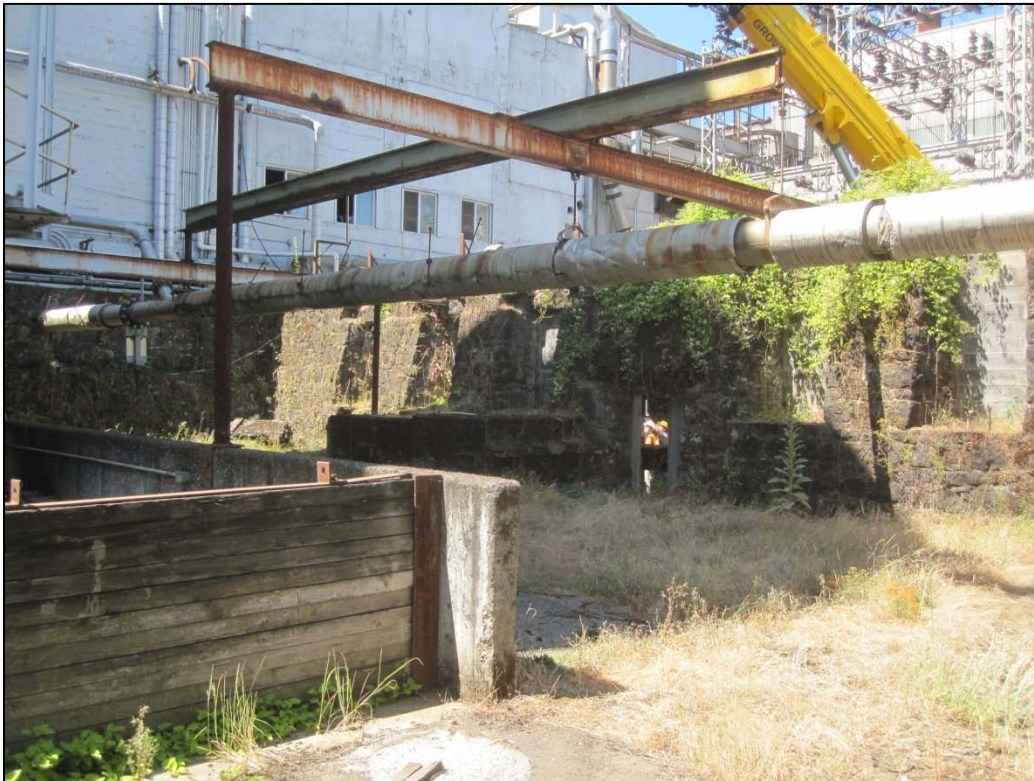
Photo 17. Historic building foundations adjacent to the grotto (08/03/2012).

Enhance Grotto to Provide Stormwater Treatment – The grotto can be enhanced to provide microhabitat for invertebrates and native cliff-dwelling plants as well as a historically significant viewpoint. Because of its proximity to Tailrace #1 and low elevation it may also be incorporated into the stormwater management plan for the site. Adjacent to the grotto is the skeleton of a building sometimes referred to as the Roman Ruins (Photos 16 & 17). The grotto can be converted into a rain garden to provide localized treatment of stormwater. The grotto provides easy access to a stormwater treatment site for visitors and can be a good location to provide educational signage and information about urban stormwater treatment.

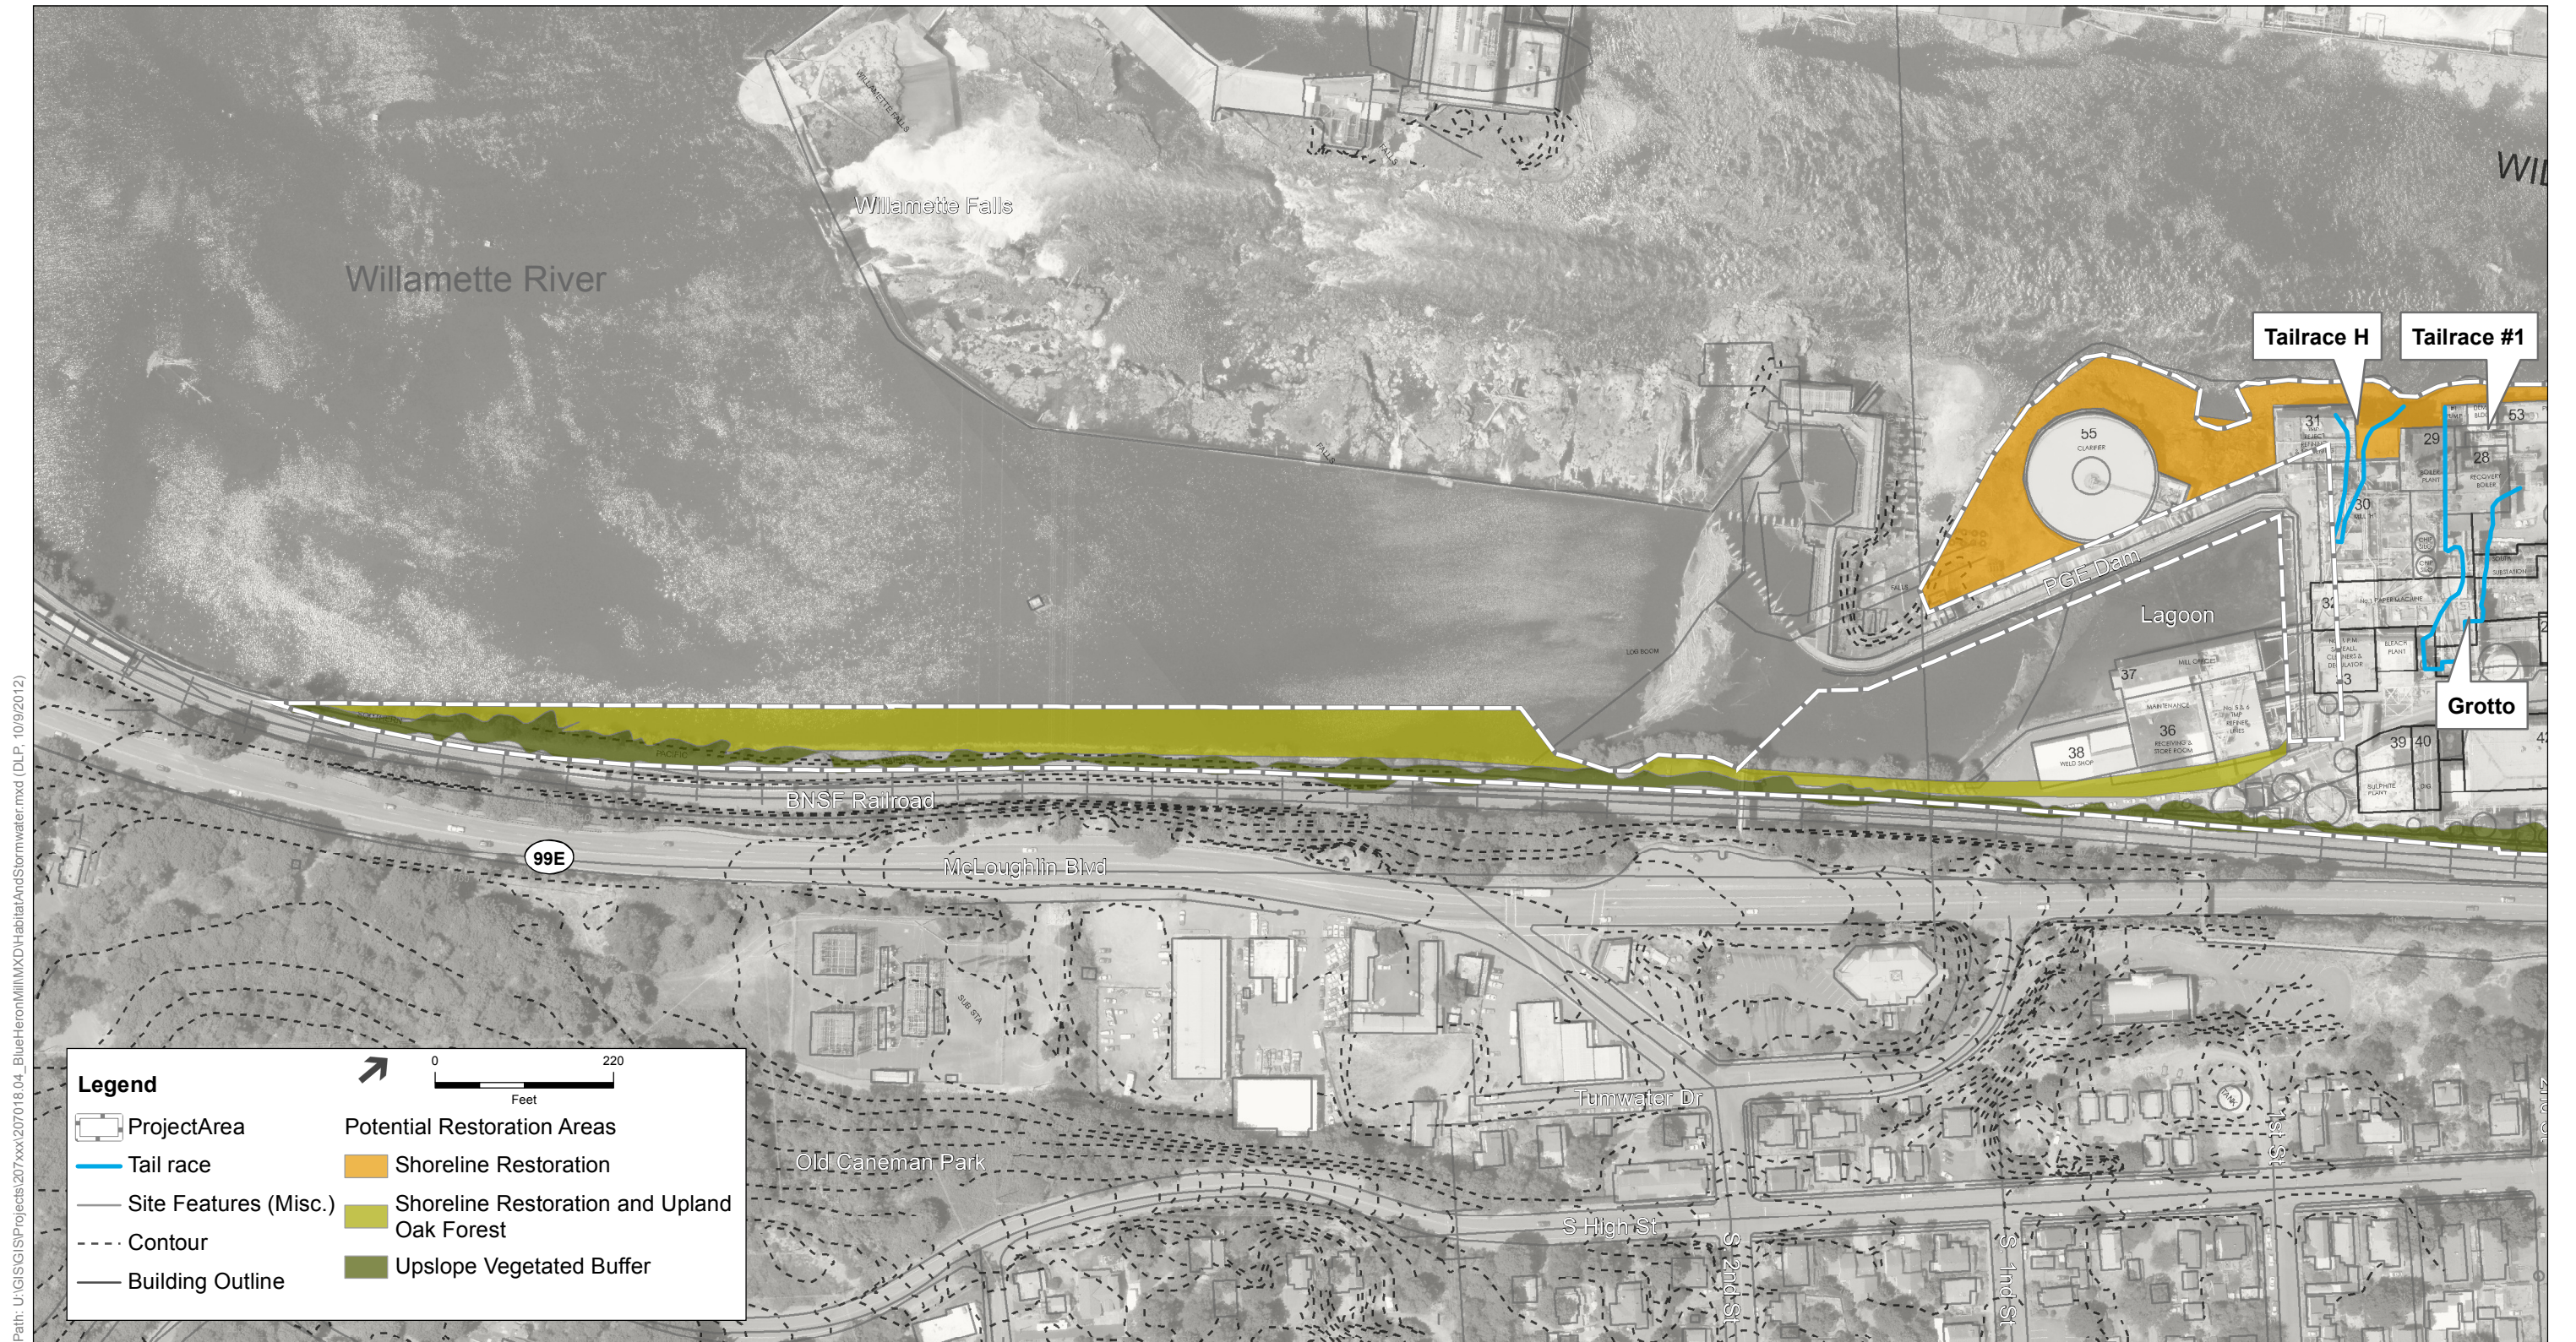
Blue Heron Mill . 207018.04
Figure 1
 Habitat Restoration Opportunities
 Southern Project Area
 Oregon City, Oregon
