## Spokane Falls Aesthetic Flows

**Key Features:** Improved water connectivity, aesthetic flows, and rocky outcrop restoration.

**Location:** Riverfront Park, Spokane, Washington

**Lead entity:** Avista Utilities Corporation

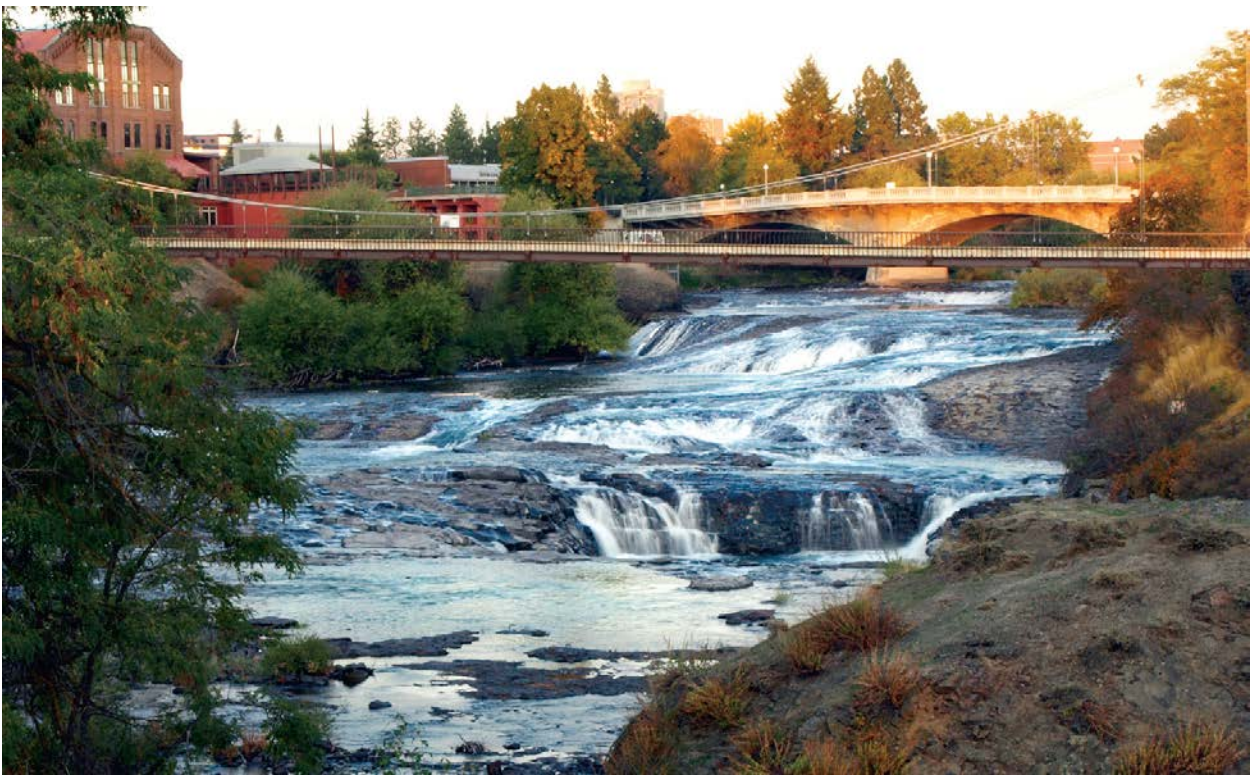
**Figure 1, View of the Spokane River north channel after construction**

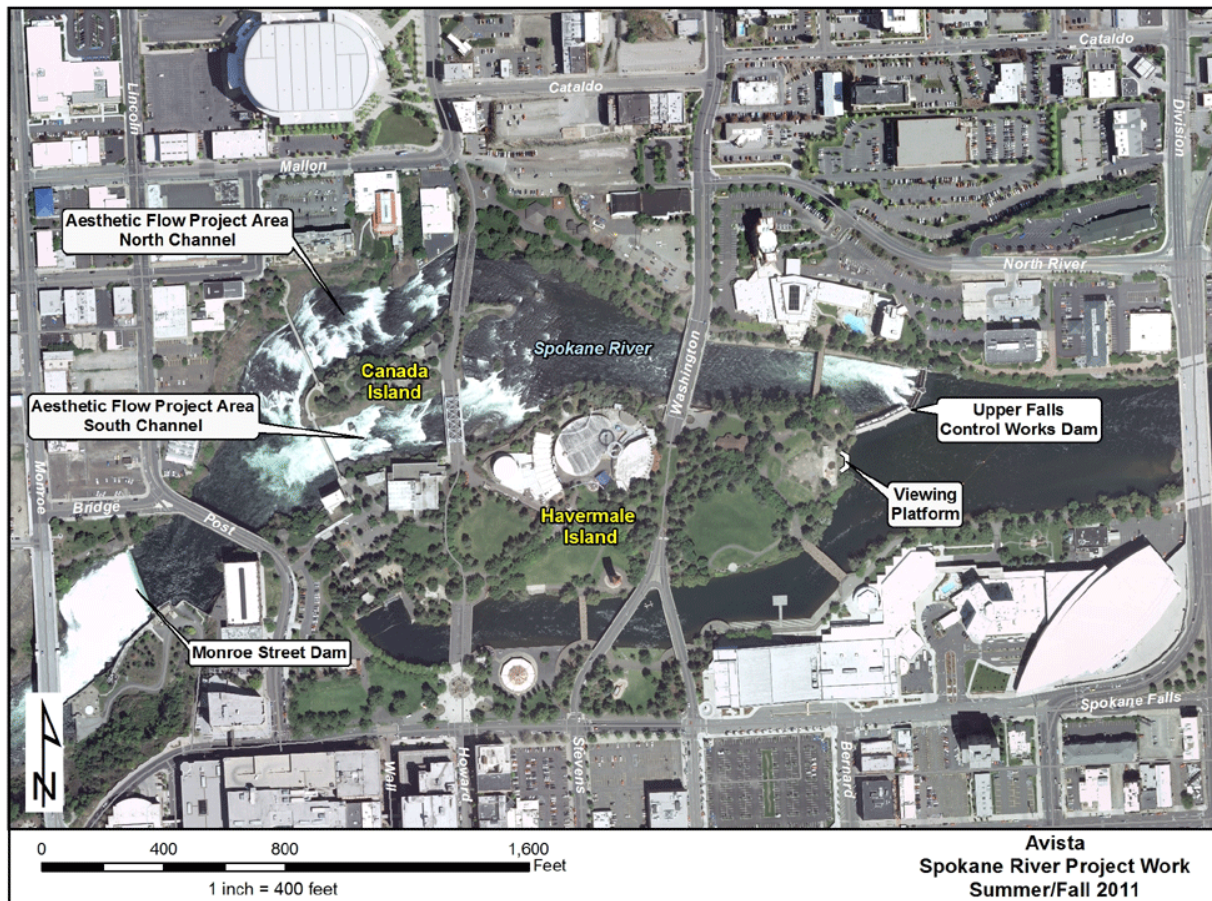
Figure 2, Map of the aesthetic flows project area.

The Upper Falls Hydroelectric Development was up for relicensing in the early 2000s. Stakeholders requested an aesthetics study for the Upper Falls Development as part of relicensing to identify when river flows provided aesthetic views for the public. Avista worked with stakeholders including the City of Spokane, Friends of the Falls, Spokane Canoe and Kayak Club, the Friends of the Centennial Trail, and The Sierra Club to explore alternatives to increase aesthetics in the north channel (Richards 2012). Installing weirs in the channel was the agreed upon solution to divert more water to the north channel and spread it out more evenly.

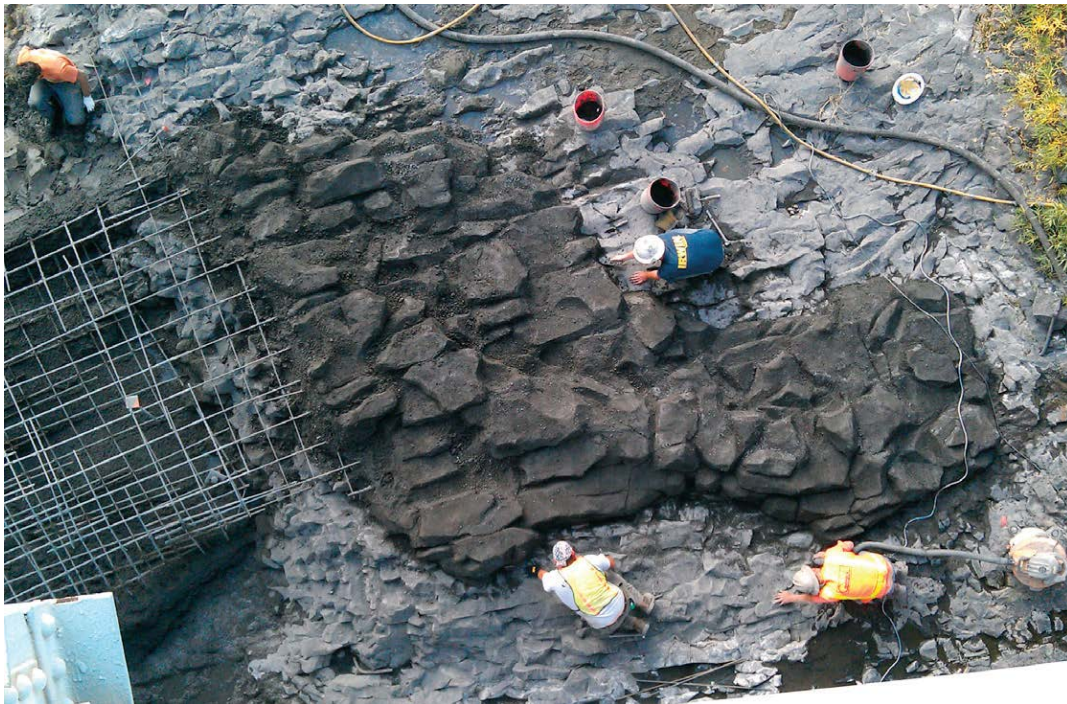
**Figure 4, Construction workers sculpting concrete over a metal framework.**

Construction was carried out in the summer of 2012. A total of 9 weirs were installed; one large weir upstream of Canada Island to divert more water into the north channel, and 8 additional weirs in the north channel to spread flow. Weirs were constructed of reinforced concrete sprayed over a metal framework anchored into bedrock. Concrete was hand sculpted to achieve a bedrock-like texture and blend into the basalt (Figure 4).

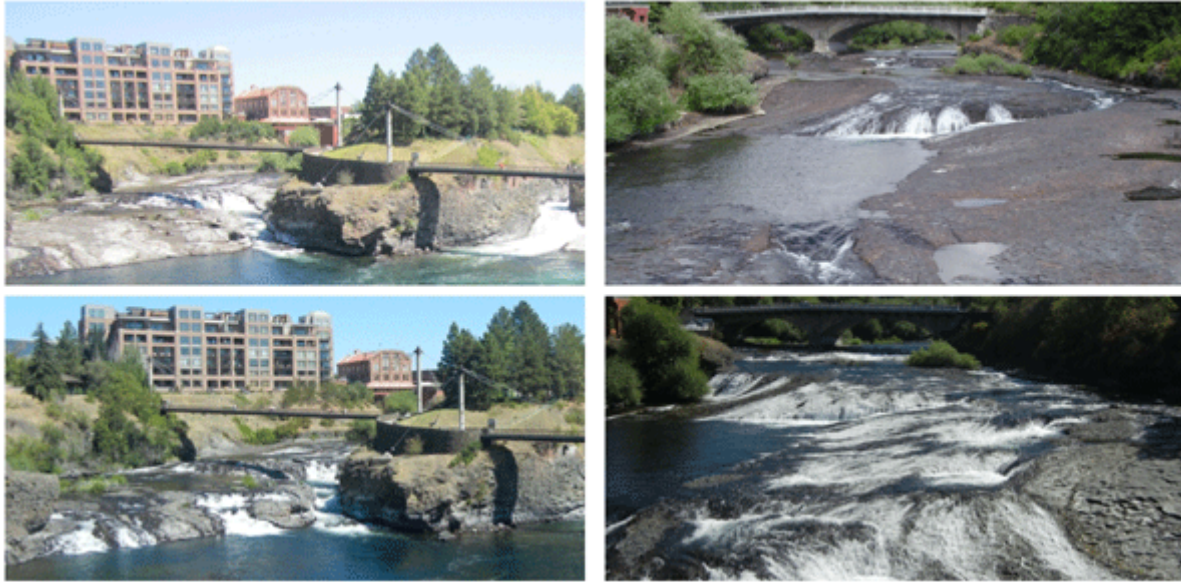
**Figure 3, North channel before (top at 500cfs) and after (bottom at 300cfs) construction.**

These weirs increased flow in the north channel and diverted water away from the man made cut where the river flows along the downstream tip of Canada Island (figure 3). Where water used to flow through a notch in the north channel, it is now spread over the entire face of the bedrock providing improved fish habitat and aesthetics for viewers (Fitzhugh 2015).
