*Morphology and Dynamics of the Sandy River at the Boat Ramp
in Oxbow Regional Park, Oregon*

Metro Regional Parks and Greenspaces

Final Report
December 2000

The Sandy River at Oxbow Park, Oregon
Morphology and dynamics in the vicinity of the boat ramp

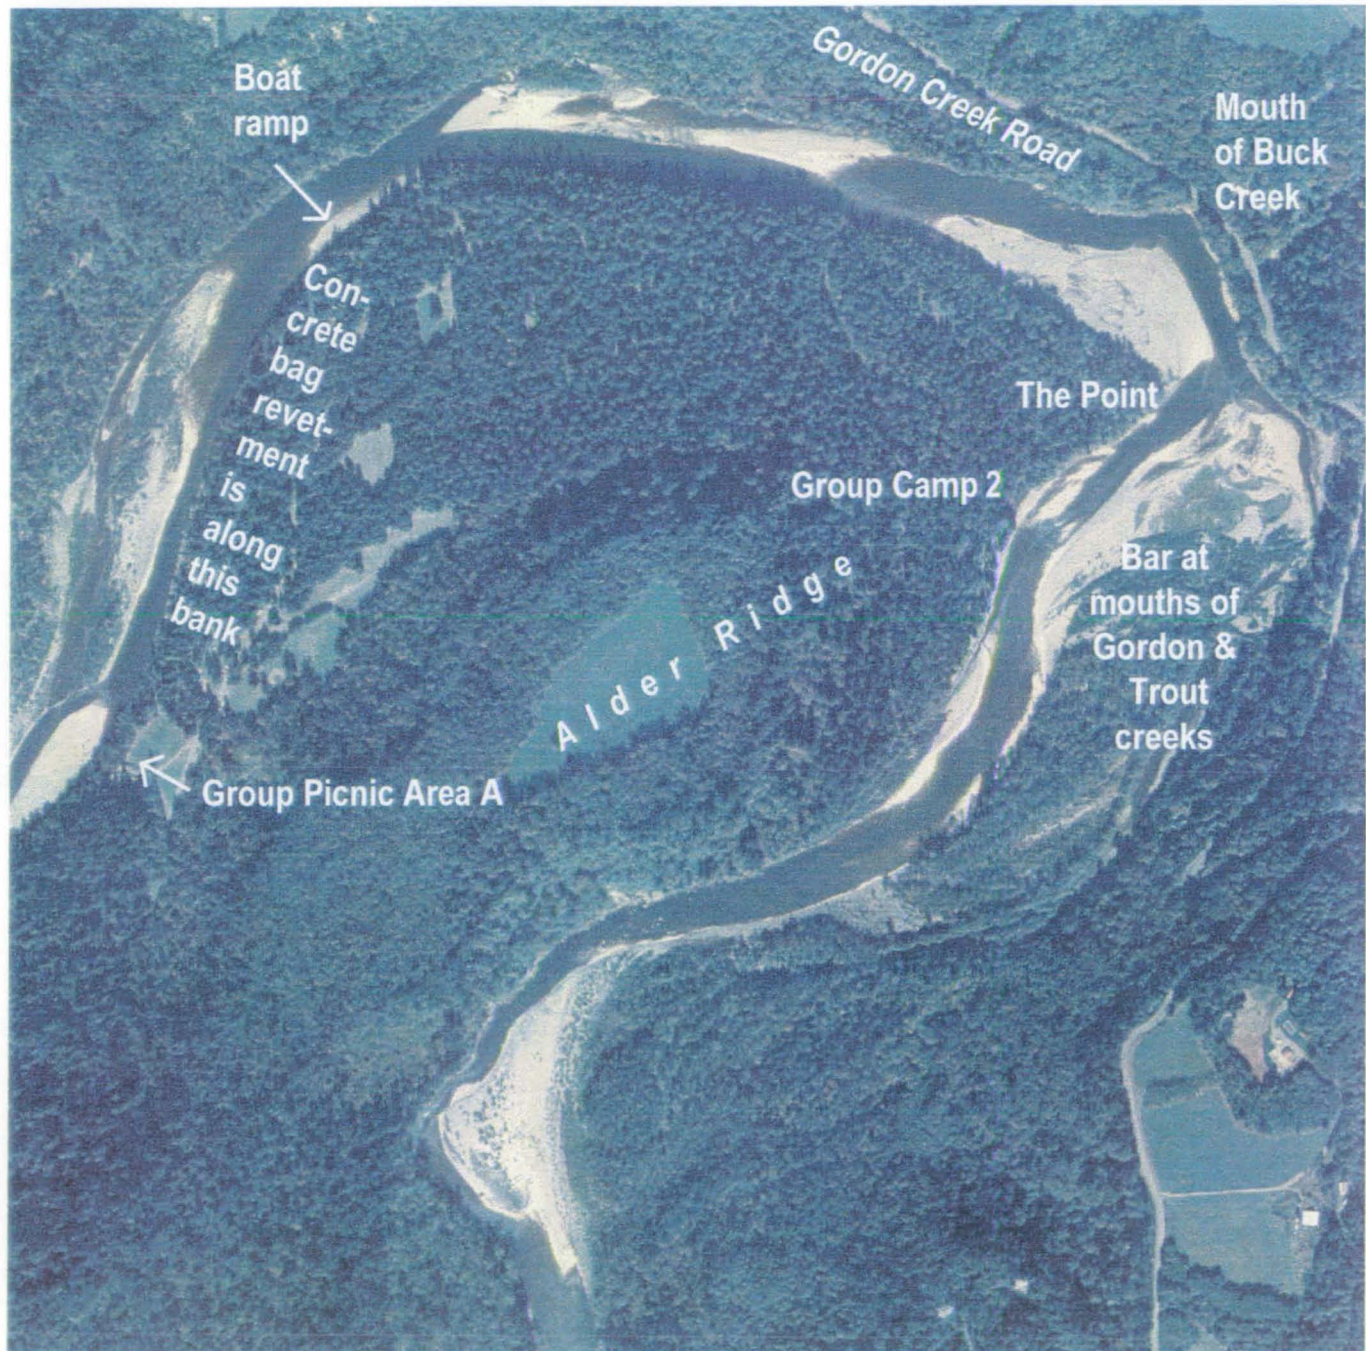
Figure 3: The Sandy River around Alder Ridge in Oxbow Regional Park

*The bright areas along the river in this 1997 photo show areas of erosion and deposition after the 1996 flood. Dynamic bank erosion occurred in the vicinity of Group Camp #2, and dynamic deposition occurred on the downstream tip of the bar at the mouths of Gordon and Trout Creeks and created an extensive bar downstream of "The Point."*

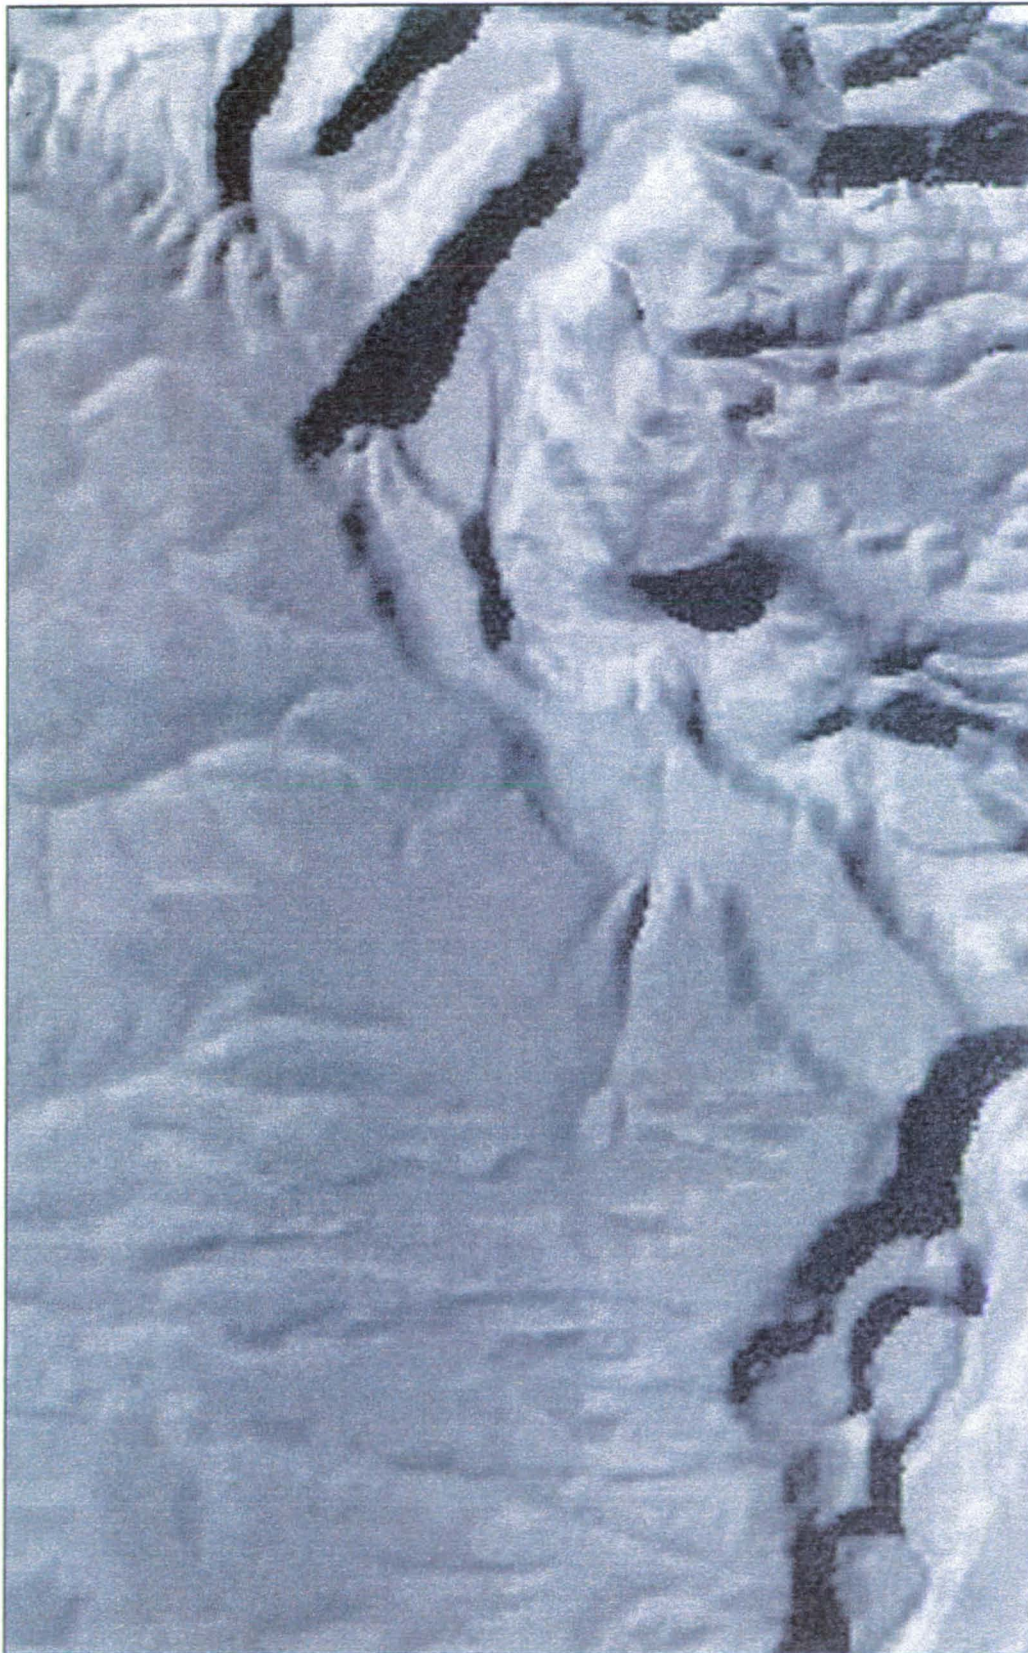
**Figure 4: The inner gorge of the Sandy River.**

Direct stream erosion of gravel-bearing strata is one source of sediments to the modern-day Sandy River system. Landslides and debris flows on the steep inner gorges of the river is another (*please see Figure 4, next page*).<sup>16</sup> Glacially-derived sediments are transported into the system from moraine deposits in the Brightwood area and other locations in the upper watershed.<sup>17</sup> Channel downcutting and valley widening processes also add rock detritus to the river system. All these sediments are transported downstream to the lower reaches of the river where decreased gradient and velocity allow their deposition. The relatively low gradient of the river and the moderate valley confinement at Oxbow Park make this reach of the Sandy a dynamic zone of sediment deposition and transport.

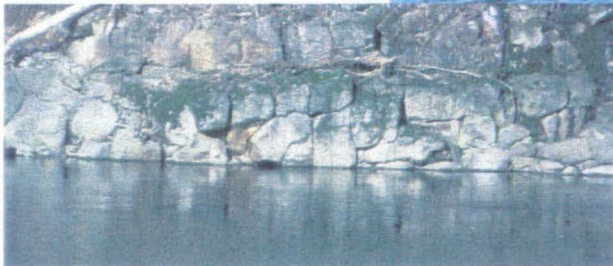
Boring lava, Troutdale formation and Sandy River mudstone confine the channel on the outside bend starting below the mouth of Gordon and Trout creeks.

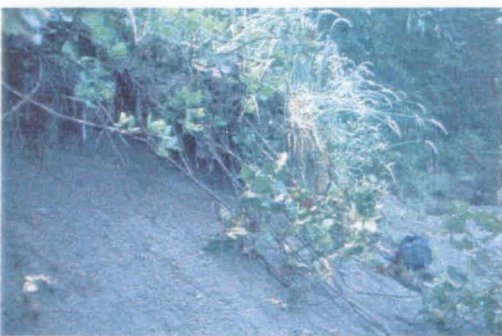
Erosion of the streambank near Group Camp 2 proceeds as follows: Ordinary bankfull events exert shear stresses on the highly erodible lahar sands comprising the riverbank. Materials at the toe of the bank are swept away and the top of the bank is undercut. The bank is not stable at such a

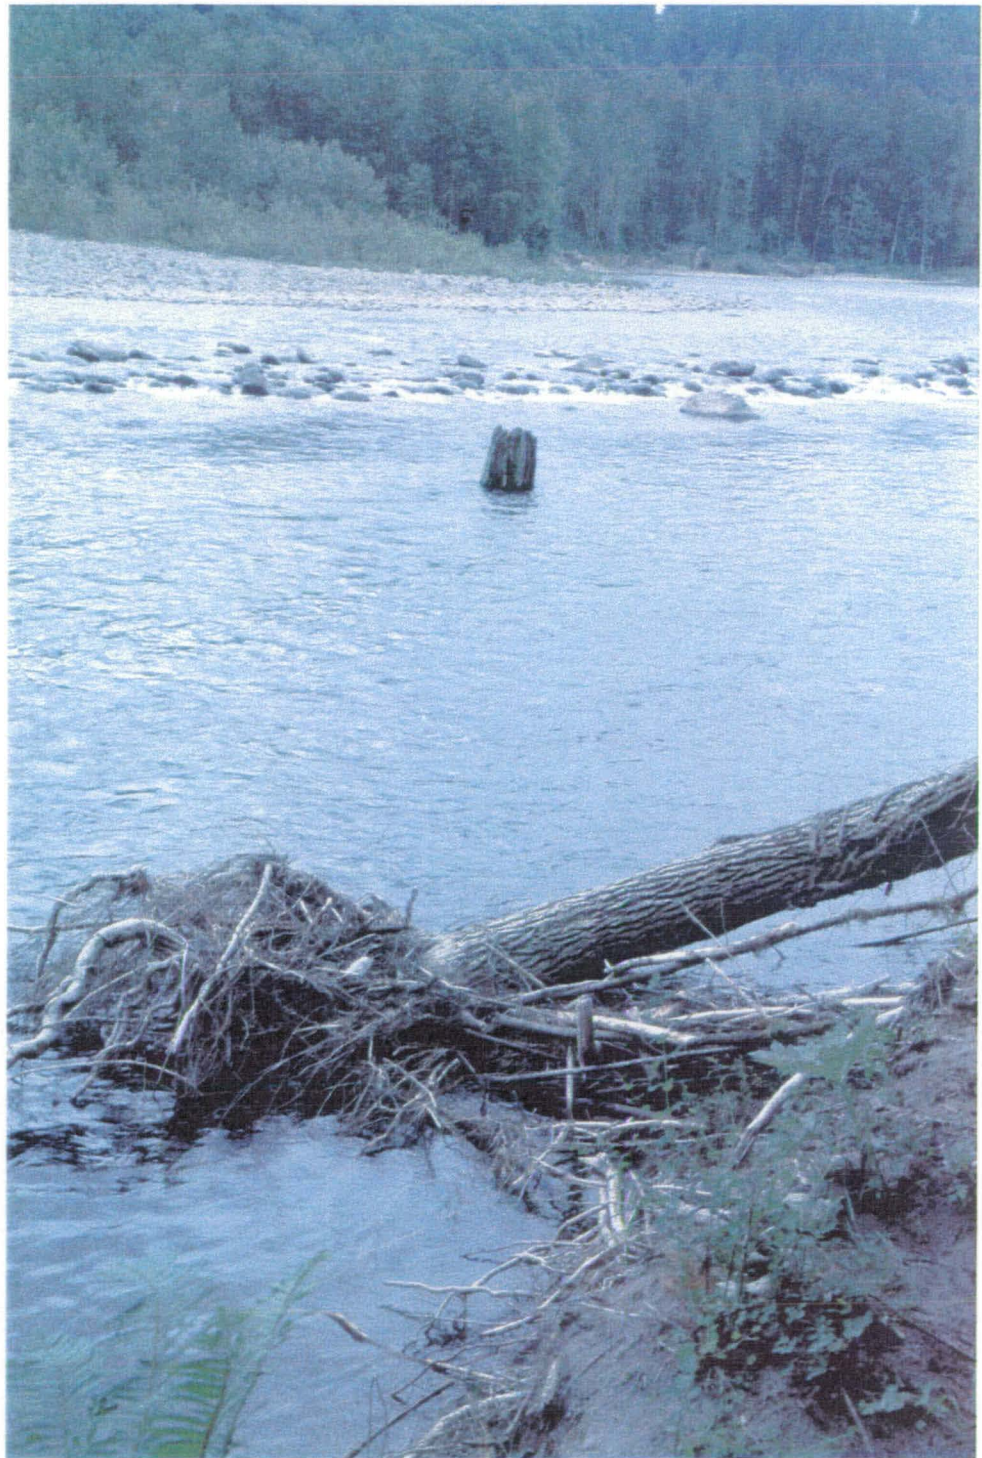
According to park managers, the Thanksgiving Day storm of 1999 exposed this stump in the channel near Group Camp 2. This tree is thought to have been buried by sediment-laden runoff from lahar activity during the Old Maid eruptive period, about 200 years ago. This tree is rooted below the bed of the present-day channel, suggesting that incision through the lahar materials is still taking place in this reach. This is consistent with findings that incision is taking place at several nearby locations downstream. The lahar terrace level eroded in the vicinity of Group Camp 2 by the high flow events of '96 and '99 has already been removed in downstream locations where greater channel incision has taken place. This photo was taken from the bank near Group Camp 2, looking obliquely upstream across the channel toward the upstream end of the bar at the mouths of Gordon and Trout creeks also shown on the next page.

Left: The 1999 Thanksgiving Day flood exhumed a tree in growth position in the channel in the vicinity of Group Camp 2.

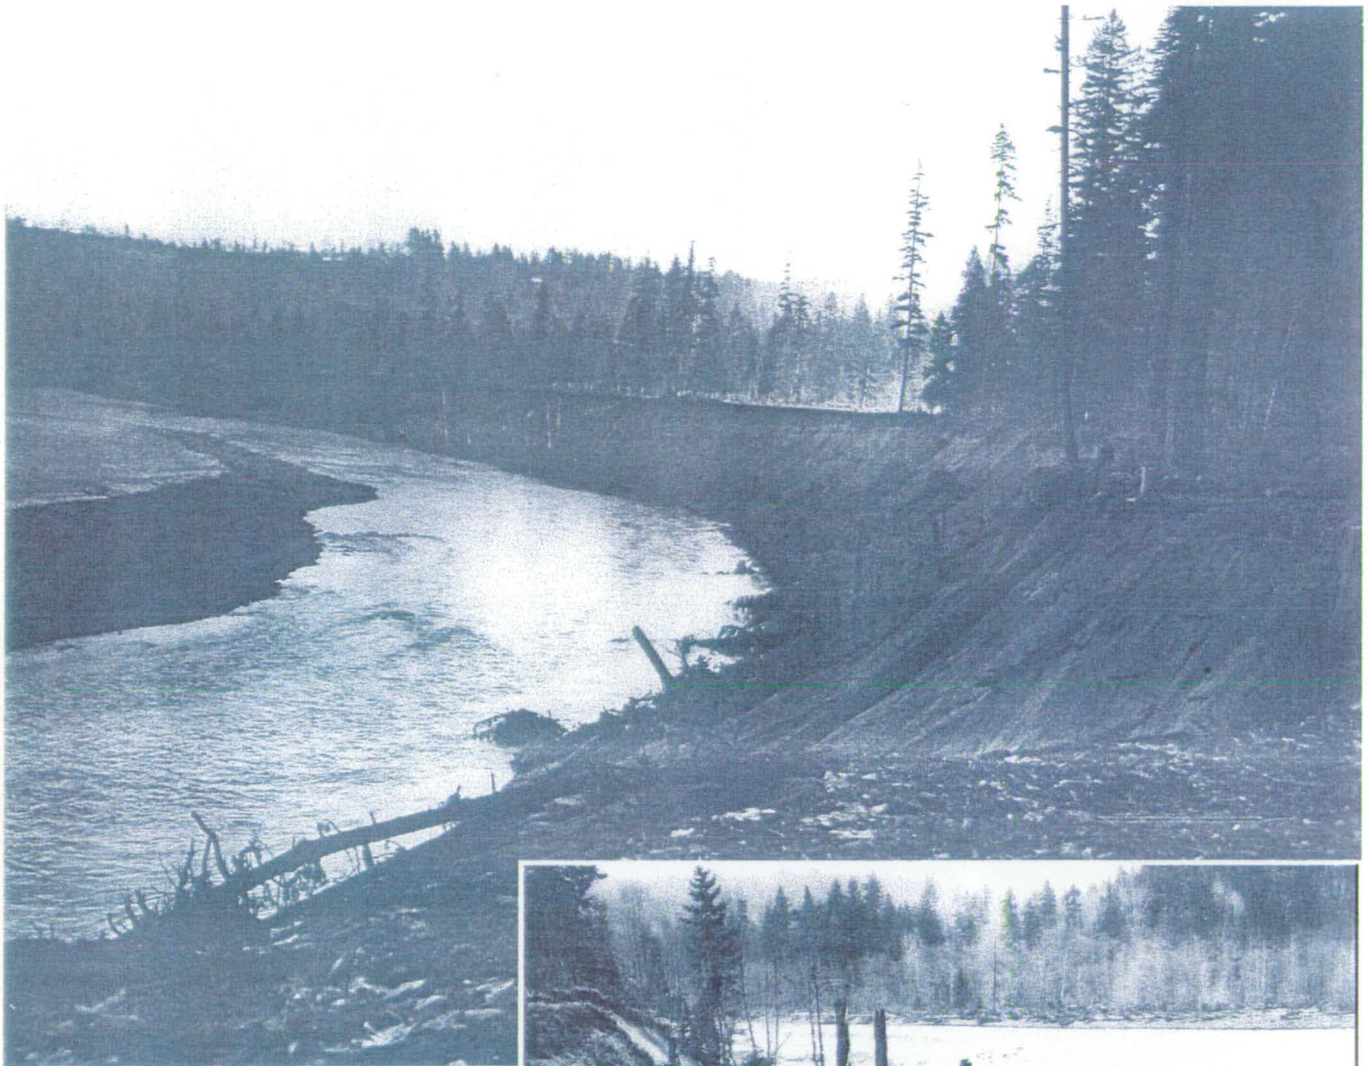
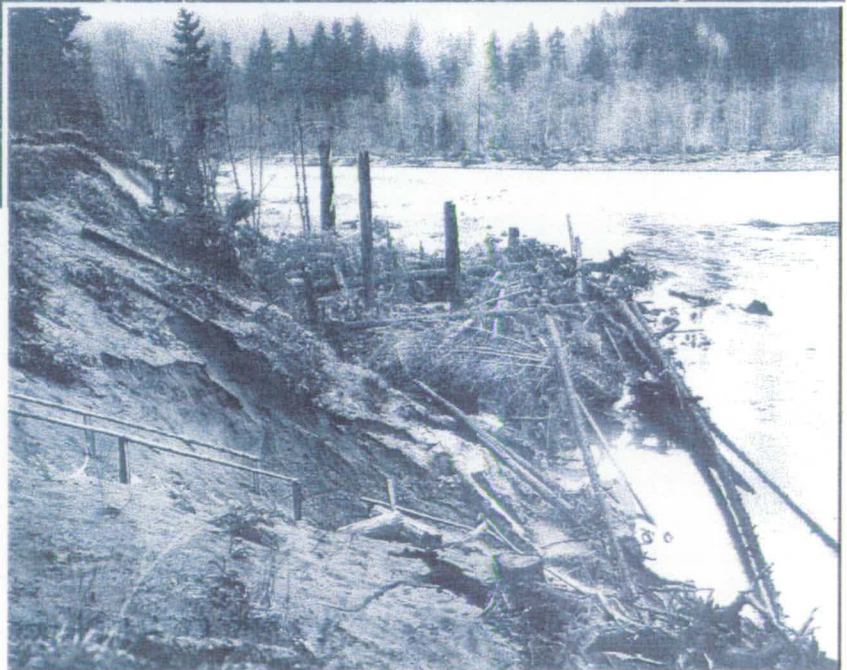
The 1964 flood exhumed forests that had been buried during rapid aggradation after the Old Maid eruptive period on Mount Hood, about 200 years ago. The area pictured is the long bank downstream of the present-day boat ramp. This bank was subsequently armored with a concrete bag revetment built by the Youth Conservation Corps in the late 1960s.

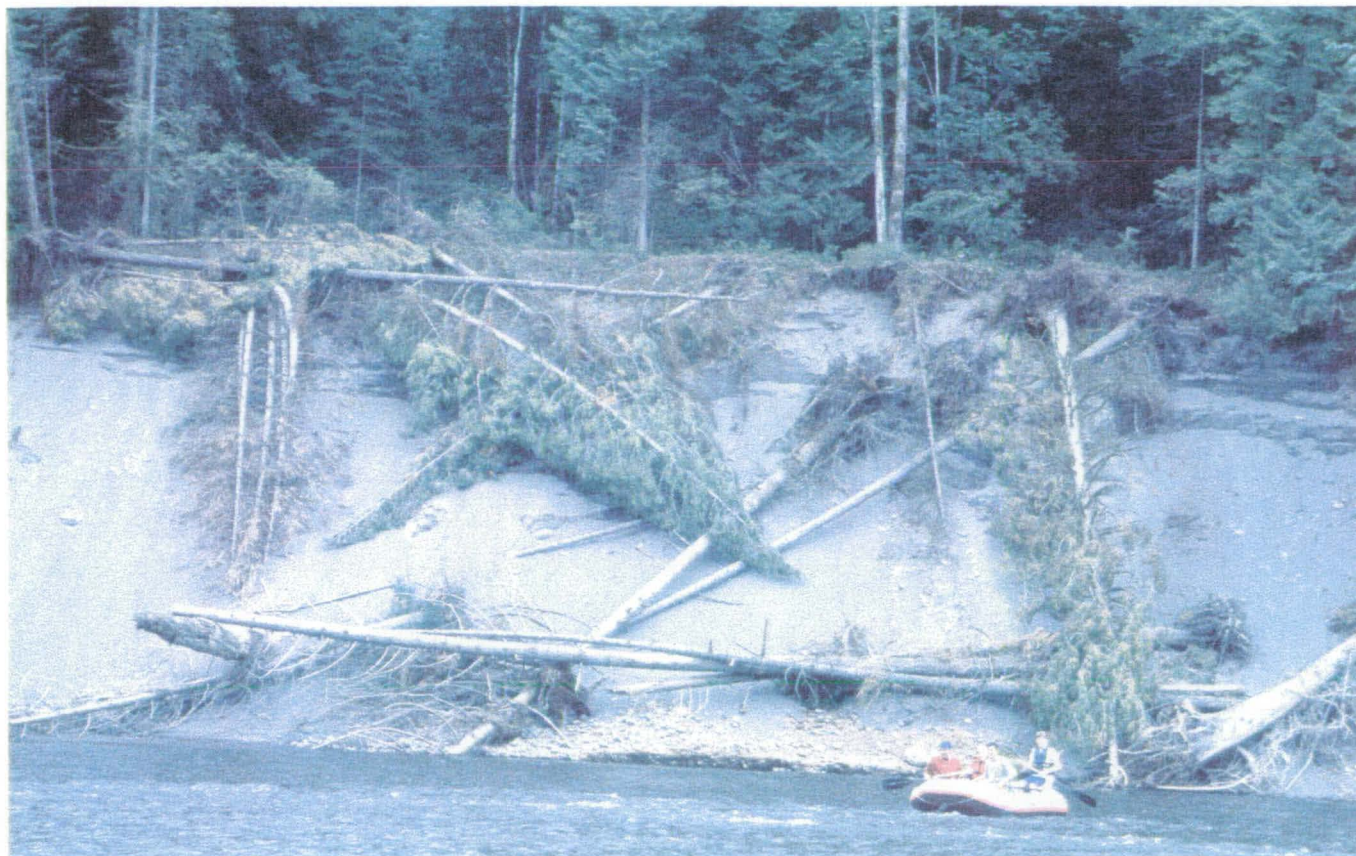
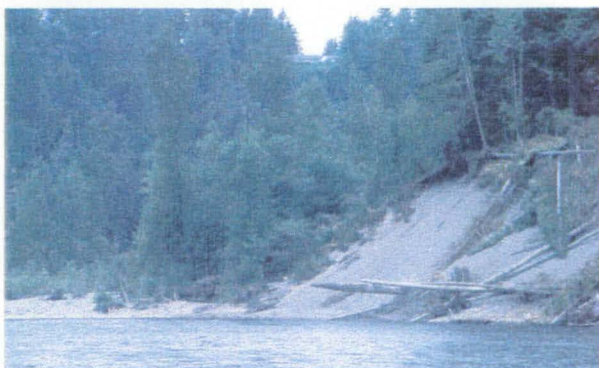
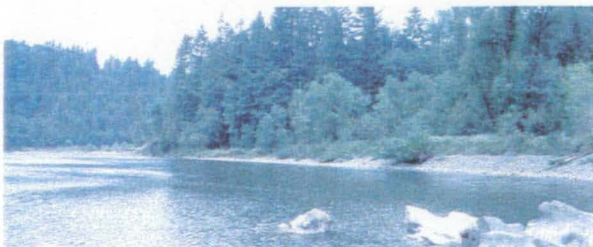
Photo
page
10

Another striking exposure of trees buried by lahar outwash is located approximately opposite Picnic Area B in the park. In the photo above, the tree in horizontal position is being exhumed. The others have fallen from above, having succumbed to bank failure caused by undercutting and oversteepening. In the photo to the left, note the elevation of the active floodplain on the left (downstream is to the left). The bottom photo shows the floodplain just upstream of this remnant lahar terrace. Thus, the terrace is being eroded both vertically and laterally by bankfull flows as well as flows of greater magnitude.
