United States Department of the Interior

FISH AND WILDLIFE SERVICE

Re: Smith-Bybee Lake Water Control Structure and Dike Rehabilitation

SMITH-BYBEE WATER CONTROL STRUCTURE

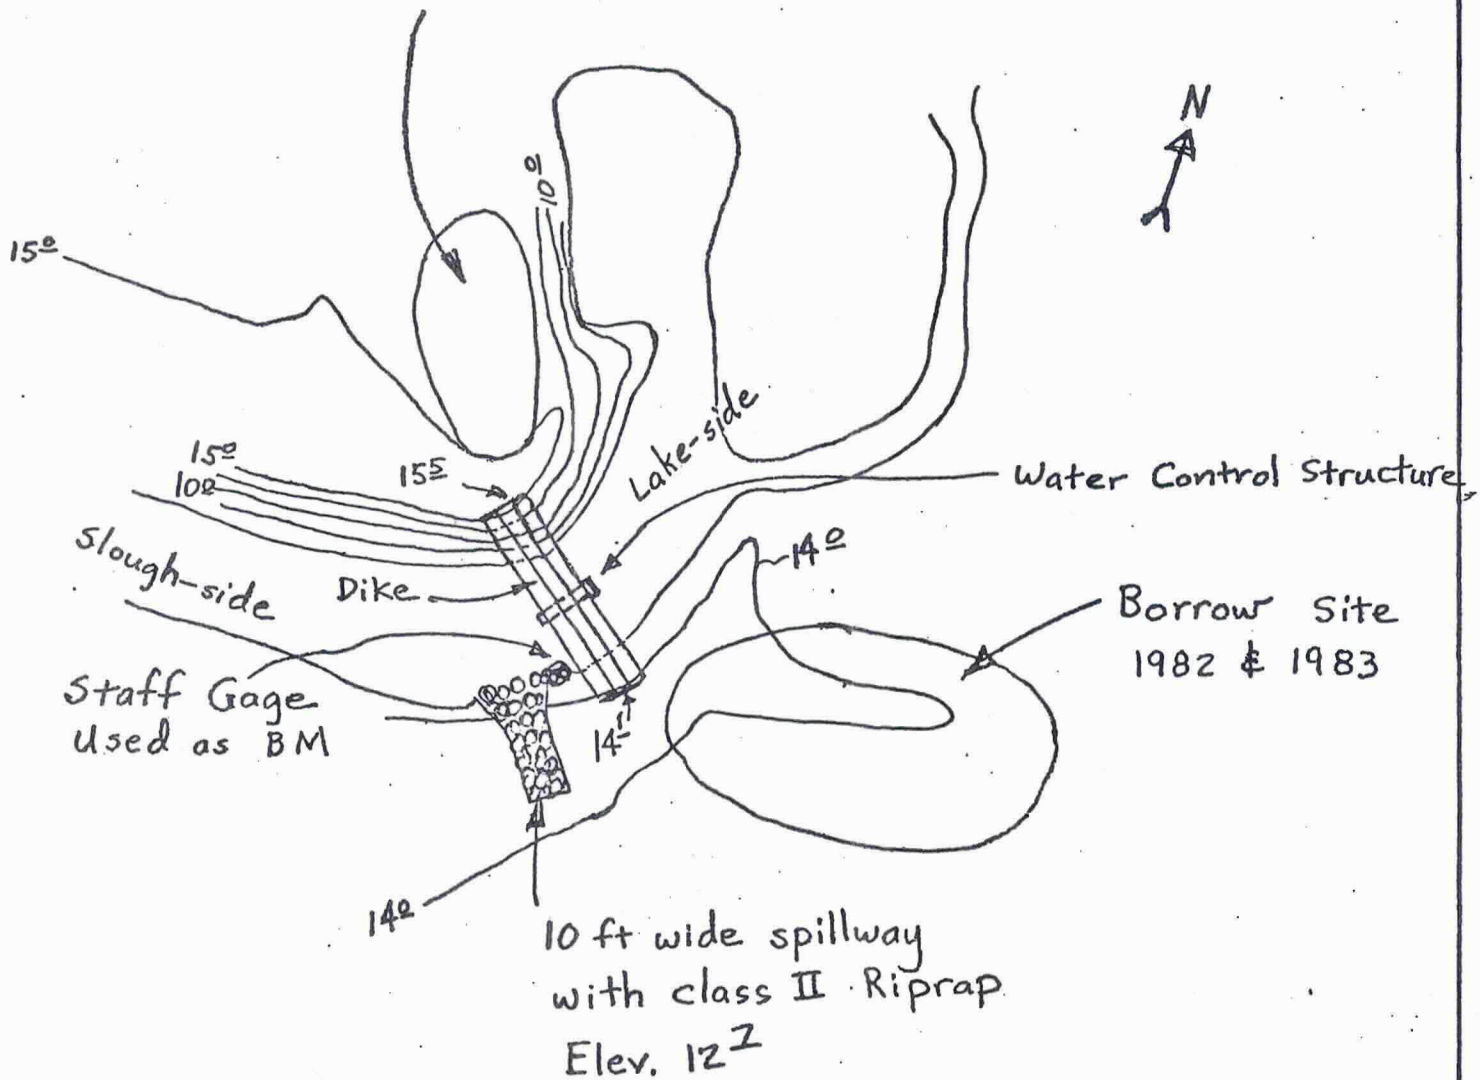
CONTROL STRUCTURE

The rehabilitation work consisted of replacing previously eroded dike material, realigning and relocating the displaced 60-inch diameter CMP, adding anti-flotation devices to the CMP, constructing a natural spillway, and adding riprap material to the surface of the dike.
