Metro
Smith and Bybee Wetlands
Multnomah Channel Marsh
Water Control Facilities
Structural Inspection Report
 March 16, 2015

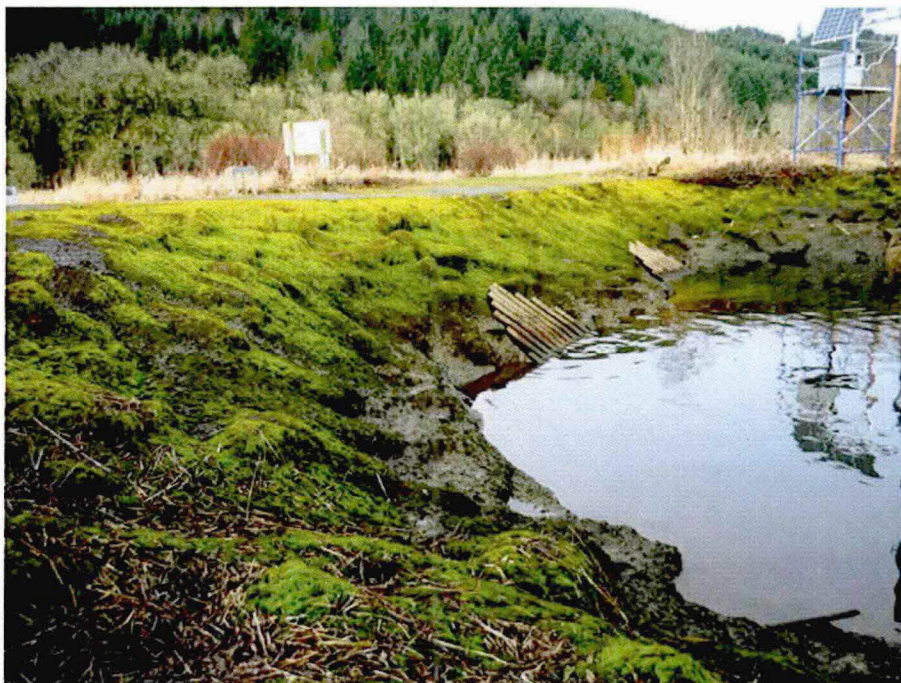
Photo A25: East Elevation (looking northwest)

Grouted rip-rap slopes were covered with moss and appeared to be in good condition (see photo A25).
