**PHASE 2 STABILIZATION
PLANNING AND DESIGN ANALYSIS**

ST. JOHNS LANDFILL - PORTLAND, OREGON

REPORT July 2005

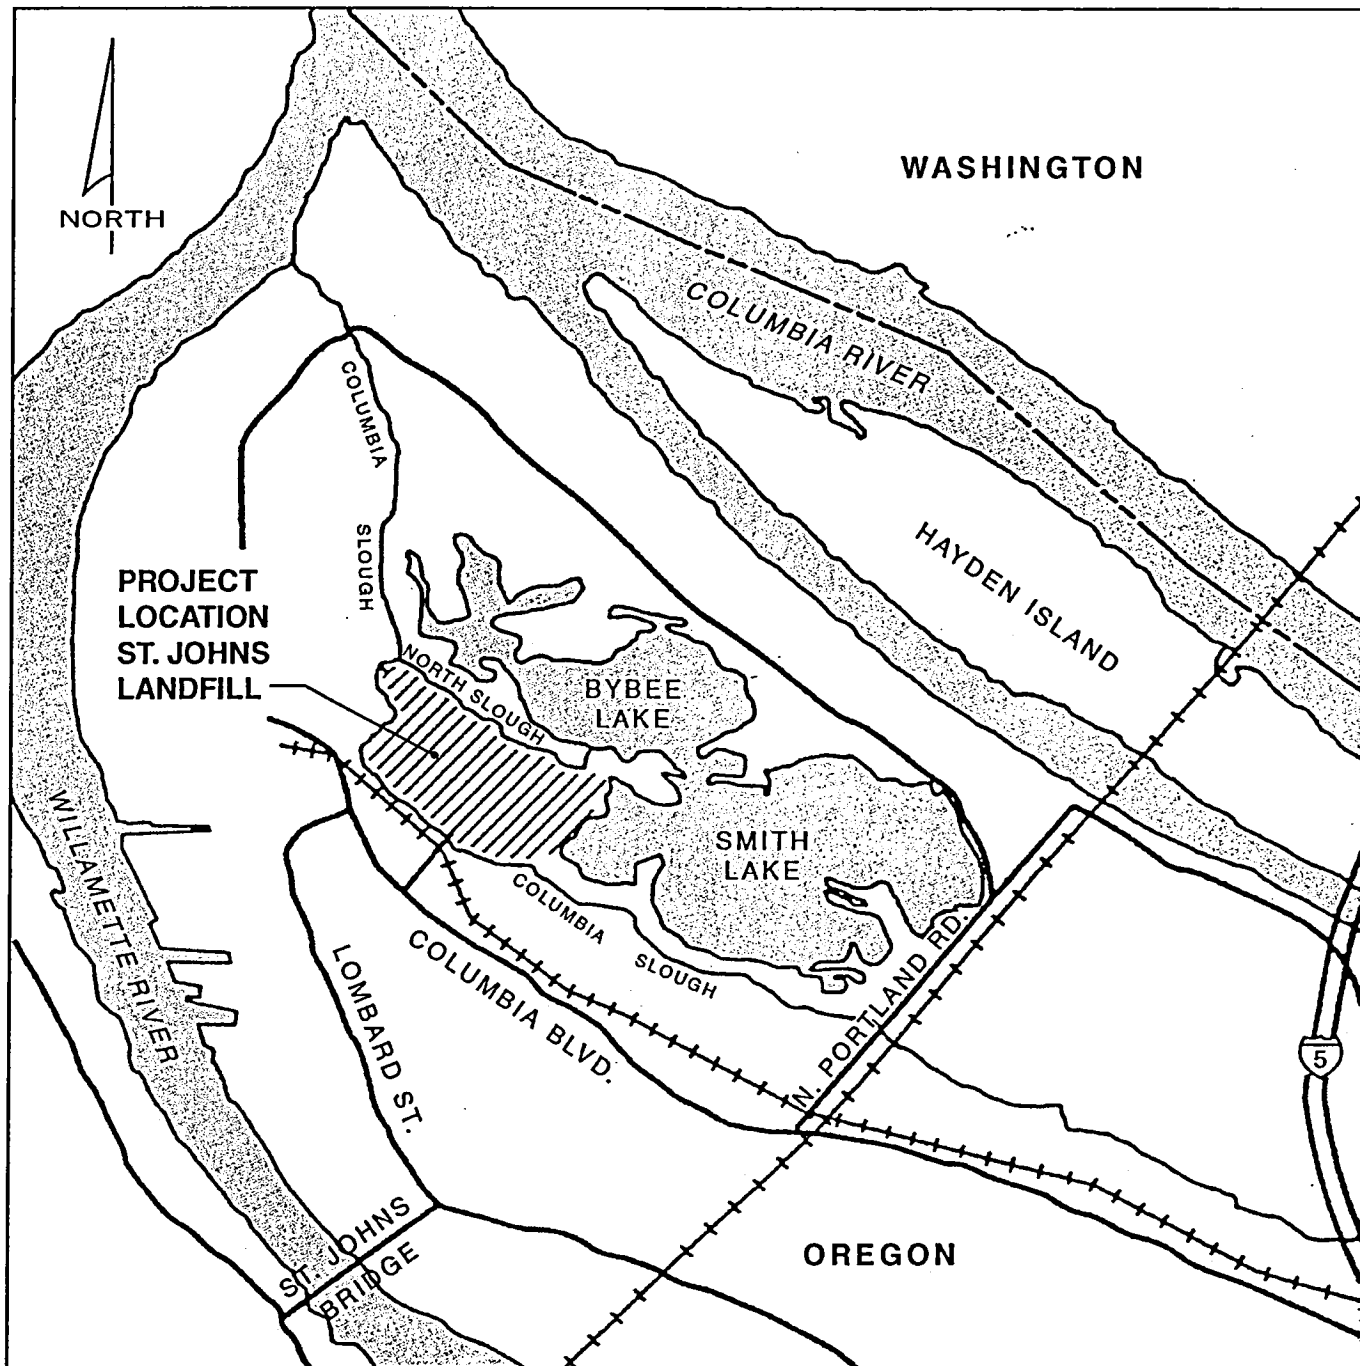
FIG. 4

Similar to previous reconnaissances of the site, the erosion appears to be most severe below the average high tide waterline. The eroded toe condition is essentially continuous around the non-repaired areas, and there are indications of isolated minor shallow slumps. The most notable scour and slumping appears to be between Sections 9 and 10, and also near Section 12 (Fig. 2). The dike segment between Section 9 and 10 exhibits heavy undercutting of the toe, which has exposed the root masses of numerous trees. Several of the trees have fallen into the slough in this area. The inspection team also observed a few isolated bowl-shaped depressions in the upper portion of the slope through this area, which suggests that some shallow slumping has occurred. As discussed previously, the prioritized Phase 2 repair area lies within this segment of the dike. A photograph of existing shoreline conditions between Sections 9 and 10 is shown on Figure 4.

The dike in the vicinity of Section 12 shows signs of significant erosion and recent slope failures. A photograph of a slope failure near Section 12 is shown on Figure 4. We observed headscarp cracks near the crest of the dike and relatively large bowl-shaped slump features. The ongoing erosion and slumping through this area are occurring in a segment of the naturally formed dike. The engineered dike for the landfill is setback approximately 100 feet through this area, which indicates that it is in no immediate danger of failure. On that basis, the dike segment around Section 12 is not considered a priority repair area.

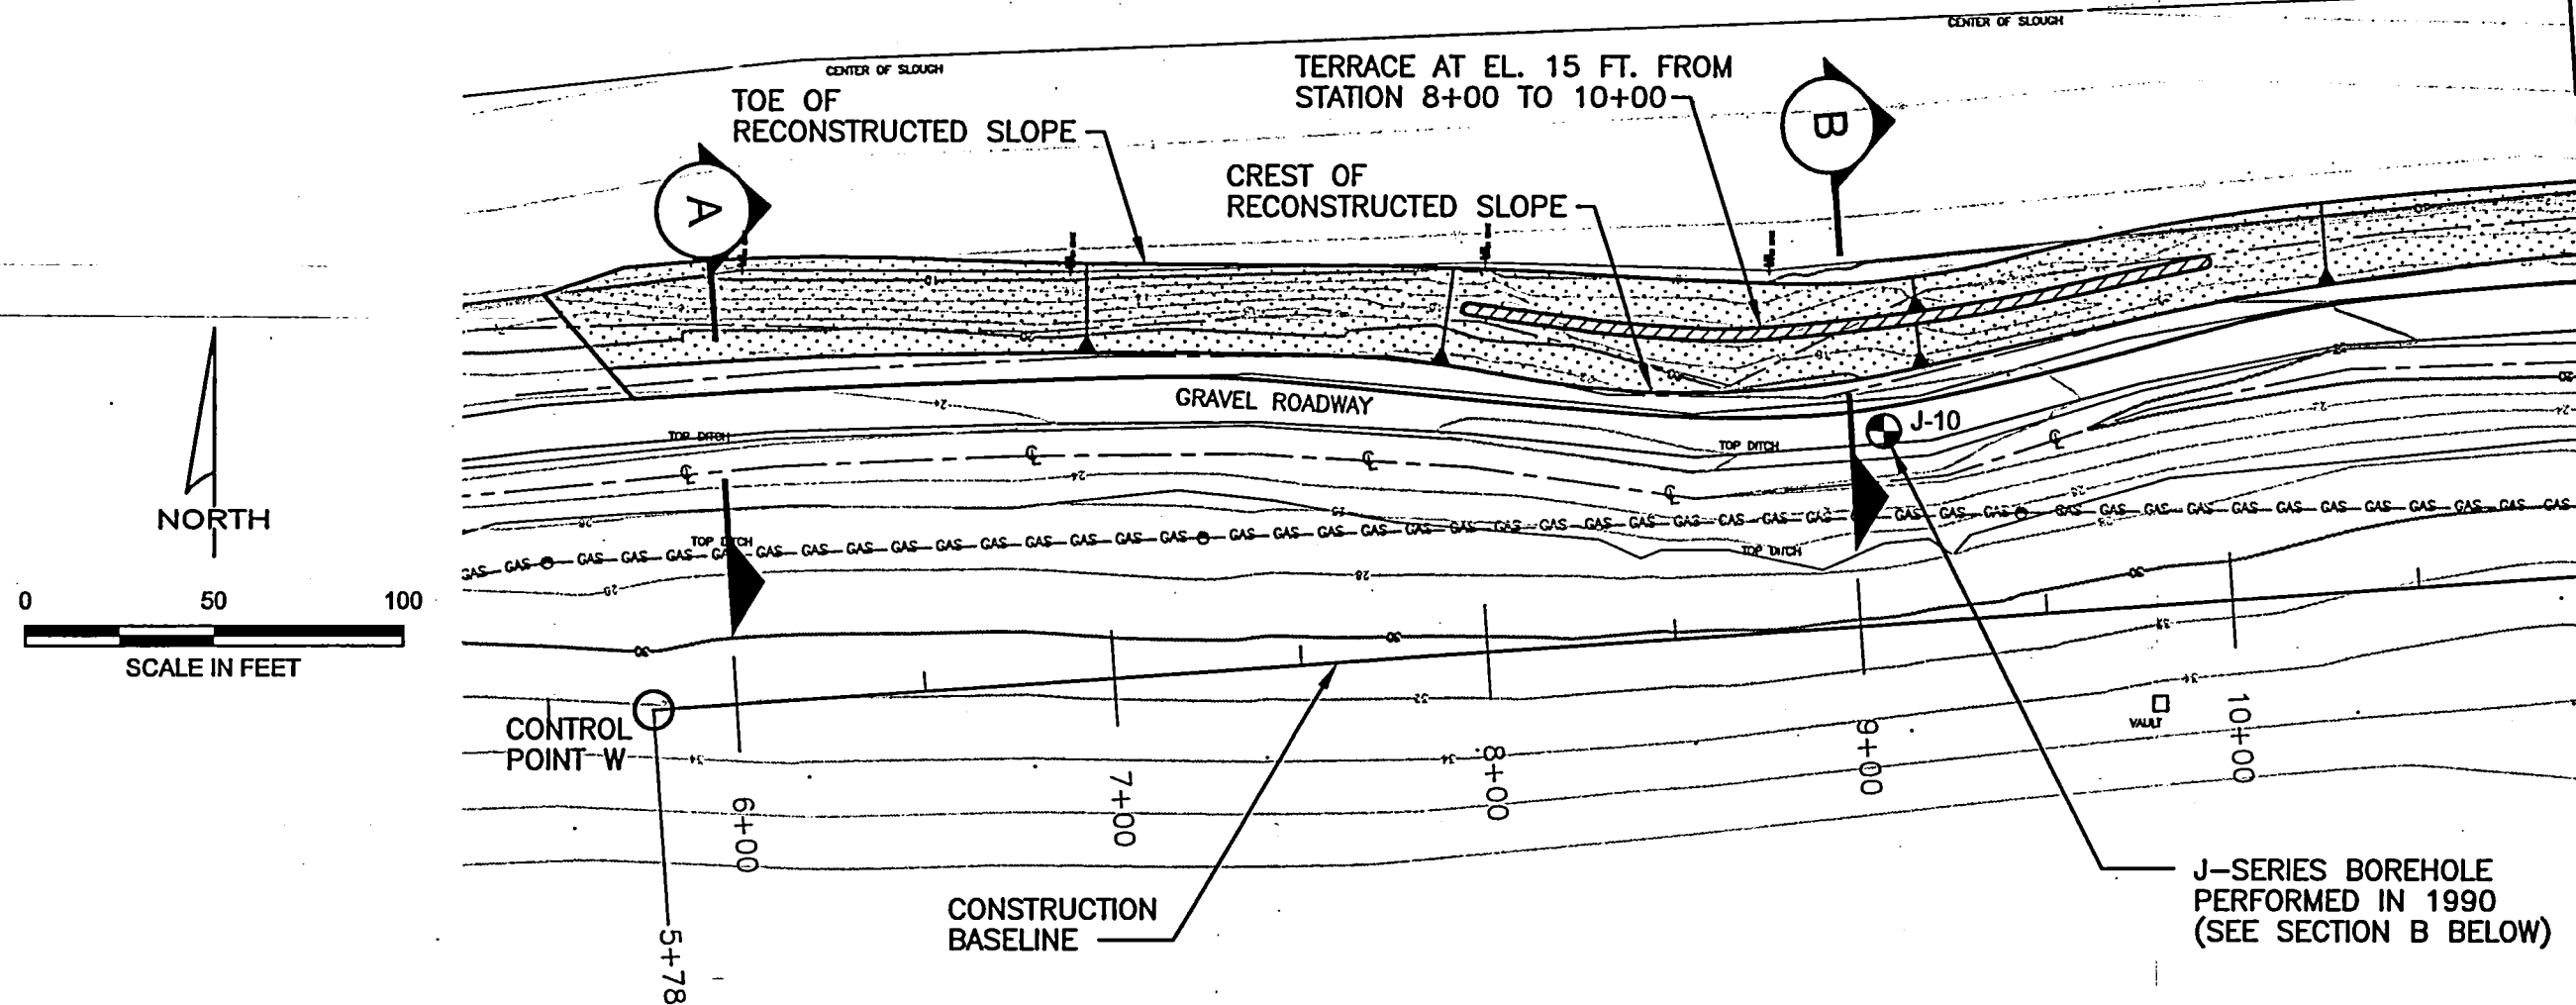
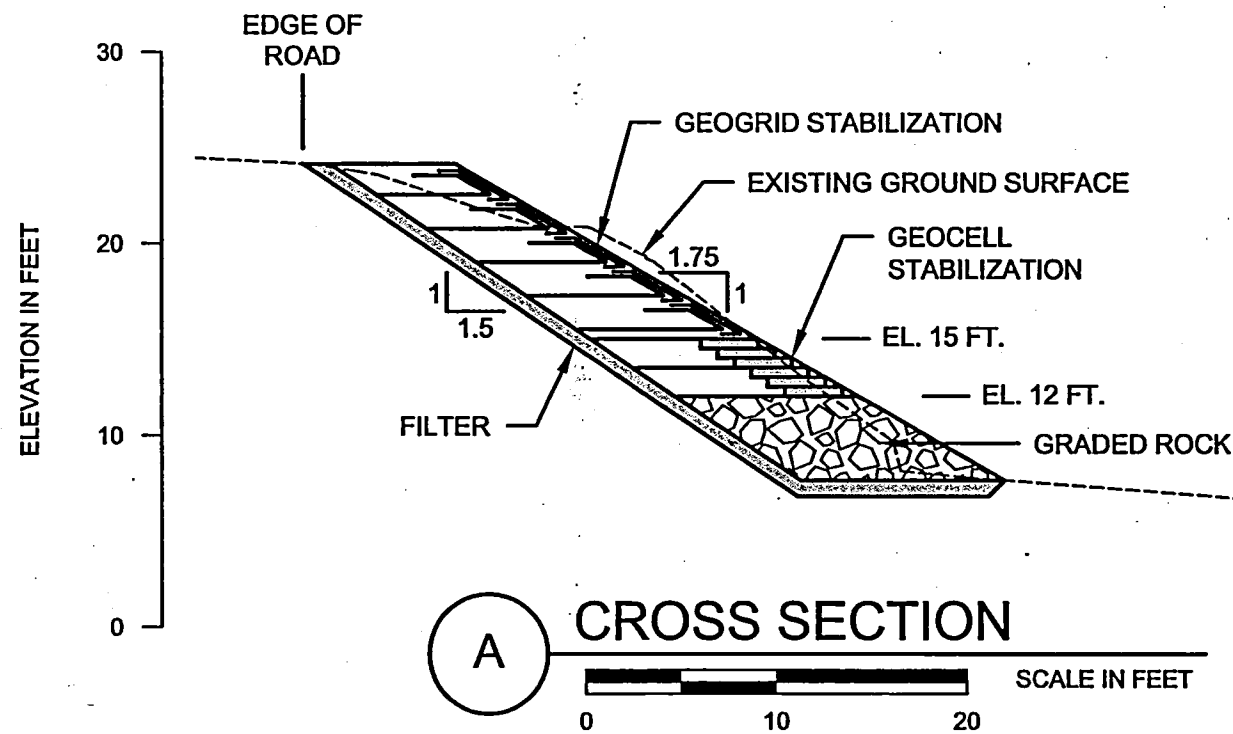
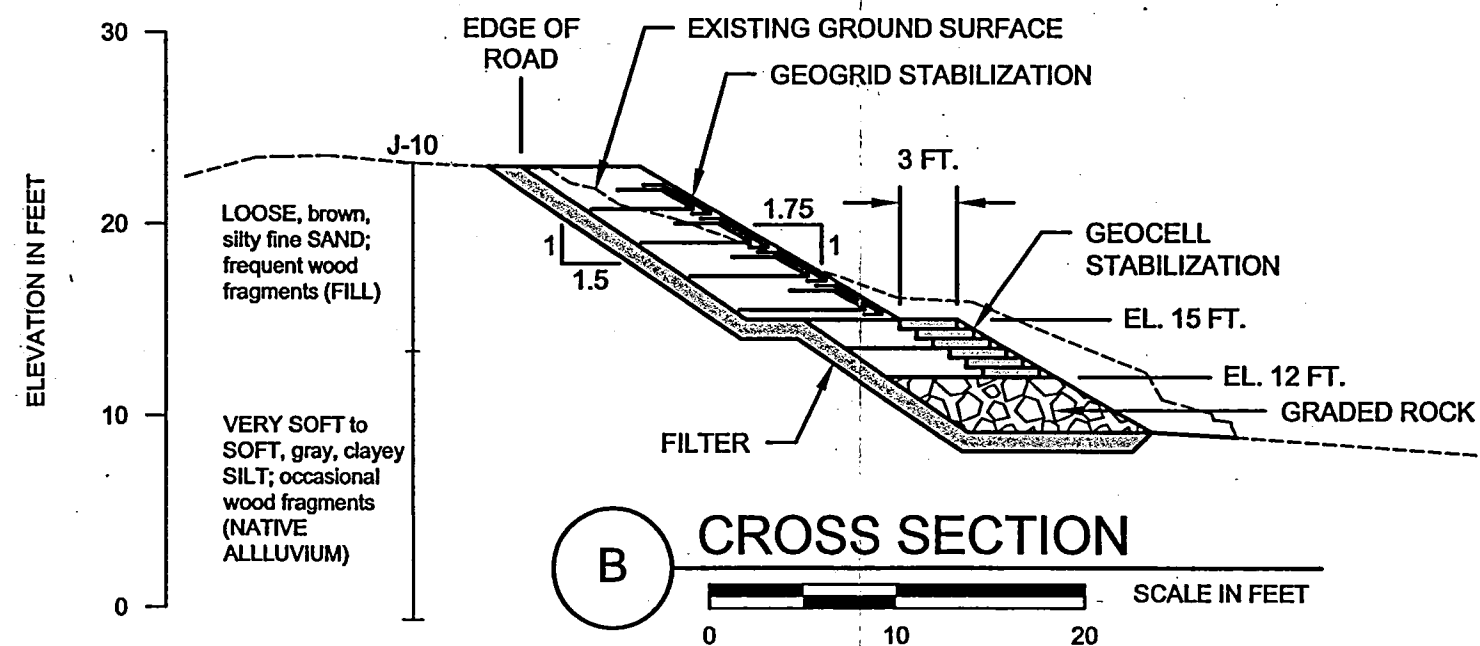
Topographic Map. Crane & Merseth Engineering/Surveying prepared a topographic map and cross-sections of the priority Phase 2 repair area in August 2004. The topographic map is shown on Figures 5 and 6. Crane & Merseth arbitrarily selected the stationing shown on the figures. Station 15+78 on Figure 6 coincides with the west end (i.e., Section 10) of the Phase 1 repair area that occurred in 2000.
