HAZARDOUS MATERIALS SURVEY REPORT

WILLAMETTE FALLS RIVERWALK, PHASE 1—OREGON CITY,
OREGON

Prepared for
METRO REGIONAL GOVERNMENT
April 25, 2018
Project No. 0075.06.02

Prepared by
Maul Foster & Alongi, Inc.
2001 NW 19th Avenue, Suite 200, Portland, OR 97209

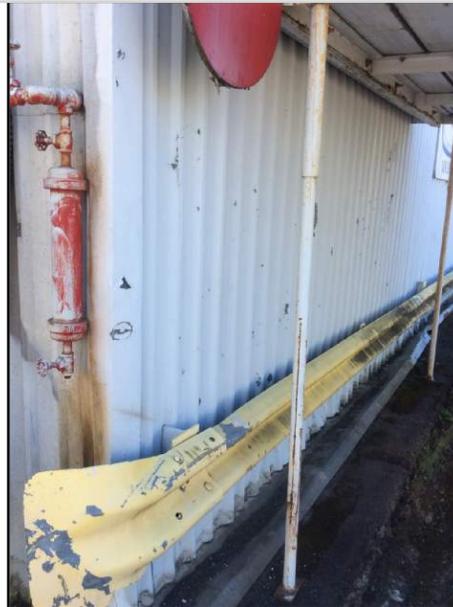
Observation ID:	Detailed Sample Location:
HBM-AAM-1-PB-1	Exterior painted surfaces of butler building
Type of Sample:	Specify Miscellaneous Material (if applicable):
PB	
Sample Color:	Sample Quantity:
White

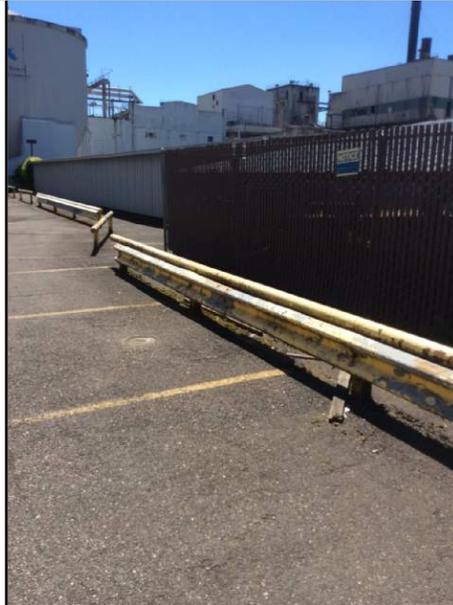
Observation ID:	Detailed Sample Location:
HBM-AAM-1-PB-2	Yellow bumpers and guardrails
Type of Sample:	Specify Miscellaneous Material (if applicable):
PB	
Sample Color:	Sample Quantity:
Yellow	2,000 sq. ft.

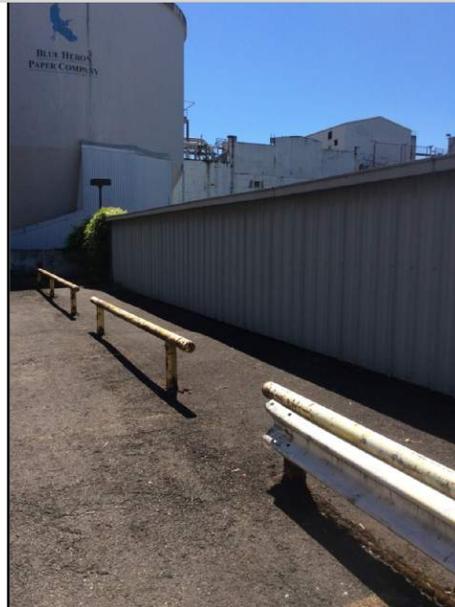
Observation ID:	Detailed Sample Location:
HBM-AAM-1-PB-3	Exterior painted surfaces of woolen mill
Type of Sample:	Specify Miscellaneous Material (if applicable):
PB	
Sample Color:	Sample Quantity:
Light gray	150 sq. ft.

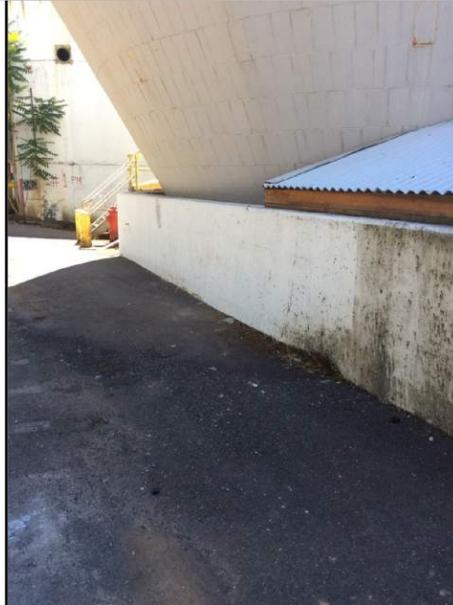
Observation ID:	Detailed Sample Location:
HBM-AAM-1-PB-4	Painted stock cylinder concrete base
Type of Sample:	Specify Miscellaneous Material (if applicable):
PB	
Sample Color:	Sample Quantity:
White	200 sq. ft.

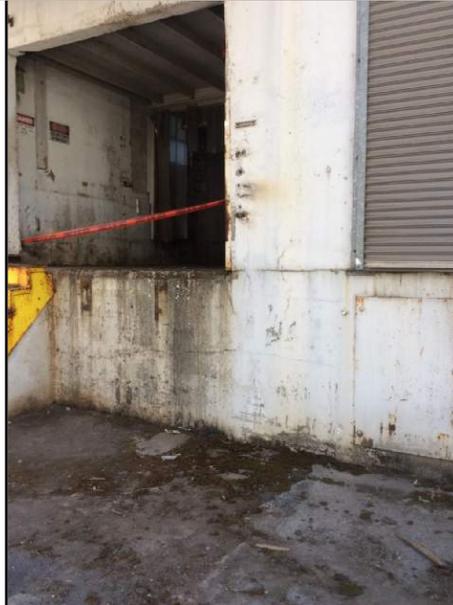
Observation ID:	Detailed Sample Location:
HBM-AAM-1-PB-5	#1 paper mill painted exterior
Type of Sample:	Specify Miscellaneous Material (if applicable):
PB	
Sample Color:	Sample Quantity:
Off white	400 sq. ft.

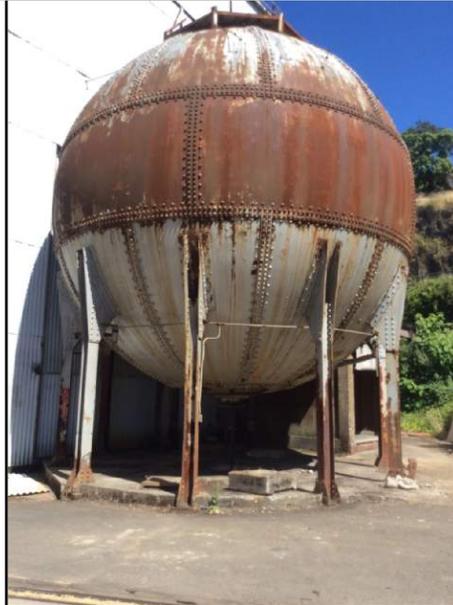
Observation ID:	Detailed Sample Location:
HBM-AAM-1-PB-6	Painted sphere
Type of Sample:	Specify Miscellaneous Material (if applicable):
PB	
Sample Color:	Sample Quantity:
Gray	400 sq. ft.

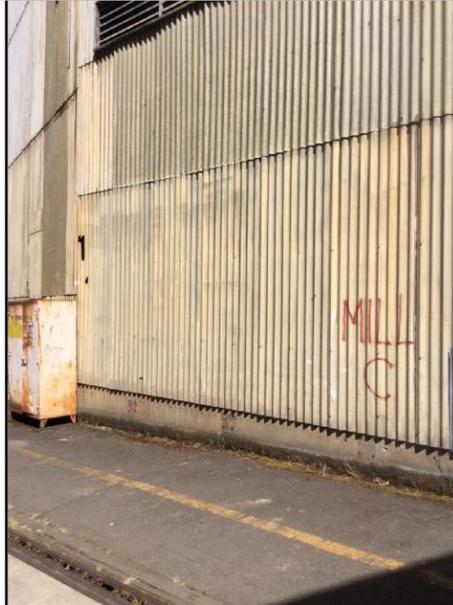
Observation ID:	Detailed Sample Location:
HBM-AAM-1-PB-7	Painted surfaces and transite on sulfate plant
Type of Sample:	Specify Miscellaneous Material (if applicable):
PB	
Sample Color:	Sample Quantity:
Grey	Entire wall face on Main Street

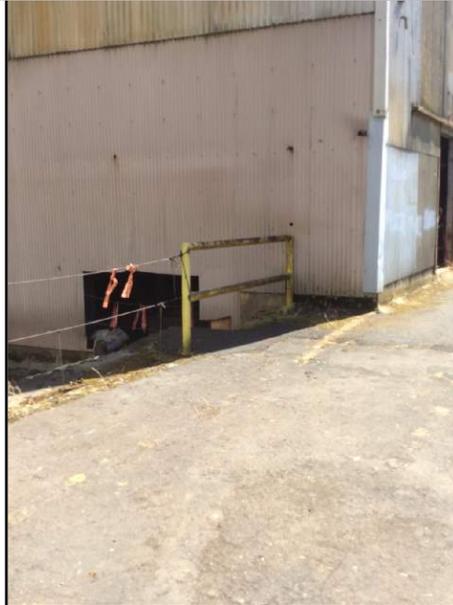
Observation ID:	Detailed Sample Location:
HBM-AAM-1-PB-8	Digester area yellow painted barriers
Type of Sample:	Specify Miscellaneous Material (if applicable):
PB	
Sample Color:	Sample Quantity:
Yellow	80 sq. ft.

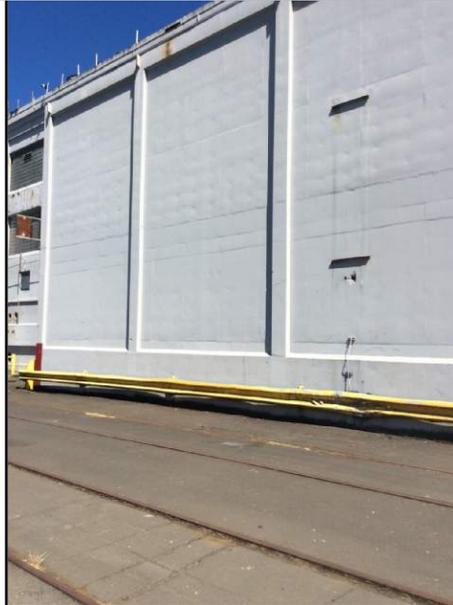
Observation ID:	Detailed Sample Location:
HBM-AAM-1-PB-11	White painted surface of number 4 paper mill
Type of Sample:	Specify Miscellaneous Material (if applicable):
PB	
Sample Color:	Sample Quantity:
White	2,000 sq. ft.

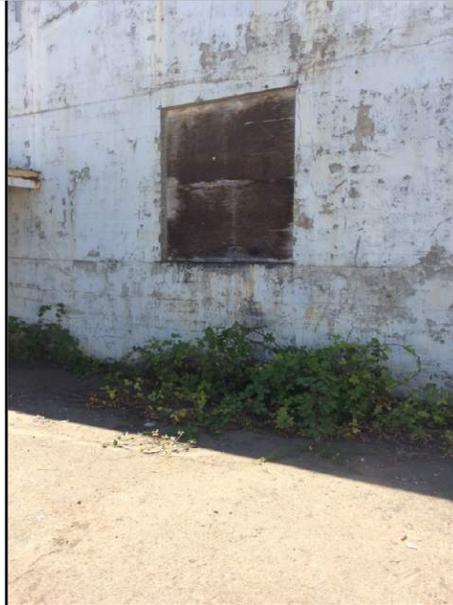
Observation ID:	Detailed Sample Location:
HBM-AAM-1-PB-16	Painted surfaces of number 2 paper mill
Type of Sample:	Specify Miscellaneous Material (if applicable):
PB	
Sample Color:	Sample Quantity:
White	1,000 sq. ft.

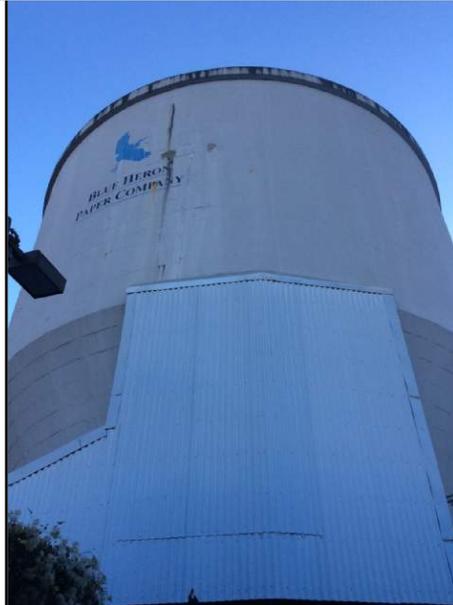
Observation ID:	Detailed Sample Location:
HBM-AAM-1-PB-13	Storage cylinder
Type of Sample:	Specify Miscellaneous Material (if applicable):
PB	
Sample Color:	Sample Quantity:
Tan	400 sq. ft.

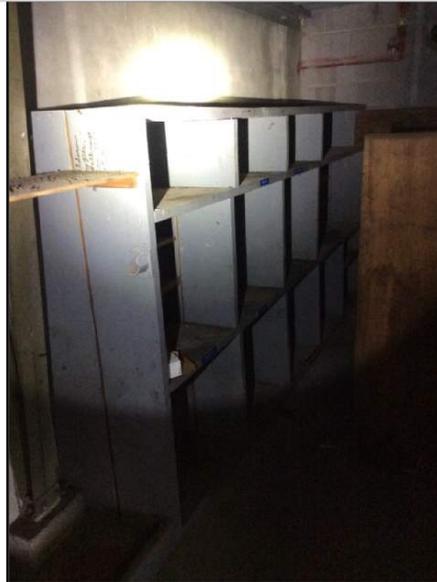
Observation ID:	Detailed Sample Location:
HBM-ASH-1-PB-1	Gray painted surfaces
Type of Sample:	Specify Miscellaneous Material (if applicable):
PB	
Sample Color:	Sample Quantity:
Dark gray	800 sq. ft.

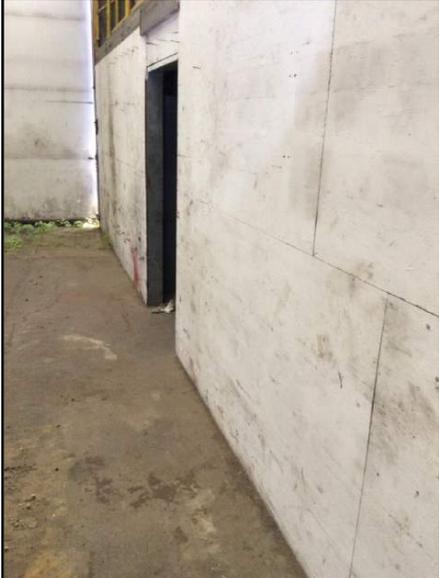
Observation ID:	Detailed Sample Location:
HBM-ASH-1-PB-2	White painted surfaces
Type of Sample:	Specify Miscellaneous Material (if applicable):
PB	
Sample Color:	Sample Quantity:
White	350 sq. ft.
Sample Photo:

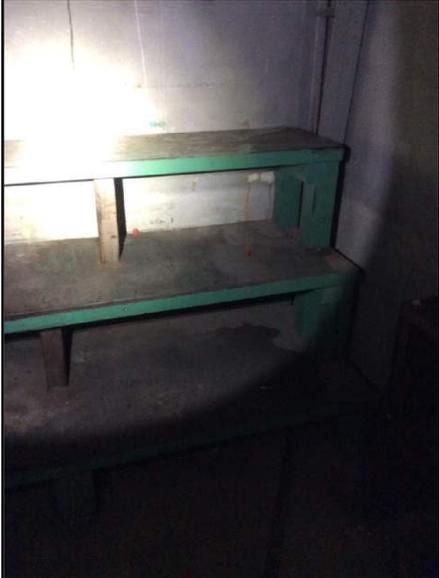
Observation ID:	Detailed Sample Location:
HBM-ASH-1-PB-3	Green painted surfaces
Type of Sample:	Specify Miscellaneous Material (if applicable):
PB	
Sample Color:	Sample Quantity:
Medium green	50 sq. ft.
Sample Photo:

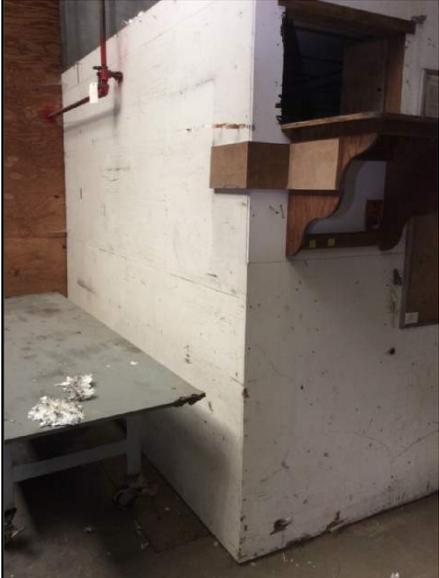
Observation ID:	Detailed Sample Location:
HBM-ASH-1-PB-4	Glossy white painted surfaces
Type of Sample:	Specify Miscellaneous Material (if applicable):
PB	
Sample Color:	Sample Quantity:
Glossy white	300 sq. ft.
Sample Photo:

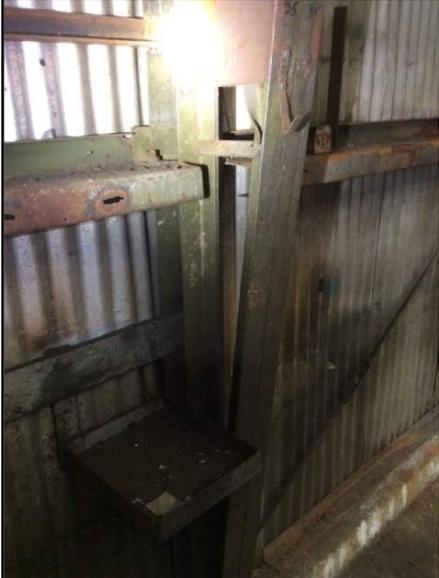
Observation ID:	Detailed Sample Location:
HBM-ASH-1-PB-7	Dark green painted metal building framing
Type of Sample:	Specify Miscellaneous Material (if applicable):
PB	
Sample Color:	Sample Quantity:
Dark green	2,000 linear feet
Sample Photo:

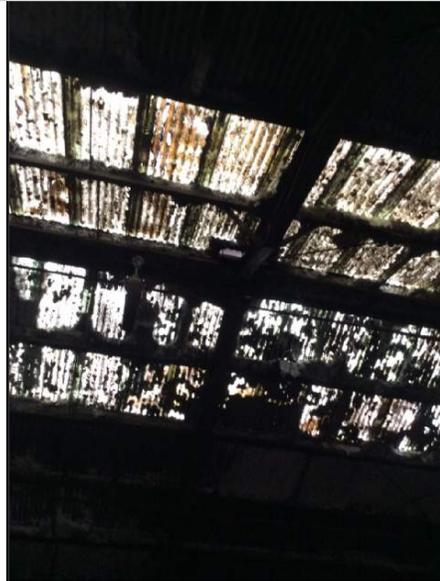
Observation ID:		Detailed Sample Location:	
HBM-ASH-1-ASB-9		Cellulose insulation	
Type of Sample:		Specify Miscellaneous Material (if applicable):	
ASB			
Is the Sample Friable?:		Sample Condition:	
Yes		Damaged friable surfacing ACM	
Sample Color:		Sample Quantity:	
		3500 sq. ft.	
Sample Photo:

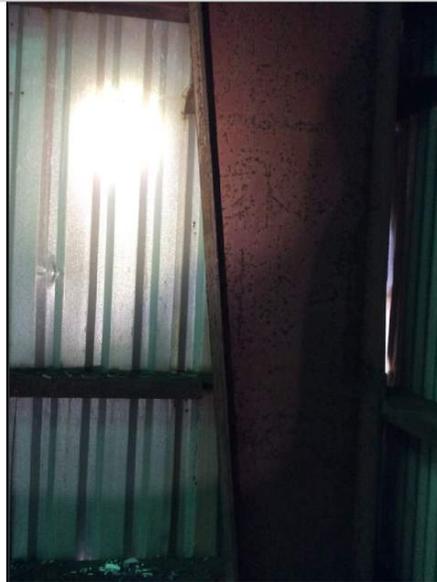
Observation ID:	Detailed Sample Location:
HBM-BBL-1-PB-1	Red painted superstructure
Type of Sample:	Specify Miscellaneous Material (if applicable):
PB	
Sample Color:	Sample Quantity:
Dark red	5,000 sq. ft.

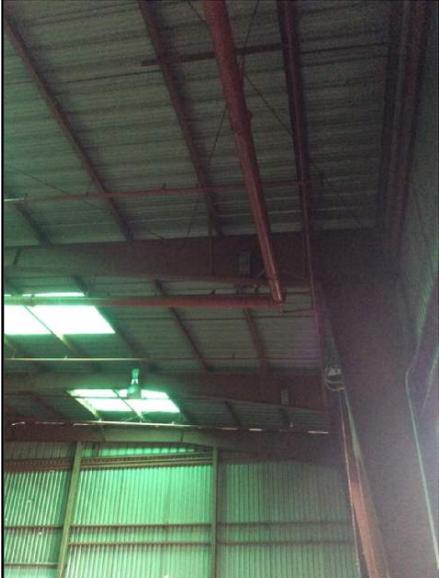
Observation ID:	Detailed Sample Location:
HBM-BBL-1-PB-4	Bright red fire suppression painted surfaces
Type of Sample:	Specify Miscellaneous Material (if applicable):
PB	
Sample Color:	Sample Quantity:
Bright red	800 linear feet
Sample Photo:

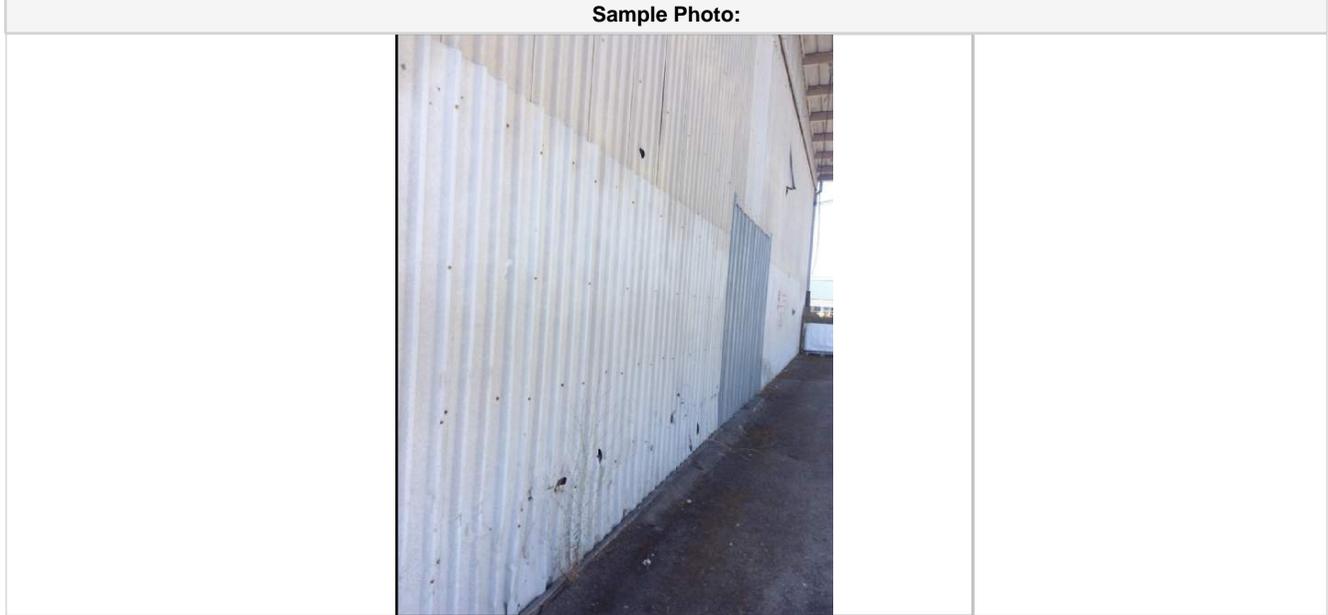
Observation ID:	Detailed Sample Location:
HBM-BBL-1-PB-5	Exterior painted surfaces, off white
Type of Sample:	Specify Miscellaneous Material (if applicable):
PB	
Sample Color:	Sample Quantity:
Off white	7,400 sq. ft.

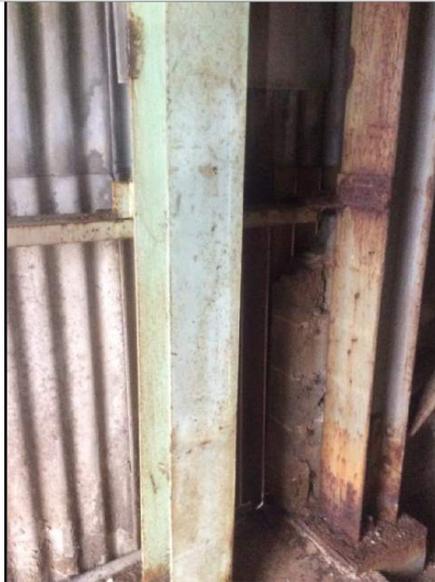
Observation ID:	Detailed Sample Location:
HBM-BPT-1-PB-1	Green painted surfaces
Type of Sample:	Specify Miscellaneous Material (if applicable):
PB	
Sample Color:	Sample Quantity:
Light green	4,000 sq. ft.

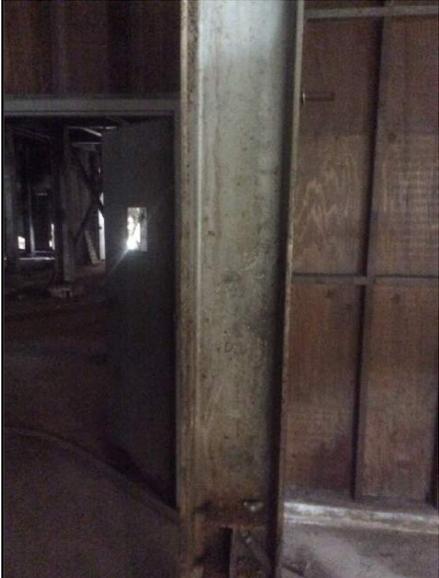
Observation ID:	Detailed Sample Location:
HBM-BPT-1-PB-2	Gray painted surfaces
Type of Sample:	Specify Miscellaneous Material (if applicable):
PB	
Sample Color:	Sample Quantity:
Gray	4,000 sq. ft.
Sample Photo:

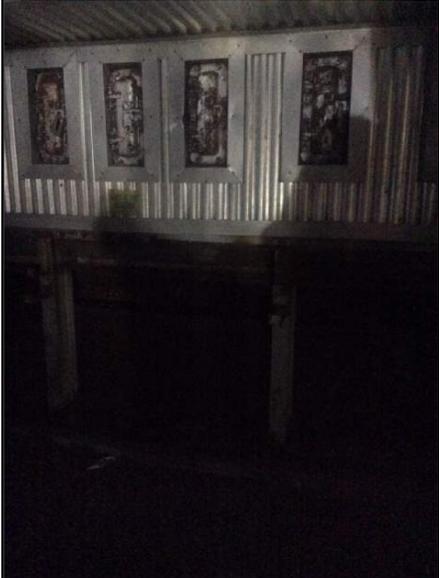
Observation ID:	Detailed Sample Location:
HBM-BPT-1-PB-3	Silver boiler, may contain asbestos
Type of Sample:	Specify Miscellaneous Material (if applicable):
PB	
Sample Color:	Sample Quantity:
Silver	750 sq. ft.
Sample Photo:

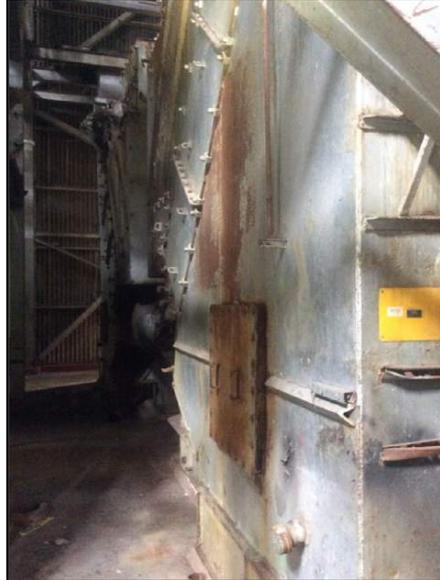
Observation ID:	Detailed Sample Location:
HBM-BPT-2-PB-1	Boilers, 4
Type of Sample:	Specify Miscellaneous Material (if applicable):
PB	
Sample Color:	Sample Quantity:
Gray	4,500 sq. ft. (asbestos containing)
Sample Photo:

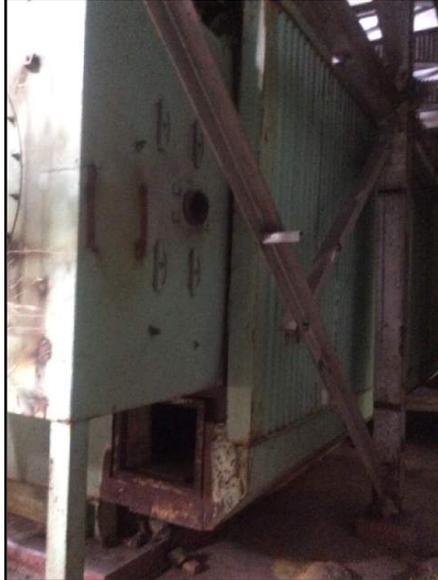
Observation ID:	Detailed Sample Location:
HBM-BPT-2-PB-2	Green boiler (asbestos containing)
Type of Sample:	Specify Miscellaneous Material (if applicable):
PB	
Sample Color:	Sample Quantity:
Green	1,600 sq. ft.

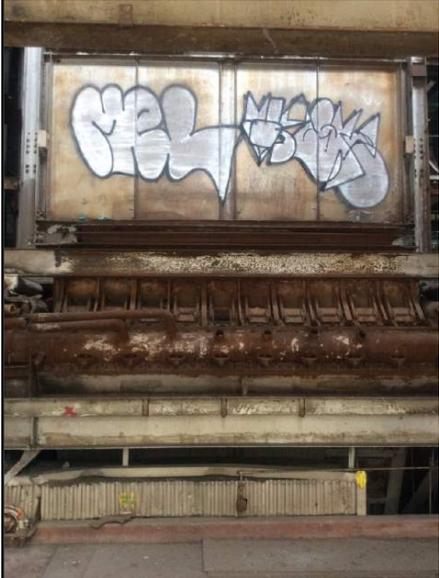
Observation ID:	Detailed Sample Location:
HBM-BPT-2-PB-3	Large silver boiler (asbestos containing)
Type of Sample:	Specify Miscellaneous Material (if applicable):
PB	
Sample Color:	Sample Quantity:
Silver	3,500 sq. ft.
Sample Photo:

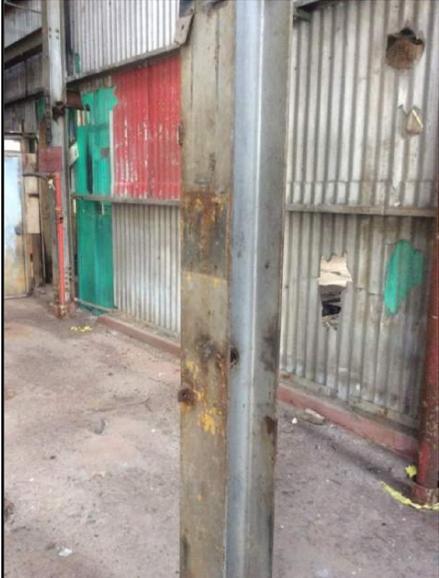
Observation ID:	Detailed Sample Location:
HBM-BPT-2-PB-5	Gray interior painted beams
Type of Sample:	Specify Miscellaneous Material (if applicable):
PB	
Sample Color:	Sample Quantity:
Gray, rusty	20,000 sq. ft.
Sample Photo:

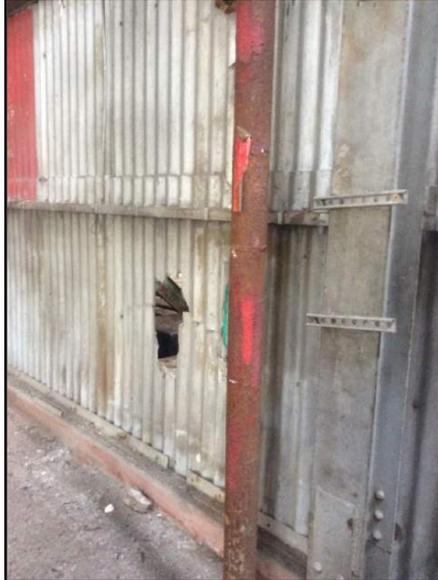
Observation ID:	Detailed Sample Location:
HBM-BPT-2-PB-6	Red rusty fire suppression
Type of Sample:	Specify Miscellaneous Material (if applicable):
PB	
Sample Color:	Sample Quantity:
Red, rusty	3,000 sq. ft.
Sample Photo:

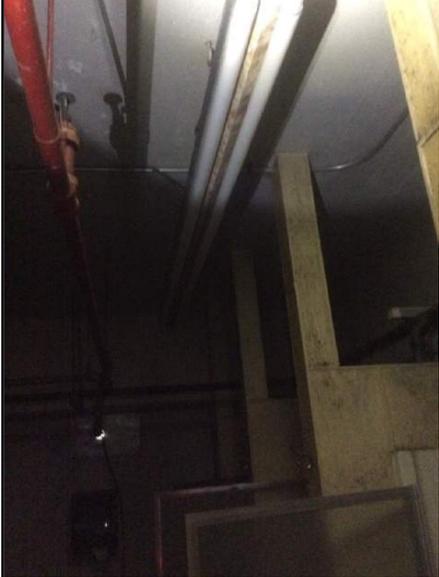
Observation ID:		Detailed Sample Location:	
HBM-BPT-1-MISC-8		Fluorescent light fixtures, locker room	
Type of Sample:		Specify Miscellaneous Material (if applicable):	
MISC		Light fixtures	
Is the Sample Friable?:		Sample Condition:	
No			
Sample Color:		Sample Quantity:	
		9	
Sample Photo:

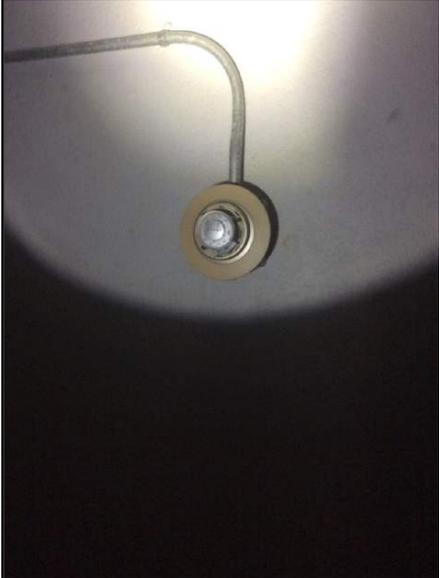
Observation ID:	Detailed Sample Location:
HBM-BPT-1-HGF-12	Locker room, thermostat
Type of Sample:	Specify Miscellaneous Material (if applicable):
HGF	
Sample Color:	Sample Quantity:
	1
Sample Photo:

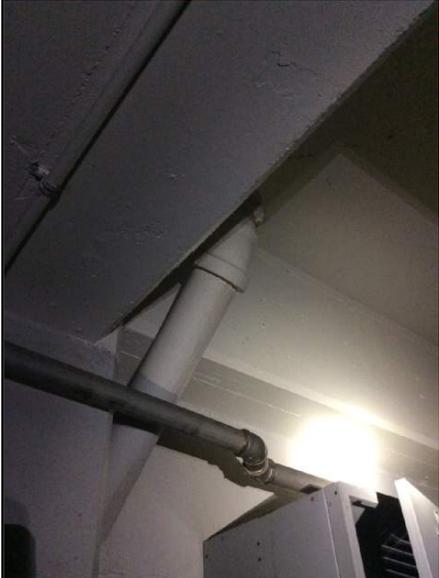
Observation ID:	Detailed Sample Location:
HBM-BPT-1-PB-15	White painted surfaces
Type of Sample:	Specify Miscellaneous Material (if applicable):
PB	
Sample Color:	Sample Quantity:
White	1,500 sq. ft.
Sample Photo:

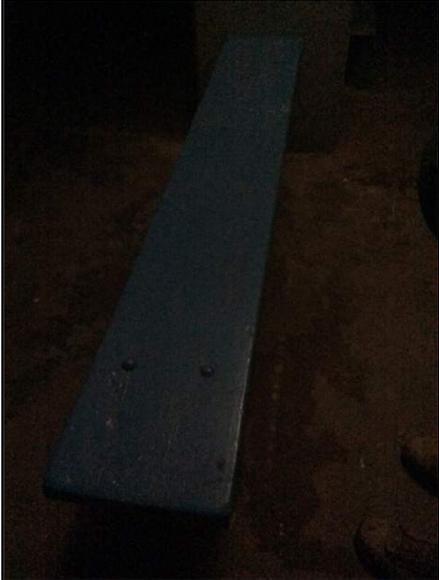
Observation ID:	Detailed Sample Location:	
HBM-BPT-1-PB-16	Blue painted surfaces	
Type of Sample:	Specify Miscellaneous Material (if applicable):	
PB		
Sample Color:	Sample Quantity:	
Bright blue	80 sq. ft.	
Sample Photo:

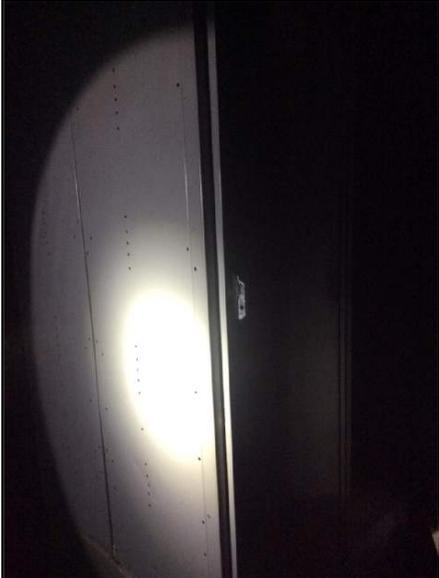
Observation ID:	Detailed Sample Location:
HBM-BPT-1-PB-17	Gray lockers
Type of Sample:	Specify Miscellaneous Material (if applicable):
PB	
Sample Color:	Sample Quantity:
Gray	
Sample Photo:

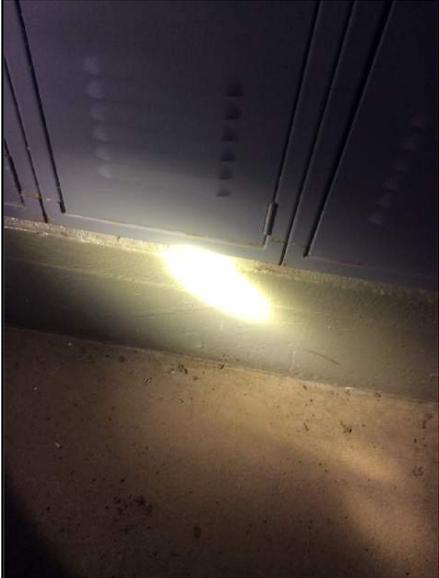
Observation ID:	Detailed Sample Location:
HBM-BPT-1-PB-18	Green base on lockers
Type of Sample:	Specify Miscellaneous Material (if applicable):
PB	
Sample Color:	Sample Quantity:
Green	300 sq. ft.
Sample Photo:

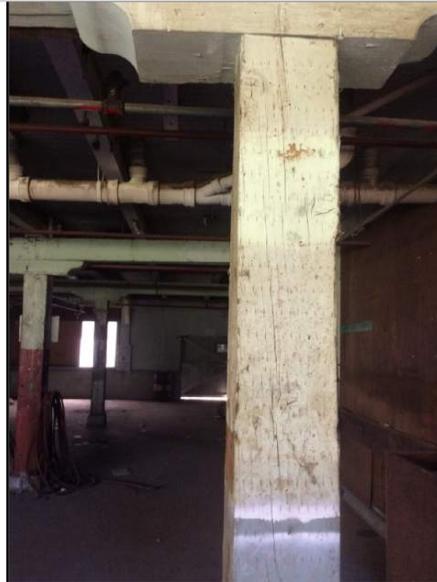
Observation ID:	Detailed Sample Location:
HBM-CSH-1-PB-1	Light green interior painted surfaces
Type of Sample:	Specify Miscellaneous Material (if applicable):
PB	
Sample Color:	Sample Quantity:
Light green	1,000 sq. ft.

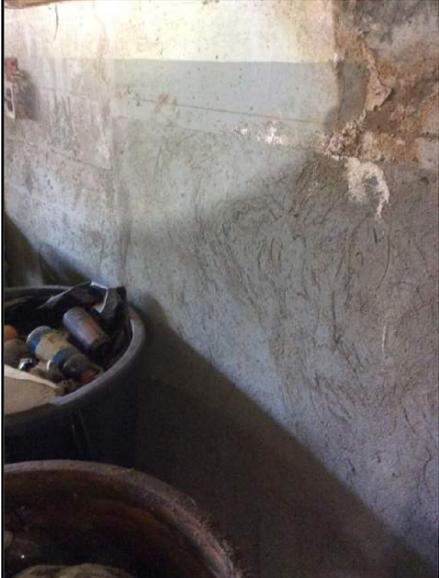
Observation ID:	Detailed Sample Location:
HBM-CSH-1-PB-2	Gray painted interior surfaces
Type of Sample:	Specify Miscellaneous Material (if applicable):
PB	
Sample Color:	Sample Quantity:
Gray	1,000 sq. ft.
Sample Photo:

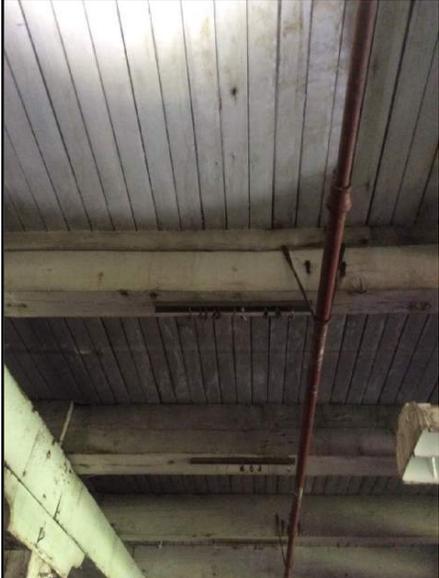
Observation ID:	Detailed Sample Location:
HBM-CSH-1-PB-3	White interior painted surfaces, ceiling and beams
Type of Sample:	Specify Miscellaneous Material (if applicable):
PB	
Sample Color:	Sample Quantity:
White	Building footprint
Sample Photo:

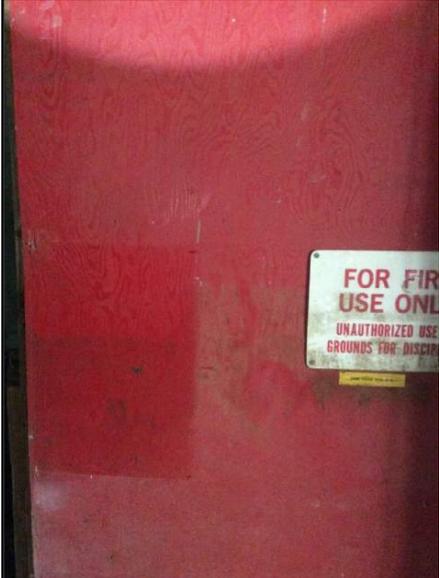
Observation ID:	Detailed Sample Location:
HBM-CSH-1-PB-4	Red painted interior surfaces
Type of Sample:	Specify Miscellaneous Material (if applicable):
PB	
Sample Color:	Sample Quantity:
Red	50 sq. ft.
Sample Photo:

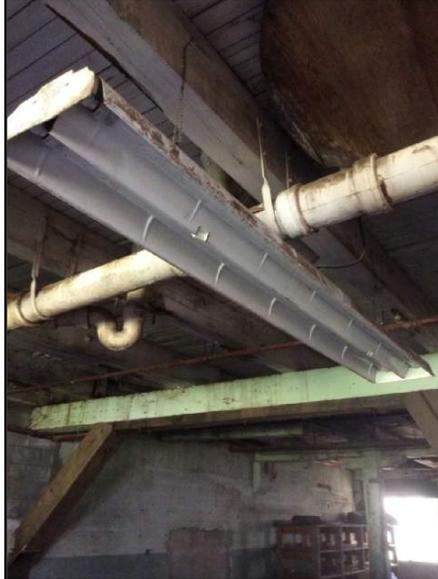
Observation ID:		Detailed Sample Location:	
HBM-CSH-1-MISC-5		Fluorescent light fixtures and ballasts	
Type of Sample:		Specify Miscellaneous Material (if applicable):	
MISC		Light fixtures	
Is the Sample Friable?:		Sample Condition:	
No			
Sample Color:		Sample Quantity:	
		11	
Sample Photo:

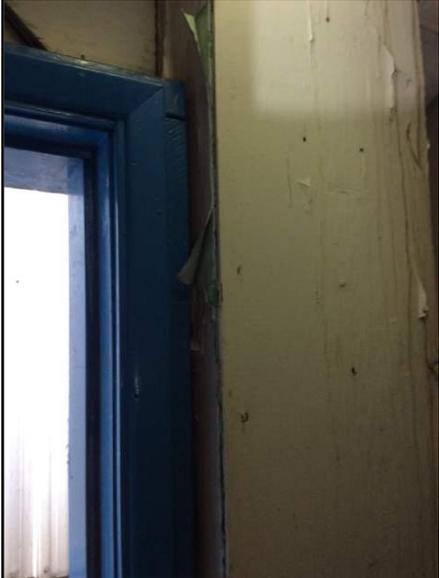
Observation ID:	Detailed Sample Location:
HBM-CSH-1-PB-8	Cream paint in restroom
Type of Sample:	Specify Miscellaneous Material (if applicable):
PB	
Sample Color:	Sample Quantity:
Cream	100 sq. ft.
Sample Photo:

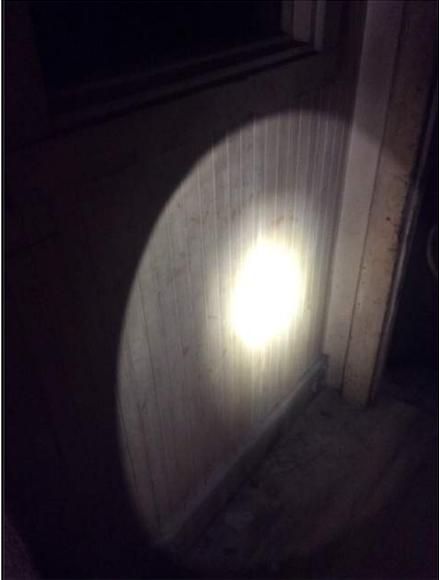
Observation ID:	Detailed Sample Location:
HBM-CSH-2-PB-9	Tan paint in entryway
Type of Sample:	Specify Miscellaneous Material (if applicable):
PB	
Sample Color:	Sample Quantity:
Tan	5,000 sq. ft.

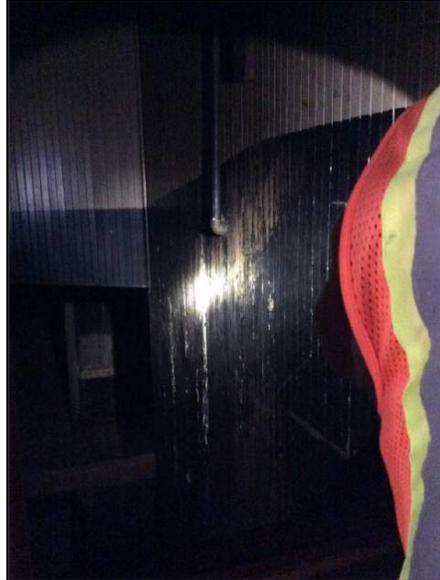
Observation ID:	Detailed Sample Location:
HBM-CSH-2-PB-10	Black paint in entryway
Type of Sample:	Specify Miscellaneous Material (if applicable):
PB	
Sample Color:	Sample Quantity:
Black	500 sq. ft.
Sample Photo:

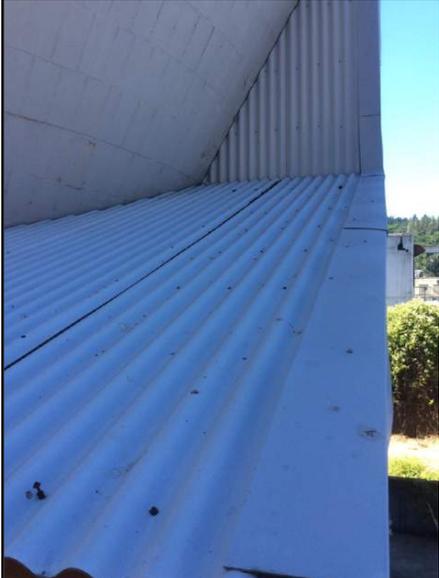
Observation ID:	Detailed Sample Location:
HBM-HSC-1-PB-3	Painted exterior roofing
Type of Sample:	Specify Miscellaneous Material (if applicable):
PB	
Sample Color:	Sample Quantity:
Light gray	100 sq. ft.
Sample Photo:

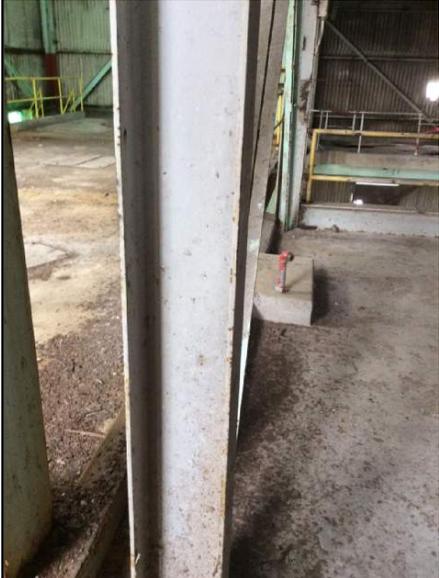
Observation ID:	Detailed Sample Location:
HBM-MHR-1-PB-3	Interior gray painted beams, catwalks
Type of Sample:	Specify Miscellaneous Material (if applicable):
PB	
Sample Color:	Sample Quantity:
Gray	20,000 sq. ft.
Sample Photo:

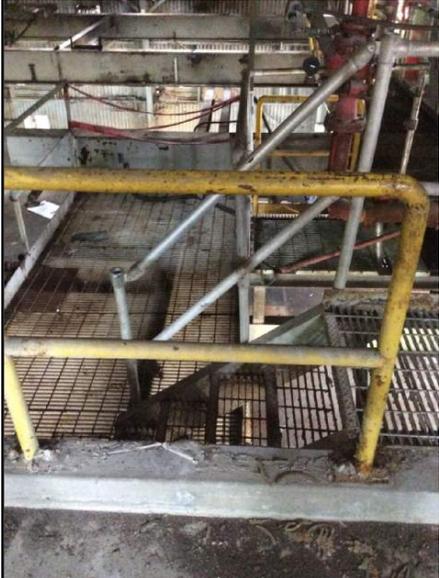
Observation ID:	Detailed Sample Location:
HBM-MHR-1-PB-4	Yellow interior painted surfaces
Type of Sample:	Specify Miscellaneous Material (if applicable):
PB	
Sample Color:	Sample Quantity:
Yellow	5,000 sq. ft.
Sample Photo:

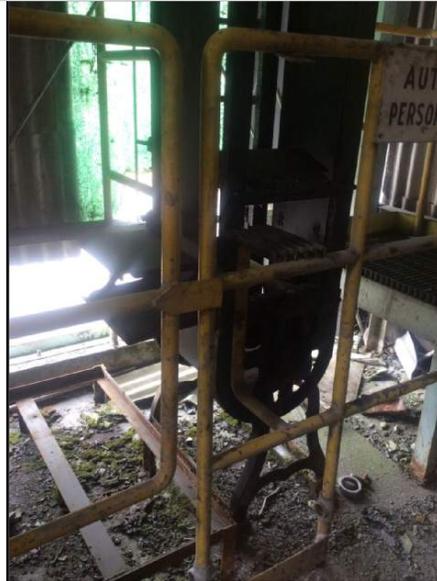
Observation ID:		Detailed Sample Location:	
HBM-MHR-1-MISC-7		Man lift motor	
Type of Sample:		Specify Miscellaneous Material (if applicable):	
MISC		Motor with hydraulic fluid	
Is the Sample Friable?:		Sample Condition:	
No			
Sample Color:		Sample Quantity:	
		1	
Sample Photo:

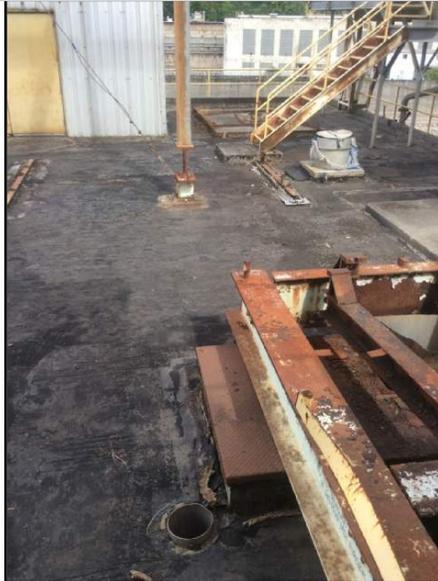
Observation ID:		Detailed Sample Location:	
HBM-MHR-1-ASB-9		Reject building asphaltic roofing	
Type of Sample:		Specify Miscellaneous Material (if applicable):	
ASB			
Is the Sample Friable?:		Sample Condition:	
No		Potential ACBM with potential for damage	
Sample Color:		Sample Quantity:	
		7,000 sq. ft.	
Sample Photo:

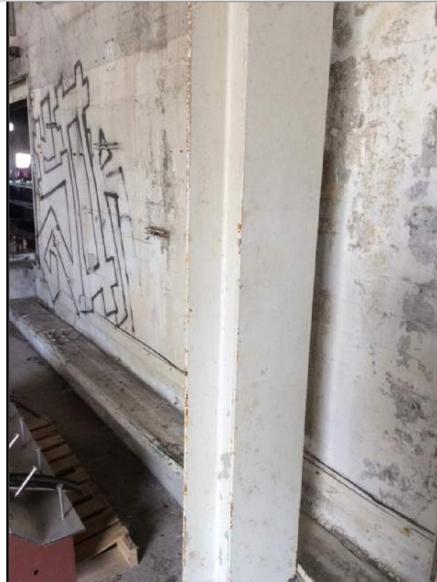
Observation ID:	Detailed Sample Location:
HBM-MLH-1-PB-1	Interior white painted surfaces
Type of Sample:	Specify Miscellaneous Material (if applicable):
PB	
Sample Color:	Sample Quantity:
White	2,000 sq. ft. on walls and 9,000 sq. ft. on beams

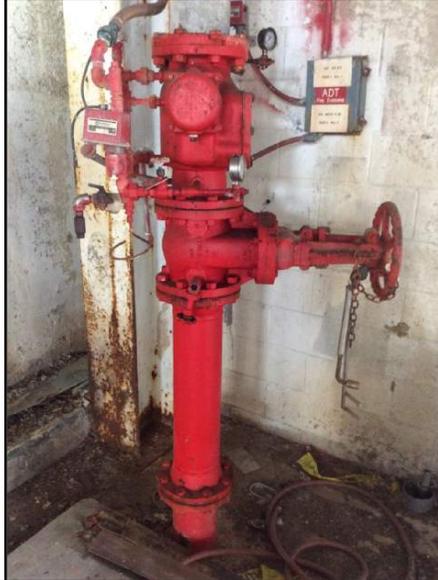
Observation ID:	Detailed Sample Location:
HBM-MLH-1-PB-2	Red fire suppression
Type of Sample:	Specify Miscellaneous Material (if applicable):
PB	
Sample Color:	Sample Quantity:
Red	1,200 sq. ft.
Sample Photo:

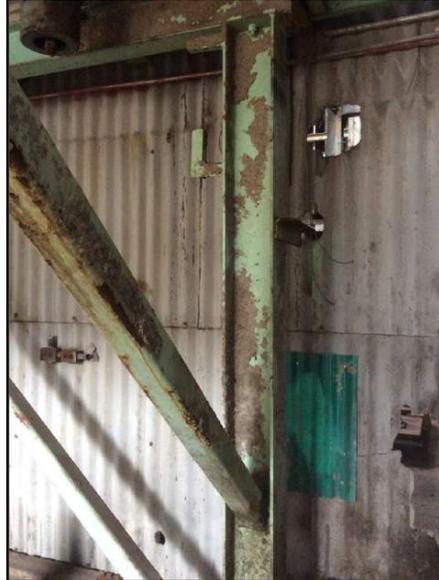
Observation ID:	Detailed Sample Location:
HBM-MLH-1-PB-4	Green painted interior beams
Type of Sample:	Specify Miscellaneous Material (if applicable):
PB	
Sample Color:	Sample Quantity:
Light green	2,000 sq. ft.
Sample Photo:

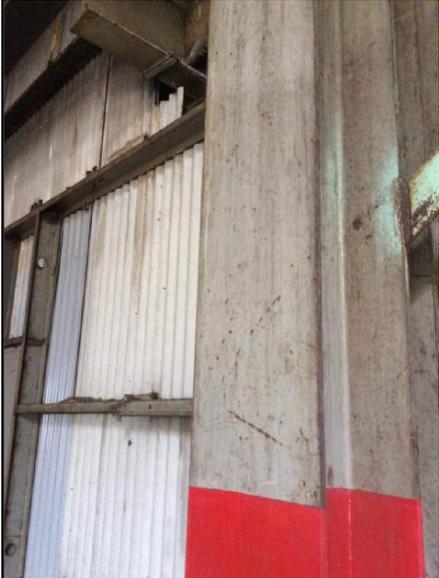
Observation ID:	Detailed Sample Location:
HBM-MLH-1-PB-5	Gray interior painted beams
Type of Sample:	Specify Miscellaneous Material (if applicable):
PB	
Sample Color:	Sample Quantity:
Gray	1,000 sq. ft.
Sample Photo:

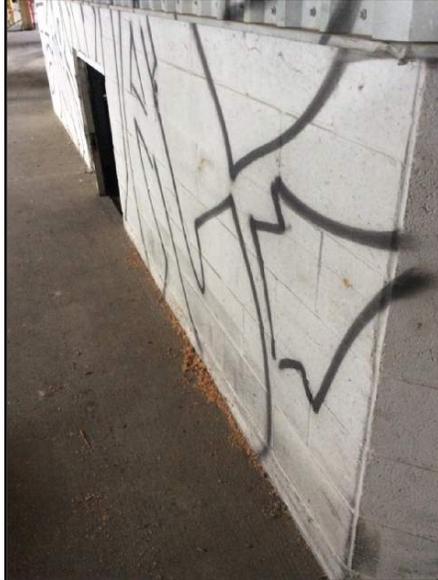
Observation ID:	Detailed Sample Location:
HBM-MLH-1-PB-8	Control center exterior surfaces, white
Type of Sample:	Specify Miscellaneous Material (if applicable):
PB	
Sample Color:	Sample Quantity:
White	400 sq. ft.

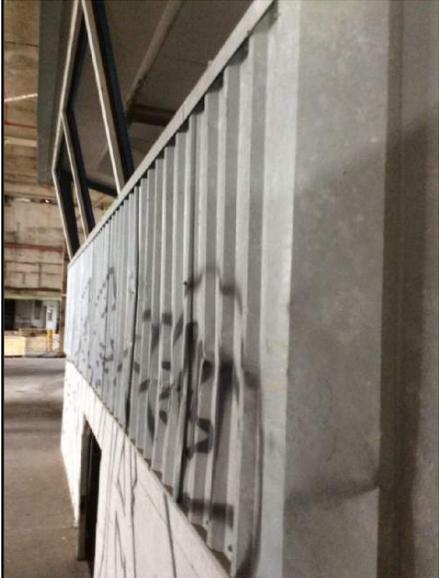
Observation ID:	Detailed Sample Location:
HBM-MLH-1-PB-9	Exterior control room painted surfaces, gray
Type of Sample:	Specify Miscellaneous Material (if applicable):
PB	
Sample Color:	Sample Quantity:
Gray	1,000 sq. ft.
Sample Photo:

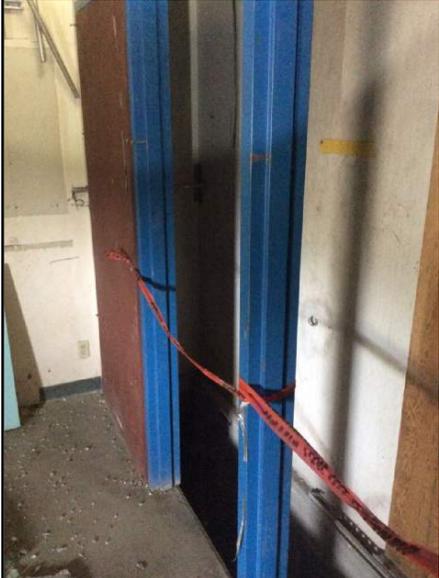
Observation ID:	Detailed Sample Location:
HBM-MLH-1-PB-13	Blue interior painted surfaces
Type of Sample:	Specify Miscellaneous Material (if applicable):
PB	
Sample Color:	Sample Quantity:
Blue	300 sq. ft.
Sample Photo:

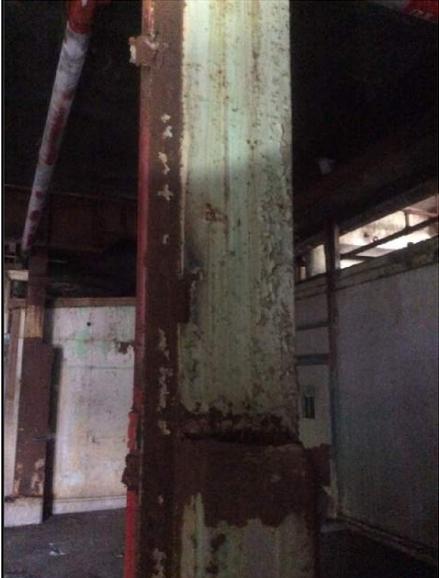
Observation ID:	Detailed Sample Location:
HBM-MLH-1-PB-20	Interior green painted columns and beams
Type of Sample:	Specify Miscellaneous Material (if applicable):
PB	
Sample Color:	Sample Quantity:
Light green	2,000 sq. ft.
Sample Photo:

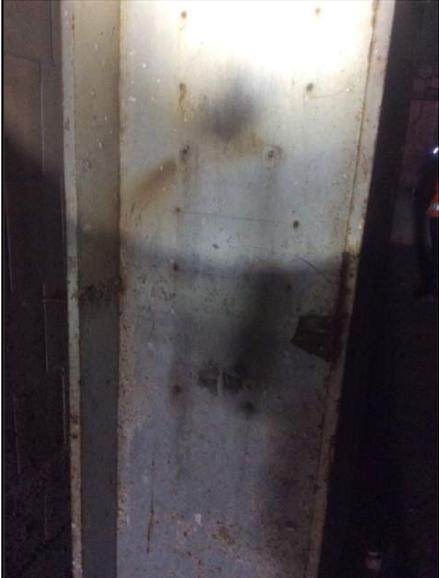
Observation ID:	Detailed Sample Location:
HBM-MLH-1-PB-21	Gray interior painted beams and columns
Type of Sample:	Specify Miscellaneous Material (if applicable):
PB	
Sample Color:	Sample Quantity:
Light gray	4,000 sq. ft.
Sample Photo:

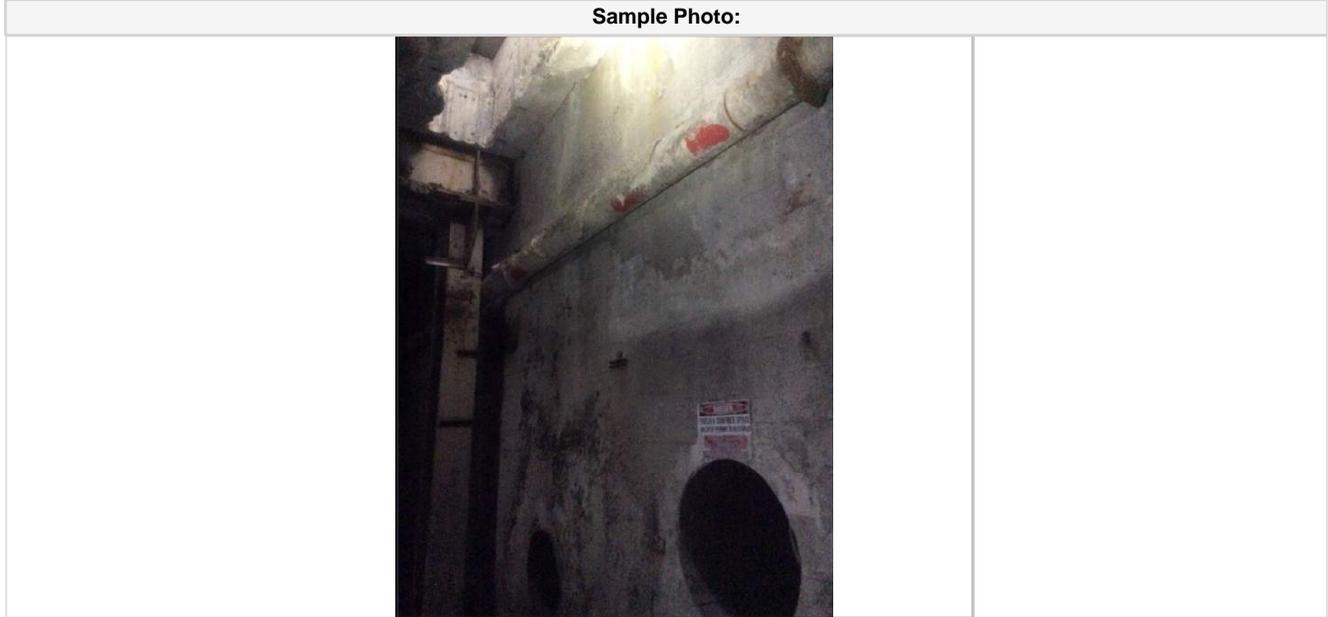
Observation ID:	Detailed Sample Location:
HBM-MLH-1-PB-22	Red fire suppression painted surfaces
Type of Sample:	Specify Miscellaneous Material (if applicable):
PB	
Sample Color:	Sample Quantity:
Red	2,000 sq. ft.

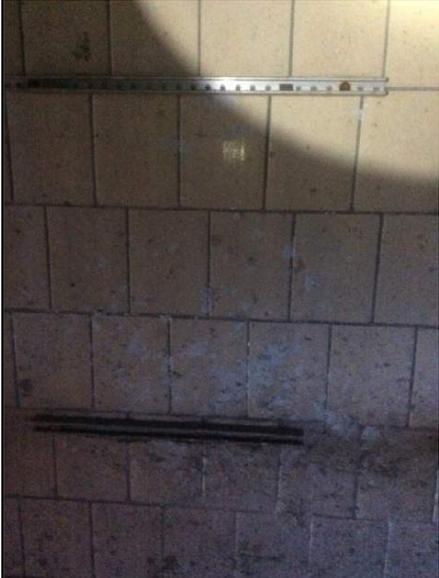
Observation ID:	Detailed Sample Location:
HBM-MLH-1-PB-23	Light tan ceramic block and mortar, may contain asbestos
Type of Sample:	Specify Miscellaneous Material (if applicable):
PB	
Sample Color:	Sample Quantity:
Light tan	6,000 sq. ft.
Sample Photo:

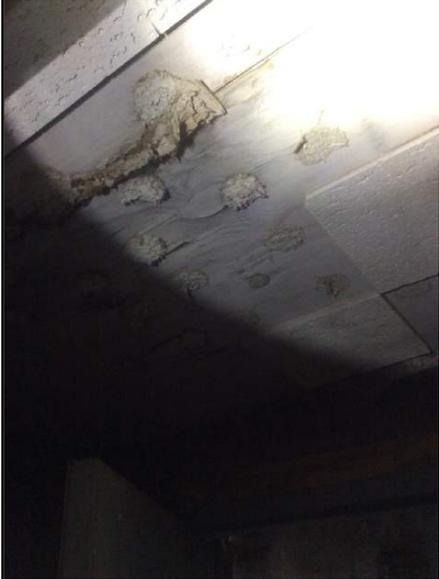
Observation ID:		Detailed Sample Location:	
HBM-MLH-1-ASB-24		Acoustic tile with glue dots	
Type of Sample:		Specify Miscellaneous Material (if applicable):	
ASB			
Is the Sample Friable?:		Sample Condition:	
Yes		Potential ACBM with potential for significant damage	
Sample Color:		Sample Quantity:	
		90 sq. ft.	
Sample Photo:

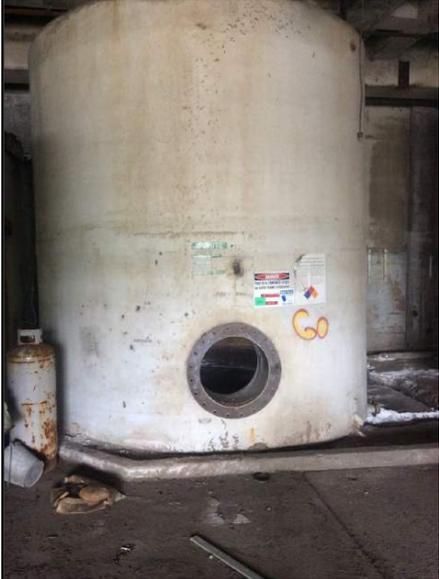
Observation ID:		Detailed Sample Location:	
HBM-MLH-1-MISC-26		Storage tanks, V Brite	
Type of Sample:		Specify Miscellaneous Material (if applicable):	
MISC		Tanks	
Is the Sample Friable?:		Sample Condition:	
No			
Sample Color:		Sample Quantity:	
		2	
Sample Photo:

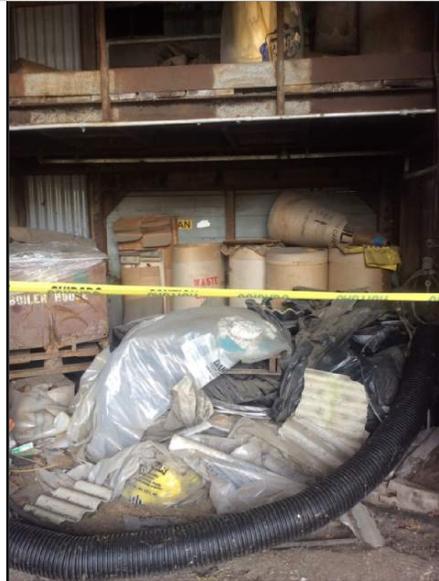
Observation ID:		Detailed Sample Location:	
HBM-MLH-1-MISC-27		Storage area universal waste	
Type of Sample:		Specify Miscellaneous Material (if applicable):	
MISC		Bulbs, solid waste	
Is the Sample Friable?:		Sample Condition:	
No			
Sample Color:		Sample Quantity:	
		Unknown	
Sample Photo:

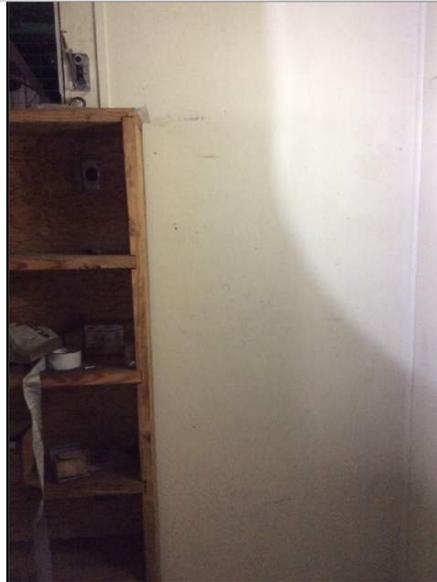
Observation ID:	Detailed Sample Location:
HBM-MWS-2-PB-1	2nd floor office white paint
Type of Sample:	Specify Miscellaneous Material (if applicable):
PB	
Sample Color:	Sample Quantity:
White	700 sq. ft.

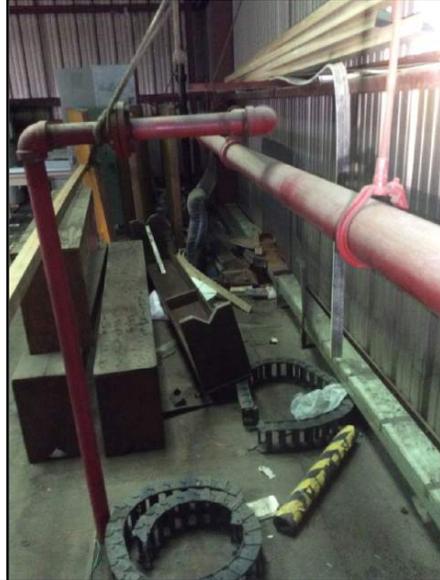
Observation ID:	Detailed Sample Location:
HBM-MWS-2-PB-2	Fire suppression red paint
Type of Sample:	Specify Miscellaneous Material (if applicable):
PB	
Sample Color:	Sample Quantity:
Red	400 linear feet of 4" pipe and 80 feet of 6" pipe
Sample Photo:

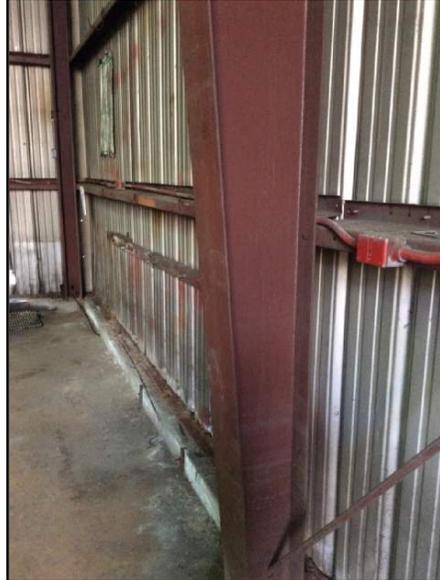
Observation ID:	Detailed Sample Location:
HBM-MWS-1-PB-3	Dark red painted metal superstructure
Type of Sample:	Specify Miscellaneous Material (if applicable):
PB	
Sample Color:	Sample Quantity:
Dark red	3,000 sq. ft.
Sample Photo:

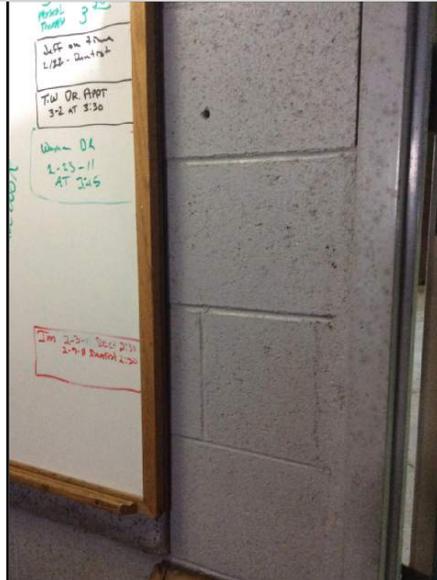
Observation ID:	Detailed Sample Location:
HBM-MWS-1-PB-4	Office and restroom glossy white painted surfaces
Type of Sample:	Specify Miscellaneous Material (if applicable):
PB	
Sample Color:	Sample Quantity:
Glossy white	2,000 sq. ft.
Sample Photo:

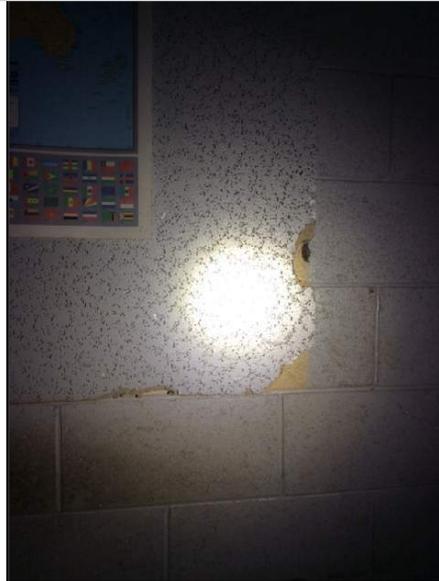
Observation ID:		Detailed Sample Location:	
HBM-MWS-1-ASB-12		Acoustic tile with dark brown glue	
Type of Sample:		Specify Miscellaneous Material (if applicable):	
ASB			
Is the Sample Friable?:		Sample Condition:	
No		Potential ACBM with potential for significant damage	
Sample Color:		Sample Quantity:	
		100 sq. ft.	
Sample Photo:

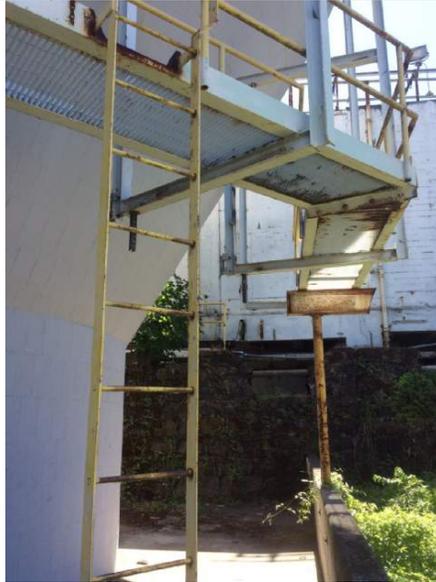
Observation ID:	Detailed Sample Location:
HBM-PM1-1-PB-4	Yellow exterior painted surfaces
Type of Sample:	Specify Miscellaneous Material (if applicable):
PB	
Sample Color:	Sample Quantity:
Light yellow	100 sq. ft.
Sample Photo:
