HAZARDOUS MATERIALS SURVEY REPORT

WILLAMETTE FALLS RIVERWALK, PHASE 1—OREGON CITY,
OREGON

Prepared for
METRO REGIONAL GOVERNMENT
April 25, 2018
Project No. 0075.06.02

Prepared by
Maul Foster & Alongi, Inc.
2001 NW 19th Avenue, Suite 200, Portland, OR 97209

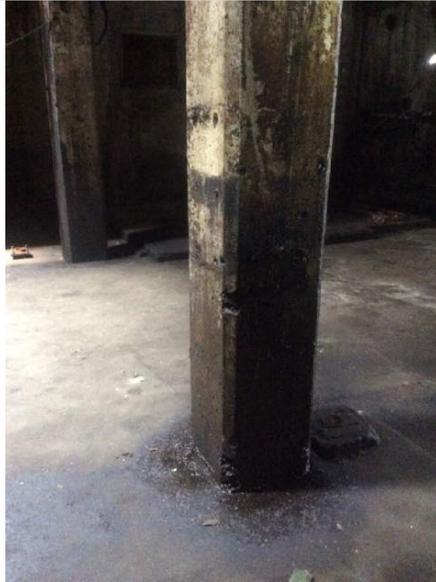
Observation ID:		Detailed Sample Location:	
HBM-PM1-O-MISC-1		PM1 basement petroleum-coated columns	
Type of Sample:		Specify Miscellaneous Material (if applicable):	
MISC		Petroleum	
Is the Sample Friable?:		Sample Condition:	
No		Other	
Sample Color:		Sample Quantity:	
		Throughout	
Sample Photo:

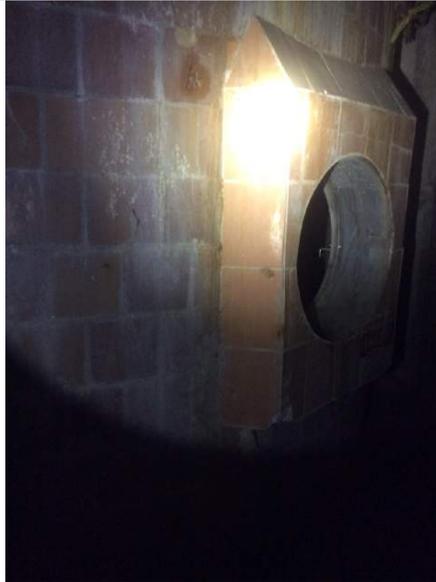
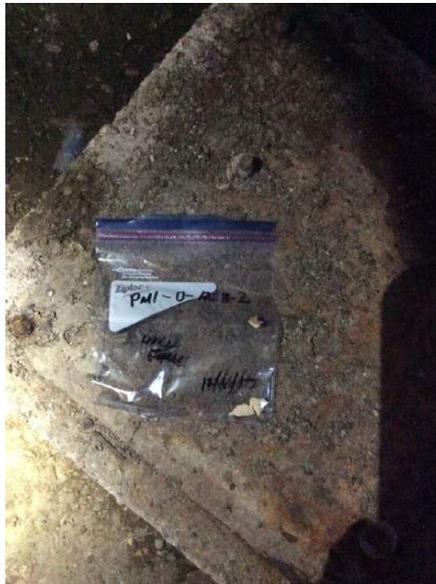
Observation ID:		Detailed Sample Location:	
HBM-PM1-O-ASB-2		PM1 basement ceramic tile vessels and mortar	
Type of Sample:		Specify Miscellaneous Material (if applicable):	
ASB			
Is the Sample Friable?:		Sample Condition:	
No		Potential ACBM with potential for damage	
Sample Color:		Sample Quantity:	
		2,500 sq. ft.	
Sample Photo:

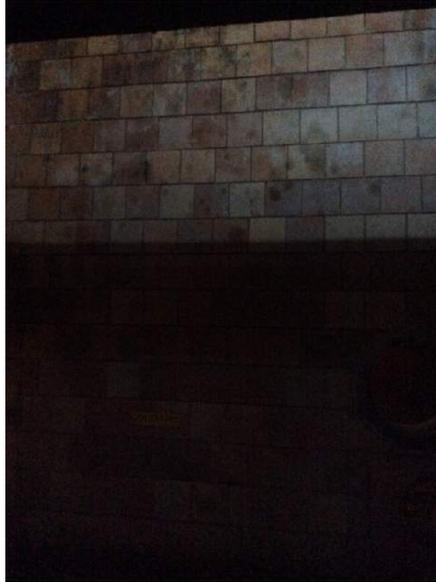
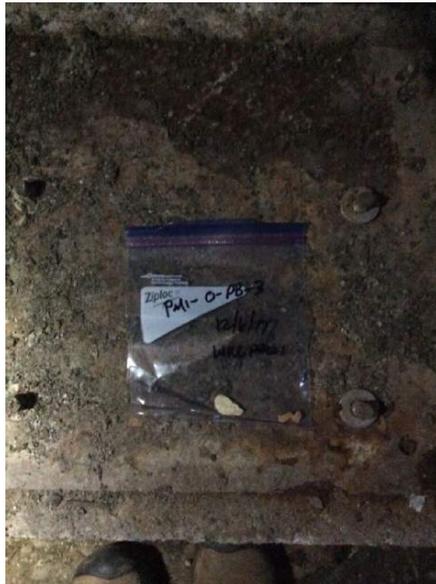
Observation ID:	Detailed Sample Location:
HBM-PM1-O-PB-3	PM1 basement tan ceramic tile vessels
Type of Sample:	Specify Miscellaneous Material (if applicable):
PB	
Sample Color:	Sample Quantity:
Tan	2,500 sq. ft.
Sample Photo:

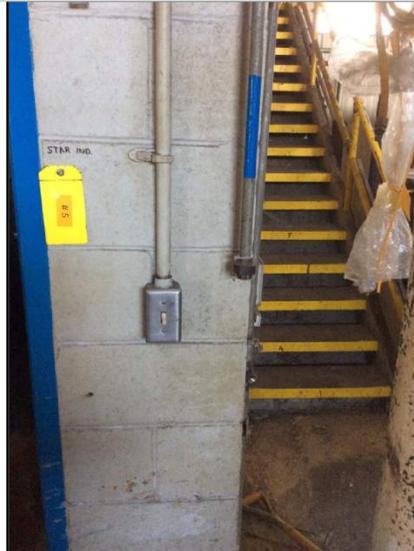
Observation ID:	Detailed Sample Location:
HBM-PSH-1-PB-1	Throughout
Type of Sample:	Specify Miscellaneous Material (if applicable):
PB	
Sample Color:	Sample Quantity:
Gray interior painted surfaces	2,600 sq. ft.

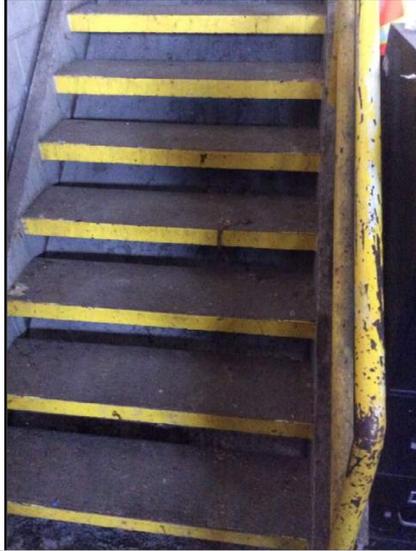
Observation ID:	Detailed Sample Location:
HBM-PSH-1-PB-2	Yellow trim paint
Type of Sample:	Specify Miscellaneous Material (if applicable):
PB	
Sample Color:	Sample Quantity:
Yellow	100 sq. ft.
Sample Photo:

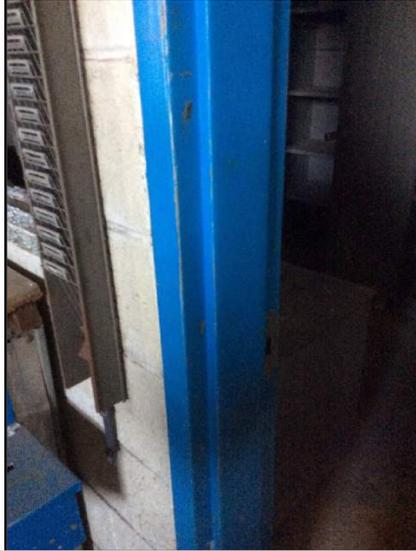
Observation ID:	Detailed Sample Location:
HBM-PSH-1-PB-3	Blue trim
Type of Sample:	Specify Miscellaneous Material (if applicable):
PB	
Sample Color:	Sample Quantity:
Blue	100 sq. ft.
Sample Photo:

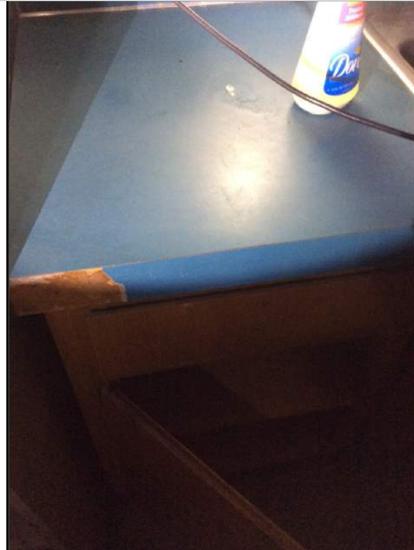
Observation ID:		Detailed Sample Location:	
HBM-PSH-1-ASB-4		Blue laminate countertop with yellow mastic	
Type of Sample:		Specify Miscellaneous Material (if applicable):	
ASB			
Is the Sample Friable?:		Sample Condition:	
Yes		Potential ACBM with potential for damage	
Sample Color:		Sample Quantity:	
		40 sq. ft.	
Sample Photo:

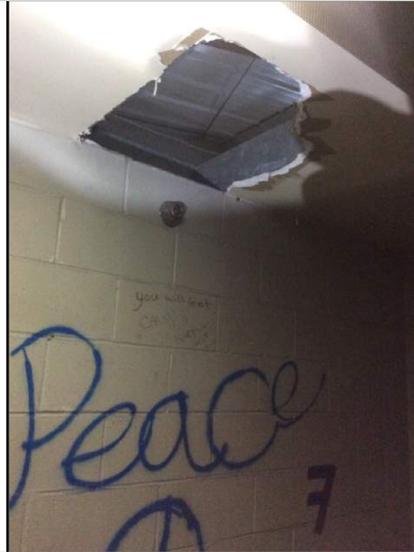
Observation ID:		Detailed Sample Location:	
HBM-PSH-2-ASB-5		White wallboard	
Type of Sample:		Specify Miscellaneous Material (if applicable):	
ASB			
Is the Sample Friable?:		Sample Condition:	
Yes		Potential ACBM with potential for damage	
Sample Color:		Sample Quantity:	
		300 sq. ft.	
Sample Photo:

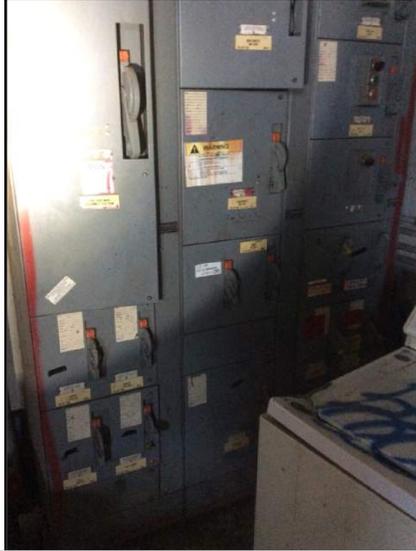
Observation ID:	Detailed Sample Location:
HBM-PSH-1-PCF-6	Electrical panel north wall, smaller switches throughout
Type of Sample:	Specify Miscellaneous Material (if applicable):
PCF	
Sample Color:	Sample Quantity:
	1 large, 8 small
Sample Photo:

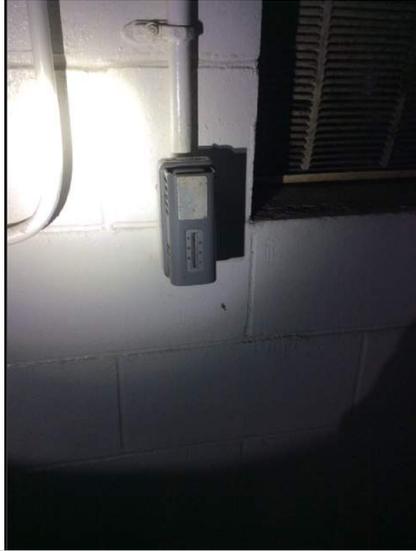
Observation ID:	Detailed Sample Location:
HBM-PSH-1-HGF-7	Mercury switch
Type of Sample:	Specify Miscellaneous Material (if applicable):
HGF	
Sample Color:	Sample Quantity:
	2. One on 1st floor, one on 2nd floor
Sample Photo:

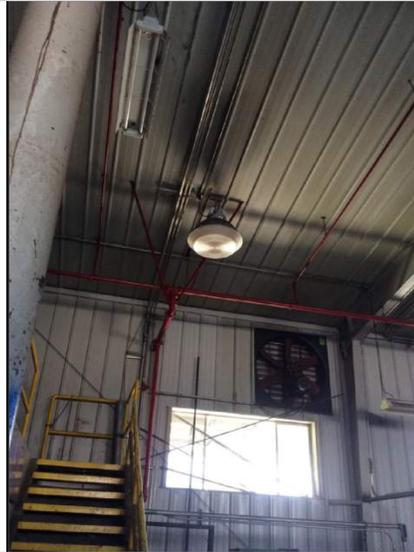
Observation ID:		Detailed Sample Location:	
HBM-PSH-1-MISC-8		7 large sodium light fixtures	
Type of Sample:		Specify Miscellaneous Material (if applicable):	
MISC		Light fixture	
Is the Sample Friable?:		Sample Condition:	
No			
Sample Color:		Sample Quantity:	
		7	
Sample Photo:

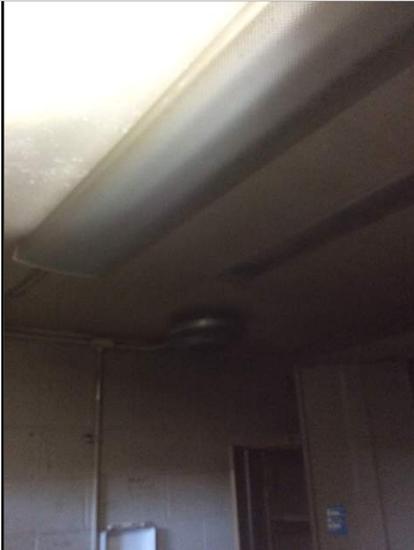
Observation ID:		Detailed Sample Location:	
HBM-PSH-1-MISC-9		Fluorescent fixtures and ballasts	
Type of Sample:		Specify Miscellaneous Material (if applicable):	
MISC		Light fixture	
Is the Sample Friable?:		Sample Condition:	
No			
Sample Color:		Sample Quantity:	
		15	
Sample Photo:

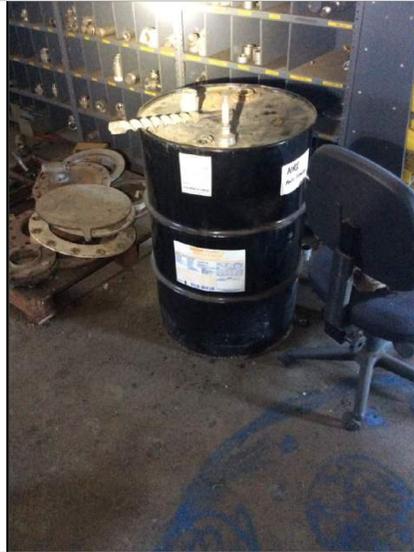
Observation ID:		Detailed Sample Location:	
HBM-PSH-1-MISC-10		Antifreeze drum	
Type of Sample:		Specify Miscellaneous Material (if applicable):	
MISC		55-gallon drum	
Is the Sample Friable?:		Sample Condition:	
No			
Sample Color:		Sample Quantity:	
		1	
Sample Photo:

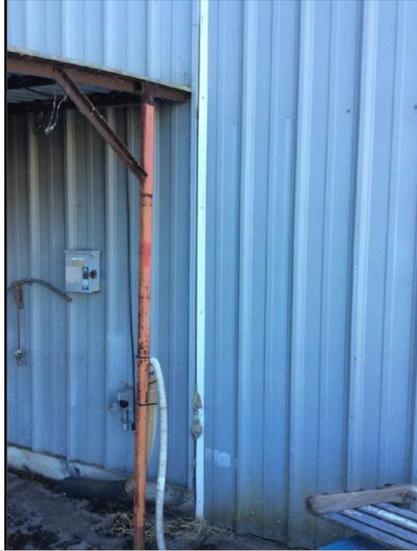
Observation ID:	Detailed Sample Location:
HBM-PSH-1-PB-11	Exterior painted surface
Type of Sample:	Specify Miscellaneous Material (if applicable):
PB	
Sample Color:	Sample Quantity:
Medium gray	
Sample Photo:

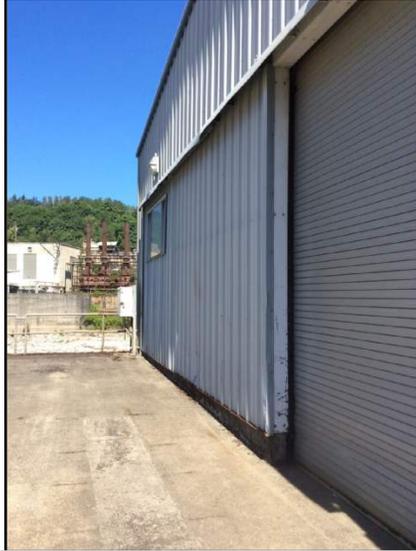
Observation ID:	Detailed Sample Location:
HBM-PSH-1-PB-12	Exterior painted surfaces
Type of Sample:	Specify Miscellaneous Material (if applicable):
PB	
Sample Color:	Sample Quantity:
Medium gray	
Sample Photo:

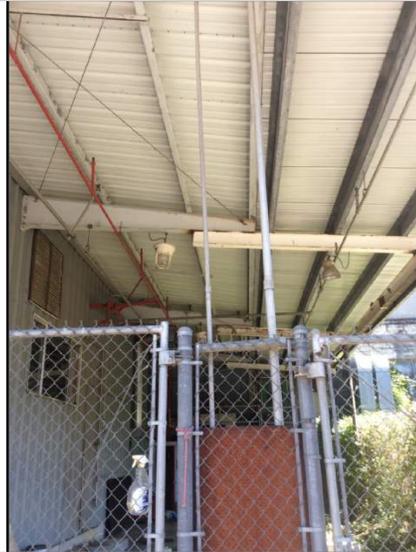
Observation ID:		Detailed Sample Location:	
HBM-PSH-1-MISC-13		Exterior lighting	
Type of Sample:		Specify Miscellaneous Material (if applicable):	
MISC		Light fixtures	
Is the Sample Friable?:		Sample Condition:	
No			
Sample Color:		Sample Quantity:	
		6	
Sample Photo:

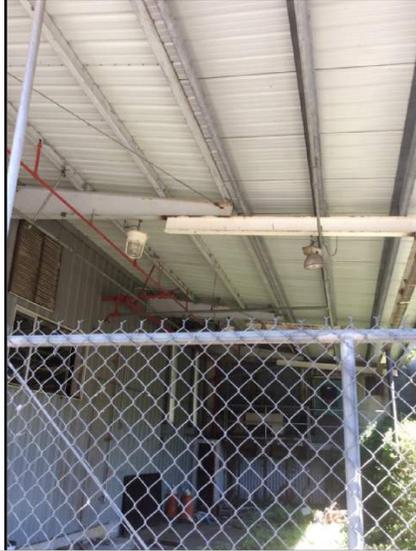
Observation ID:	Detailed Sample Location:
HBM-PSH-1-PB-14	White exterior painted surfaces
Type of Sample:	Specify Miscellaneous Material (if applicable):
PB	
Sample Color:	Sample Quantity:
White	200 sq. ft.
Sample Photo:

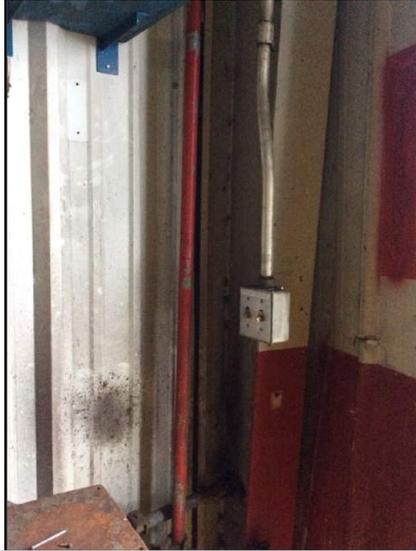
Observation ID:	Detailed Sample Location:
HBM-PSH-1-PB-15	Red fire suppression
Type of Sample:	Specify Miscellaneous Material (if applicable):
PB	
Sample Color:	Sample Quantity:
Red	100 sq. ft.
Sample Photo:

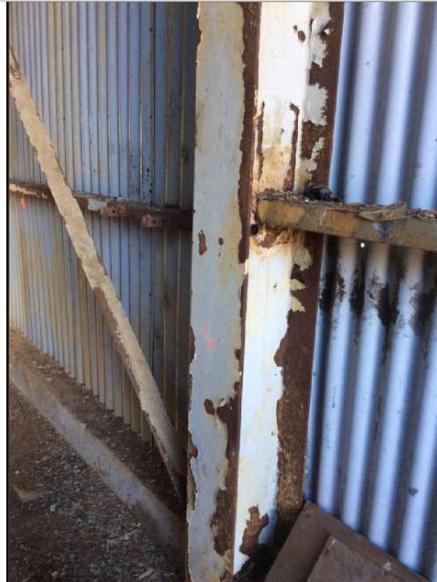
Observation ID:	Detailed Sample Location:
HBM-PST-1-PB-1	Interior off-white painted surfaces
Type of Sample: PB	Specify Miscellaneous Material (if applicable):
Sample Color: Off-white, peeling	
	Sample Quantity:
	1,000 sq. ft.

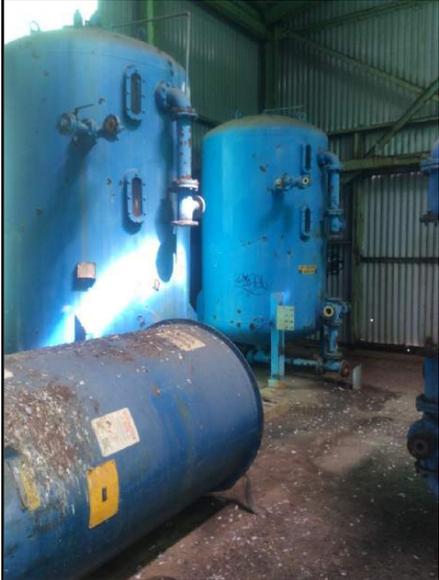
Observation ID:	Detailed Sample Location:
HBM-PST-2-PB-3	Storage tanks
Type of Sample:	Specify Miscellaneous Material (if applicable):
PB	
Sample Color:	Sample Quantity:
Blue	800 sq. ft.
Sample Photo:

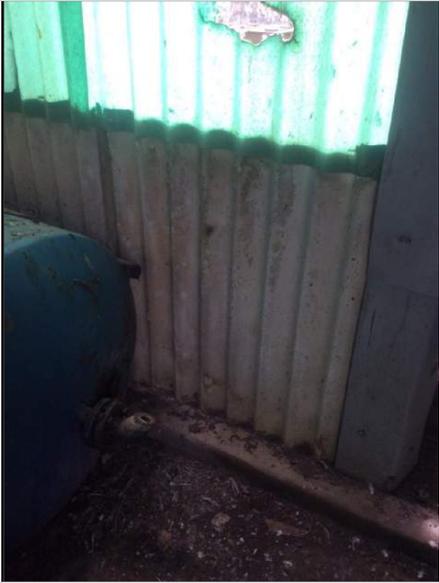
Observation ID:		Detailed Sample Location:	
HBM-PST-2-ASB-2		Transite siding	
Type of Sample:		Specify Miscellaneous Material (if applicable):	
ASB			
Is the Sample Friable?:		Sample Condition:	
No		Potential ACBM with potential for damage	
Sample Color:		Sample Quantity:	
		1000 sq. ft.	
Sample Photo:

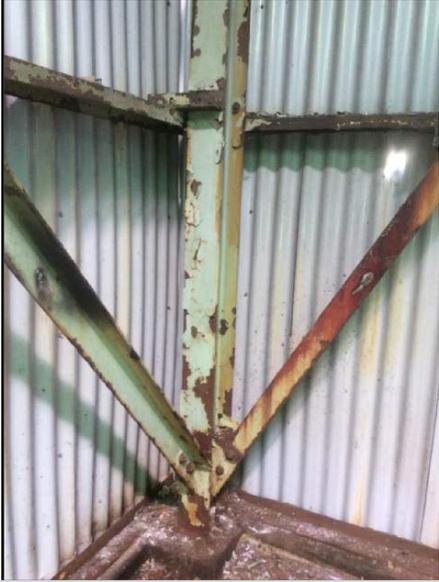
Observation ID:	Detailed Sample Location:
HBM-PST-2-PB-4	Green painted interior beams
Type of Sample:	Specify Miscellaneous Material (if applicable):
PB	
Sample Color:	Sample Quantity:
Green	1,000 sq. ft.
Sample Photo:

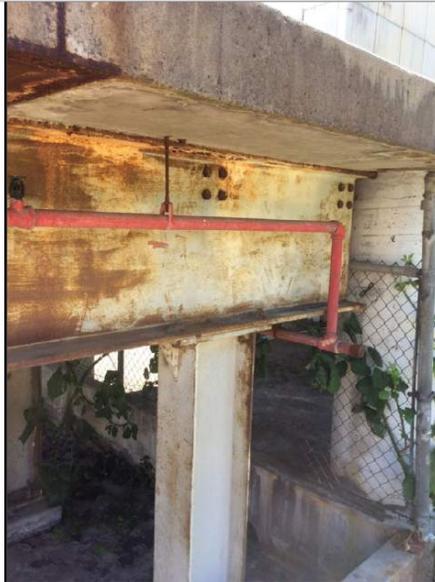
Observation ID:	Detailed Sample Location:
HBM-PWS-1-PB-1	Exterior painted beams
Type of Sample:	Specify Miscellaneous Material (if applicable):
PB	
Sample Color:	Sample Quantity:
Off-white	1,200 sq. ft.

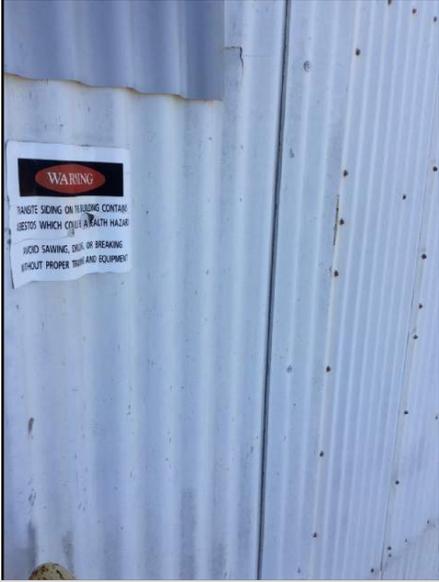
Observation ID:	Detailed Sample Location:
HBM-PWS-1-PB-2	Exterior painted transite
Type of Sample:	Specify Miscellaneous Material (if applicable):
PB	
Sample Color:	Sample Quantity:
Off-white	5,000 sq. ft.
Sample Photo:

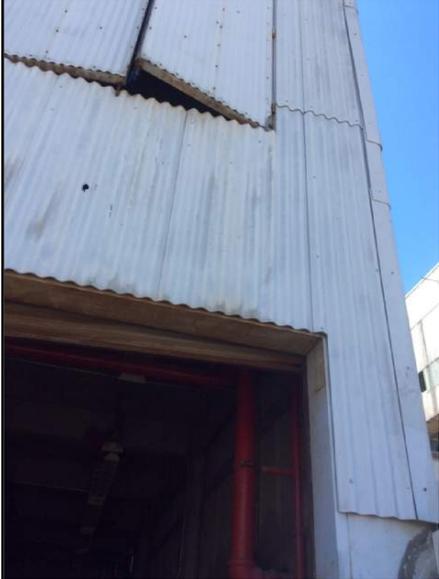
Observation ID:		Detailed Sample Location:	
HBM-PWS-1-ASB-3		Transite siding	
Type of Sample:		Specify Miscellaneous Material (if applicable):	
ASB			
Is the Sample Friable?:		Sample Condition:	
No		Potential ACBM with potential for damage	
Sample Color:		Sample Quantity:	
		5,000 sq. ft.	
Sample Photo:

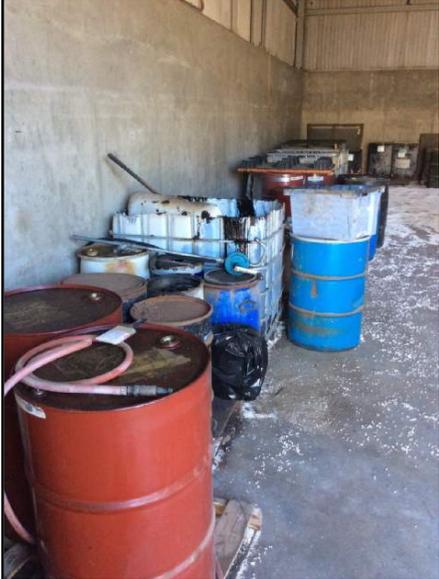
Observation ID:		Detailed Sample Location:	
HBM-PWS-1-MISC-4		Miscellaneous material	
Type of Sample:		Specify Miscellaneous Material (if applicable):	
MISC		Oil and other material in first floor of power house	
Is the Sample Friable?:		Sample Condition:	
No			
Sample Color:		Sample Quantity:	
		40 drums, 4 totes, and several buckets	
Sample Photo:

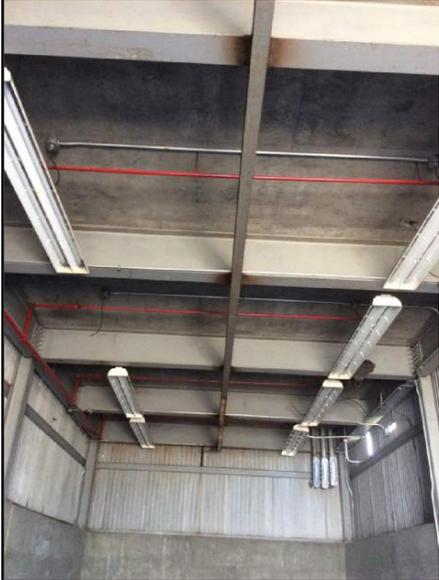
Observation ID:	Detailed Sample Location:
HBM-PWS-1-PB-5	First floor roof beams
Type of Sample:	Specify Miscellaneous Material (if applicable):
PB	
Sample Color:	Sample Quantity:
Gray	500 sq. ft.
Sample Photo:

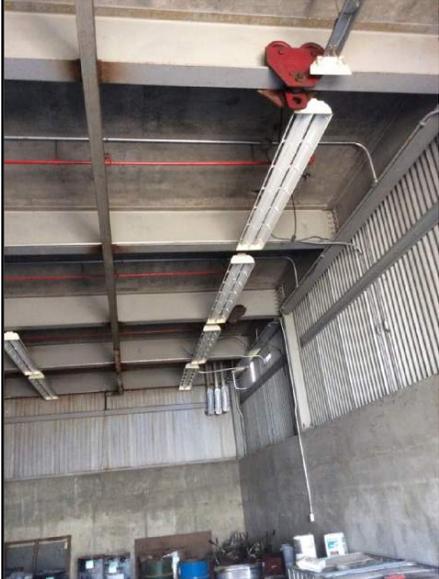
Observation ID:		Detailed Sample Location:	
HBM-PWS-1-MISC-6		Fluorescent light fixtures and ballasts	
Type of Sample:		Specify Miscellaneous Material (if applicable):	
MISC		Light fixtures	
Is the Sample Friable?:	Sample Condition:		
Sample Color:		Sample Quantity:	
		11	
Sample Photo:

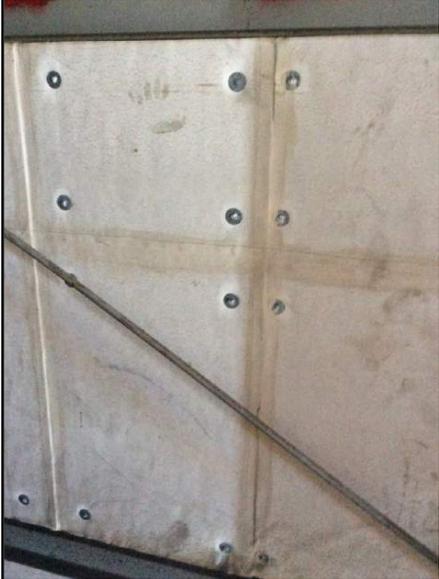
Observation ID:		Detailed Sample Location:	
HBM-PWS-2-ASB-7		Interior insulation backing and tape	
Type of Sample:		Specify Miscellaneous Material (if applicable):	
ASB			
Is the Sample Friable?:		Sample Condition:	
No		Potential ACBM with potential for damage	
Sample Color:		Sample Quantity:	
		1,500 sq. ft.	
Sample Photo:

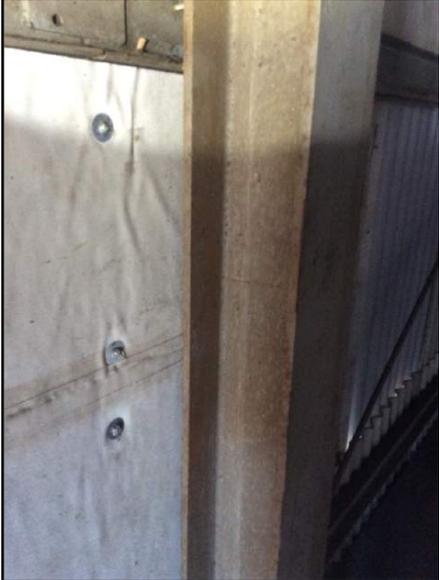
Observation ID:	Detailed Sample Location:
HBM-PWS-1-PB-8	Interior painted beams
Type of Sample:	Specify Miscellaneous Material (if applicable):
PB	
Sample Color:	Sample Quantity:
Gray	900 sq. ft.
Sample Photo:

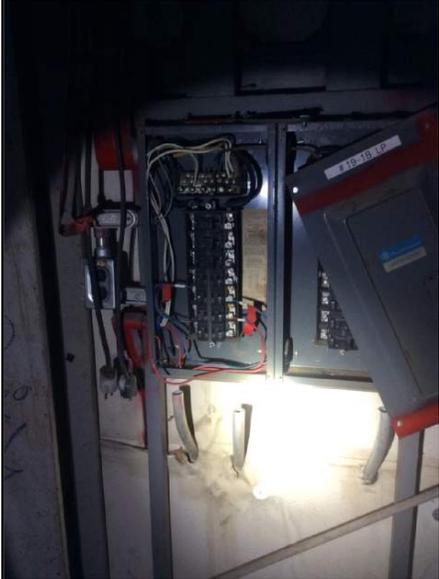
Observation ID:		Detailed Sample Location:	
HBM-PWS-2-MISC-9		Electrical components	
Type of Sample:		Specify Miscellaneous Material (if applicable):	
MISC		Breaker boxes and transformer	
Is the Sample Friable?:		Sample Condition:	
No			
Sample Color:		Sample Quantity:	
		2 boxes and 1 transformer	
Sample Photo:

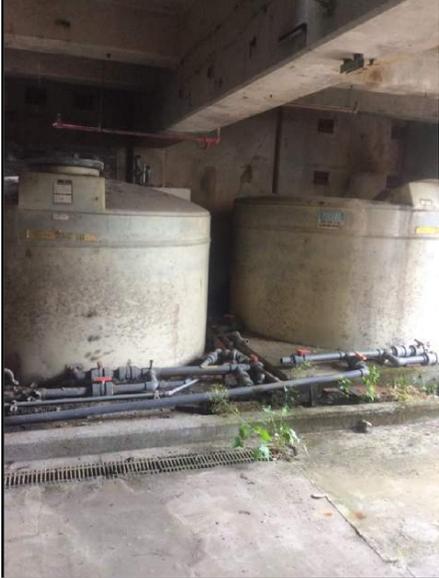
Observation ID:		Detailed Sample Location:	
HBM-RCB-1-MISC-1		Poly storage tanks	
Type of Sample:		Specify Miscellaneous Material (if applicable):	
MISC		Poly tanks	
Is the Sample Friable?:	Sample Condition:		
No			
Sample Color:		Sample Quantity:	
		2	
Sample Photo:

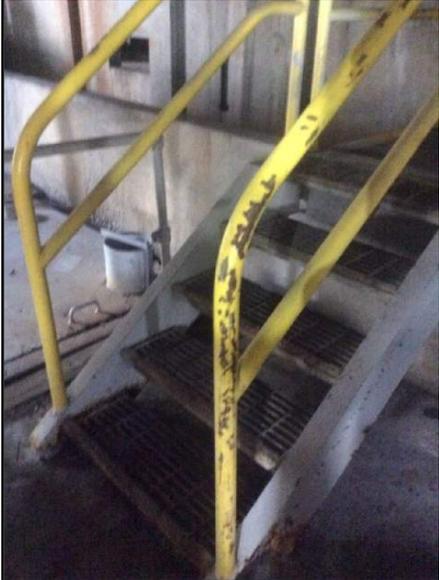
Observation ID:	Detailed Sample Location:
HBM-RCB-1-PB-2	Yellow painted surfaces
Type of Sample:	Specify Miscellaneous Material (if applicable):
PB	
Sample Color:	Sample Quantity:
Yellow	200 sq. ft.
Sample Photo:

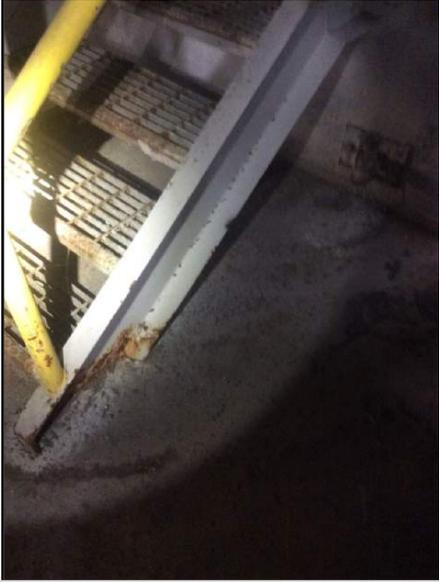
Observation ID:	Detailed Sample Location:
HBM-RCB-1-PB-3	Gray painted surfaces
Type of Sample:	Specify Miscellaneous Material (if applicable):
PB	
Sample Color:	Sample Quantity:
Gray	100 sq. ft.
Sample Photo:

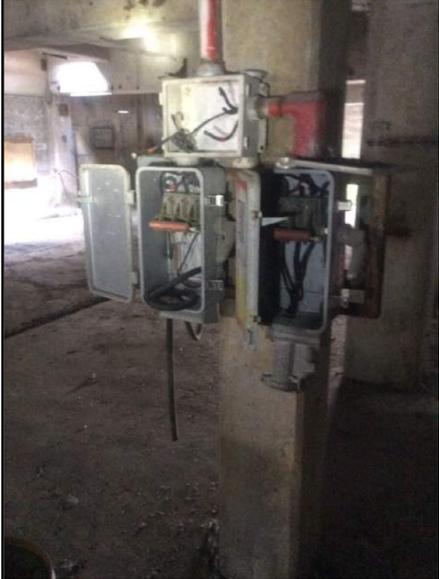
Observation ID:		Detailed Sample Location:	
HBM-RCB-1-MISC-4		Electrical components	
Type of Sample:		Specify Miscellaneous Material (if applicable):	
MISC		Electrical switch boxes	
Is the Sample Friable?:		Sample Condition:	
No			
Sample Color:		Sample Quantity:	
		2	
Sample Photo:

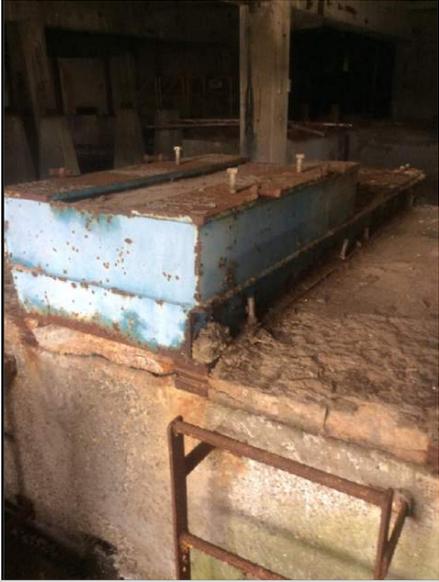
Observation ID:	Detailed Sample Location:
HBM-RCB-1-PB-5	Blue painted surfaces
Type of Sample:	Specify Miscellaneous Material (if applicable):
PB	
Sample Color:	Sample Quantity:
Blue	40 sq. ft.
Sample Photo:

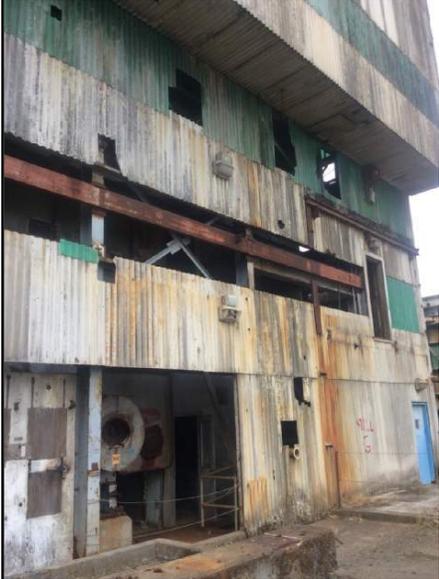
Observation ID:		Detailed Sample Location:	
HBM-RCB-1-ASB-1		Exterior transite siding	
Type of Sample:		Specify Miscellaneous Material (if applicable):	
ASB			
Is the Sample Friable?:		Sample Condition:	
No		Potential ACBM with potential for significant damage	
Sample Color:		Sample Quantity:	
		10,100 sq. ft.	
Sample Photo:

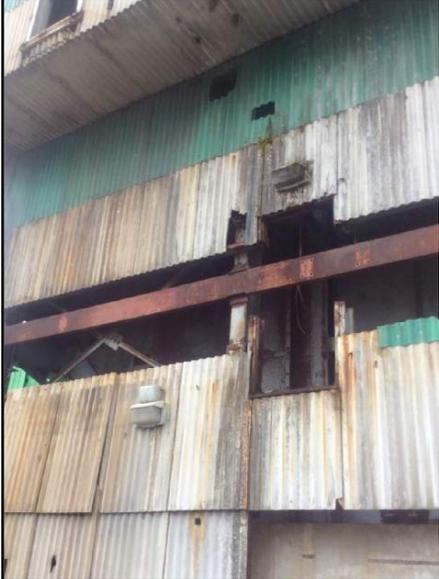
Observation ID:		Detailed Sample Location:	
HBM-RCB-2-MISC-2		Exterior lighting	
Type of Sample:		Specify Miscellaneous Material (if applicable):	
MISC		Light fixtures, north wall	
Is the Sample Friable?:		Sample Condition:	
No			
Sample Color:		Sample Quantity:	
		6	
Sample Photo:

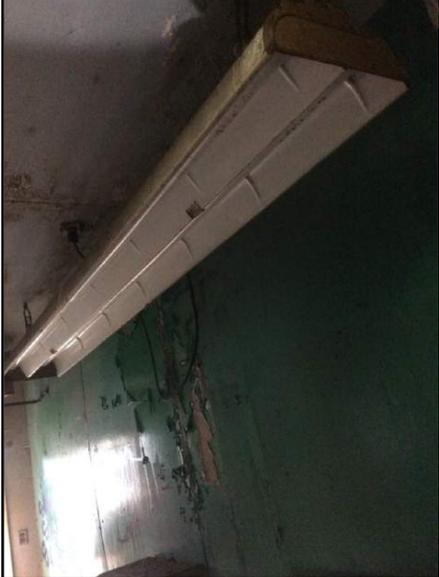
Observation ID:		Detailed Sample Location:	
HBM-RCB-2-MISC-6		Fluorescent light fixture	
Type of Sample:		Specify Miscellaneous Material (if applicable):	
MISC		Light fixture	
Is the Sample Friable?:		Sample Condition:	
No			
Sample Color:		Sample Quantity:	
		1	
Sample Photo:

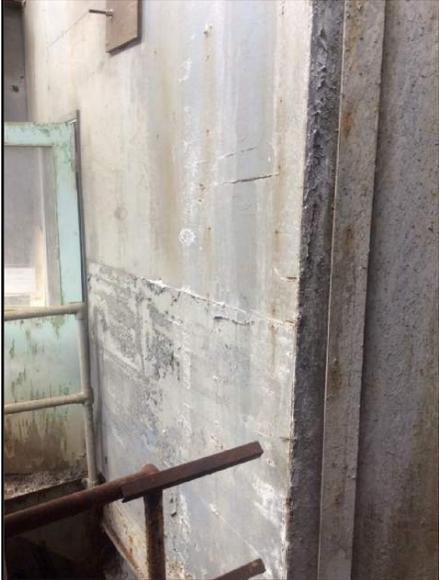
Observation ID:	Detailed Sample Location:
HBM-RCB-2-PB-3	Interior control room painted surfaces, gray
Type of Sample:	Specify Miscellaneous Material (if applicable):
PB	
Sample Color:	Sample Quantity:
Gray	400 sq. ft.
Sample Photo:

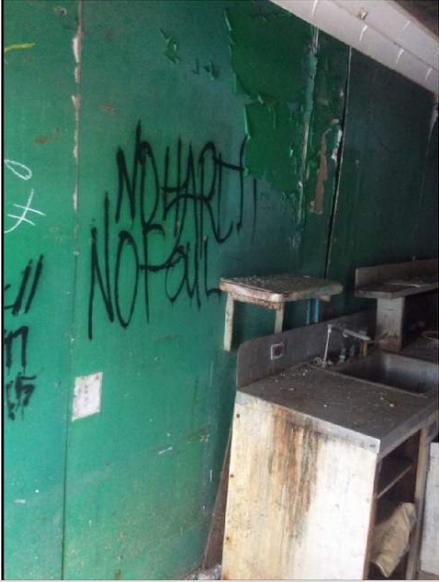
Observation ID:	Detailed Sample Location:
HBM-RCB-2-PB-4	Interior green painted surfaces
Type of Sample:	Specify Miscellaneous Material (if applicable):
PB	
Sample Color:	Sample Quantity:
Green	100 sq. ft.
Sample Photo:

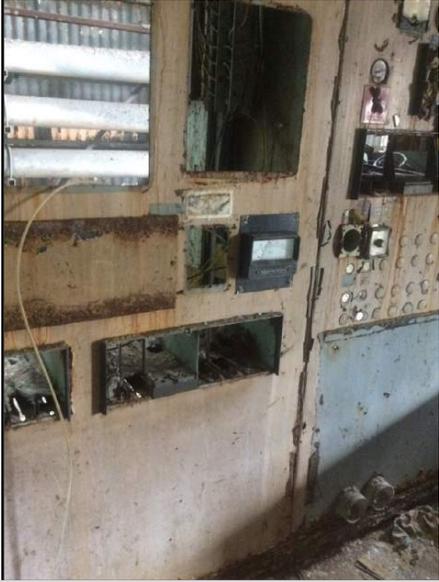
Observation ID:	Detailed Sample Location:
HBM-RCB-2-PB-5	Interior tan painted surfaces
Type of Sample:	Specify Miscellaneous Material (if applicable):
PB	
Sample Color:	Sample Quantity:
Tan	100 sq. ft.
Sample Photo:

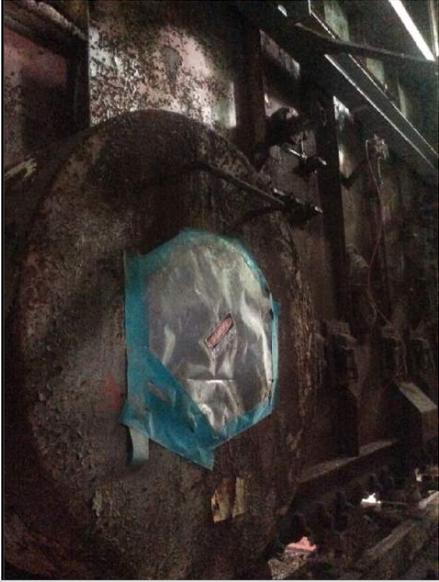
Observation ID:	Detailed Sample Location:
HBM-RCB-2-PB-7	Recovery boiler
Type of Sample:	Specify Miscellaneous Material (if applicable):
PB	
Sample Color:	Sample Quantity:
Gray, asbestos containing	4,500 sq. ft.
Sample Photo:

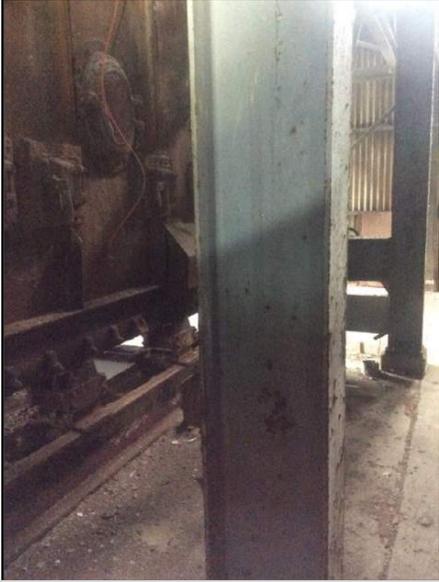
Observation ID:	Detailed Sample Location:
HBM-RCB-2-PB-8	Interior gray painted beams
Type of Sample:	Specify Miscellaneous Material (if applicable):
PB	
Sample Color:	Sample Quantity:
Gray	10,000 sq. ft.
Sample Photo:

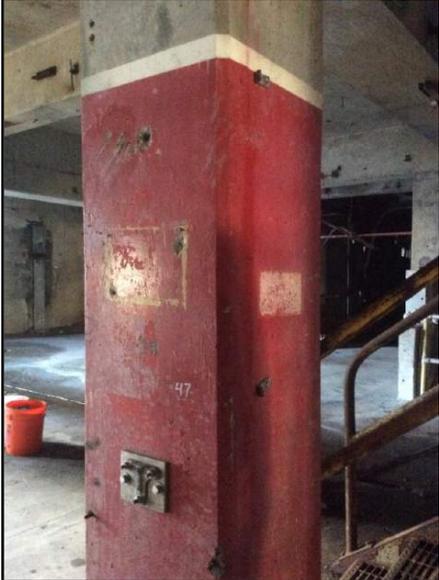
Observation ID:	Detailed Sample Location:
HBM-RCB-1-PB-9	Red fire paint
Type of Sample:	Specify Miscellaneous Material (if applicable):
PB	
Sample Color:	Sample Quantity:
Red	100 sq. ft.
Sample Photo:

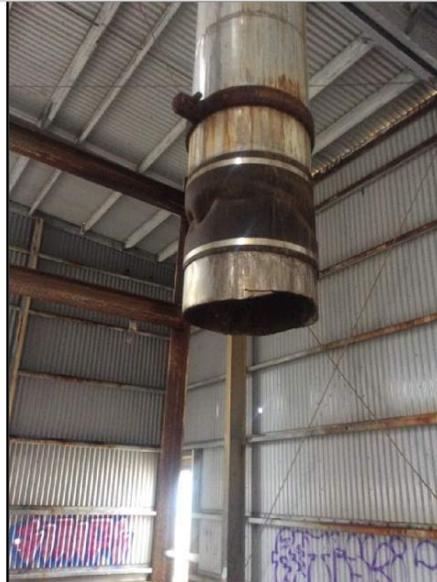
Observation ID:	Detailed Sample Location:
HBM-SC1-1-PB-2	Interior white painted beams
Type of Sample:	Specify Miscellaneous Material (if applicable):
PB	
Sample Color:	Sample Quantity:
White	400 sq. ft.

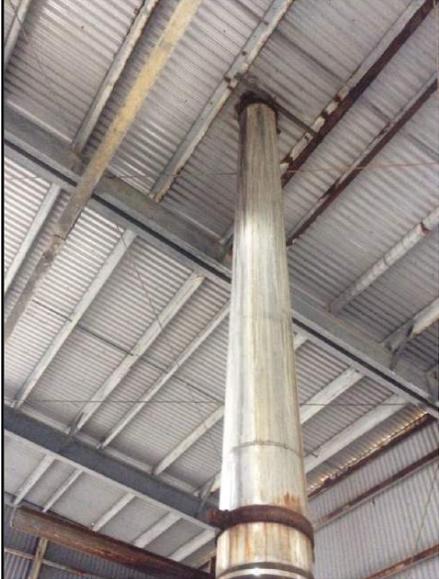
Observation ID:		Detailed Sample Location:	
HBM-SC1-1-ASB-3		Roof penetration sealant	
Type of Sample:		Specify Miscellaneous Material (if applicable):	
ASB			
Is the Sample Friable?:	Sample Condition:		
	Potential ACBM with potential for damage		
Sample Color:		Sample Quantity:	
		20 sq. ft.	
Sample Photo:

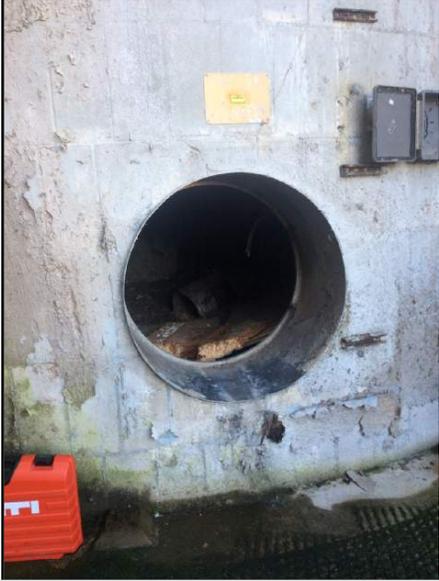
Observation ID:		Detailed Sample Location:	
HBM-SC1-O-ASB-5		Stock cylinder base concrete block	
Type of Sample:		Specify Miscellaneous Material (if applicable):	
ASB			
Is the Sample Friable?:		Sample Condition:	
No		Potential ACBM with potential for damage	
Sample Color:		Sample Quantity:	
		10,000 sq. ft.	
Sample Photo:

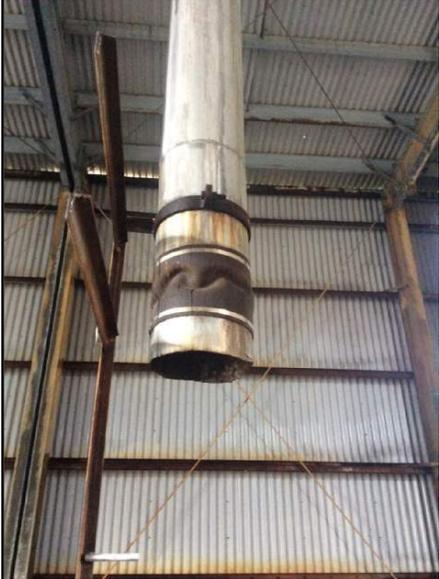
Observation ID:		Detailed Sample Location:	
HBM-SC1-1-ASB-4		Ceiling pipe gasket	
Type of Sample:		Specify Miscellaneous Material (if applicable):	
ASB			
Is the Sample Friable?:		Sample Condition:	
No		Potential ACBM with potential for damage	
Sample Color:		Sample Quantity:	
		10 sq. ft.	
Sample Photo:

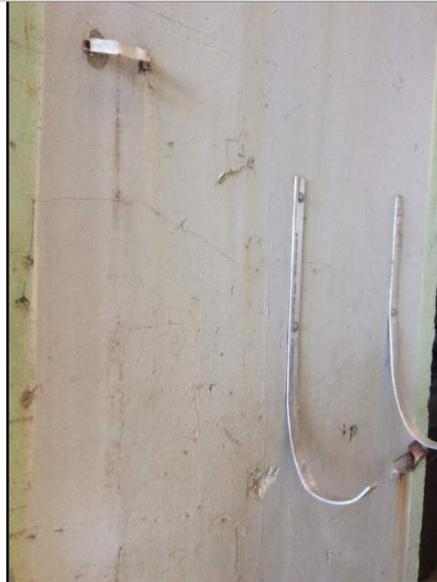
Observation ID:	Detailed Sample Location:
HBM-TSC-1-PB-1	Exterior painted surfaces where flaking, beams
Type of Sample:	Specify Miscellaneous Material (if applicable):
PB	
Sample Color:	Sample Quantity:
Light gray	4,000 sq. ft.

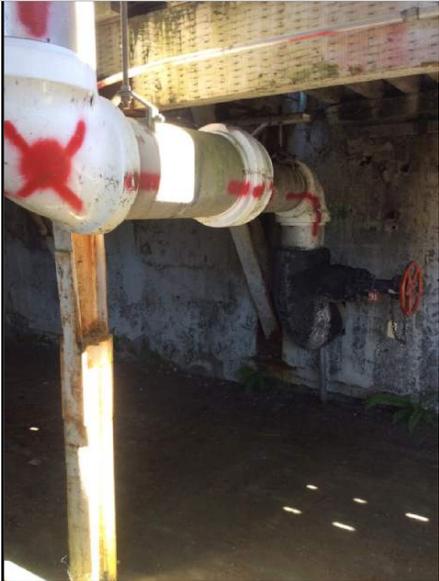
Observation ID:		Detailed Sample Location:	
HBM-TSC-1-ASB-2		Hard joints and TSI	
Type of Sample:		Specify Miscellaneous Material (if applicable):	
ASB			
Is the Sample Friable?:	Sample Condition:		
No	Damaged or significantly damaged		
Sample Color:		Sample Quantity:	
		80 linear feet	
Sample Photo:

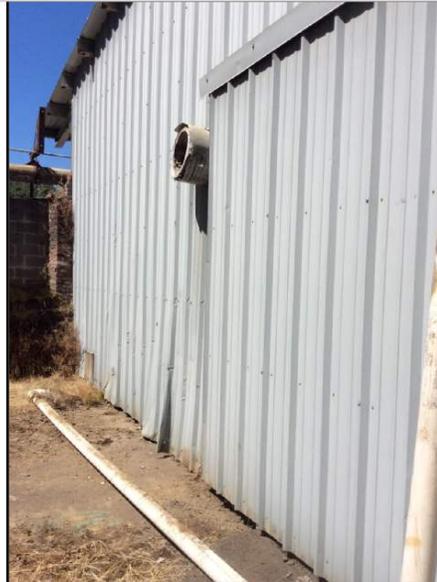
Observation ID:	Detailed Sample Location:
HBM-WMF-1-PB-1	Exterior painted surfaces
Type of Sample:	Specify Miscellaneous Material (if applicable):
PB	
Sample Color:	Sample Quantity:
Light blue	Building footprint
Sample Photo:

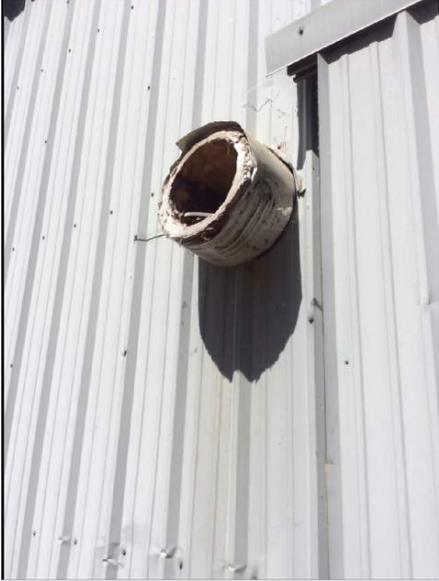
Observation ID:		Detailed Sample Location:	
HBM-WMF-1-ASB-2		South exterior penetration and insulation	
Type of Sample:		Specify Miscellaneous Material (if applicable):	
ASB			
Is the Sample Friable?:		Sample Condition:	
Yes		Potential ACBM with potential for damage	
Sample Color:		Sample Quantity:	
		4 sq. ft.	
Sample Photo:

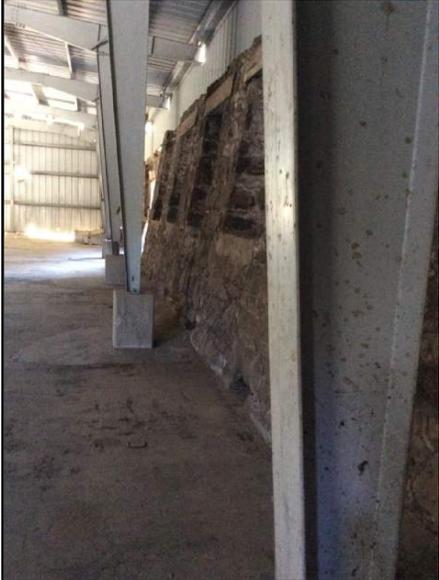
Observation ID:	Detailed Sample Location:
HBM-WMF-1-PB-3	Interior painted beam surfaces
Type of Sample:	Specify Miscellaneous Material (if applicable):
PB	
Sample Color:	Sample Quantity:
White	3,000 sq. ft.
Sample Photo:

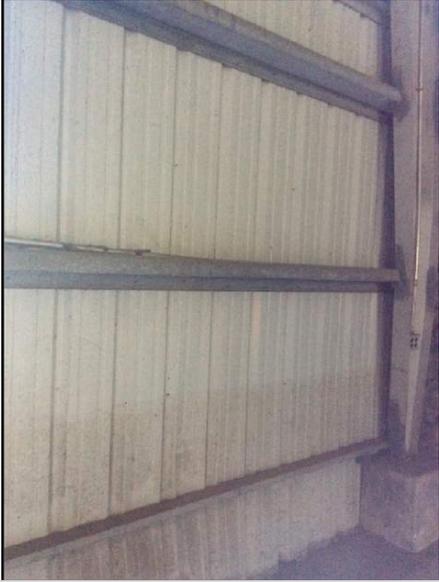
Observation ID:	Detailed Sample Location:
HBM-WMF-1-PB-4	Interior painted ceiling and walls
Type of Sample:	Specify Miscellaneous Material (if applicable):
PB	
Sample Color:	Sample Quantity:
White	Building footprint (X1.5)
Sample Photo:

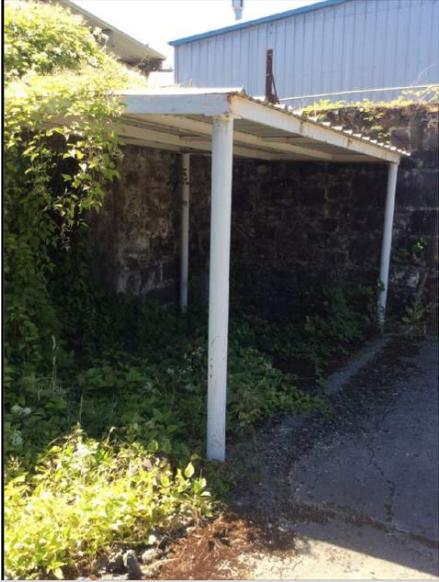
Observation ID:	Detailed Sample Location:
HBM-WMF-1-PB-5	White painted lean-to structure
Type of Sample:	Specify Miscellaneous Material (if applicable):
PB	
Sample Color:	Sample Quantity:
White	200 sq. ft.
Sample Photo:

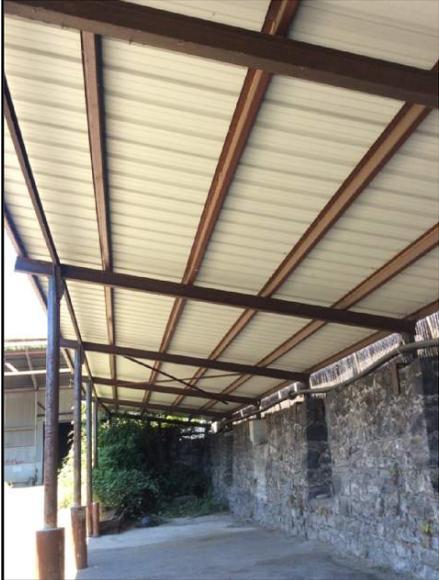
Observation ID:	Detailed Sample Location:
HBM-WMF-1-PB-6	Red painted steel roofing beams (crossbeams and poles aren't painted)
Type of Sample:	Specify Miscellaneous Material (if applicable):
PB	
Sample Color:	Sample Quantity:
Dark red	1,000 sq. ft.
Sample Photo:

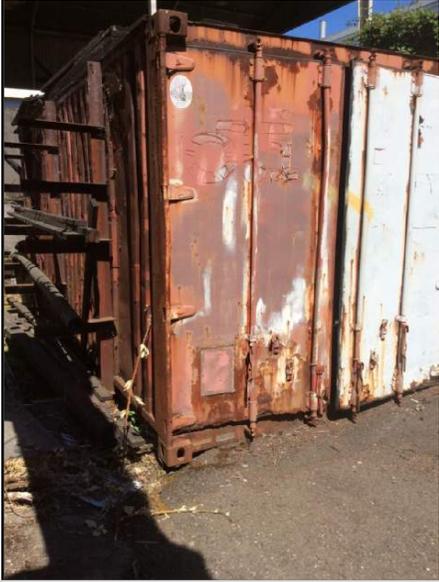
Observation ID:	Detailed Sample Location:
HBM-WMF-1-PB-7	Red and white shipping container
Type of Sample:	Specify Miscellaneous Material (if applicable):
PB	
Sample Color:	Sample Quantity:
Red and white	800 sq. ft.
Sample Photo:

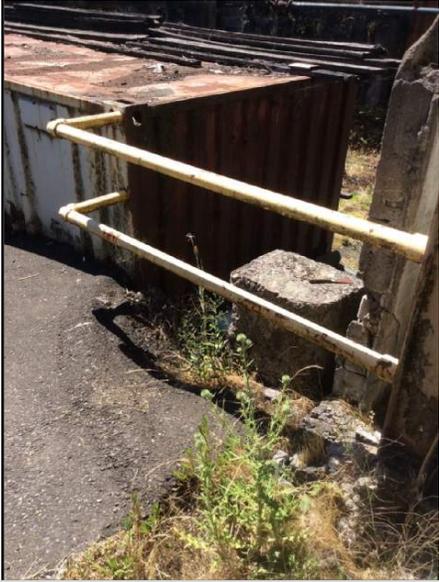
Observation ID:	Detailed Sample Location:
HBM-WMF-1-PB-8	Yellow painted railings
Type of Sample:	Specify Miscellaneous Material (if applicable):
PB	
Sample Color:	Sample Quantity:
Light yellow	10 sq. ft.
Sample Photo:

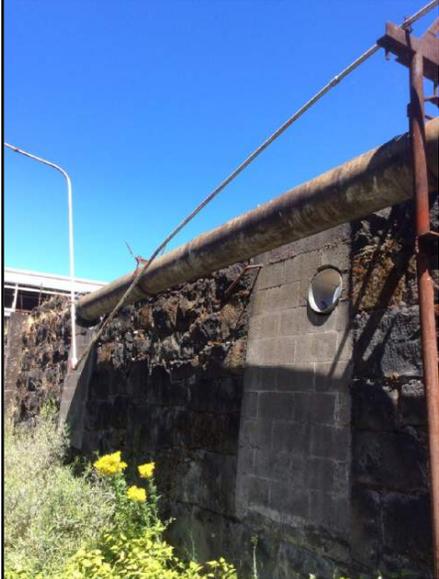
Observation ID:		Detailed Sample Location:	
HBM-WMF-1-ASB-9		Exterior 12" pipe wrap	
Type of Sample:		Specify Miscellaneous Material (if applicable):	
ASB			
Is the Sample Friable?:		Sample Condition:	
No		Potential ACBM with potential for damage	
Sample Color:		Sample Quantity:	
		200 linear feet	
Sample Photo:

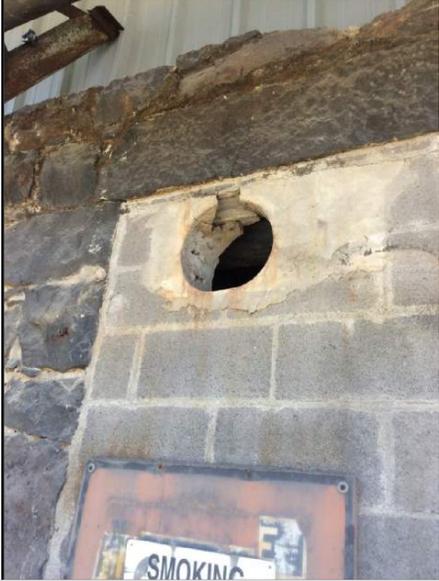
Observation ID:		Detailed Sample Location:	
HBM-WMF-1-ASB-10		Penetration mud	
Type of Sample:		Specify Miscellaneous Material (if applicable):	
ASB			
Is the Sample Friable?:		Sample Condition:	
Yes		Potential ACBM with potential for damage	
Sample Color:		Sample Quantity:	
		4 sq. ft.	
Sample Photo:
