## DURHAM

### GENERAL DESCRIPTION

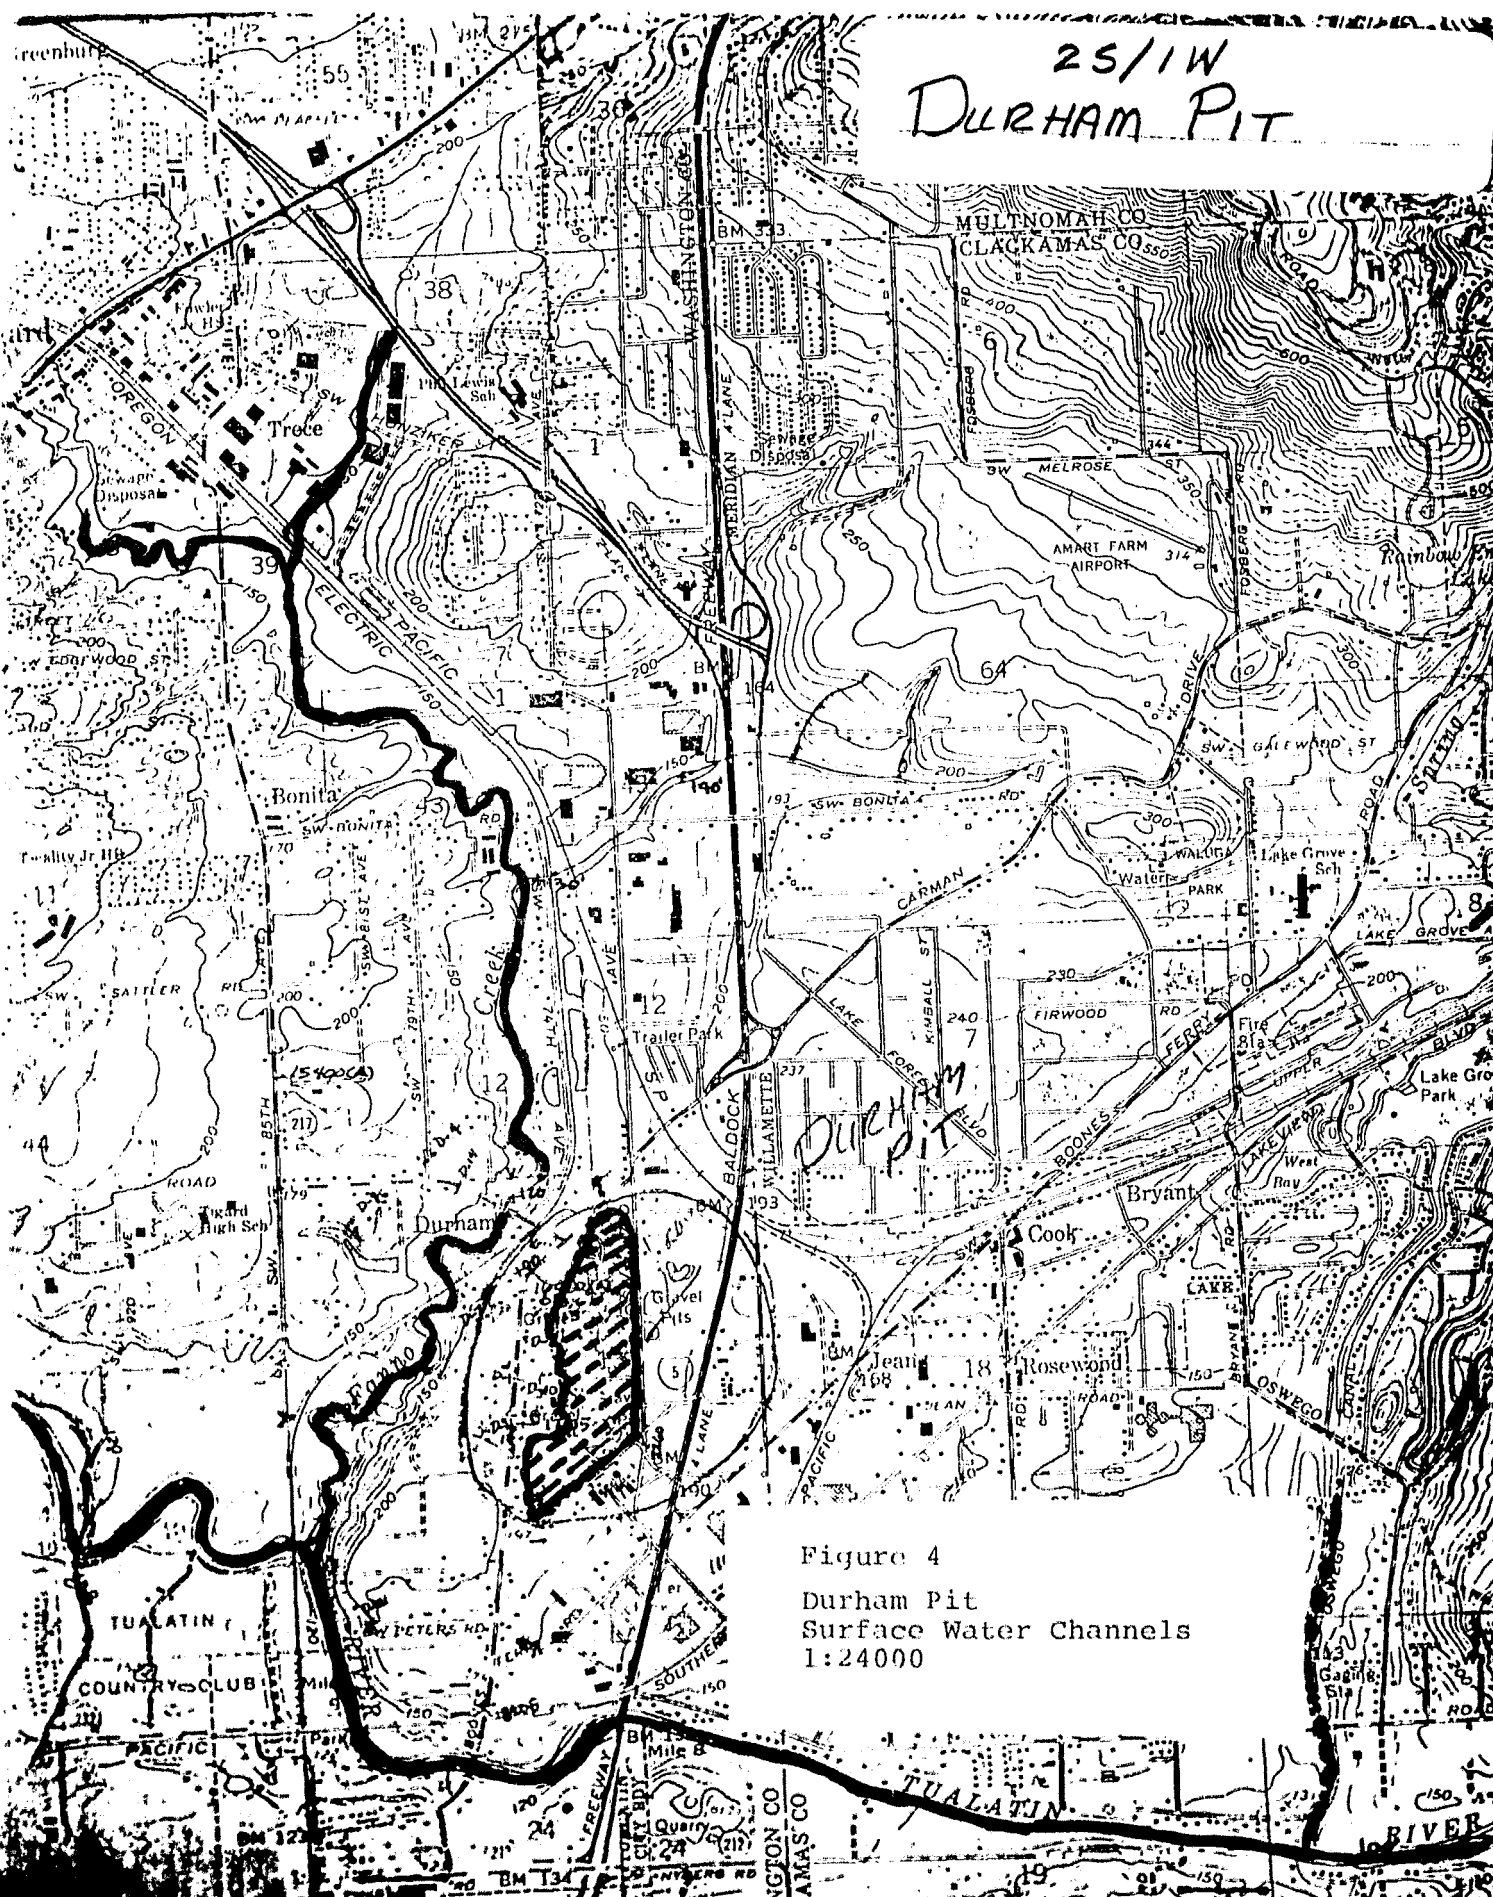
Figure 4  
Durham Pit  
Surface Water Channels  
1:24000

This site's flood hazard is negligible; the entire site is above the elevations of the 1933 Tualatin River flood (Figure 4).
