## ST. JOHNS LANDFILL SLOPE RESTORATION ANNUAL PLANT ESTABLISHMENT MONITORING REPORT

November 12, 2004

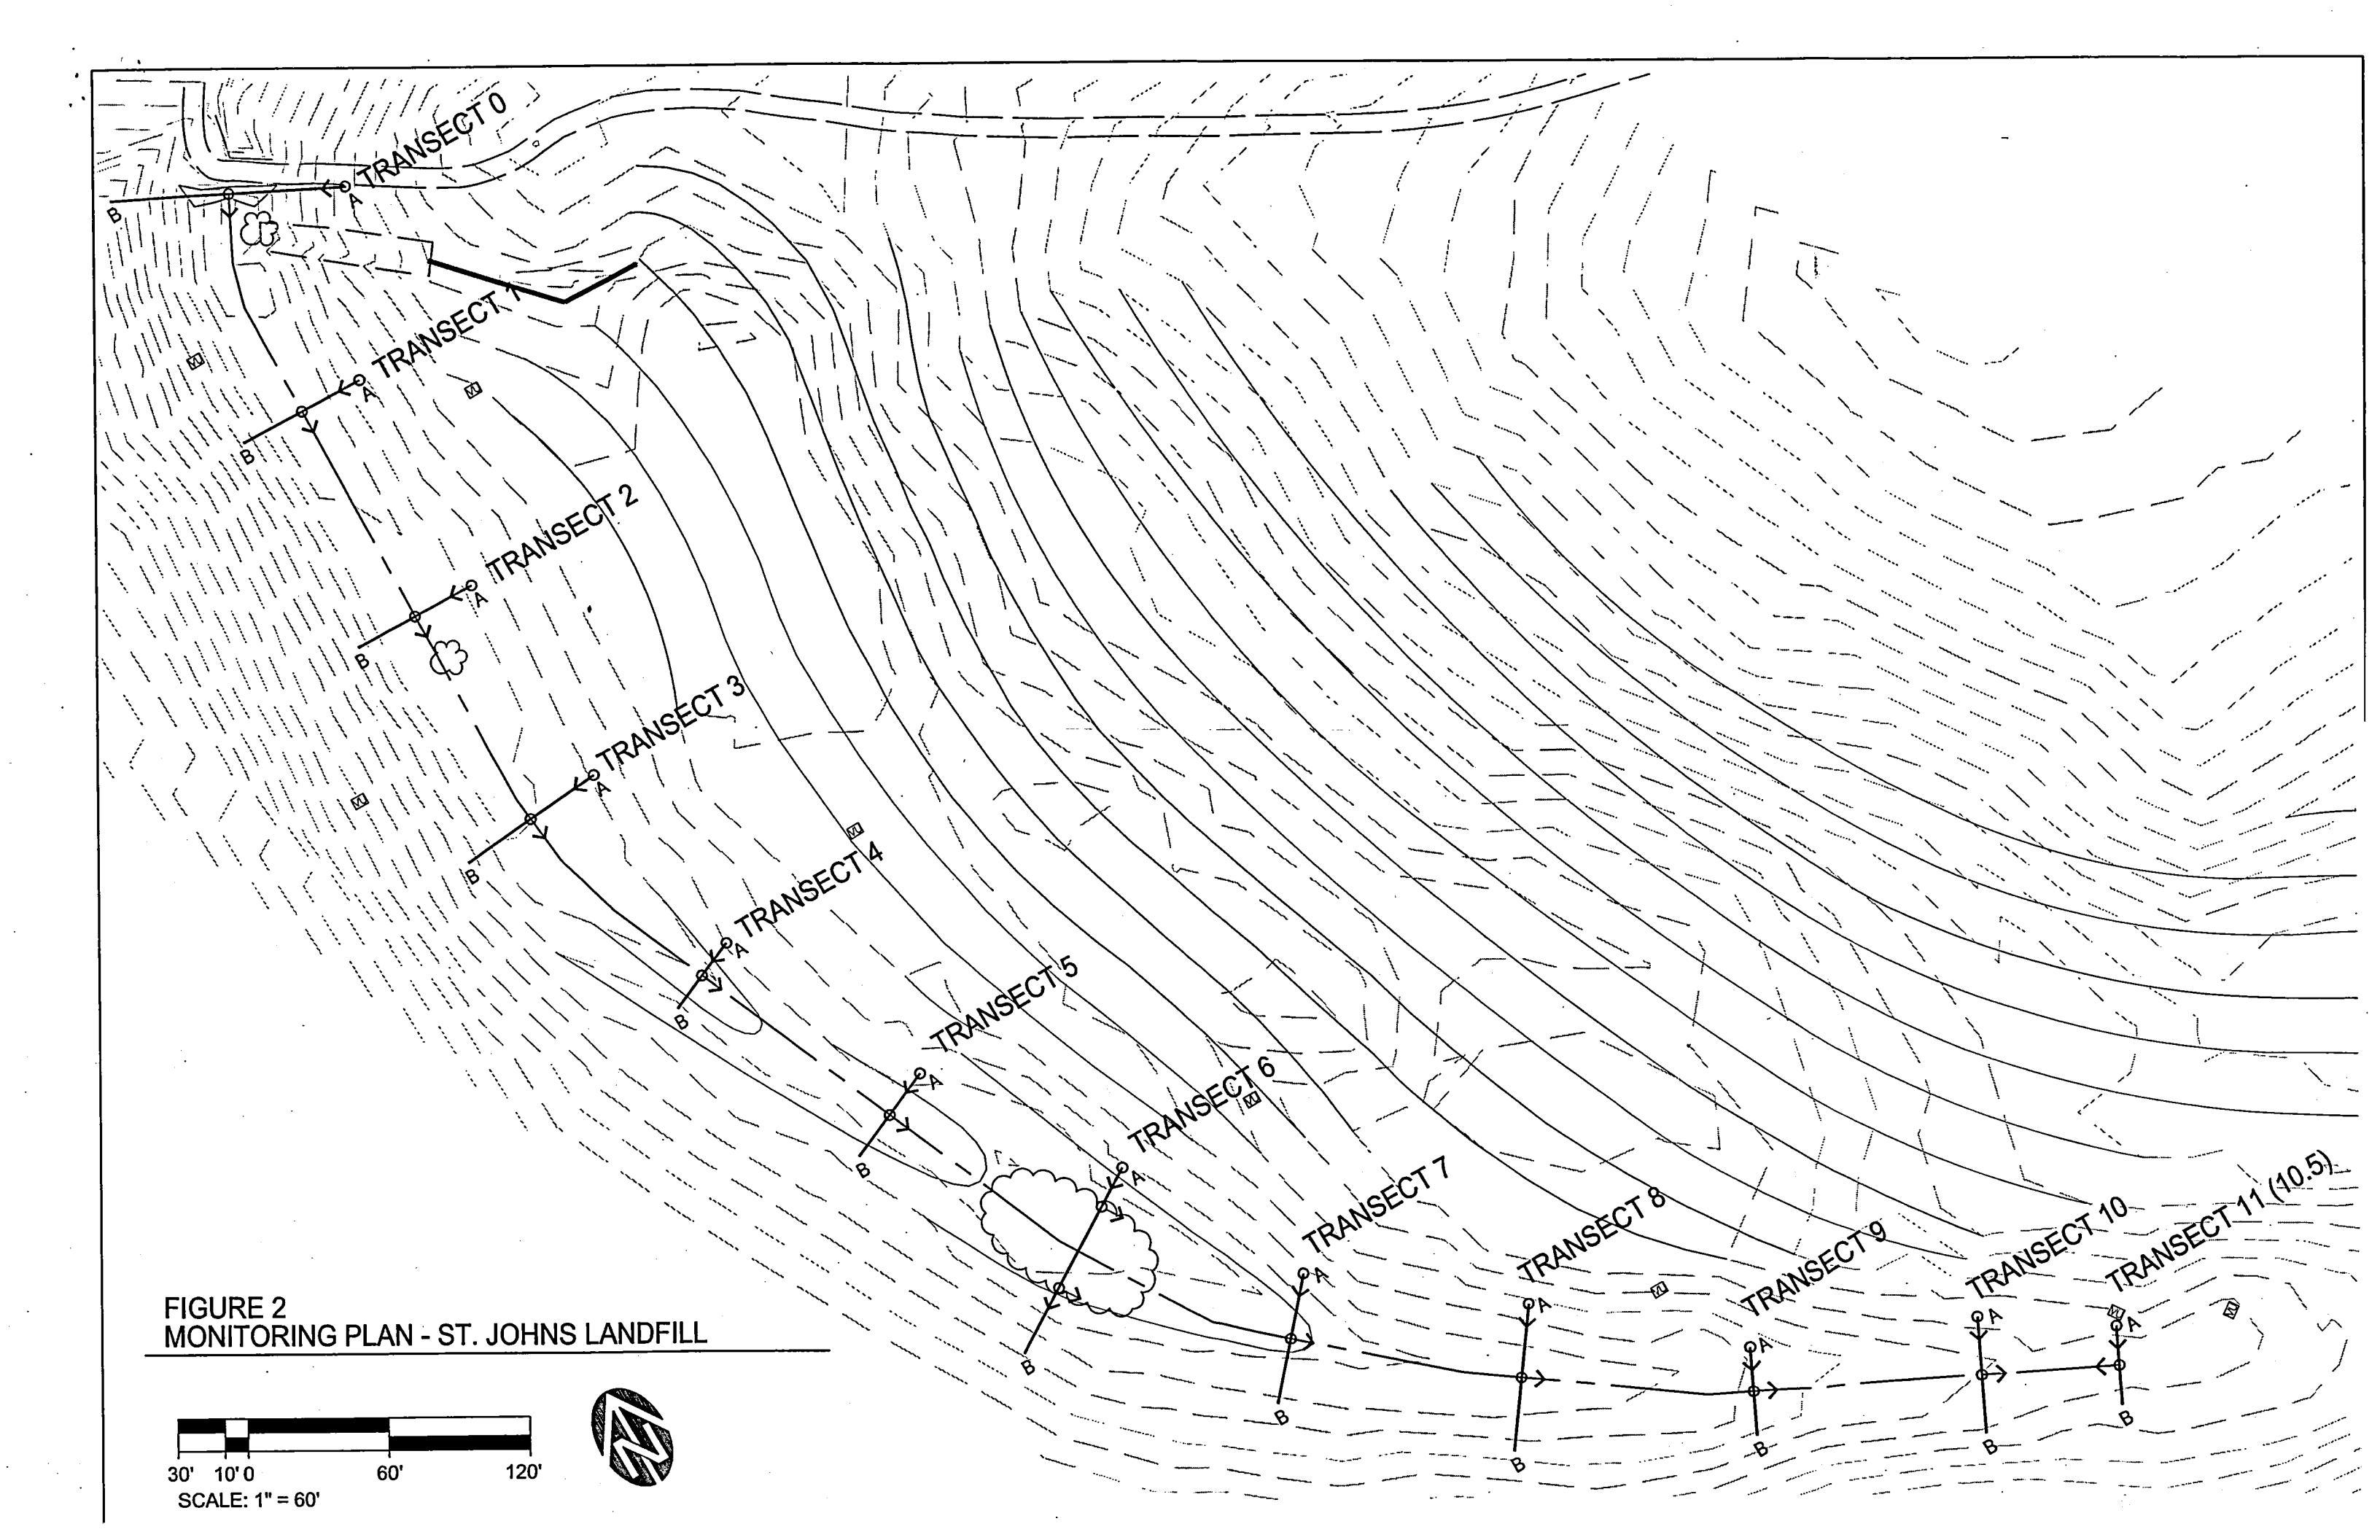
The site was divided into transects spaced at 100 foot intervals. The transects cross the swale starting on the east side and end on the west side. The first transect,  $0^{A} - 0^{B}$ , is located at the culvert at the north limit of the site. From that point, transects were established at 100 foot intervals along the centerline of the swale. The last transect,  $11^{A} - 11^{B}$  is located at the east end of the swale at the edge of the plantings. It is 50-feet from transect 10 due to the length of the planted area. Transect ends were marked with 24 inch orange-tipped wooden stakes that are labeled with the transect number. The stakes were left in the field for future monitoring.

Two photo stations were established for each transect. One photo was taken looking from the  $T^A$  stake to the  $T^B$  stake, along the transect. A second photo was taken from the middle of the transect looking south and/or east to the next transect. The photo at transect 11 was taken looking to the west, back along the project site.

Data sheets summarizing the precise findings along each transect are included in Appendix A. Photos of each transect are included in Appendix B. Figure 1 is a list of plant material and quantities installed, and general condition observed after one growing season. Figure 2 shows the transect and photostation locations on the site.
