SMITH AND BYBEE COMPREHENSIVE NATURAL RESOURCE PLAN APPENDIX

APPENDICES TABLE OF CONTENTS

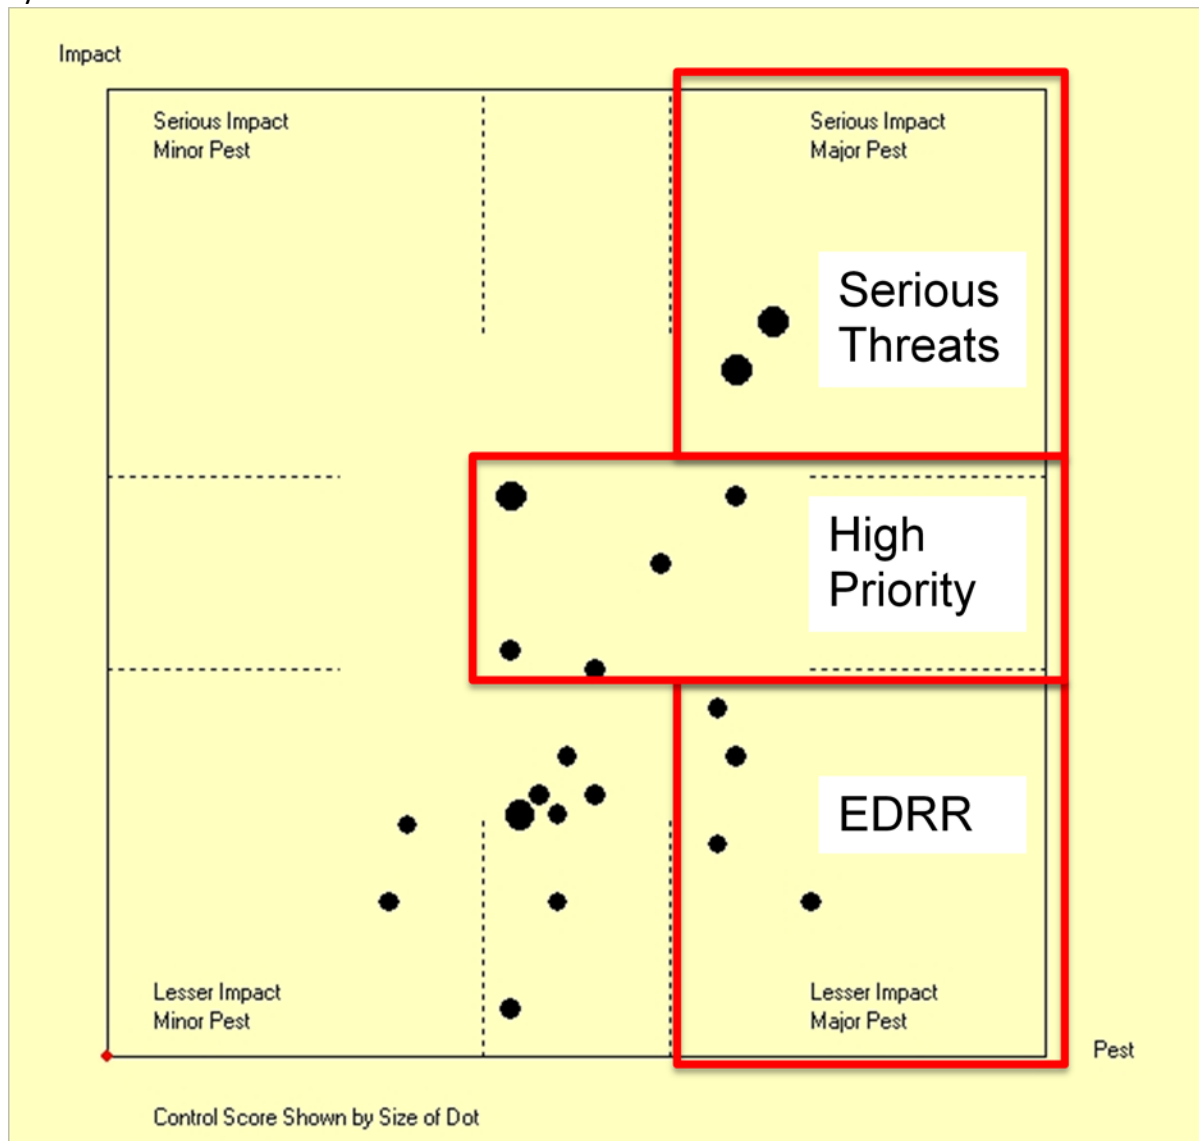
Figure 1. Scatter plot showing general results for 20 species evaluated with Alien Plants Ranking System.

The plot in Figure 1 shows results for all 20 species. Increasing impact to Smith and Bybee Wetlands is on the vertical axis, and increasing potential to be a pest is on the horizontal axis. The size of the dot indicates relative difficulty of control for that species. Invasive species that pose the greatest threat are represented by dots in the upper right corner of the plot – they are major pests with a big impact. The red box in the bottom right corner indicates plants that are major pests but have not made as much impact at Smith and Bybee Wetlands yet. Because their distribution is limited, there is an opportunity to control them before they become major problems. In the middle area, a red box outlines plants (dots) that are emerging threats, at least in some areas.

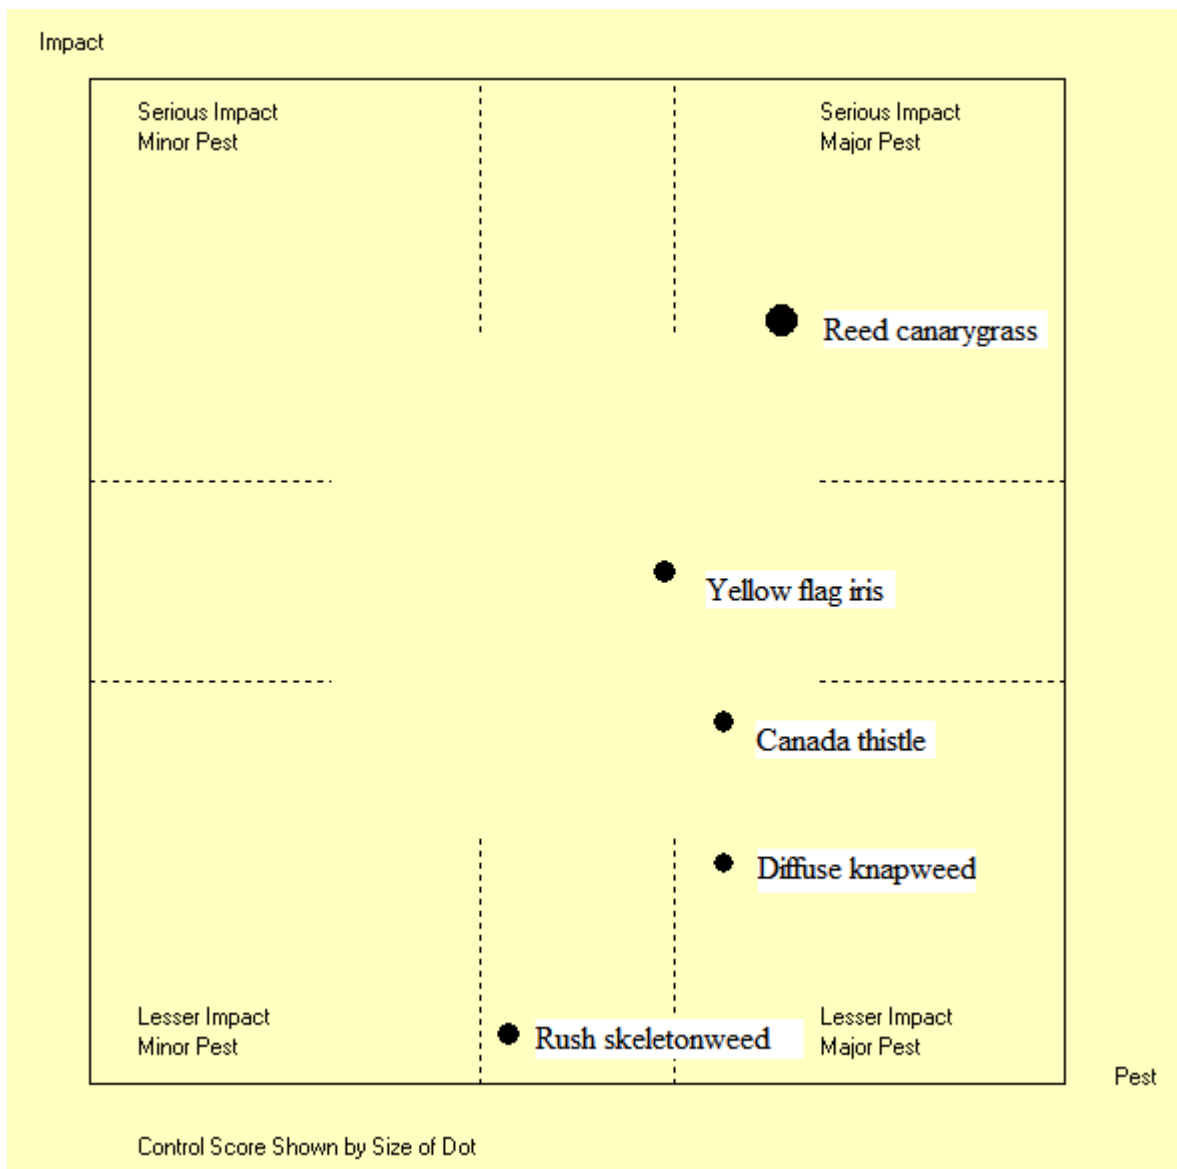
Figure 2. Selected species evaluated with APRS, showing their relative placements.

In Figure 2, selected species are labeled to show their placement by APRS. Labeling all species would render the graph unreadable; the species shown were selected to demonstrate the range of results for well-known weeds that differ in their abundance and distribution at SBW. Reed canarygrass is known to be a serious problem at the wetlands, displacing Columbia sedge meadows, shrub habitats and riparian forests. Yellow flag iris is an emerging threat, and Canada thistle can have big impacts on open meadows. Diffuse knapweed, a major problem throughout the West, is in the early stages of invasion at Smith and Bybee Wetlands. Rush skeletonweed, although somewhat invasive, is not posing much of a problem there.

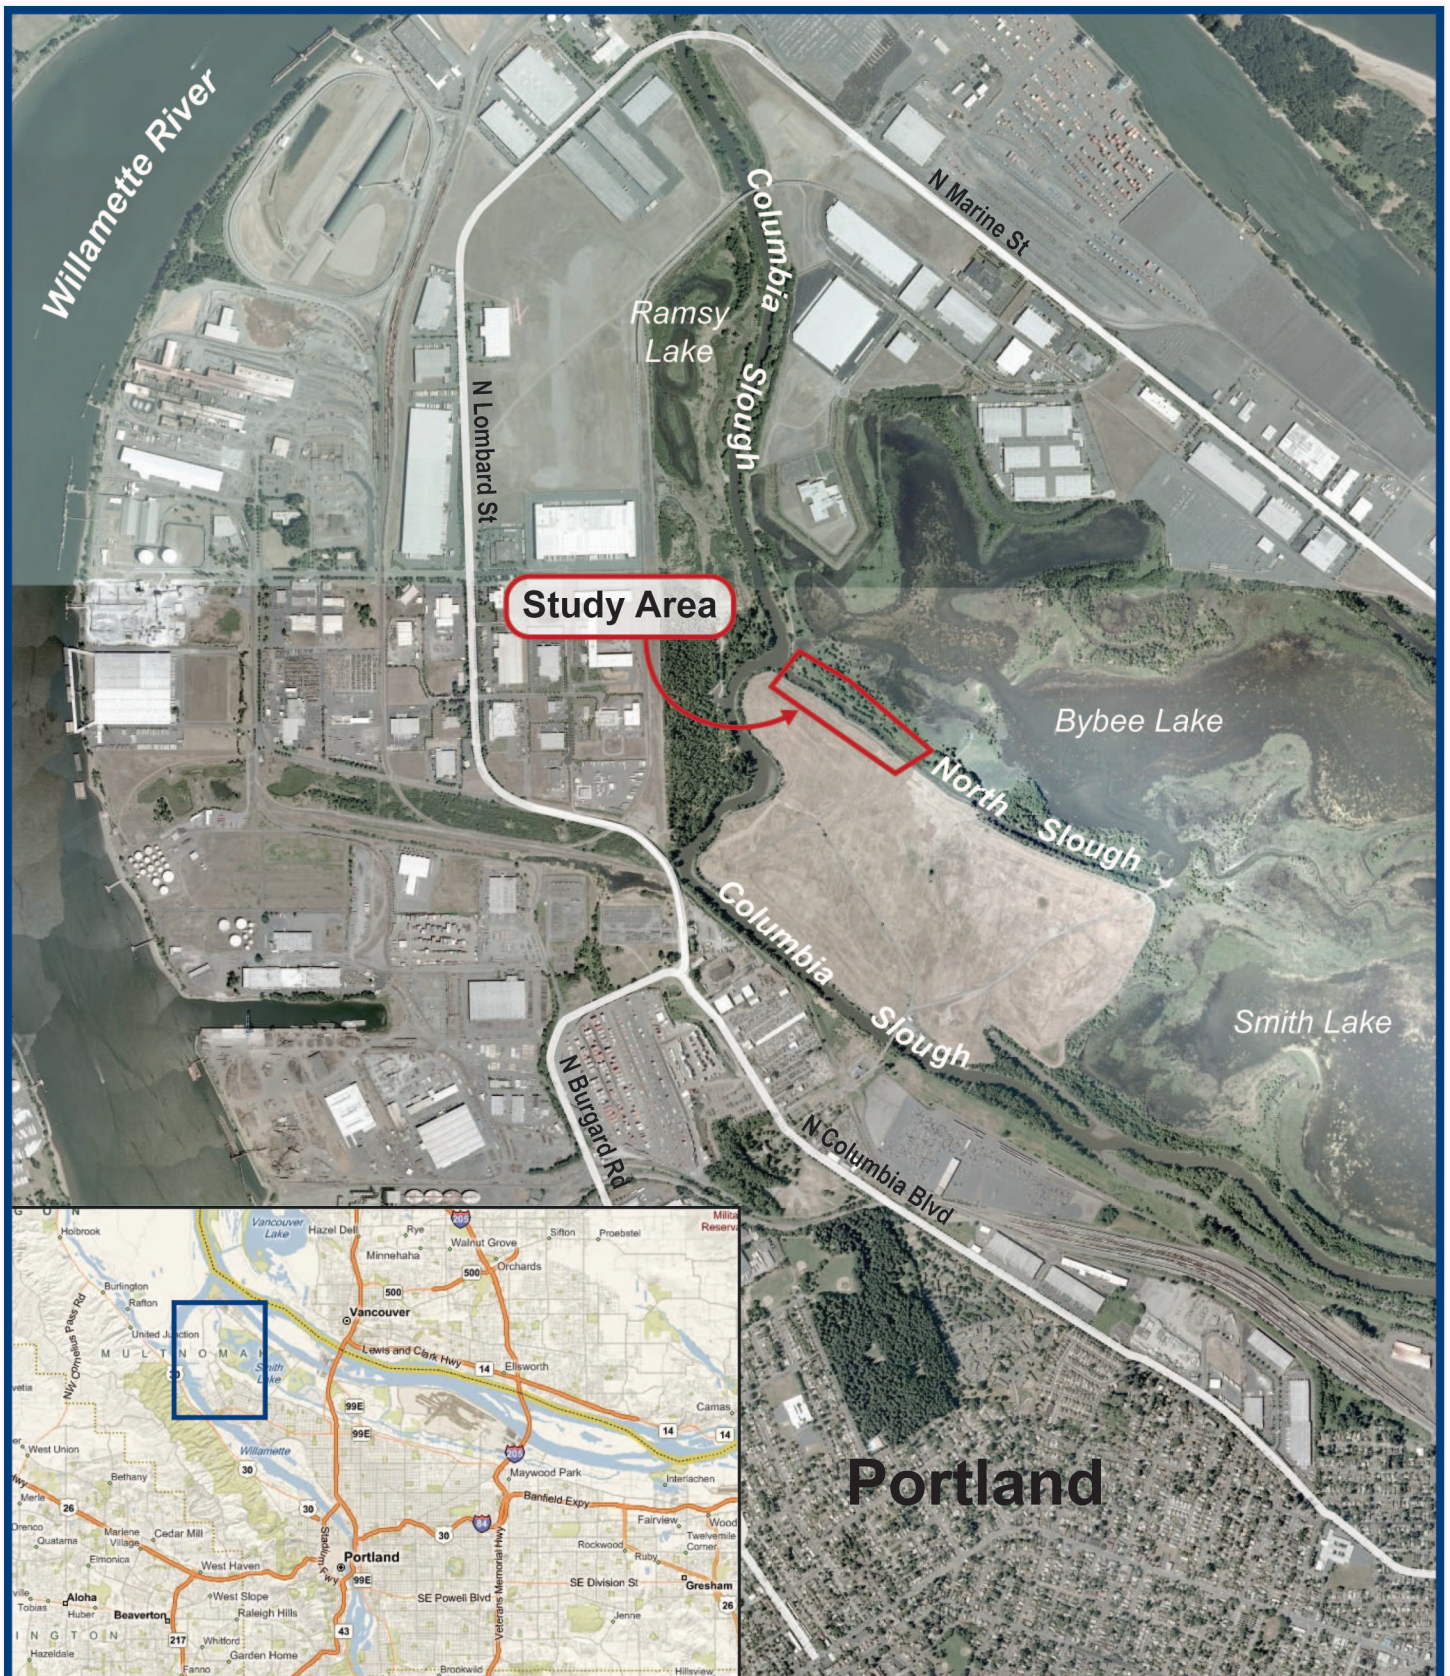
Figure 2. Alternative Bridge Sites and Environmental Constraints

During a February 2007 field reconnaissance conducted by consulting biologists, three distinct habitat types were observed within the study area. These habitats include 1) a large forested wetland at the northeastern edge of the study area; 2) an open upland area (dominated by reed canarygrass between the forested wetland and the North Slough's north bank; and 3) the North Slough and its associated riparian area. Photographs documenting the condition of these habitats during the field reconnaissance are presented in the Natural Resources Technical Memo prepared by Mason, Bruce & Girard [MB&G] (2007) (see Appendix C). The Technical Memo includes mapping indicating the approximate limits of wetlands and other habitats. Figure 2 shows the major environmental features and constraints identified during the field reconnaissance.

Eight alternatives – each representing a unique combination of basic bridge design (cable stay or steel truss), orientation (perpendicular or skewed), and two locations (Site A and B) - were evaluated against 19 criteria relevant to regulatory compliance, permitting, technical design, and design guidelines. For a given criterion, each alternative was assigned one of three ratings: “Pass”, “Pass with Modification”, or “Fail”. Figure 1 is a map showing the project vicinity. Figure 2 is an aerial photograph overlain with the study area, locations studied for the bridge crossing, and certain environmental constraints.

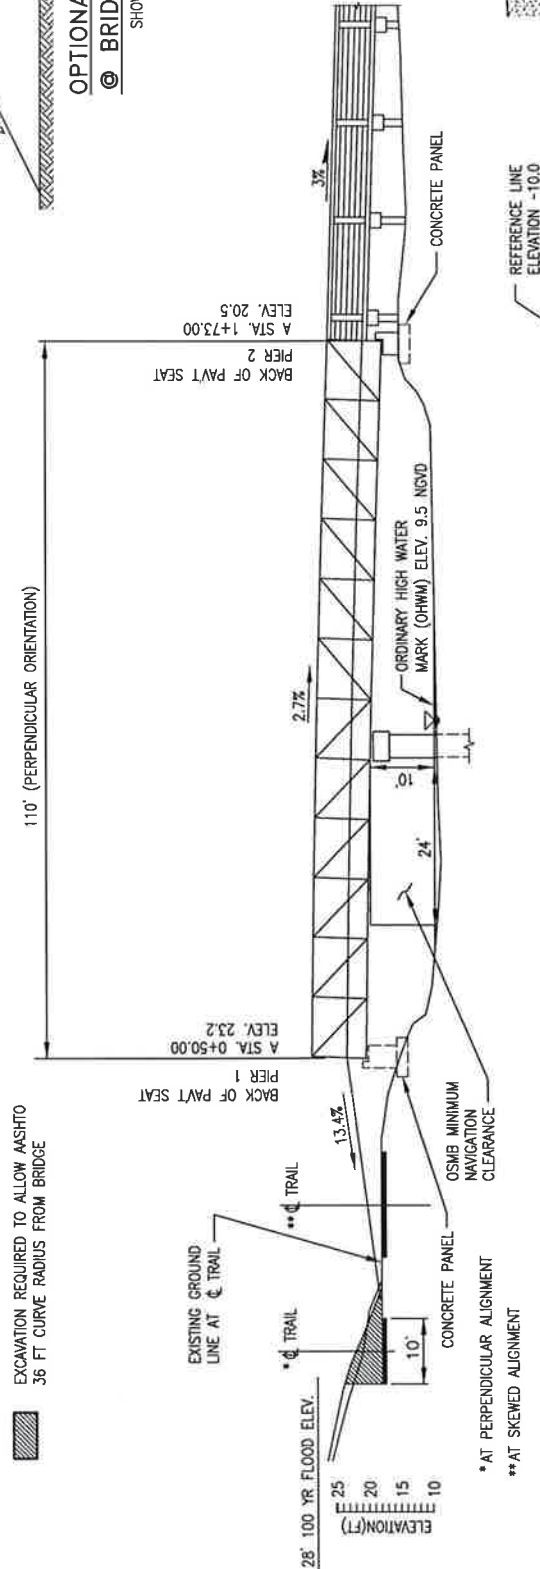
ELEVATION
SCALE: 1" = 20'

NOTE: COMPLIANCE W/ ADA STANDARD 3% SLOPE WOULD
EXTEND EXCAVATION APPROXIMATELY 150 FEET
HORIZONTALLY INTO LANDFILL.

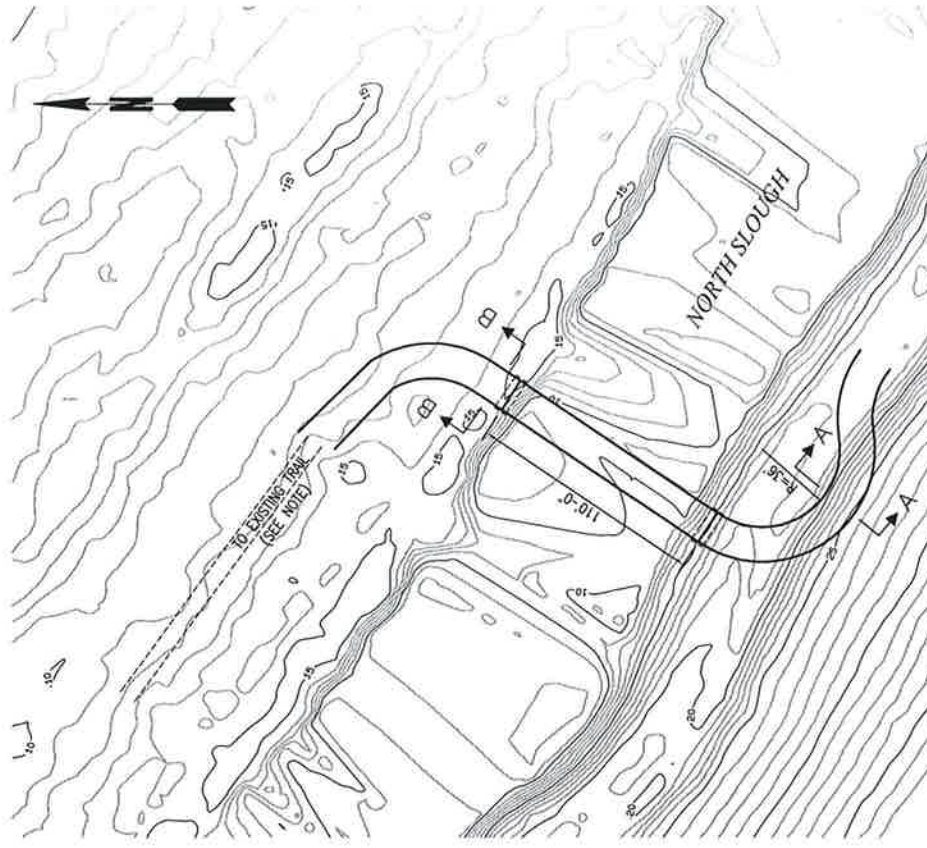
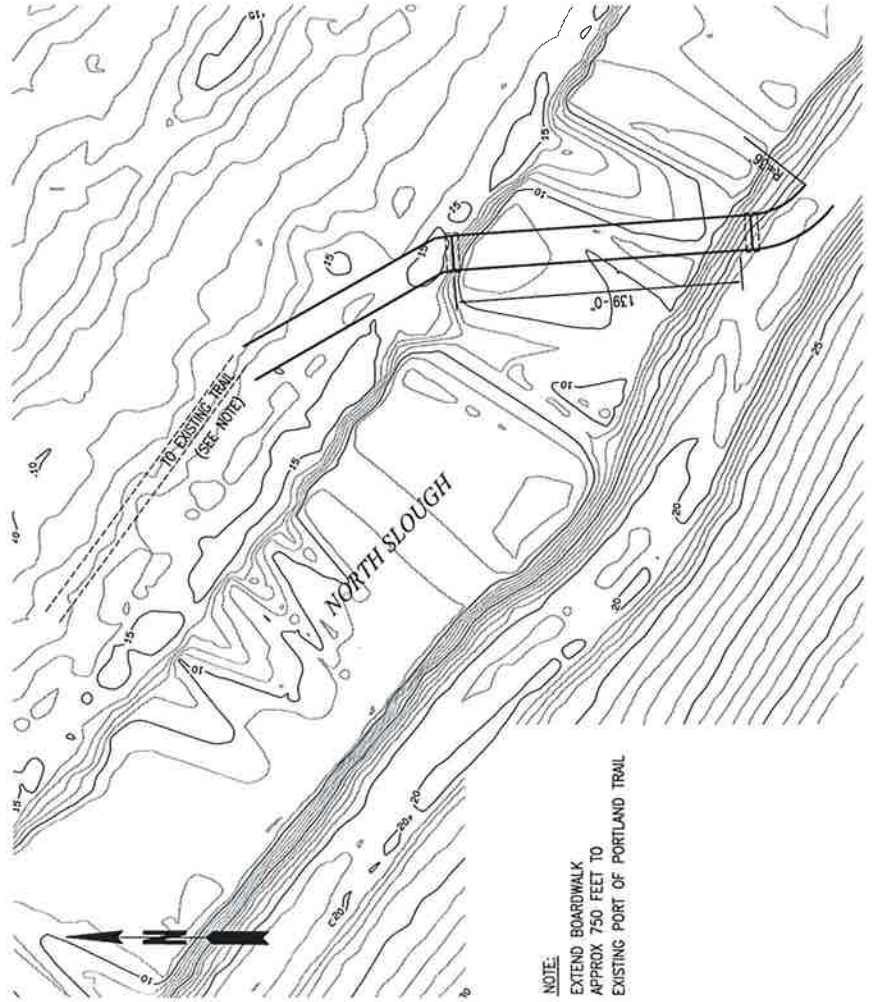
NOTE:
EXTEND BOARDWALK
APPROX 750 FEET TO
EXISTING PORT OF PORTLAND TRAIL

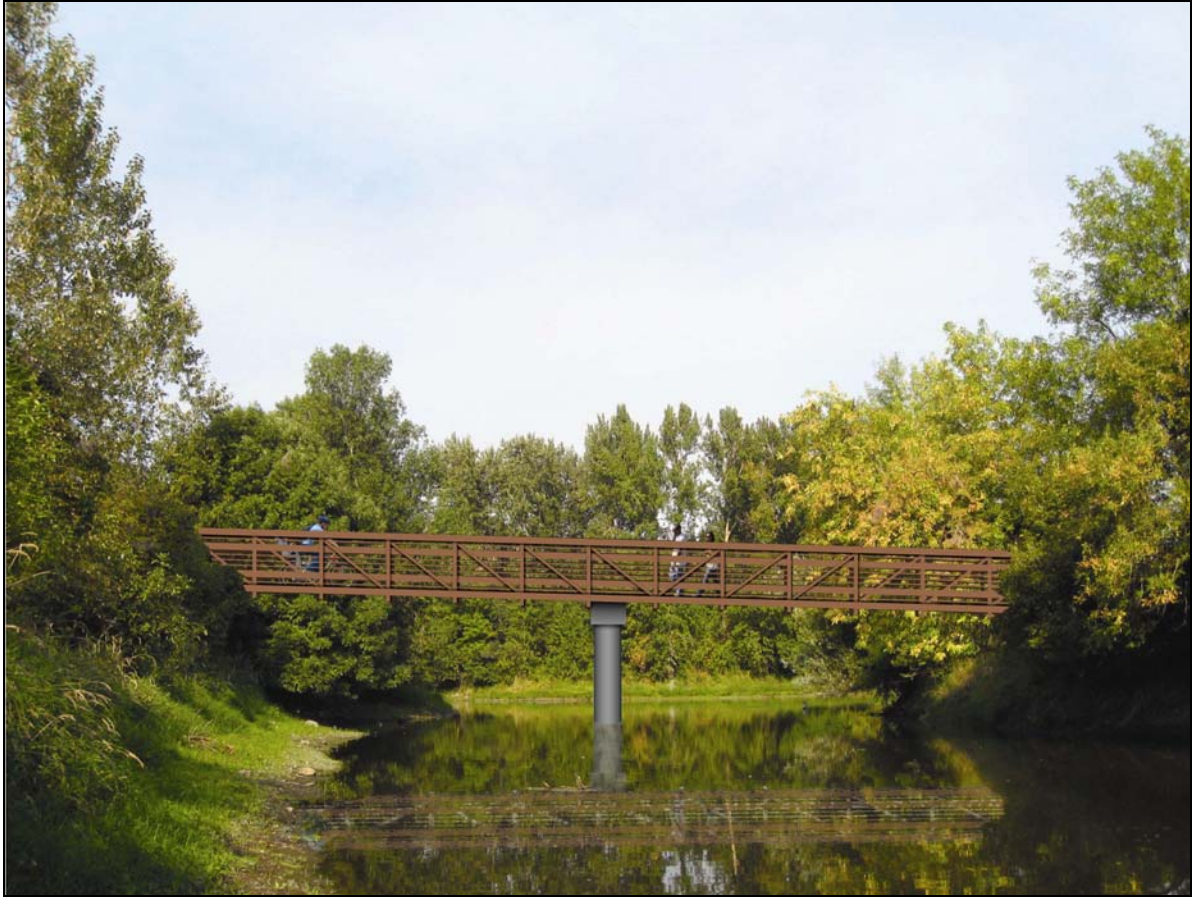
Figure 8. Conceptual view of North Slough Bicycle / Pedestrian Bridge recommended alternative (looking west toward confluence with Columbia Slough).

The North Slough Bridge Feasibility Study was initiated to identify alternative bridge configurations (if any) that would meet an established set of regulatory, technical and design criteria. Based on the application of all feasibility criteria established for this project, the preferred alternative is 2B, the steel truss bridge located at Site A on a skewed orientation (Figure 8 shows a simulation of a bridge in this location). This is the only configuration that meets all environmental, technical and design criteria. An estimated schedule for design through construction of Alternative 2B, the steel truss at Site A is provided in Appendix H.

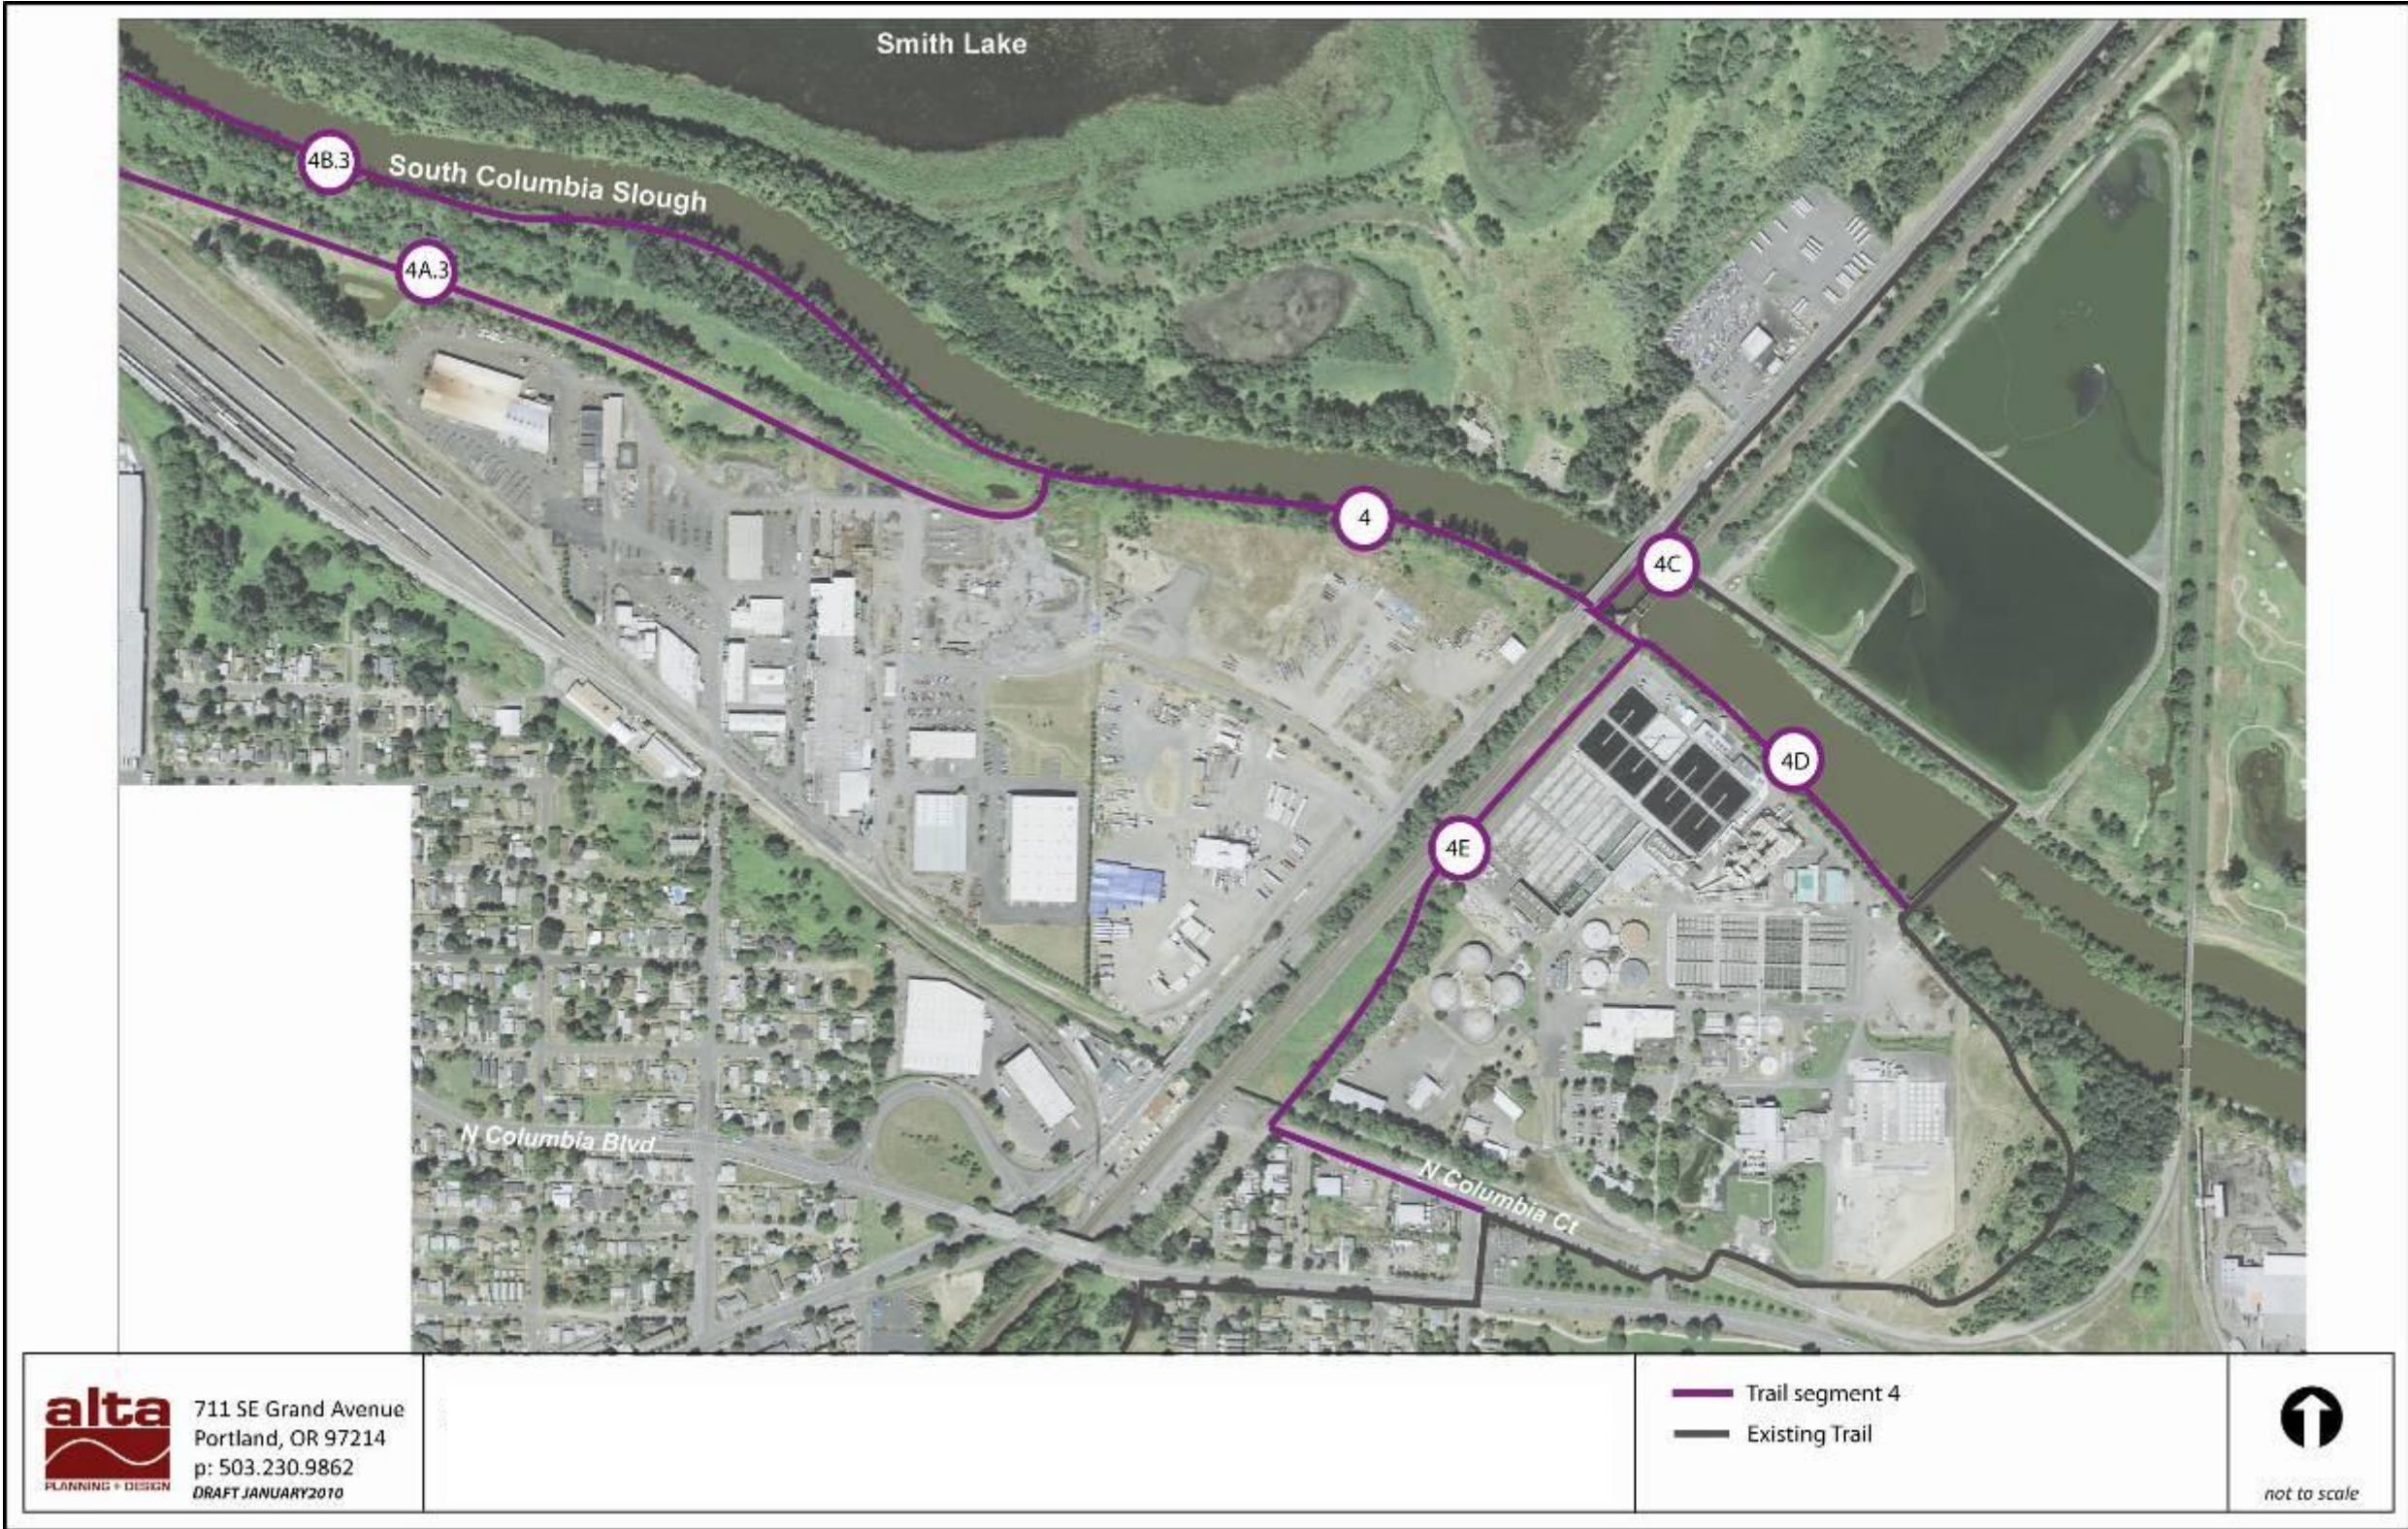
Figure 3. South Slough Trail Alignment Options - East

The trail alignment options are shown in Figures 2 & 3 and their characteristics are described briefly below.

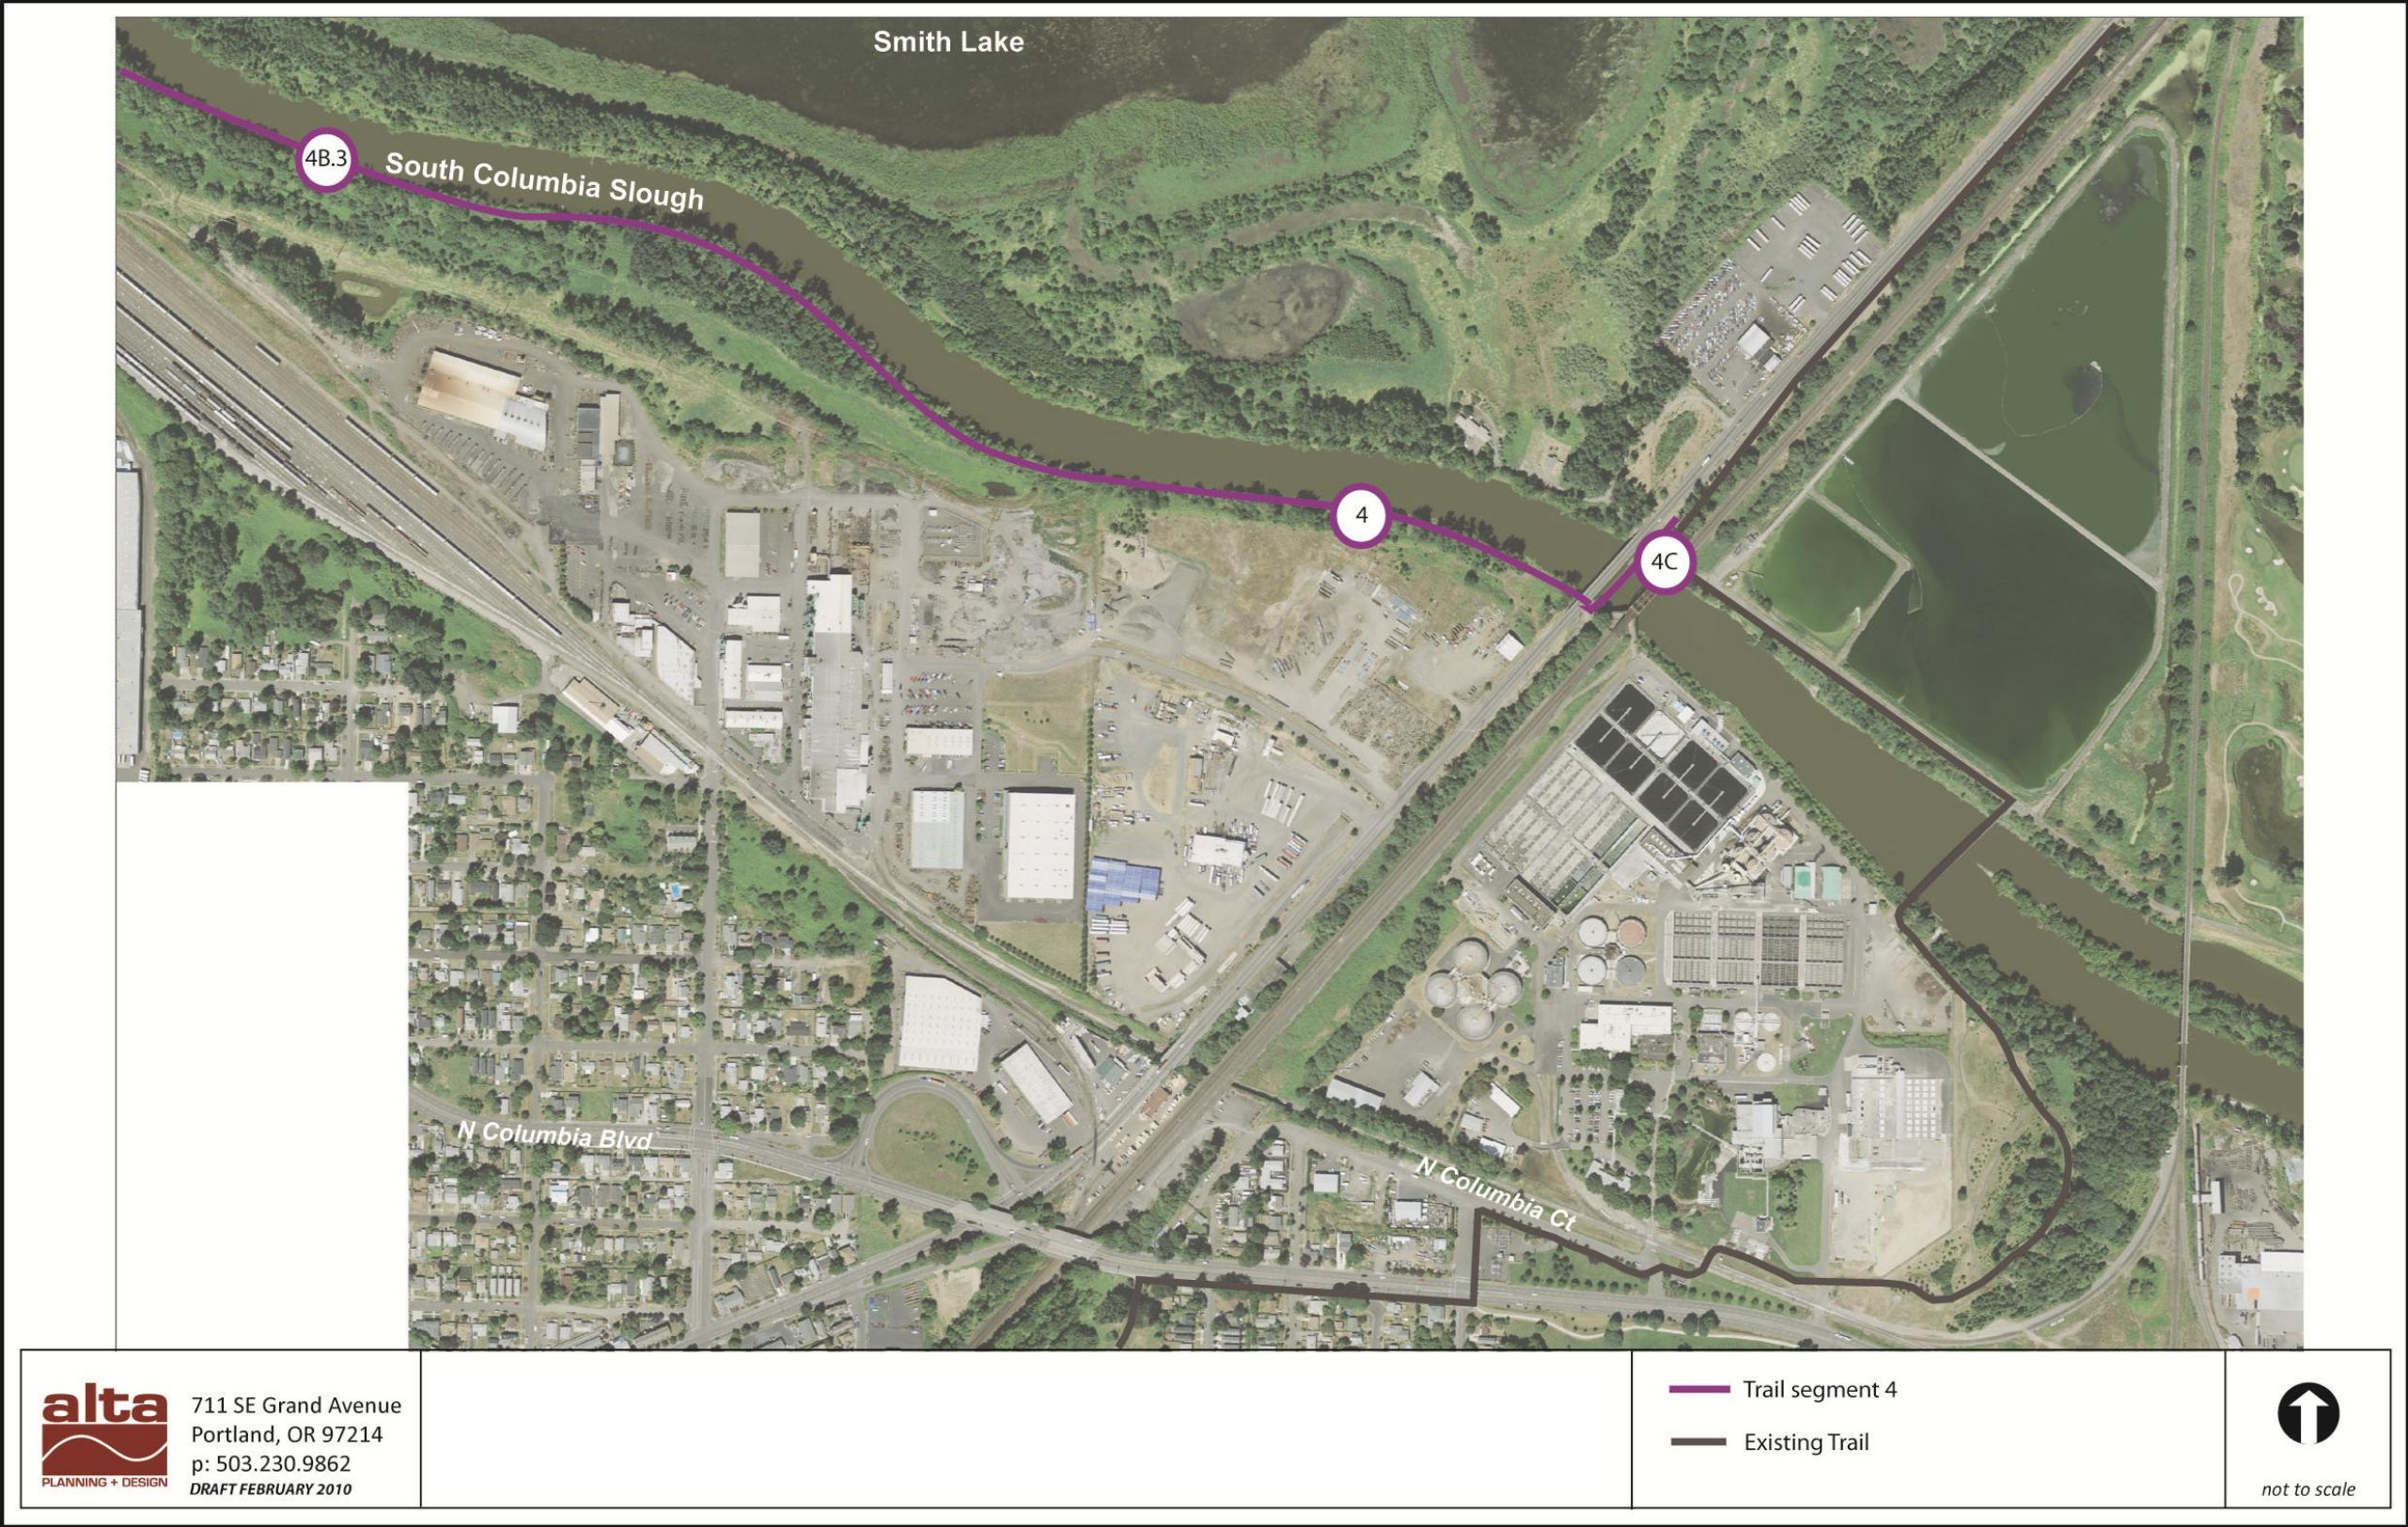
Figure 5. South Slough Trail Preferred Alignment - East

The preferred South Slough trail alignment is shown on Figures 4 & 5 on pages 31 and 32. It should be noted that while this is the preferred alignment, there are other feasible options within each segment if one of the preferred options becomes infeasible for any reason.

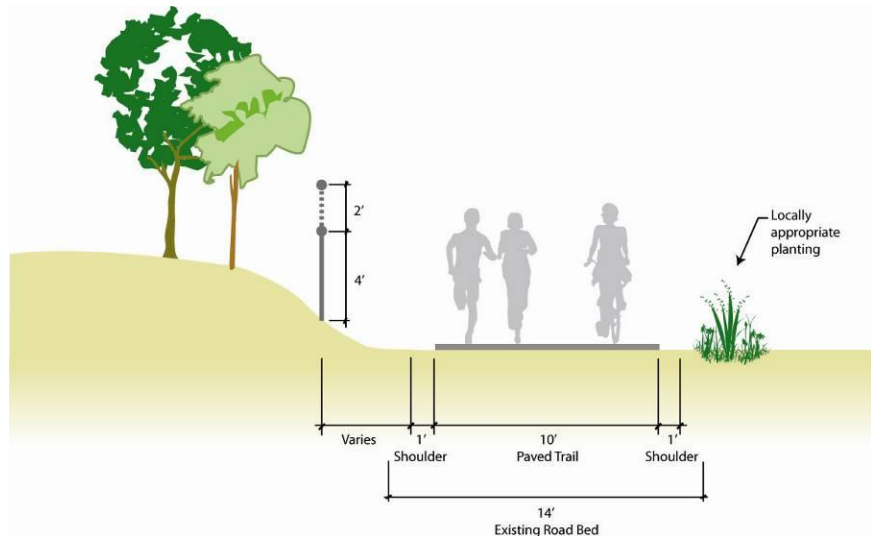
Figure 6. Paved Multi-Use Trail in Landfill

Figures 6-10 illustrate the trail in different settings throughout the preferred alignment.

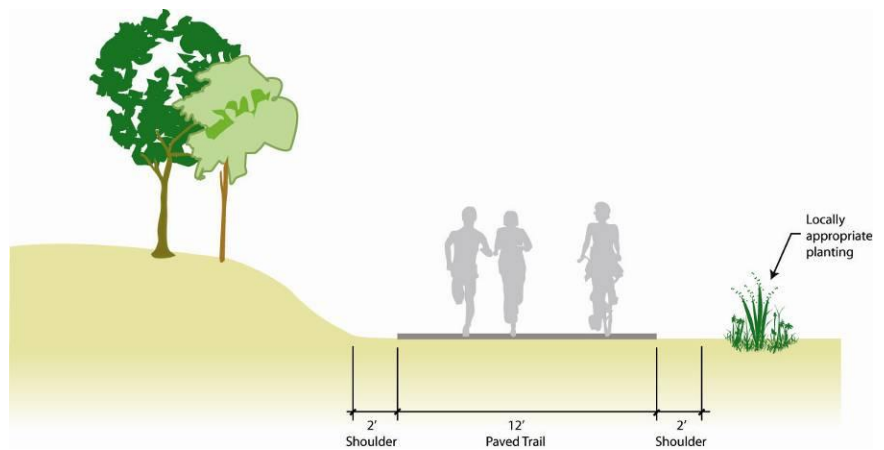
Figure 7. Paved Multi-Use Trail along Sough Slough

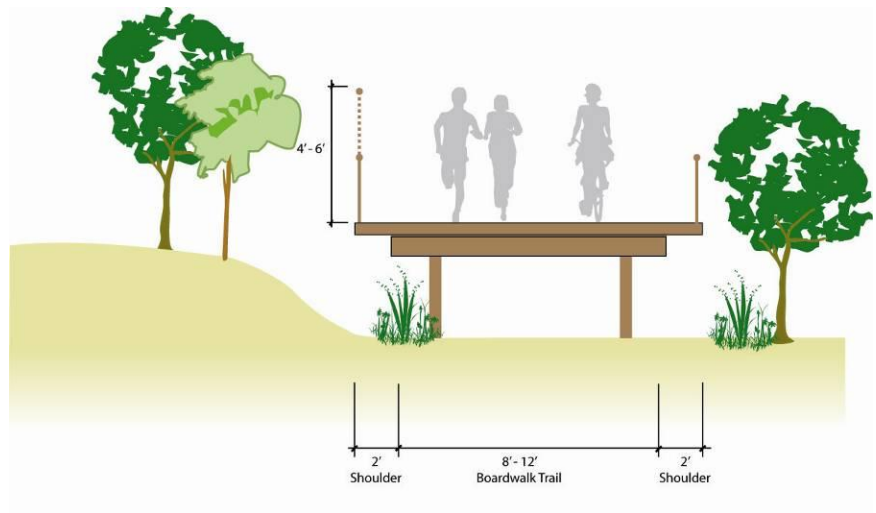
Figure 8. Boardwalk over Wapato Wetlands

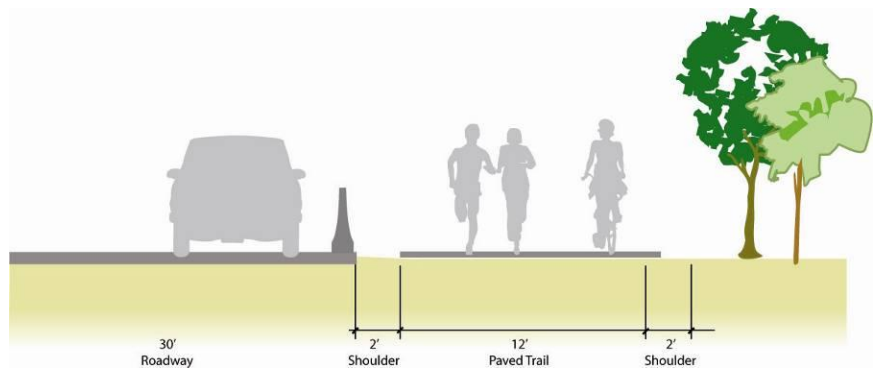
Figure 9. Trail adjacent to Landfill Access Road

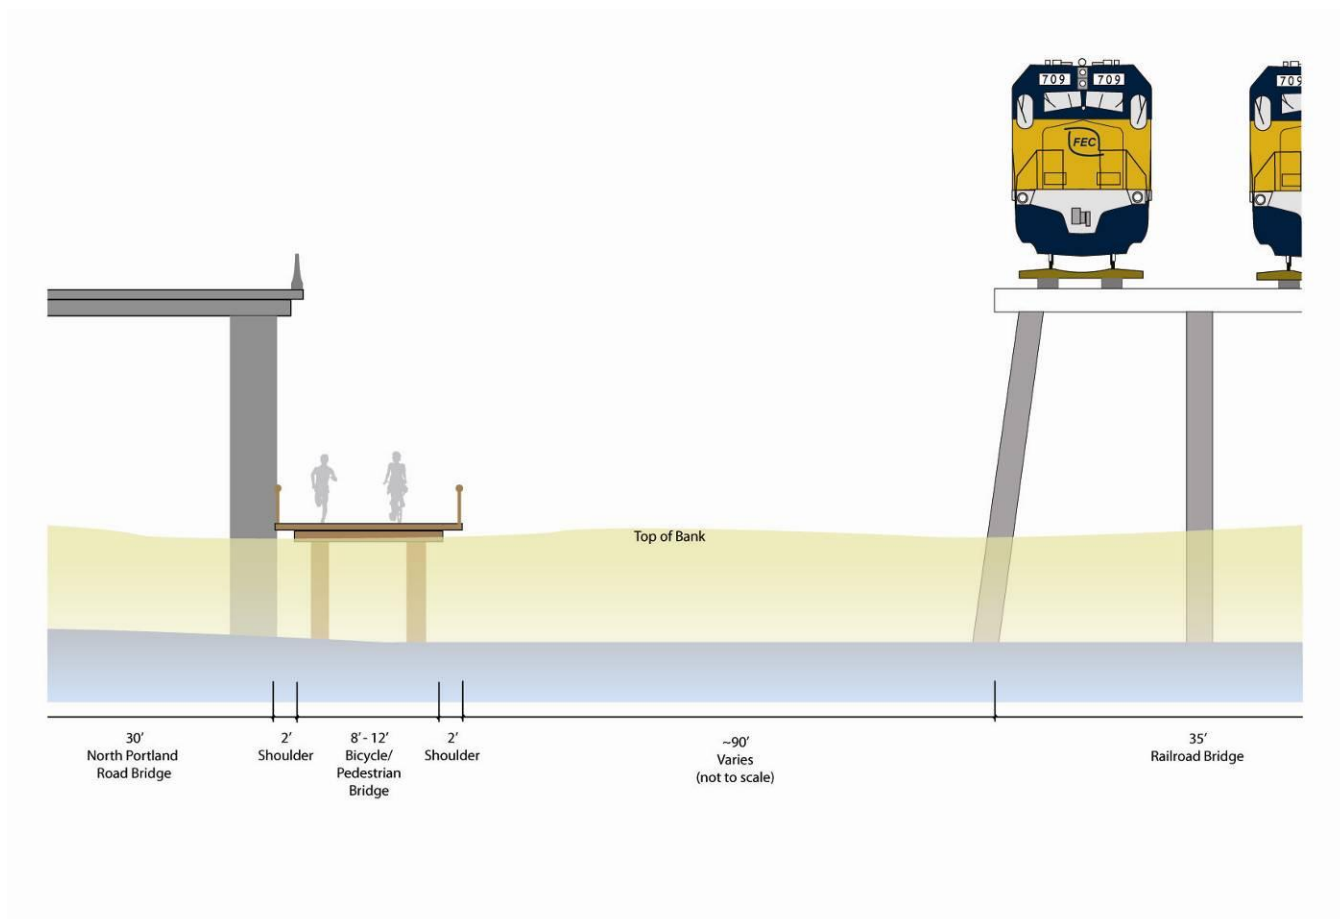
Figure 10. Bicycle/Pedestrian Bridge adjacent to North Portland Road

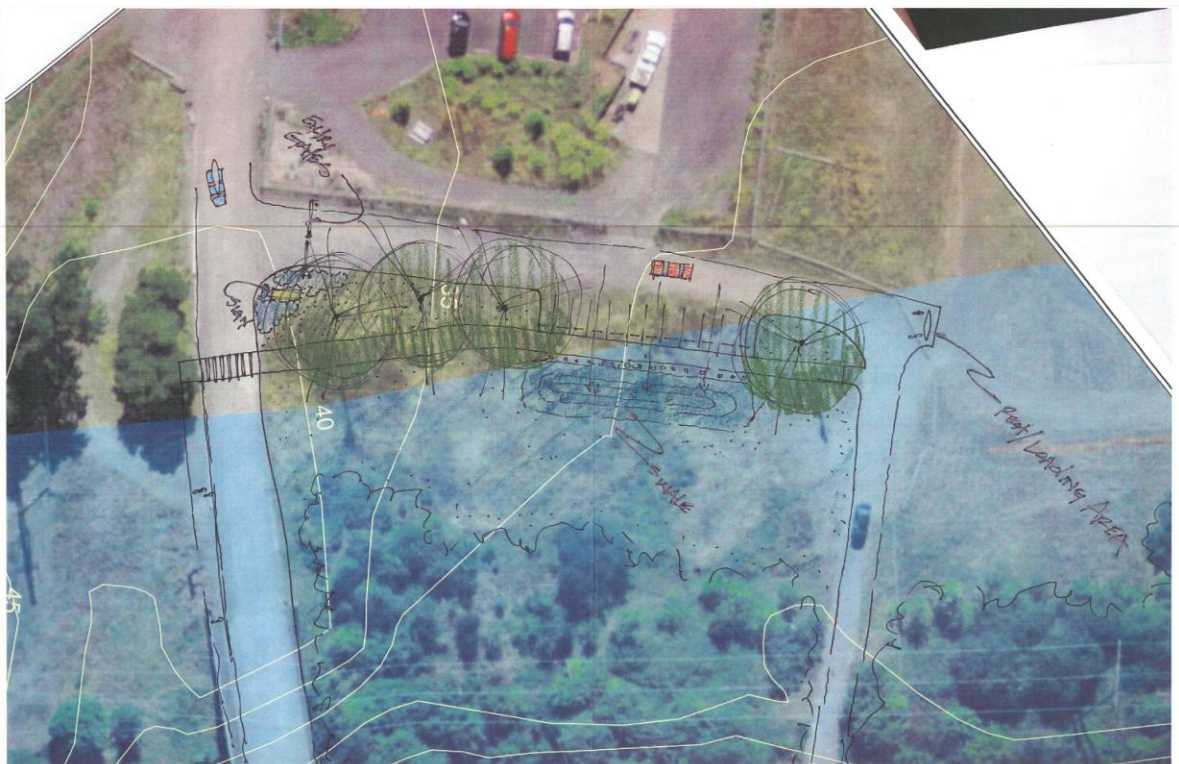
Figure 11 below shows the proposed trailhead adjacent to the south side of the St. Johns landfill bridge. Trailhead improvements will include paved parking for approximately 8 vehicles, bioswale to filter stormwater from the parking area, connection to the South Slough trail, ramp to the canoe/boat launch and a portable restroom.

Figure 11. Sketch of proposed trailhead adjacent to existing St. Johns landfill bridge

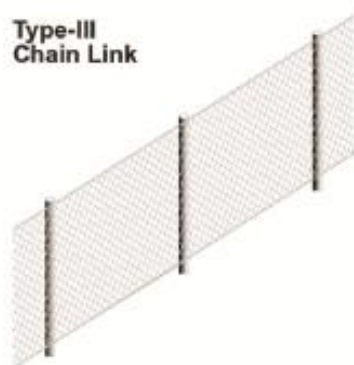
**Type-III
Chain Link**

Chain link fences are popular due to their effectiveness in keeping trail users on the trail, relative low cost, and ease of maintenance. Chain link fence may not be appropriate for areas with a high history of trespassing, since it is very easy to cut and vandalize. Most chain link fences are visually unappealing - and tend to project an image of an urban industrial environment. For this reason, trail designers should explore using other, more appealing types of fences whenever possible.

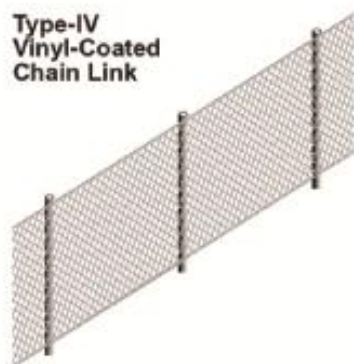
**Type-IV
Vinyl-Coated
Chain Link**

Similar to Type III, but with either a plastic woven fabric or wood battens in the chain link material providing a stronger deterrence to potential trespassers and a solid-type barrier to help catch debris and provide wind and visual buffering.
