SMITH AND BYBEE COMPREHENSIVE NATURAL RESOURCE PLAN APPENDIX

APPENDICES TABLE OF CONTENTS

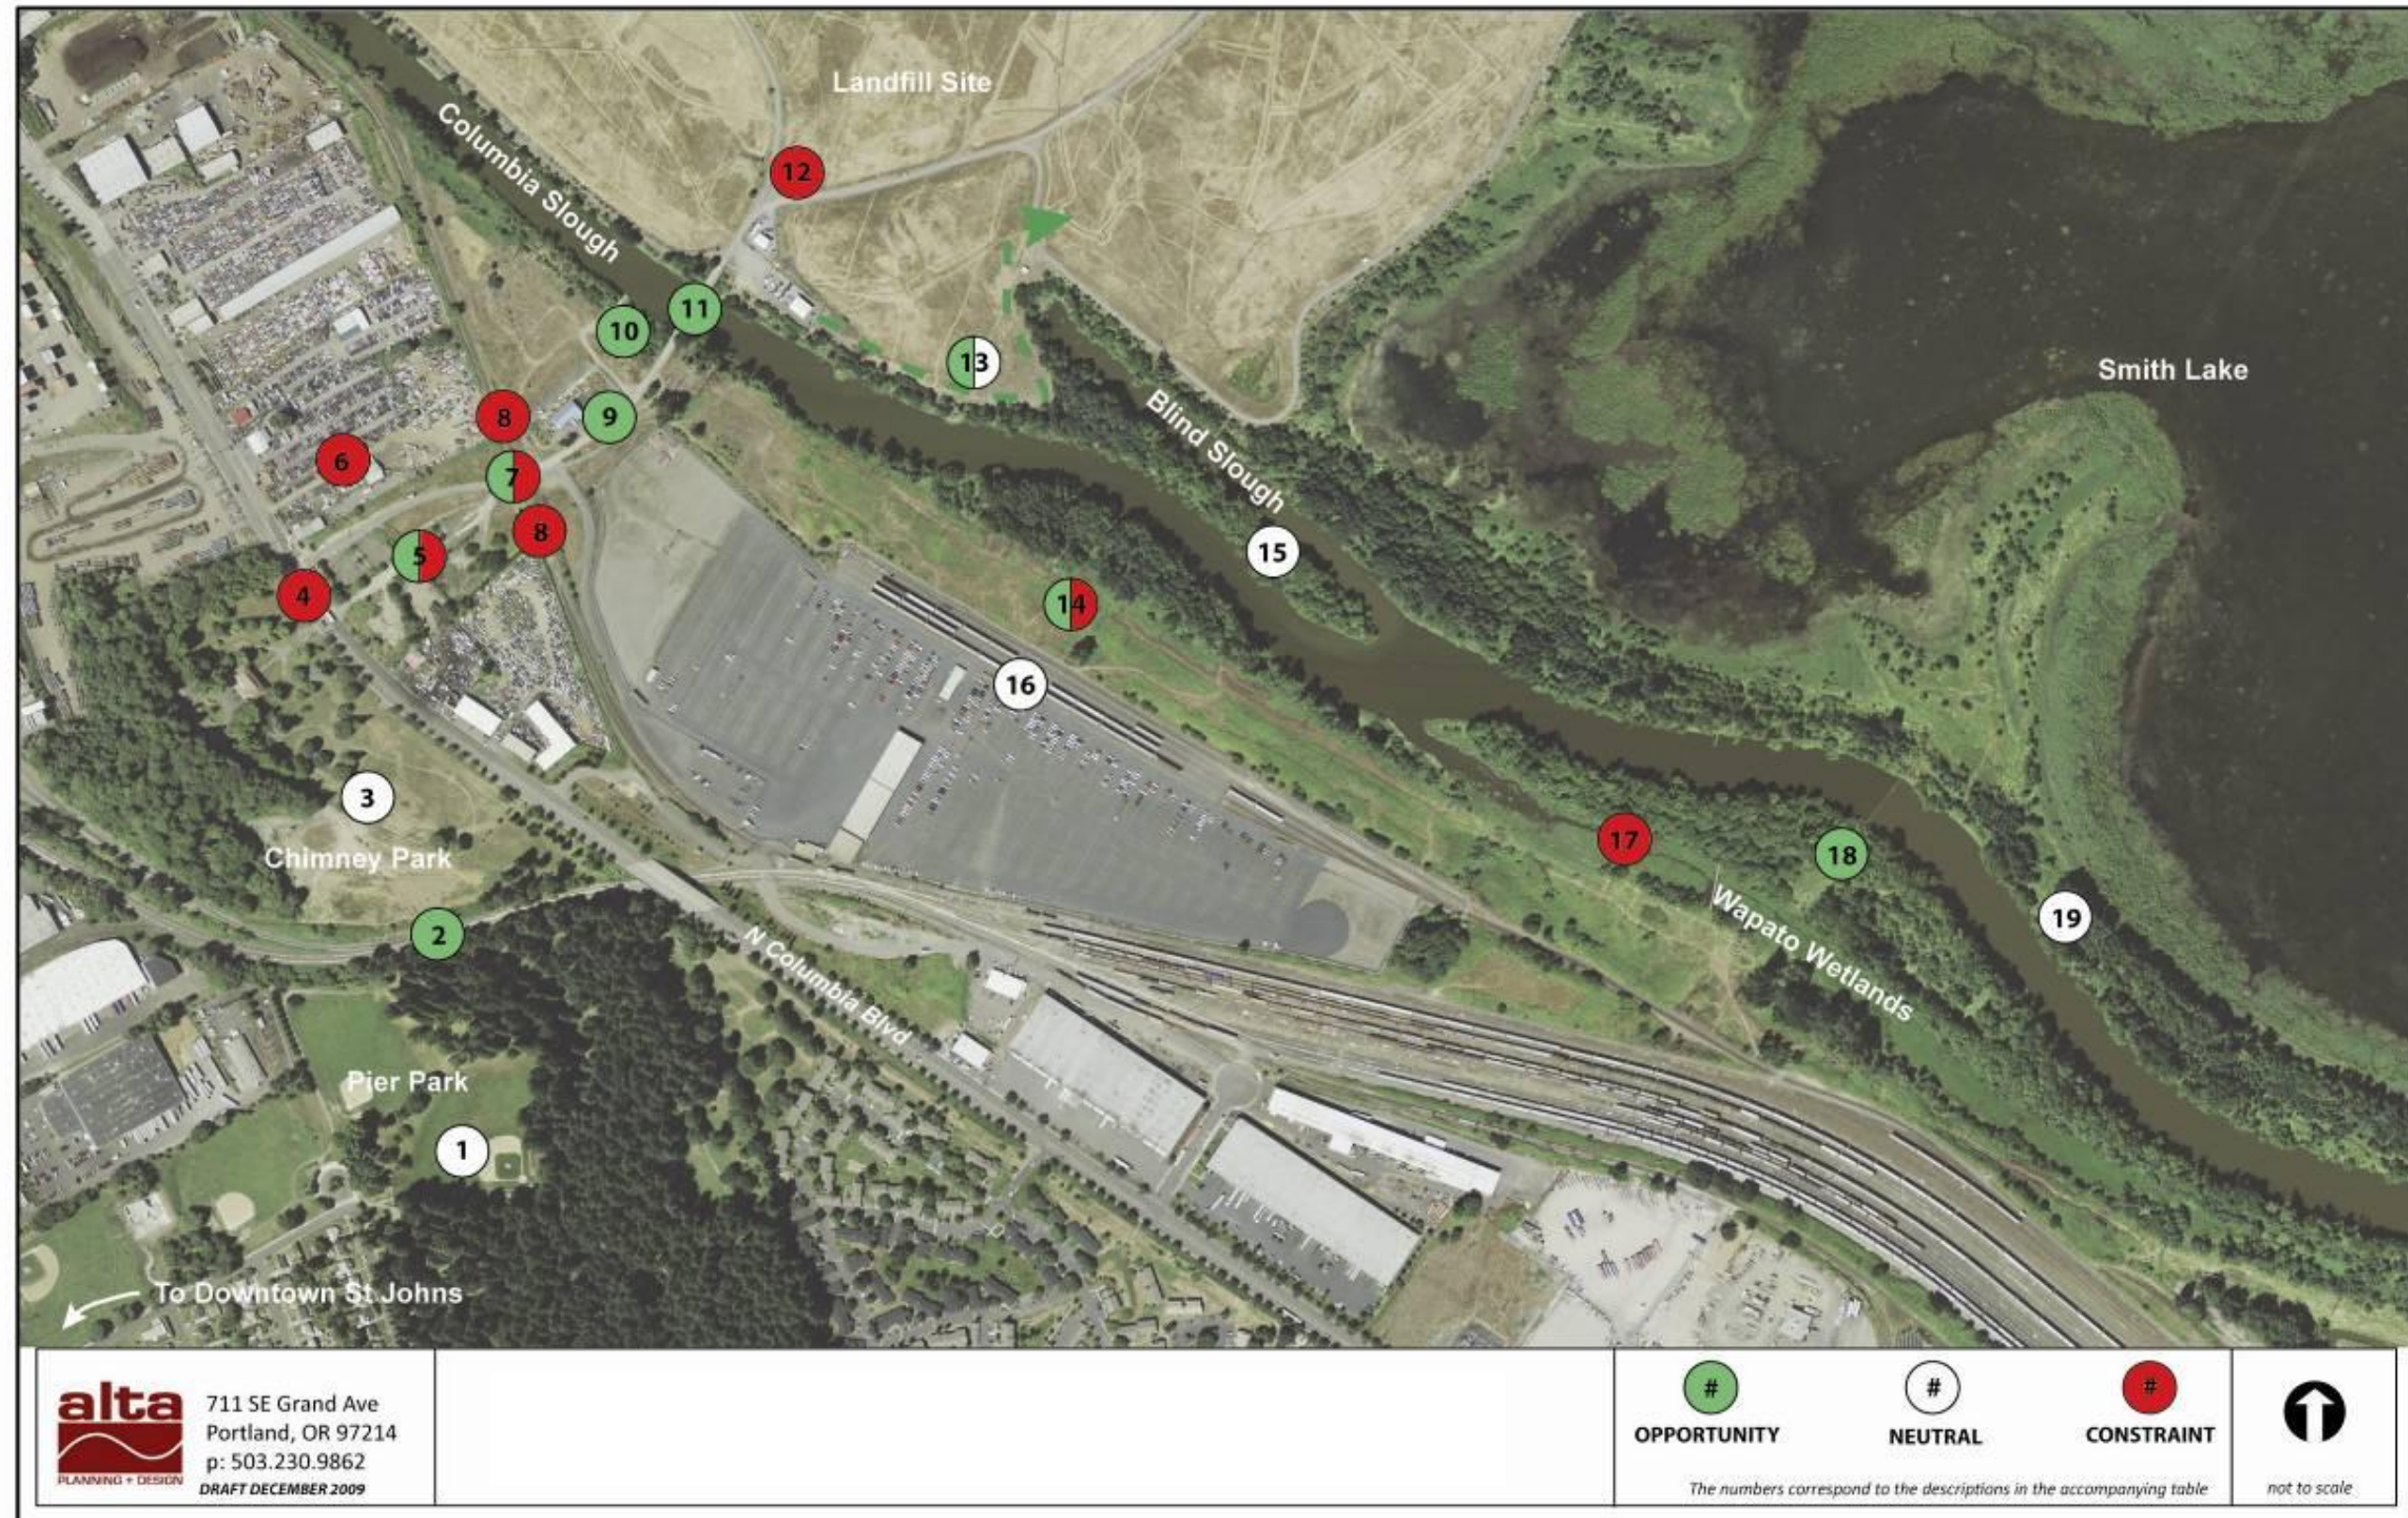
Map B1. Opportunities & Constraints - West

| No. | Location | Description of Issue |
|---|--|--|
| 26 | South bank of Columbia Slough between east side of North Portland Road bridge and the existing bike/pedestrian bridge near the WWTP. | There is an overgrown restored riparian edge along the Columbia Slough just outside the WWTP fencing that might accommodate a trail on a cantilevered platform. It would require extensive engineering and environmental review for implementation. |
| 29 | Union Pacific railroad tracks south of WWTP | The railroad tracks are located in a narrow cut, requiring a new bike/ped bridge to crossover them, allowing trail to continue south and east to existing Peninsula Crossing trail. |

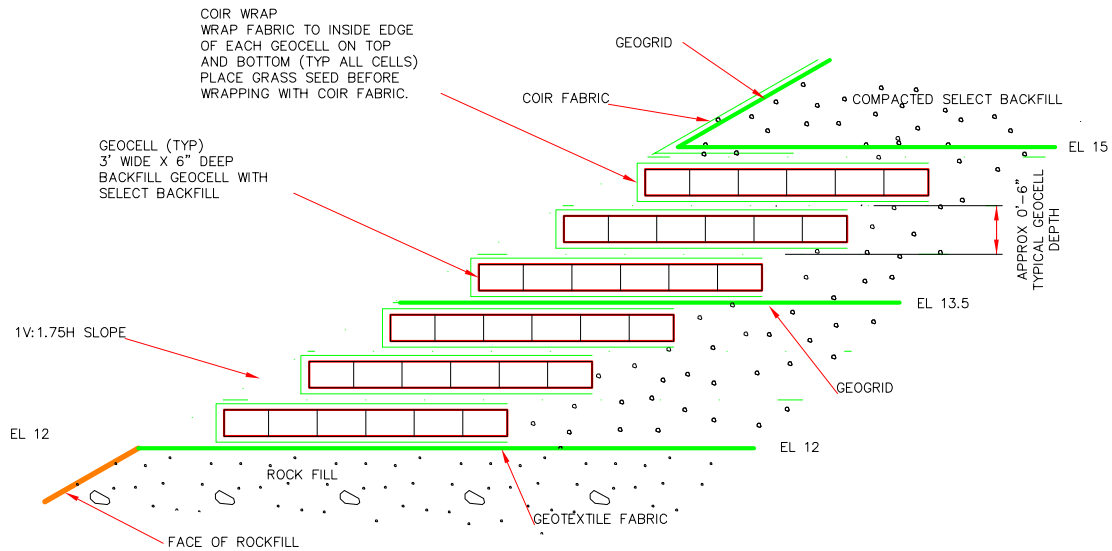
TYPICAL GEOCELL DETAIL
NTS

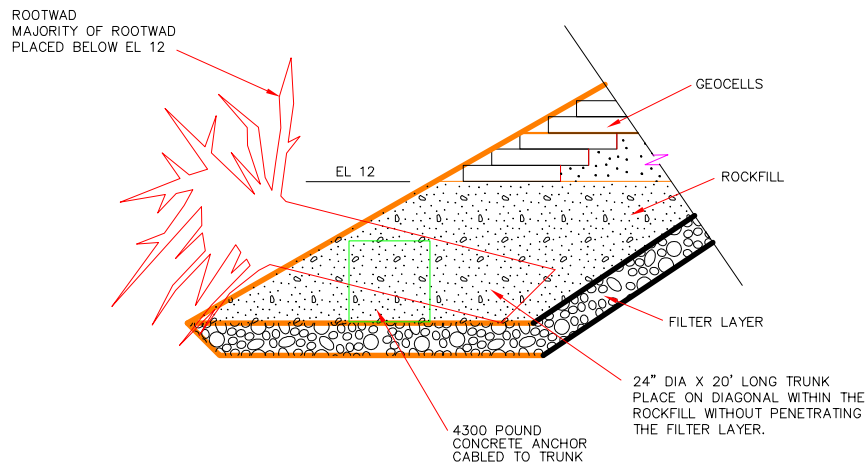
TYPICAL ROOTWAD DETAIL
NTS
