**Geotechnical Data Report
Willamette Falls Riverwalk
Public Yard / Alcove Area
Oregon City, Oregon**

**May 19, 2017
NGI Project No. 2919.1.1**

**Northwest Geotech, Inc.**
Northwest Testing, Inc.

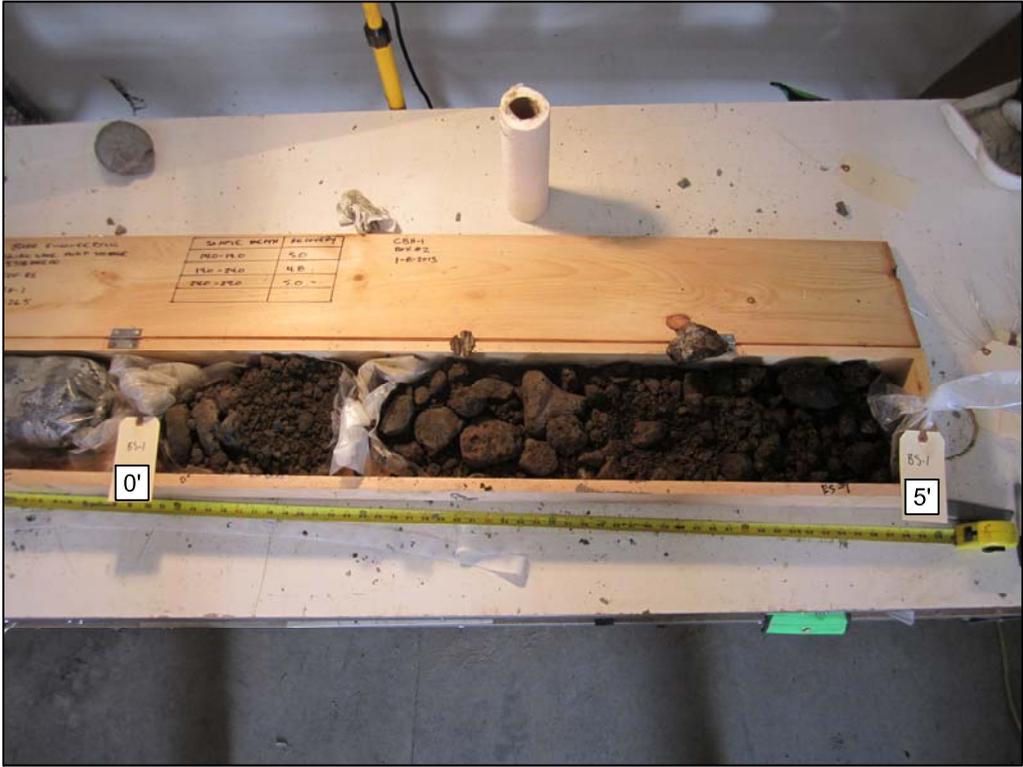
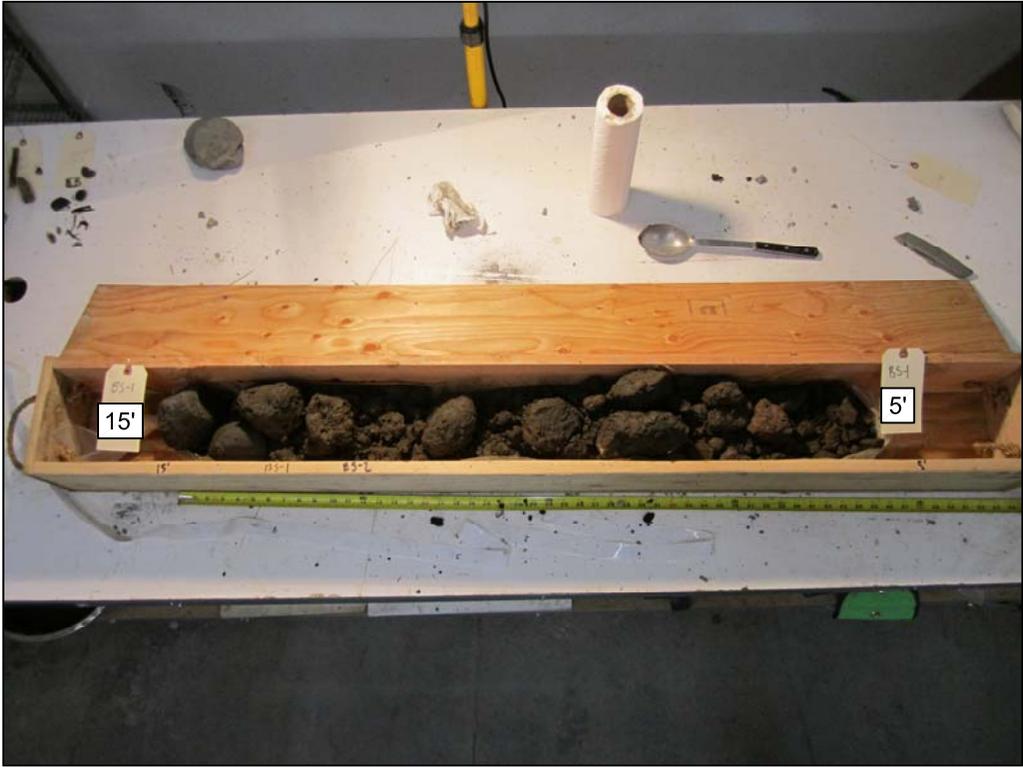
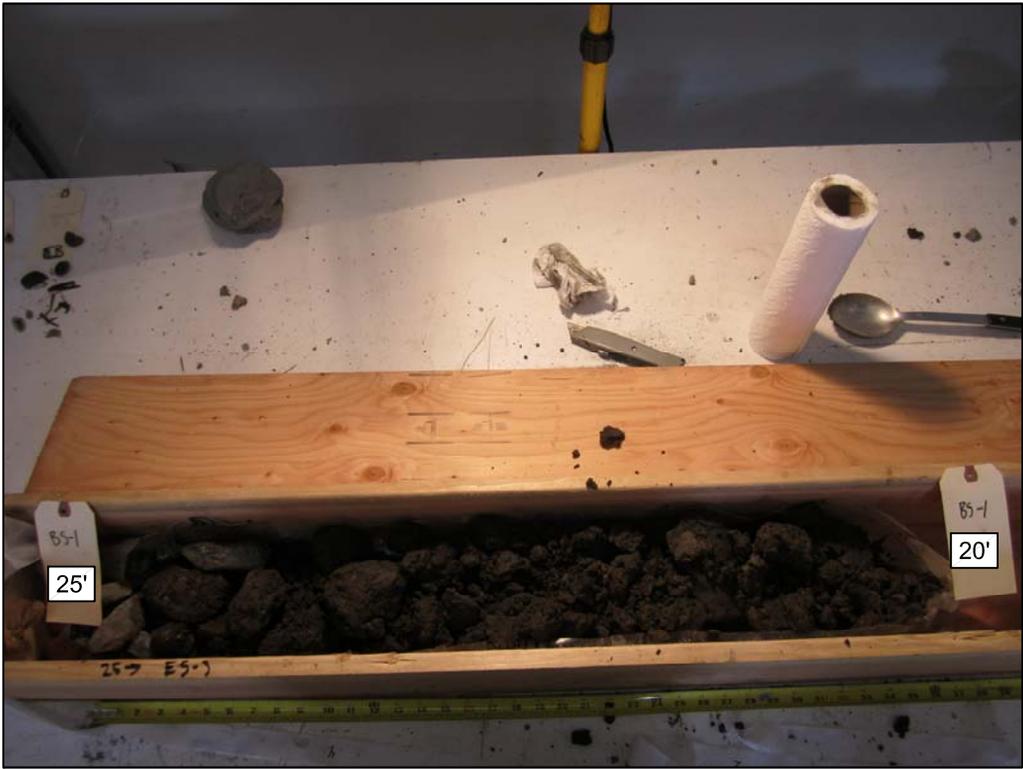
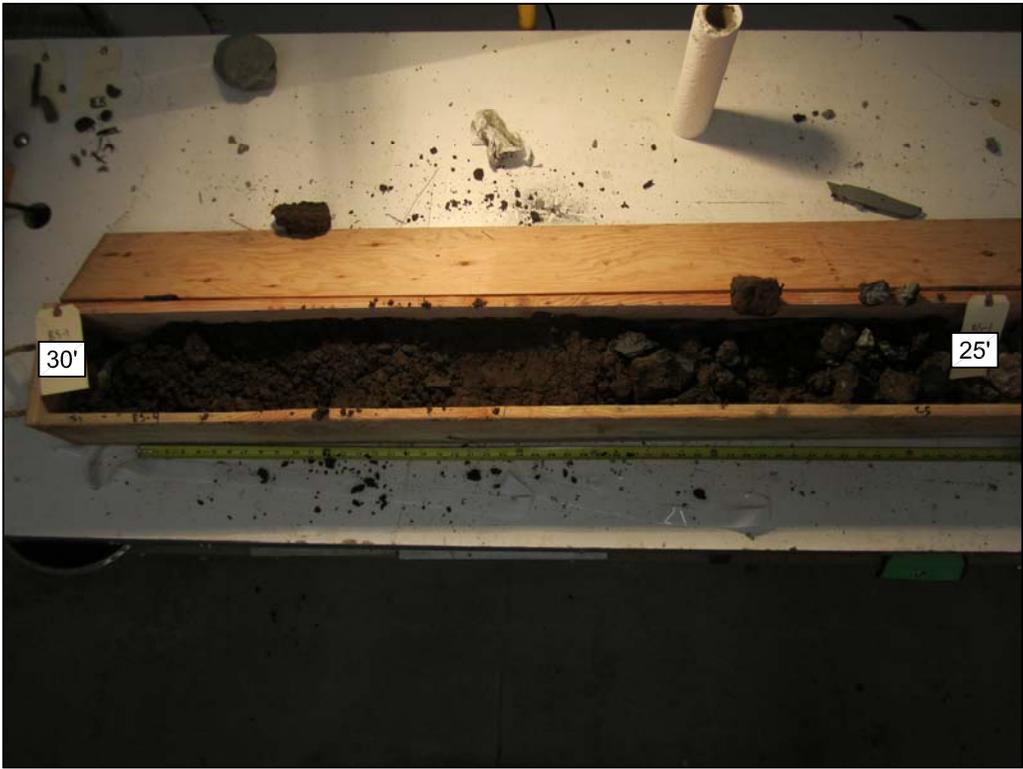
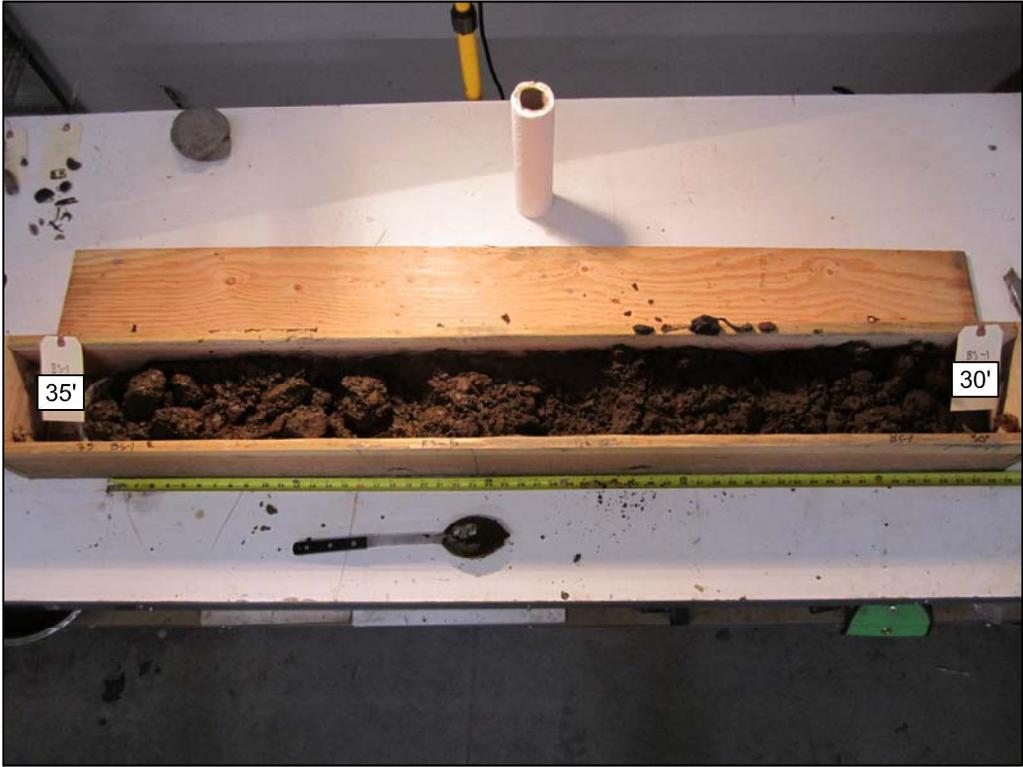
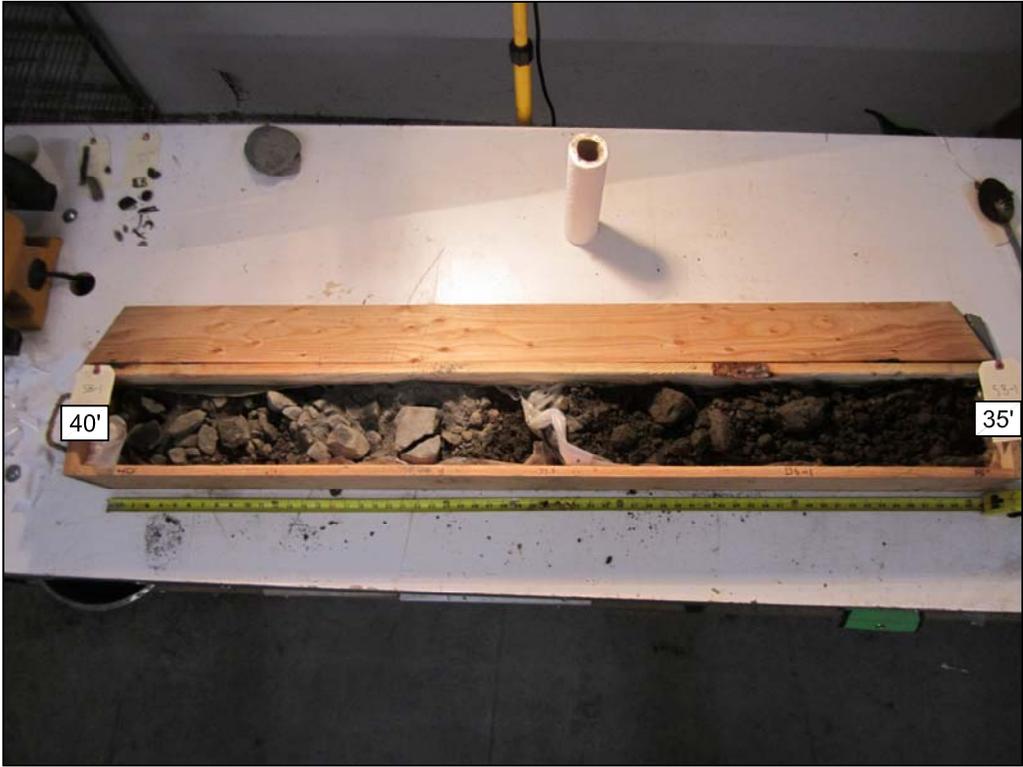
FIGURE NO. C-1 (1 OF 3)

CORE LOG PHOTO S-1

Appendix C presents photographs of the recovered sonic cores prior to removing samples for laboratory testing.

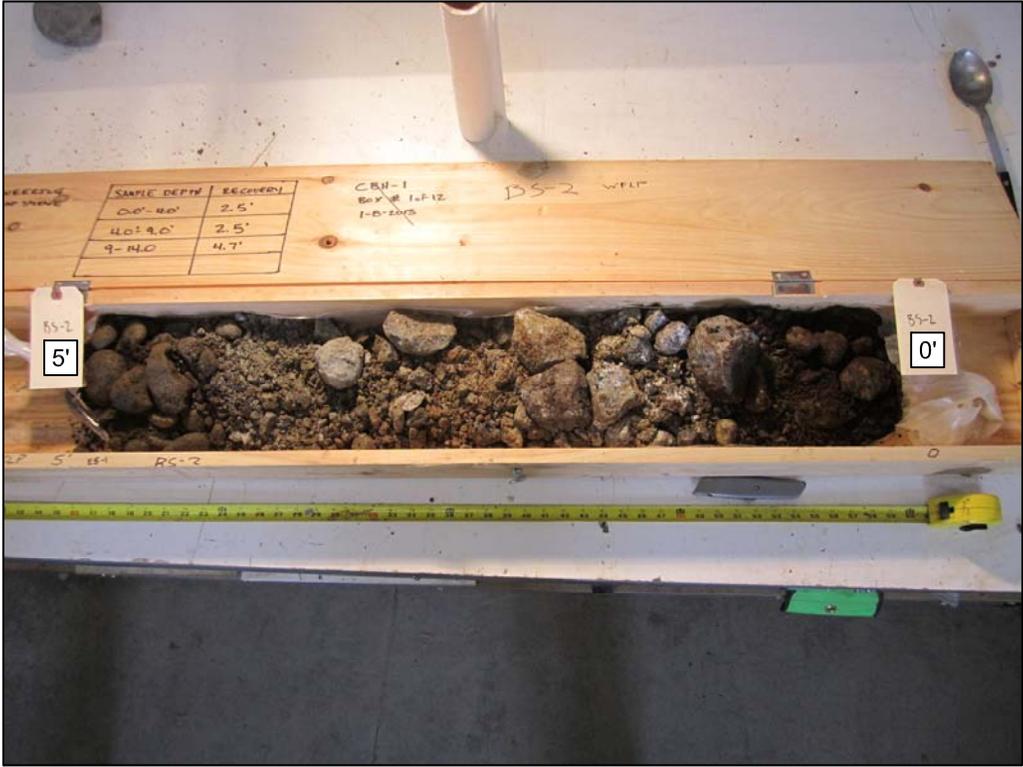
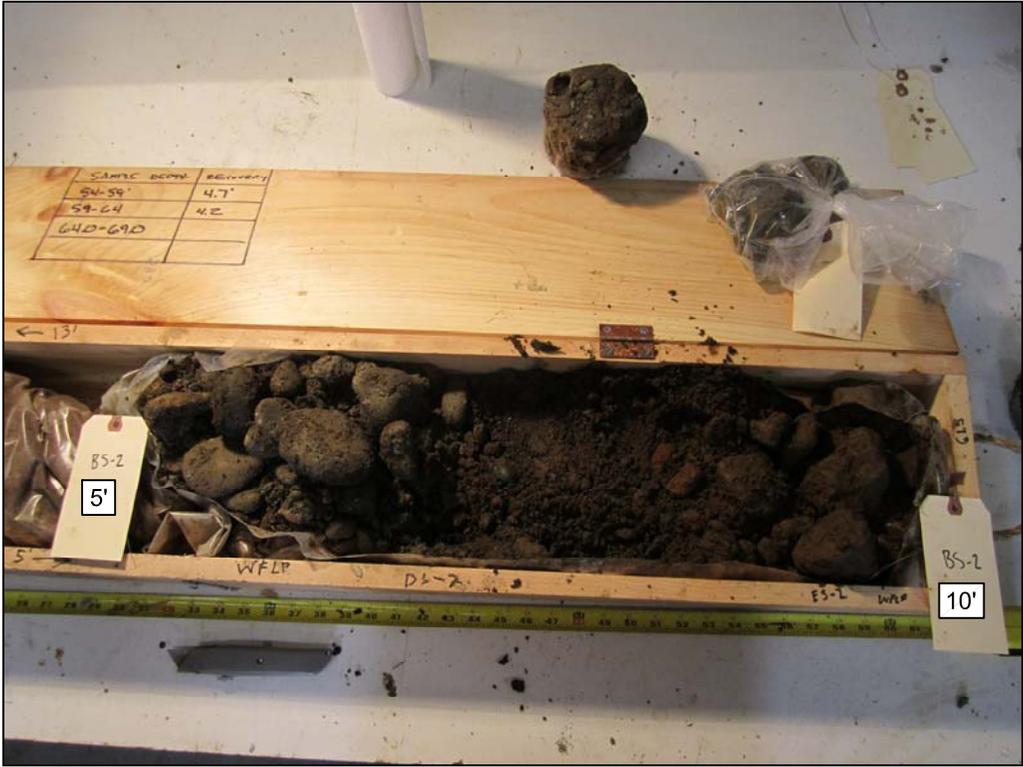
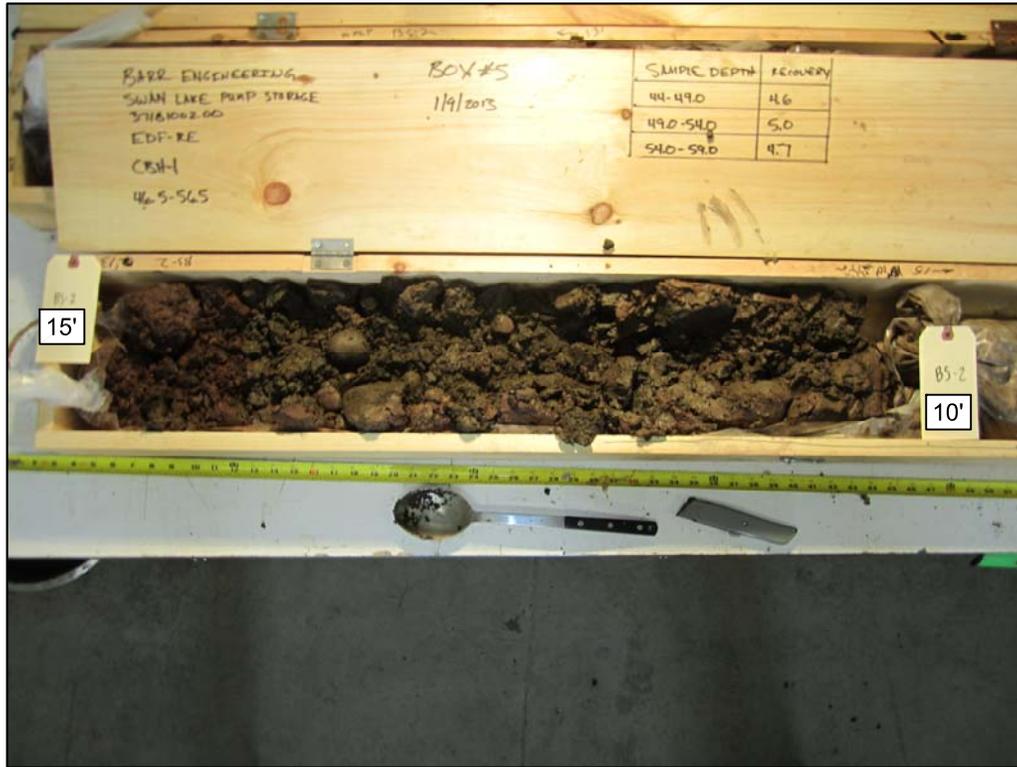
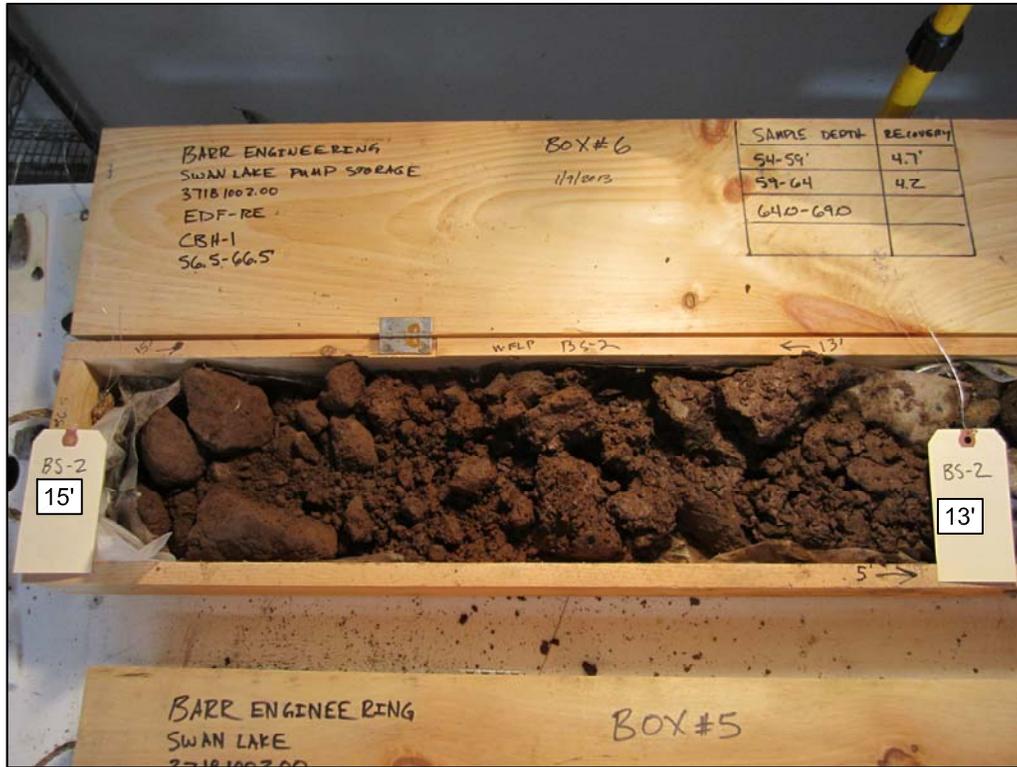
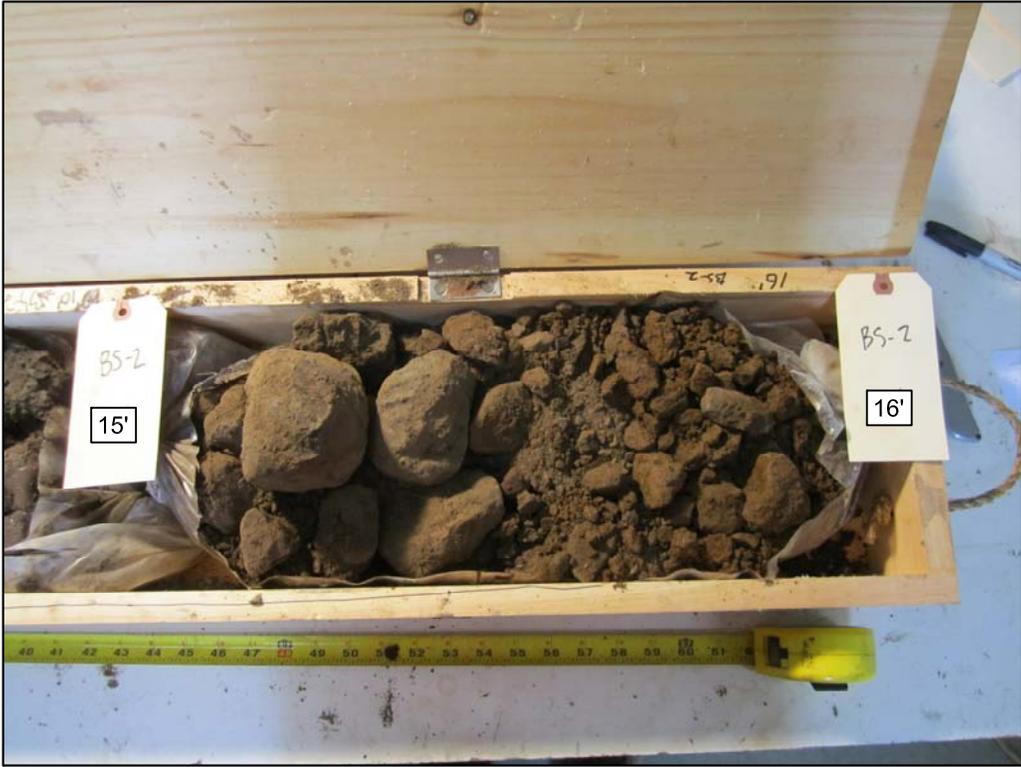
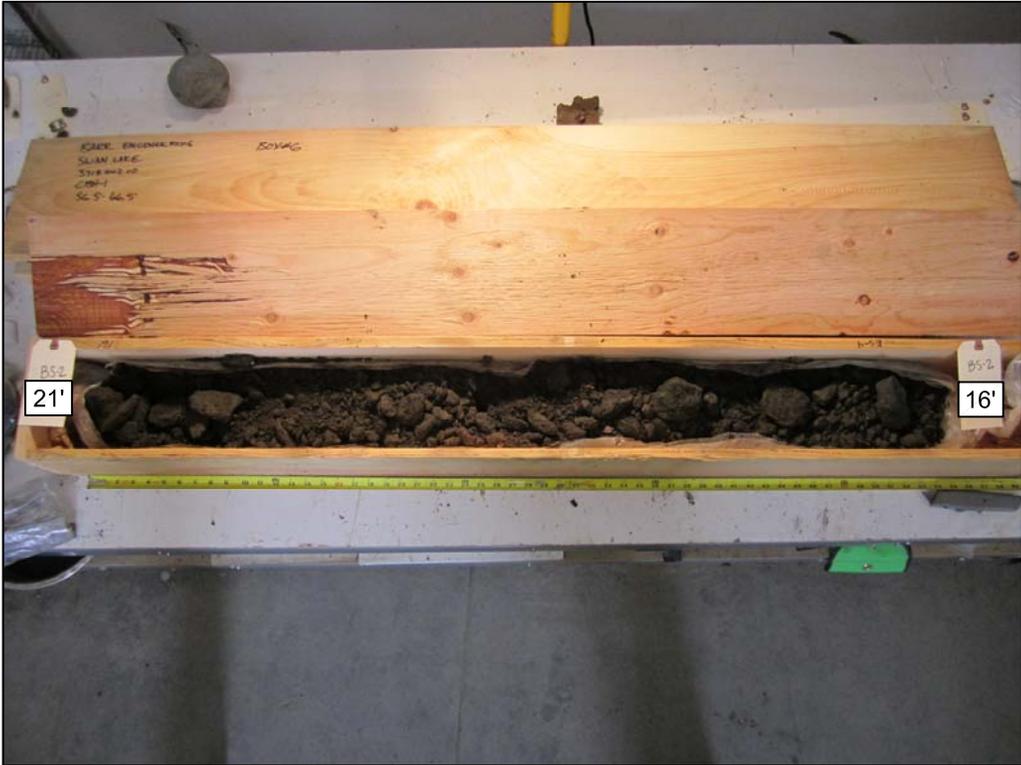
FIGURE NO. C-2 (1 OF 4)

CORE LOG PHOTO S-2

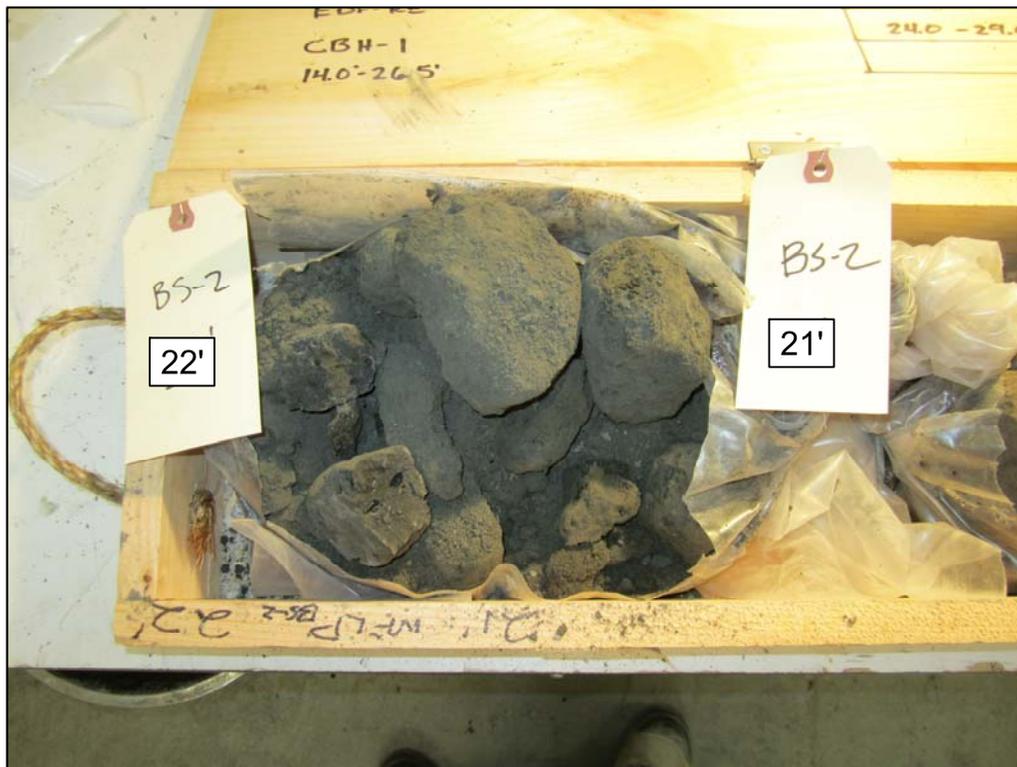
FIGURE NO. C-2 (4 OF 4)

CORE LOG PHOTO S-2

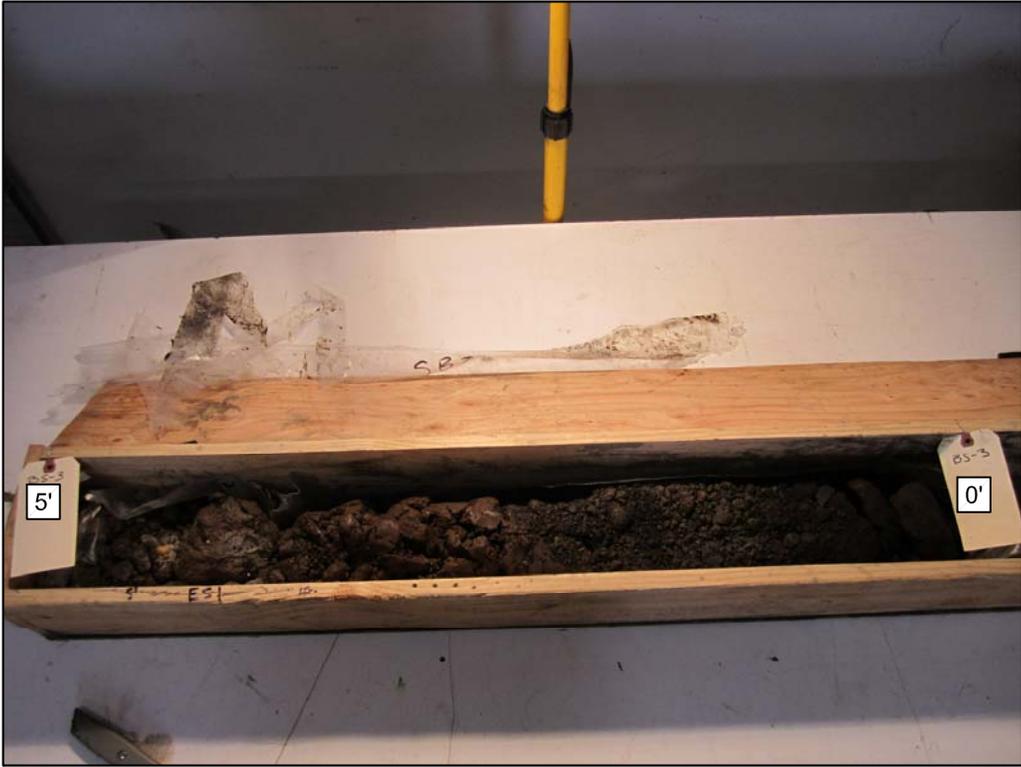
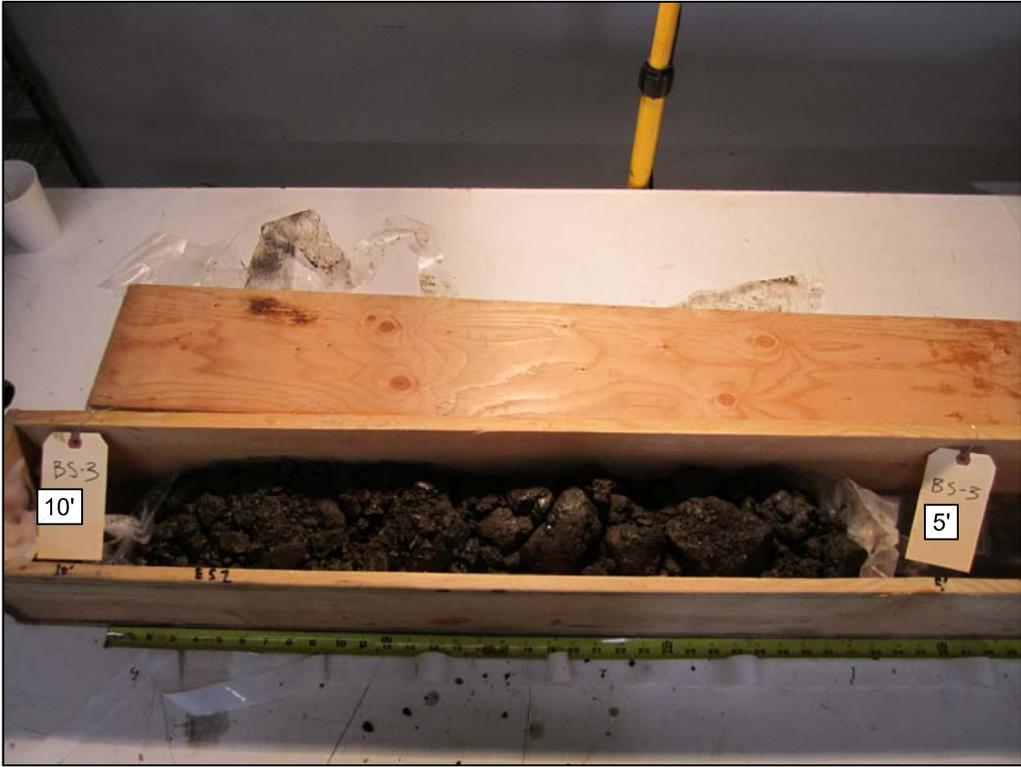
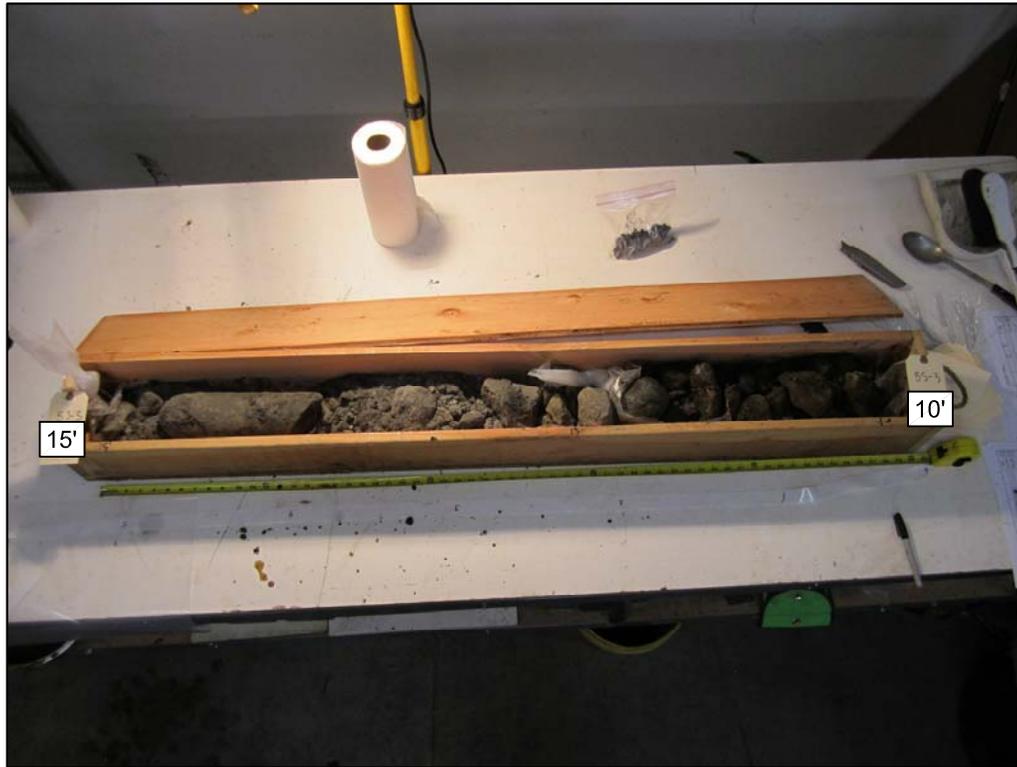
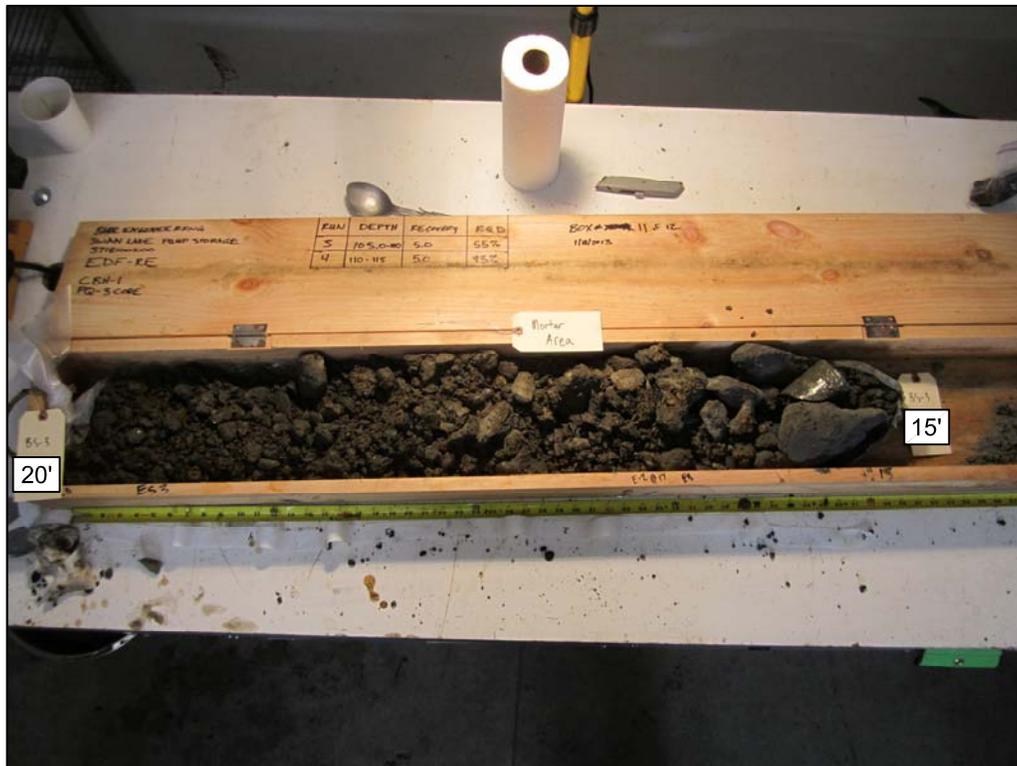
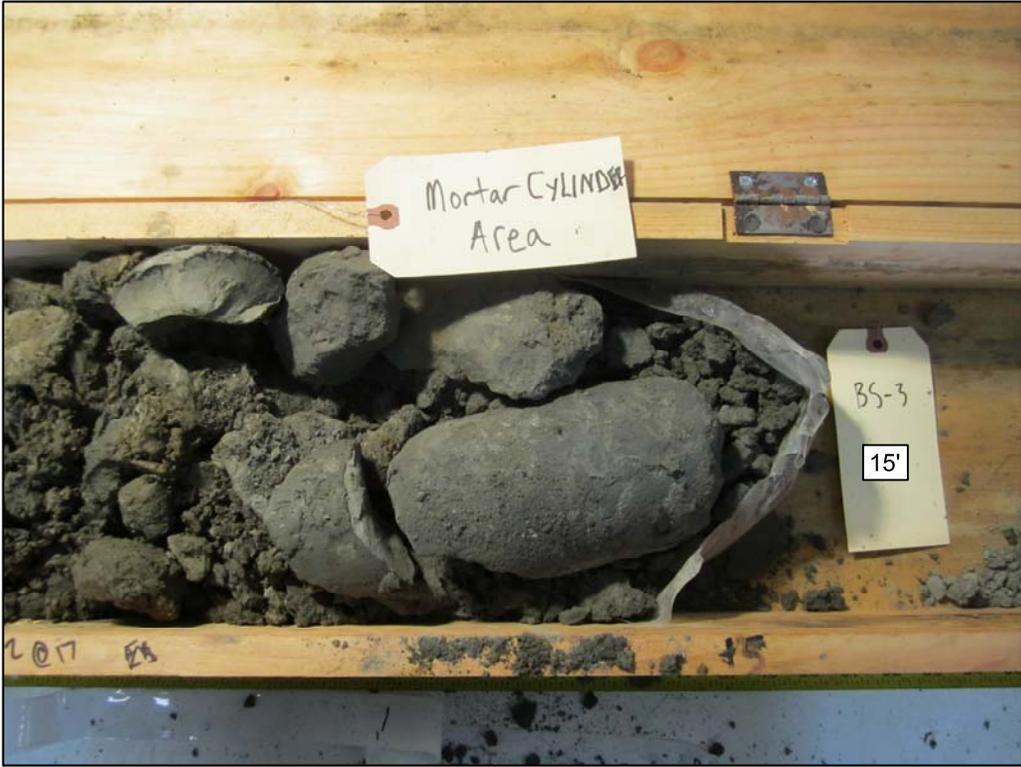
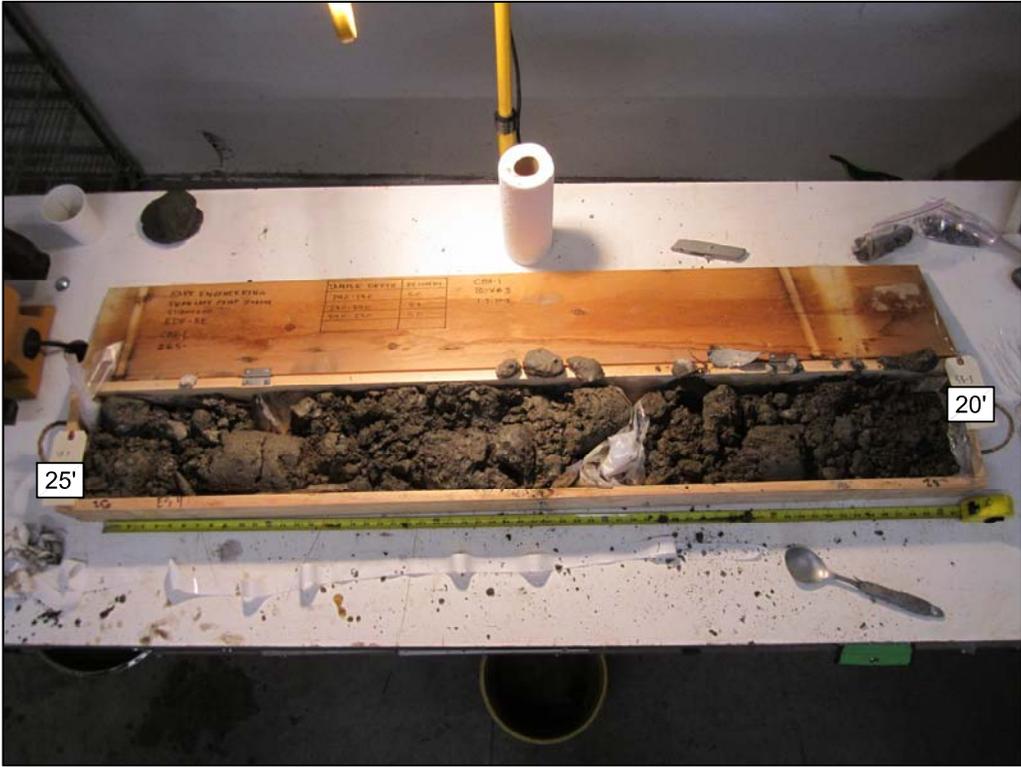
FIGURE NO. C-3 (1 OF 5)

CORE LOG PHOTO S-3

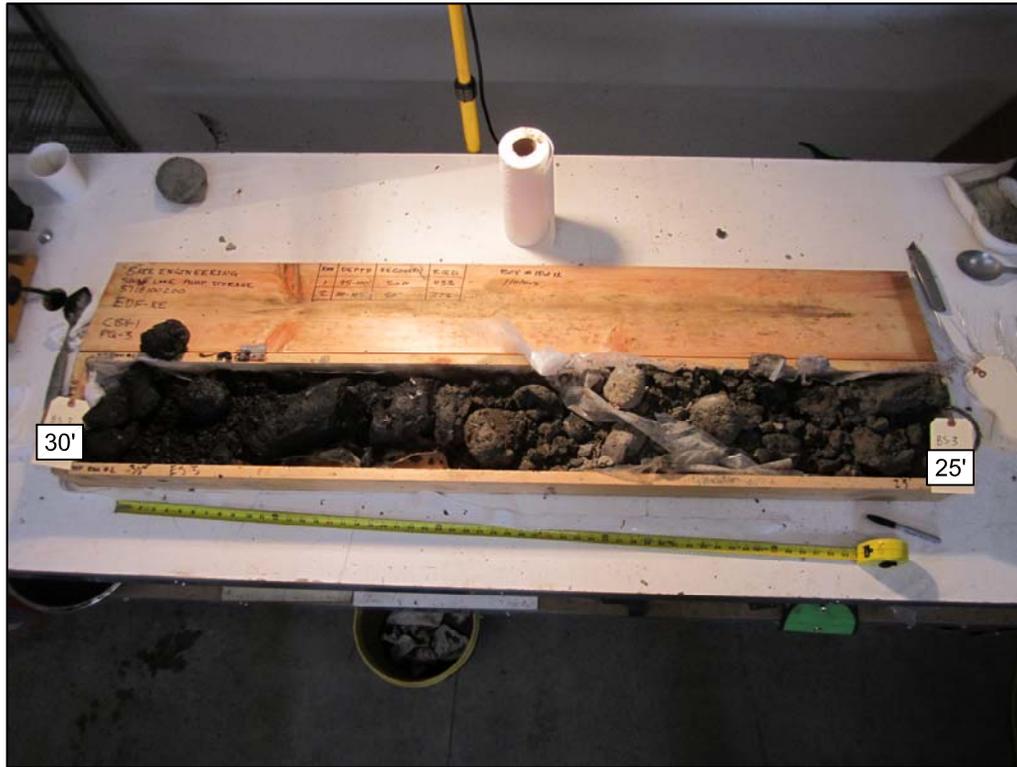
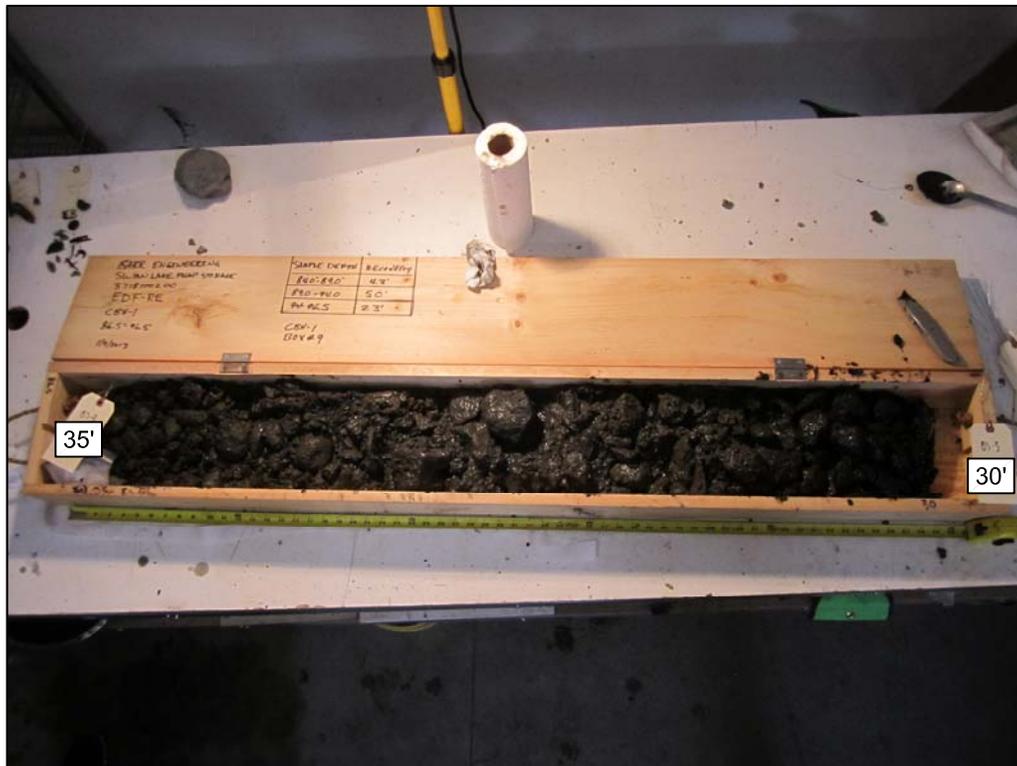
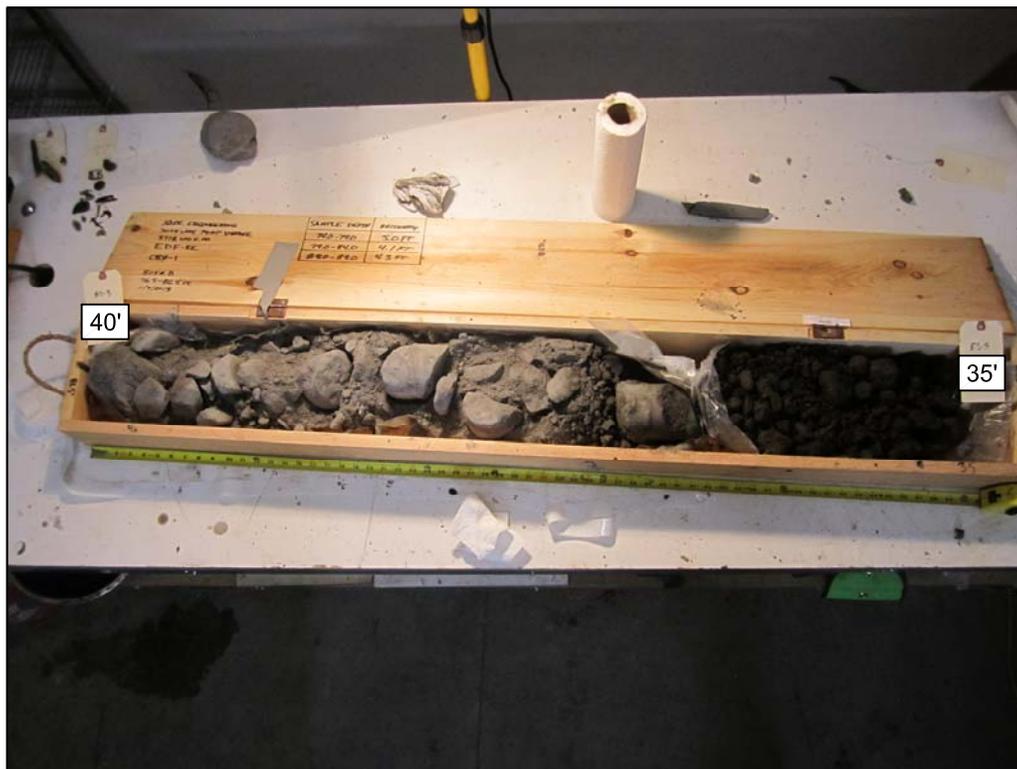
FIGURE NO. C-3 (4 OF 5)

CORE LOG PHOTO S-3

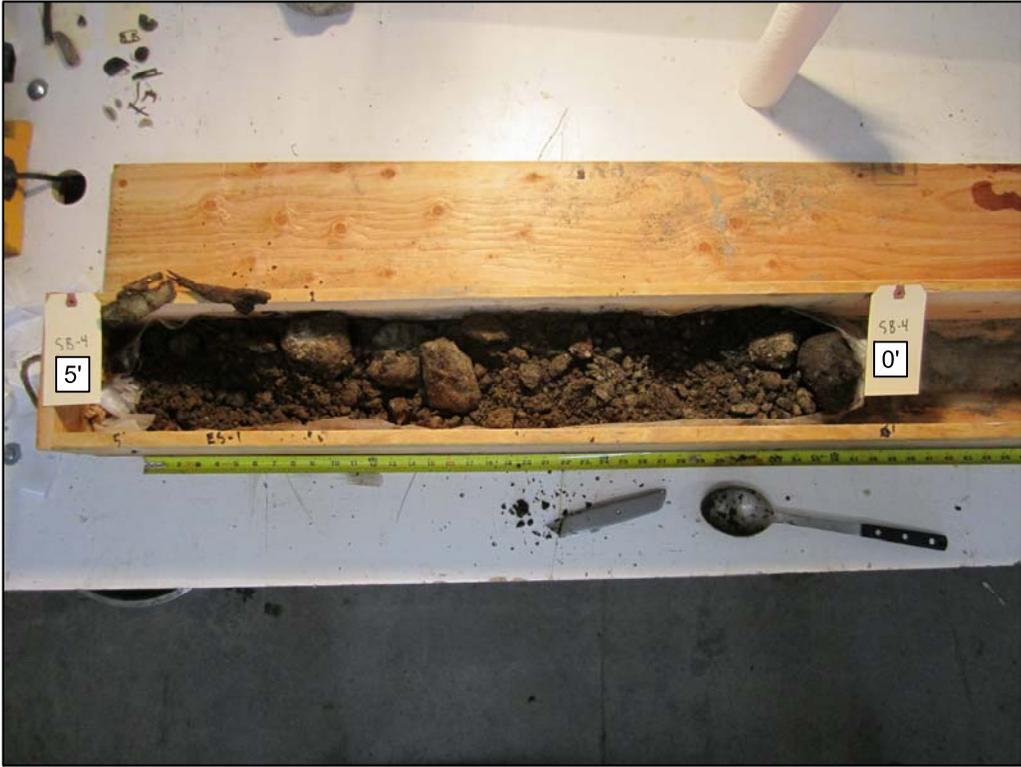
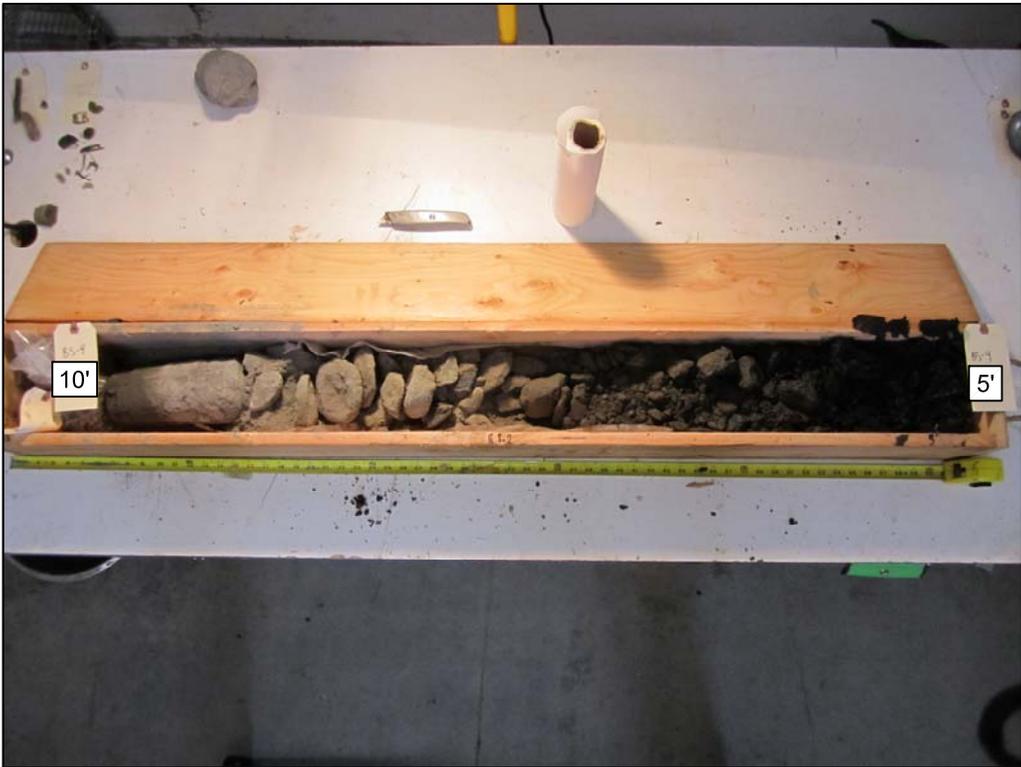
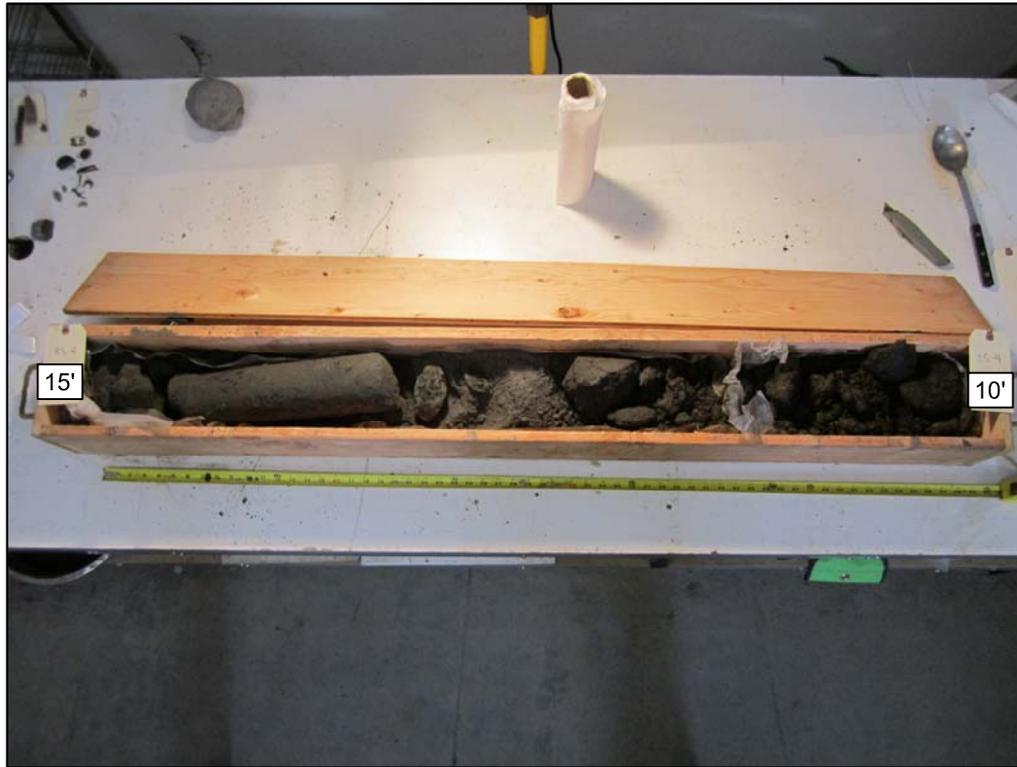
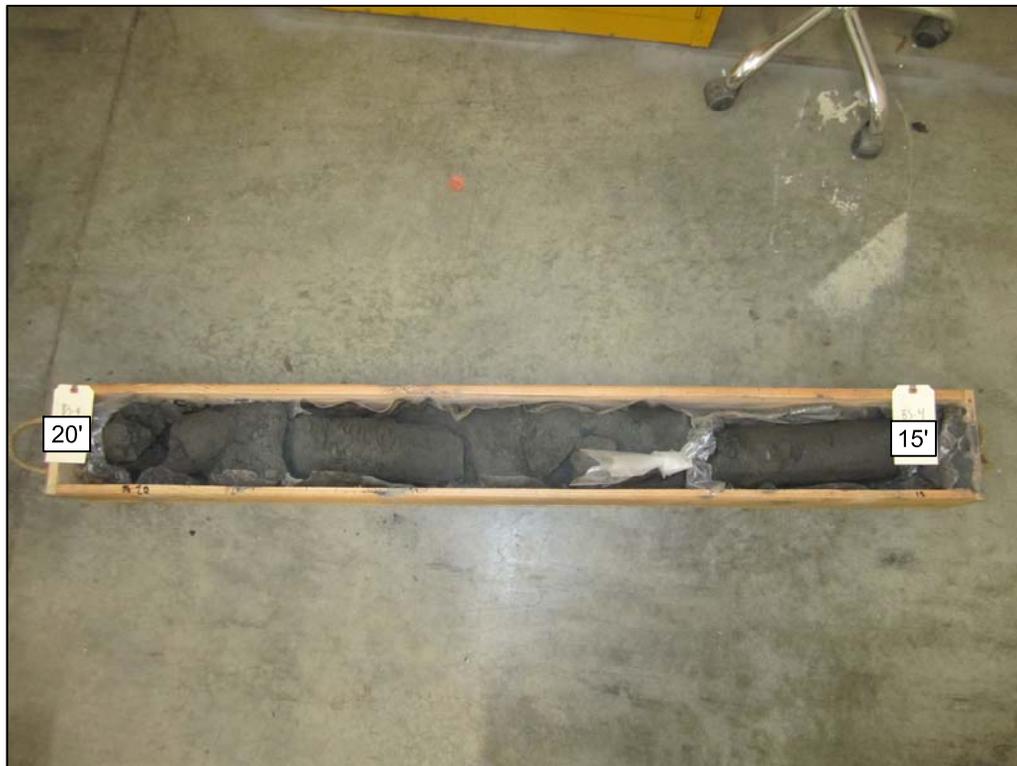
FIGURE NO. C-4 (1 OF 2)

CORE LOG PHOTO S-4

The result of the unconfined compressive strength of the basalt was only possible from the S-4 boring as no solid cores long enough to be tested were recovered elsewhere. The test result indicated an unconfined compressive strength of 6,720 psi.
